**Re: Revised Deferral Request
Ogden Dump Valve Release
Incident Number nAPP2216725109
Eddy County, New Mexico**

BTA Oil Producers, LLC
Revised Deferral Request
Ogden Dump Valve Release

**Re: Deferral Request
Ogden Dump Valve Release
Incident Number NAPP2216725109
Eddy County, New Mexico**

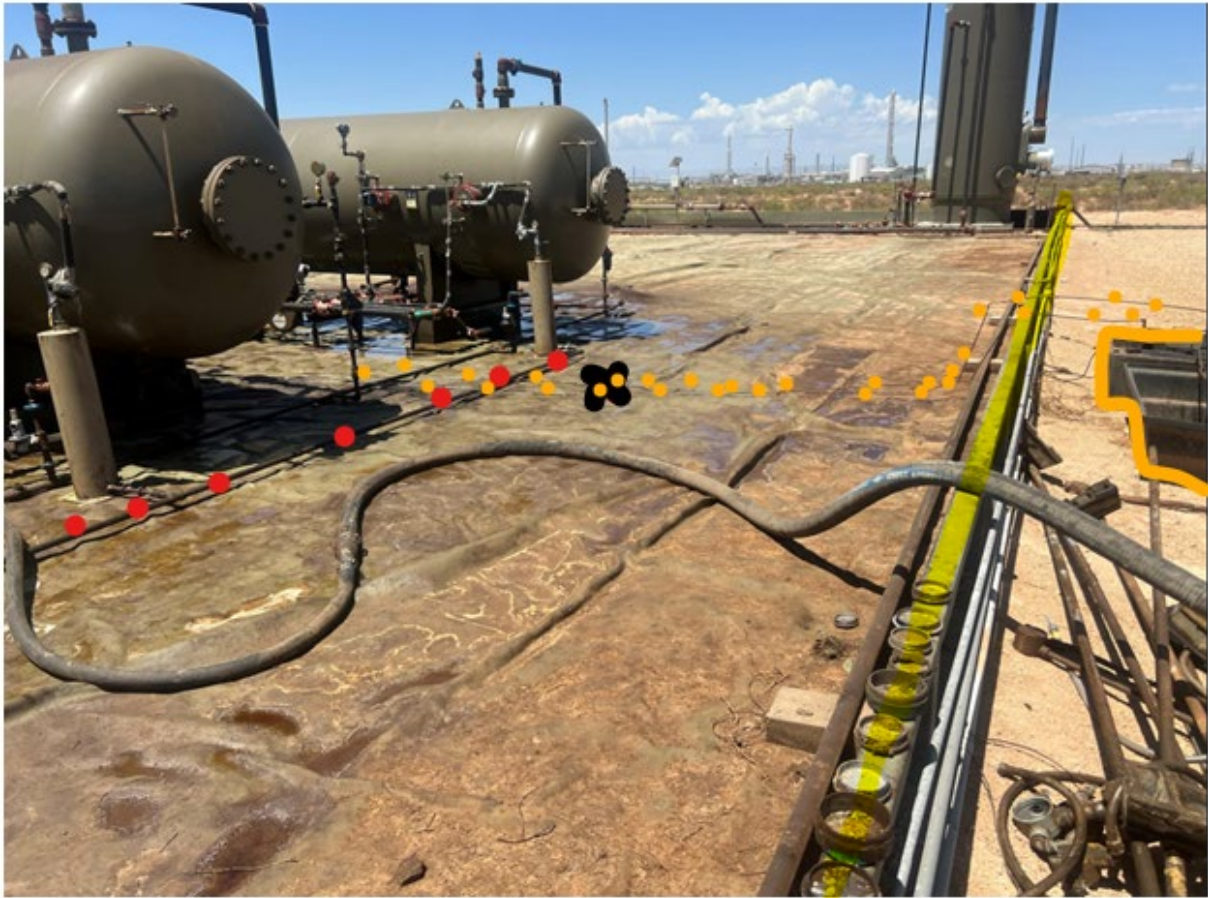
- The area is not free of equipment, please see the photo, included in the photolog in the report, below marked with the active equipment and noting the proximity of the steel containment wall. In addition, a second photo below shows equipment just outside this location, which would have to be shut down and possibly removed in order to reach the location of the impacted soil. Note that the second photo was taken just prior to completing the delineation, the black x marks the approximate location of BH01.

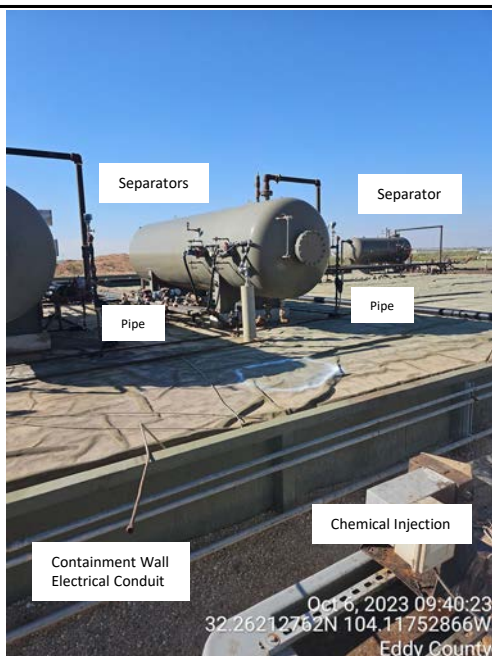
Photograph 1 Date: October 6, 2023
Description: Patched liner at BH01 location, facing southwest

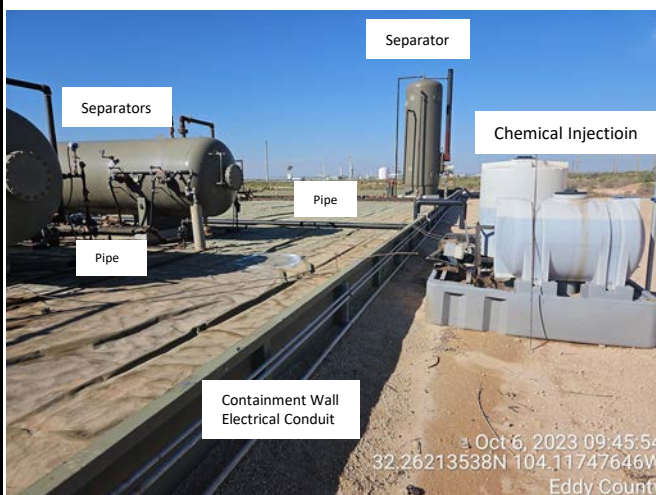
Photograph 2 Date: October 6, 2023
Description: Patched liner at BH01 location, facing west

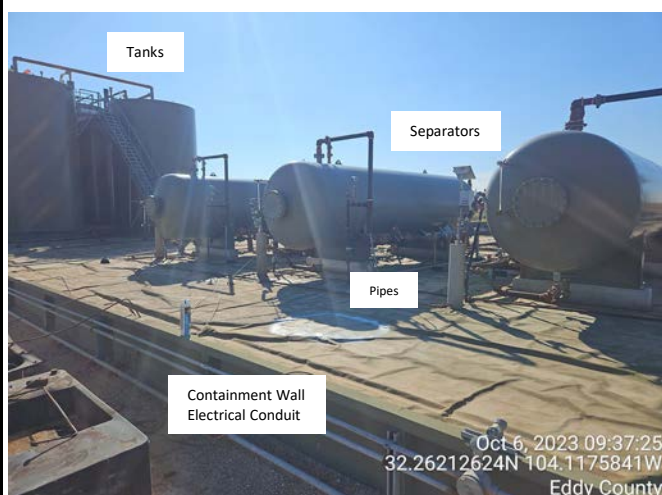
Photograph 3 Date: October 6, 2023
Description: Patched liner at BH01 location, facing southeast

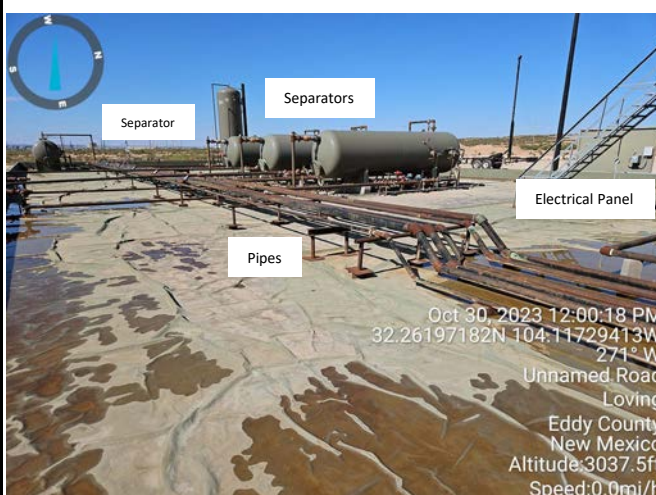
Photograph 4 Date: October 30, 2023
Description: Active equipment inside of lined containment, facing northwest

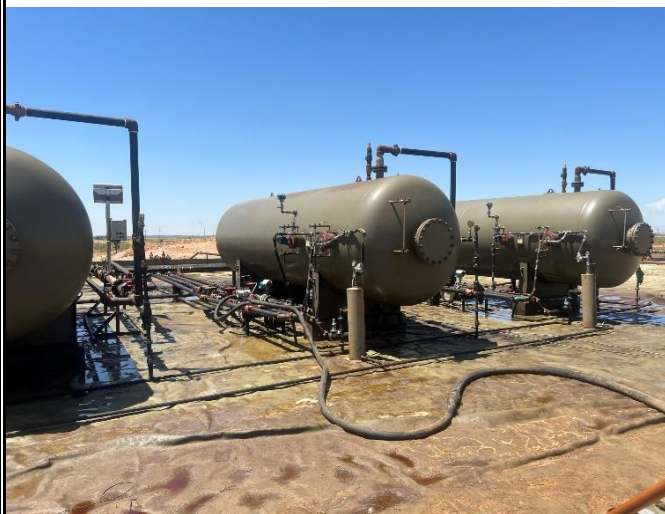
Photograph 1 Date: June 23, 2022

Description: Photo of release extent taken during Liner Inspection activities, facing southwest.

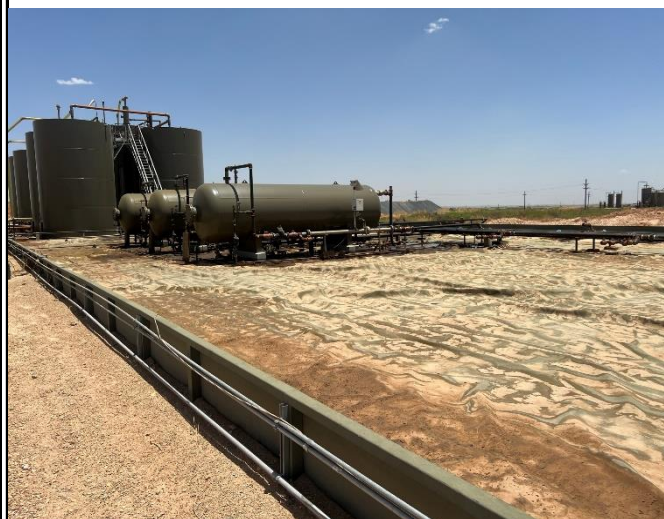
Photograph 2 Date: June 23, 2022

Description: Photo of release extent confined in secondary containment, facing southeast.

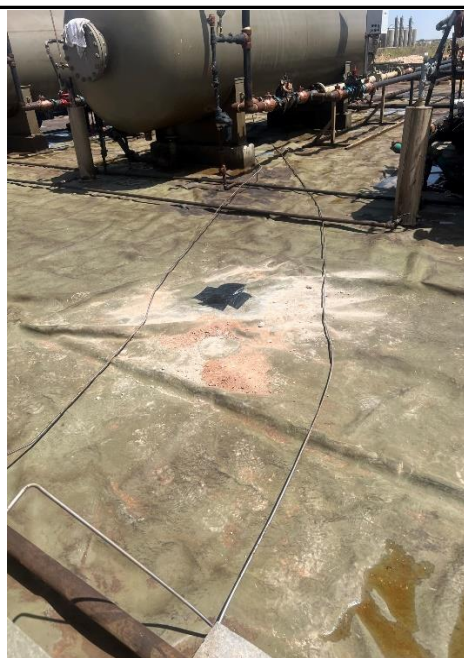
Photograph 4 Date: June 24, 2022

Description: Photo of BH01 location taken during delineation activities, facing south.
