## Release Notification

Site Name San Juan 28-7 Unit 183M	Site Type Well Site
Date Release Discovered 01/15/2019	API# (if applicable) 30-039-25660

Re: Closure Report  
San Juan 28-7 Unit 183M  
Hilcorp Energy Company  
Rio Arriba County, New Mexico  
Incident ID No.: NCS1901627746

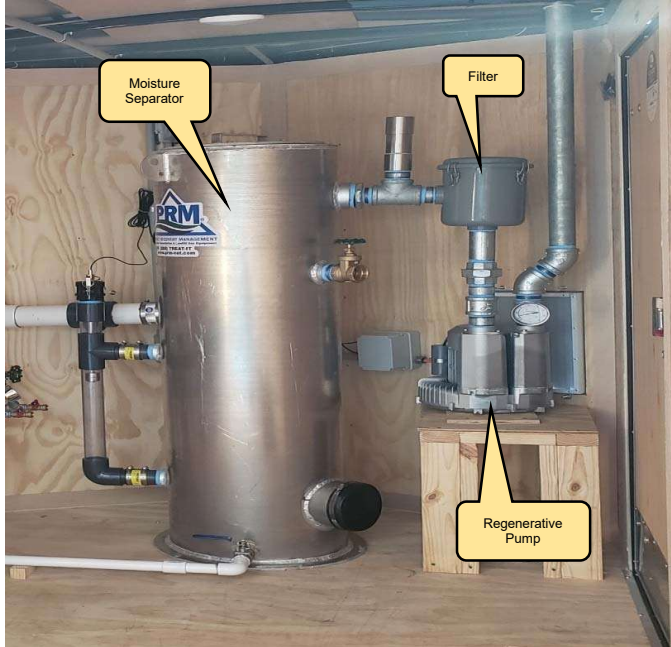
<b>Direction:</b> N/A			
<b>Comments:</b> View of moisture separator, filter, and regenerative pump.			
<b>Photo No.:</b> 4

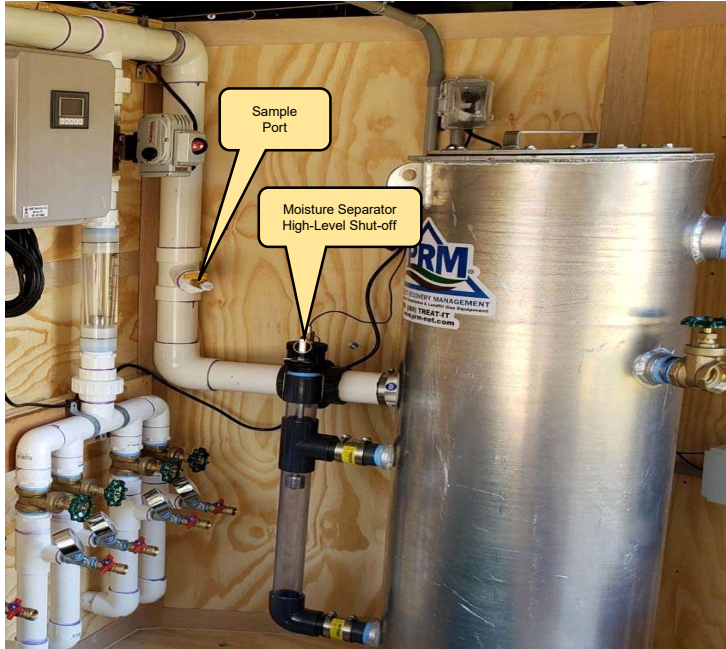
<b>Direction:</b> N/A			
<b>Comments:</b> View of leg 1 of the manifold and automation system, trunk line, moisture separator high-level shut-off, and gas sample port.

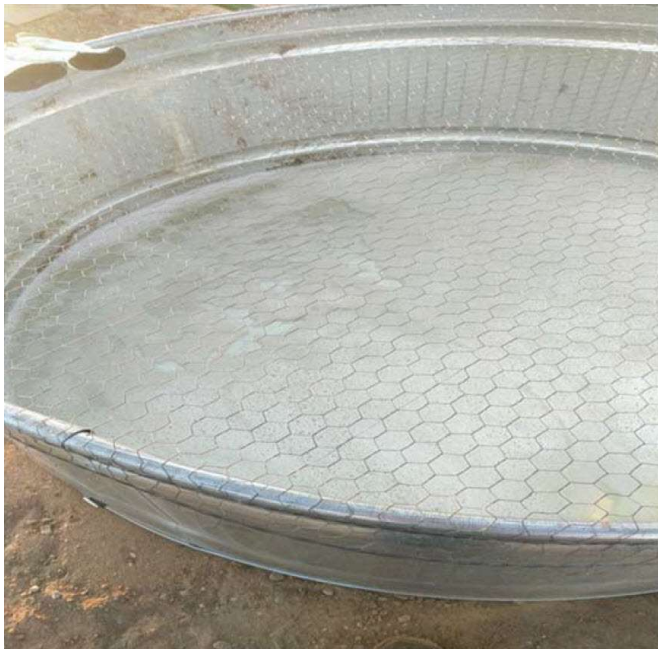
<b>Direction:</b> N/A			
<b>Comments:</b> View of open-top water/condensate storage tank fitted with bird netting.			
<b>Photo No.:</b> 6

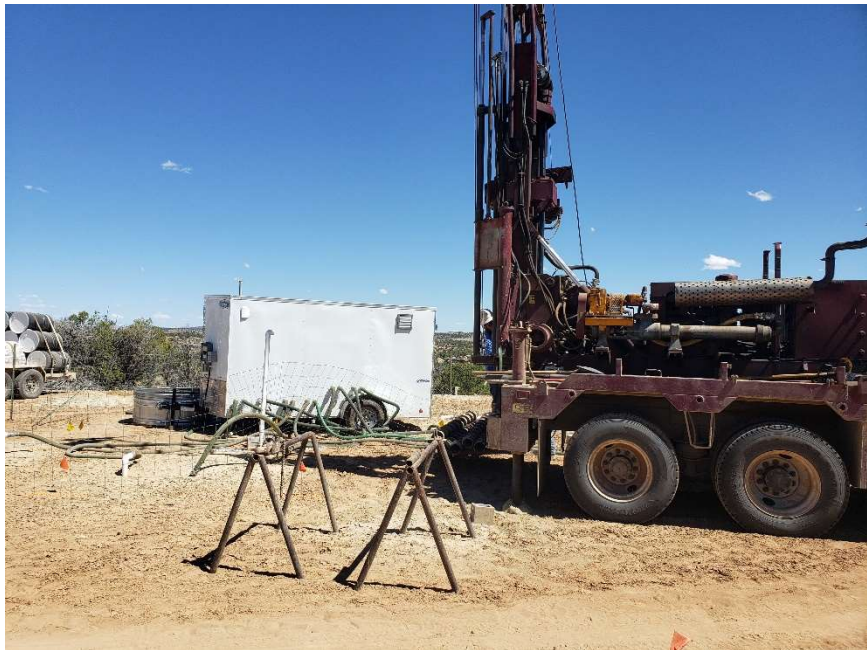
<b>Direction:</b> East			
<b>Comments:</b> View of drilling rig during soil monitoring event, location is SM4.  Note: SVE trailer in background.

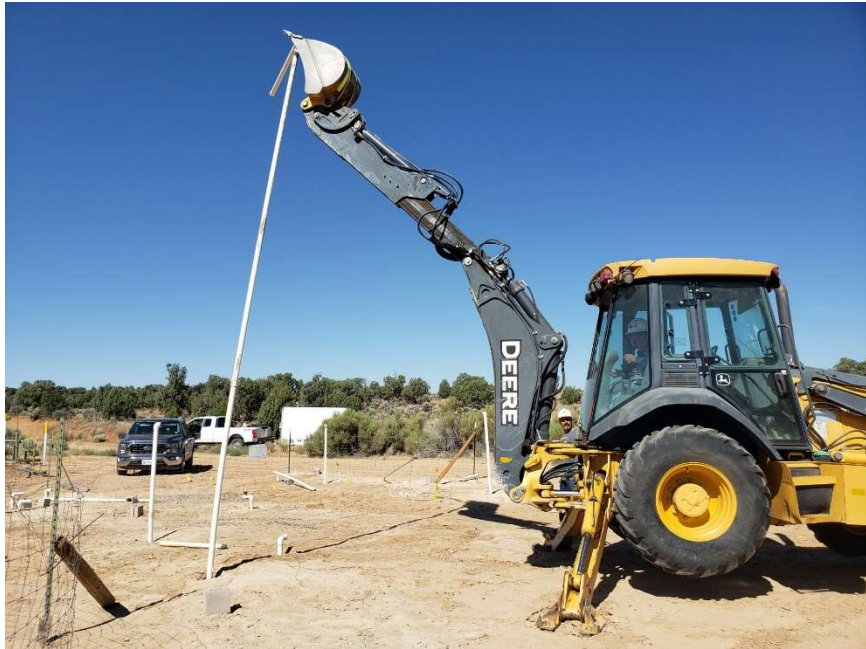
<b>Direction:</b> North			
<b>Comments:</b> SVE well and vent plugging and abandonment.  Note: All wells were sealed with hydrated bentonite.			
<b>Photo No.:</b> 8

SVE wells and vents were removed with a backhoe and plugged with hydrated bentonite. The horizontal extent of impacted soil was delineated as 20 ft x 28 ft, a footprint of 560 square feet (ft<sup>2</sup>) with perimeter of 96 linear feet. Approximately 125 cubic yards (yd<sup>3</sup>) of clean overburden soil was excavated and stockpiled adjacent to the excavation as shown in Figure 6. The impacted soil from the 6.0 to 9.5 ft depth interval was treated in place. A fence was erected surrounding the excavation and stockpiles and the excavation was sloped to allow an escape route for wildlife.

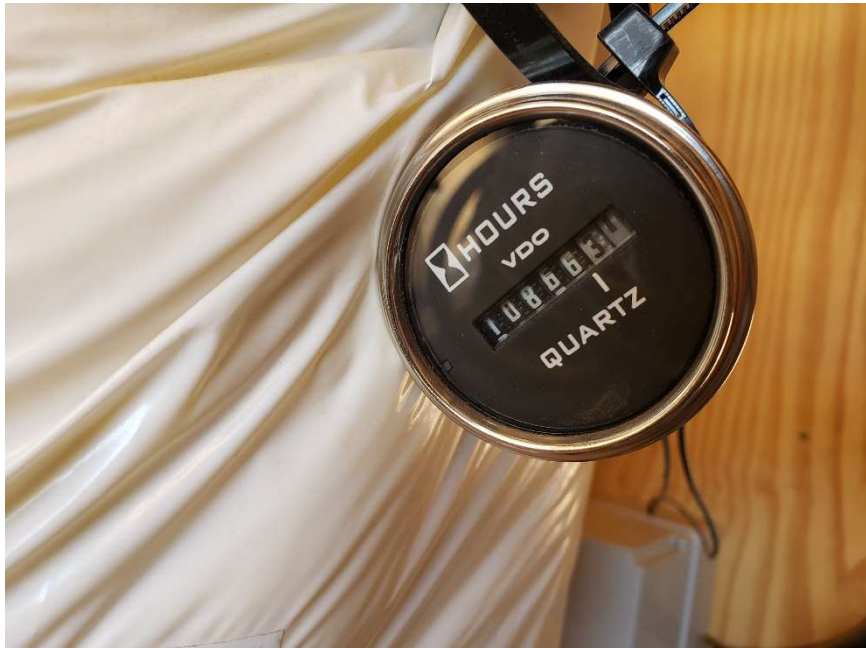
<b>Direction:</b> N/A			
<b>Comments:</b> View of hour meter reading at system shut down on 07/24/23 at 11:00.

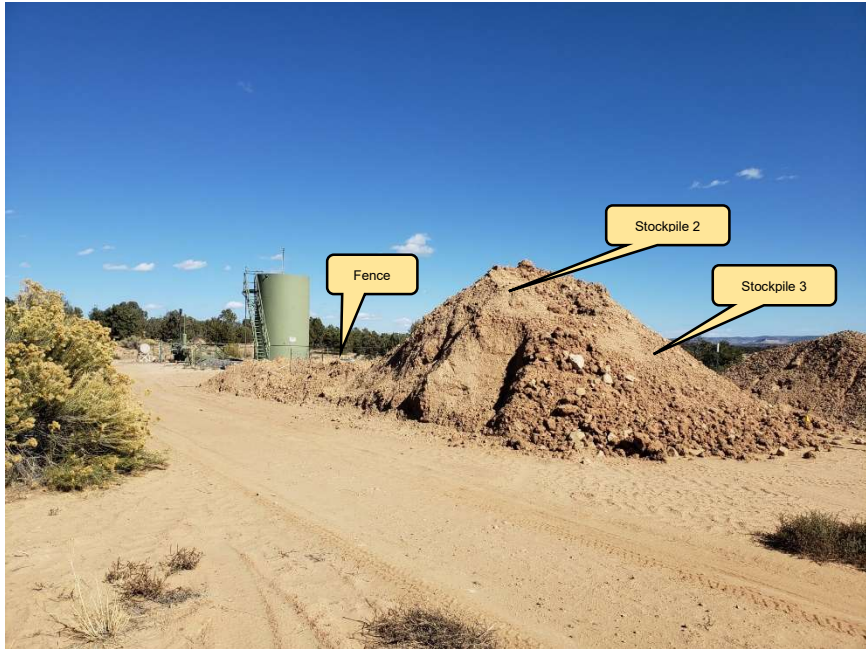
<b>Direction:</b> Northeast			
<b>Comments:</b> View of stockpiled overburden soil, earthen vehicle barricade, and fence.			
<b>Photo No.:</b> 8

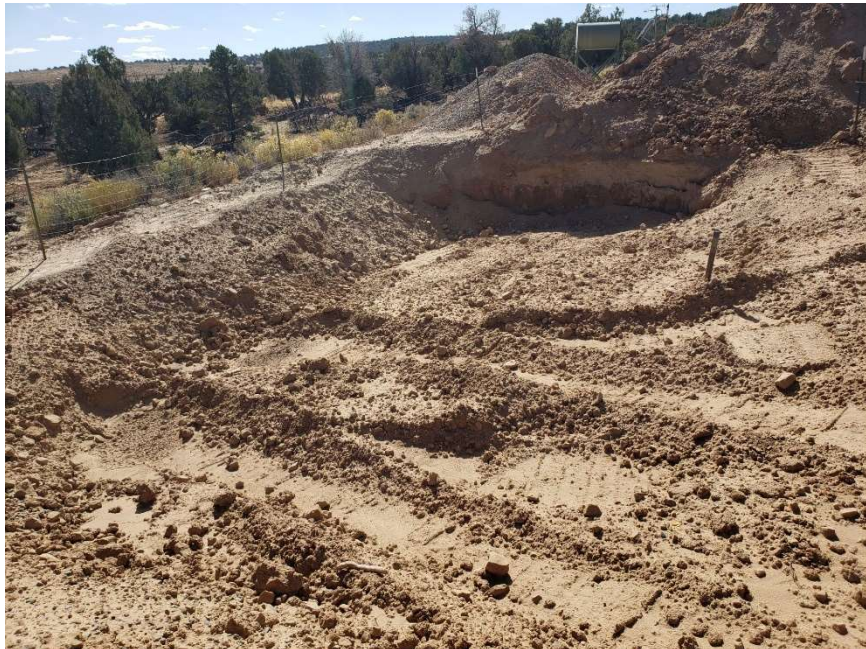
<b>Direction:</b> South			
<b>Comments:</b> View of in-situ treated soils.  Note: sidewalls sloped to allow escape route for wildlife and perimeter fencing.

The soil was mixed using an excavator to: 1) incorporate amendments, 2) promote volatilization of the most volatile hydrocarbon fraction (i.e., GRO), and 3) aerate the soil to promote biodegradation. Approximately 73 yd<sup>3</sup> of soil was treated in-situ. The final size of the excavation measured approximately 28 ft by 20 ft (approximately 560 ft<sup>2</sup>), with an average depth of 9.5 ft bgs. Corrective actions are documented in the attached photographic log.
