Closure Report
HHNM Pipeline ROW (8.25.2023)
Incident #: nAPP2325255948
Eddy County, New Mexico
Unit H Sec 09 T26S R27E
32.059987°, -104.188197°

Diesel Release

**Re: Closure Report
HHNM Pipeline ROW (8.25.2023)
Chevron U.S.A., Inc.
Site Location: Unit H, S09, T26S, R27E
(Lat 32.059987°, Long -104.188197°)
Eddy County, New Mexico**

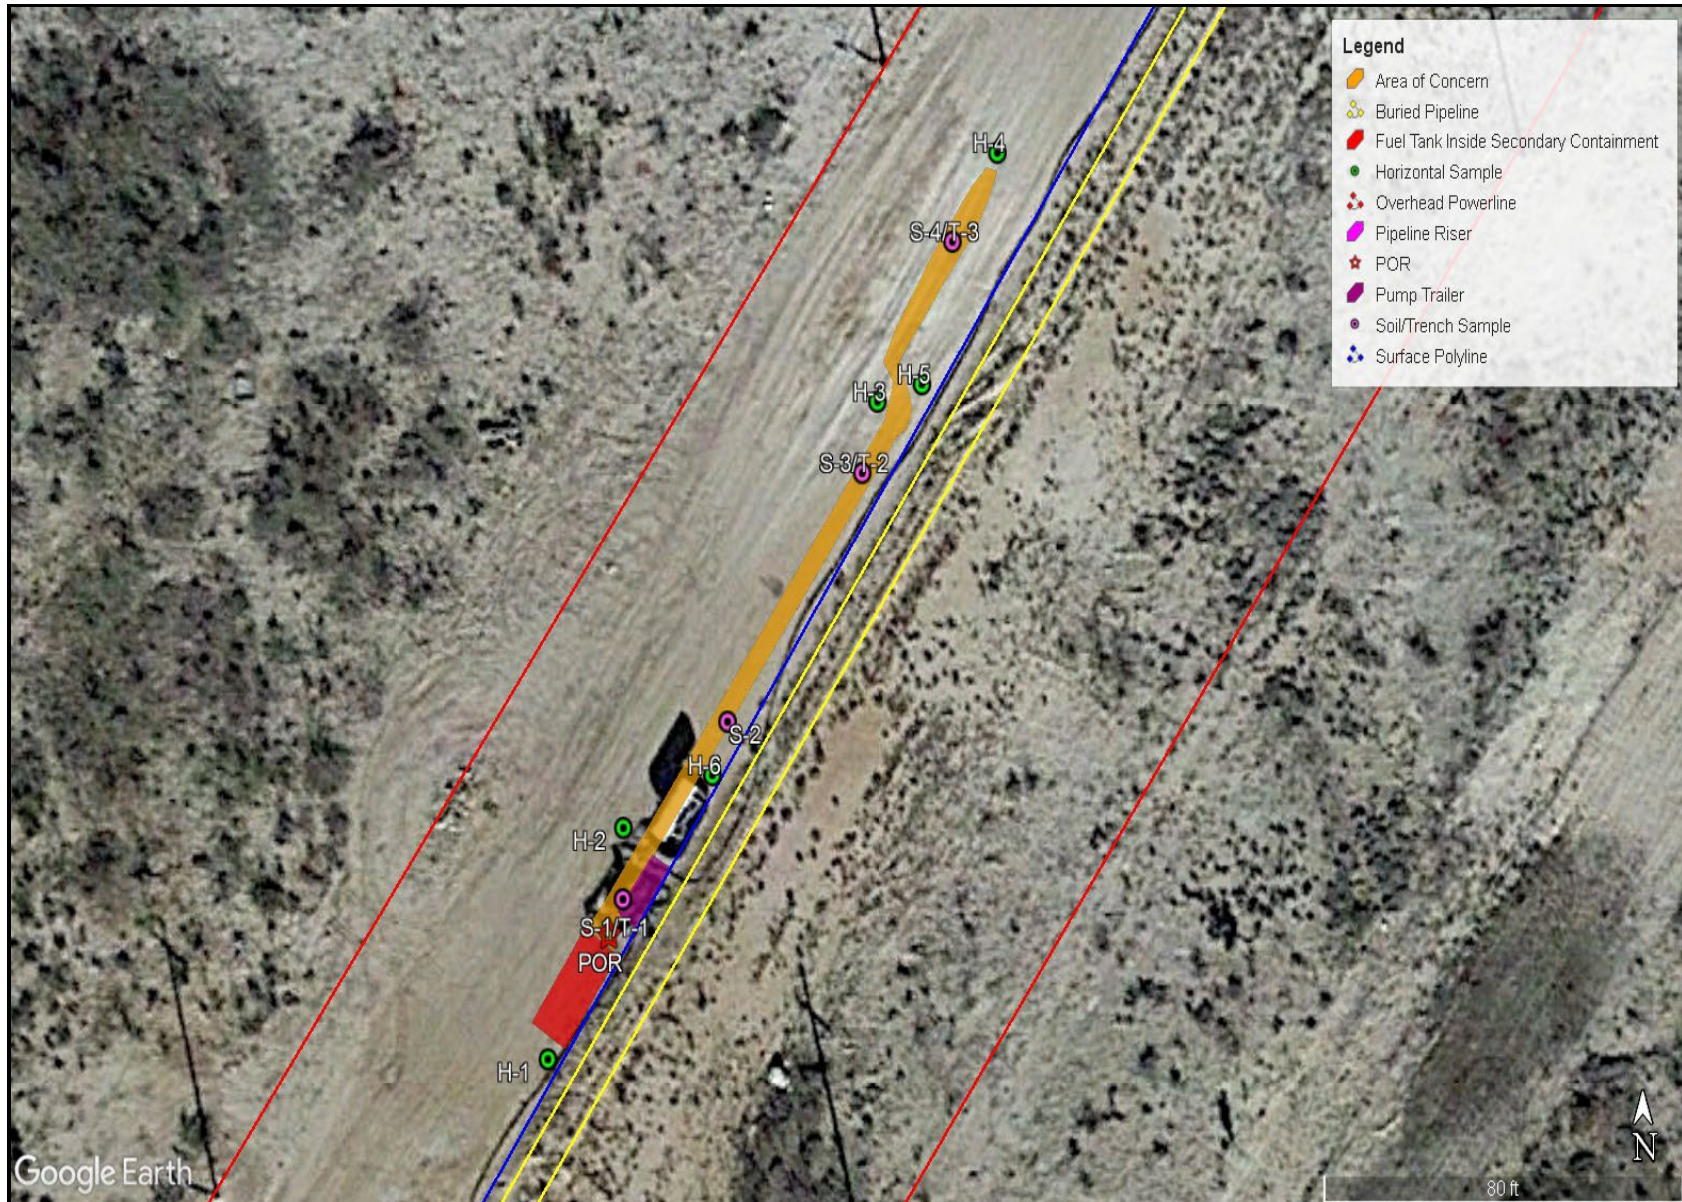
FIGURE 3

SAMPLE LOCATION MAP
CHEVRON U.S.A., INC.
HHNM PIPELINE ROW (8.25.2023)
EDDY COUNTY, NEW MEXICO
32.059987°, 104.188197°

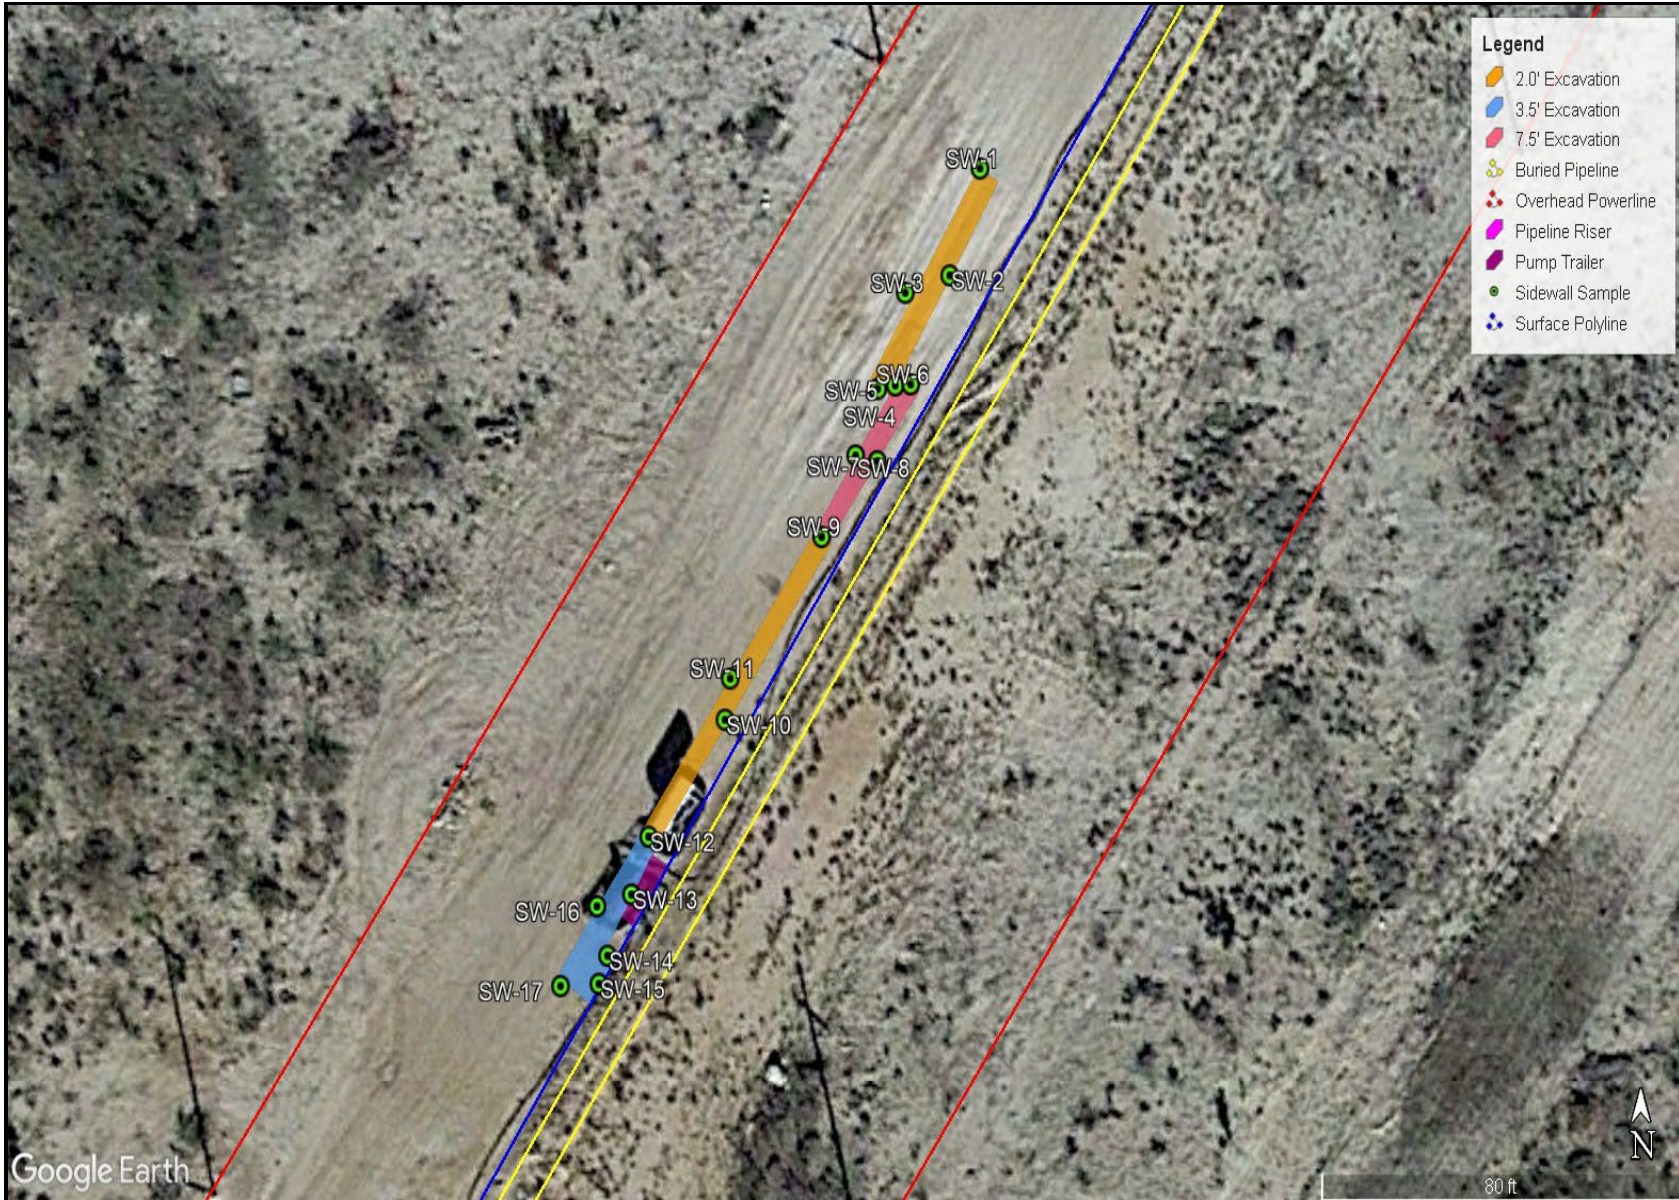
<p>EXCAVATION DEPTH MAP CHEVRON U.S.A., INC. HHNM PIPELINE ROW (8.25.2023) EDDY COUNTY, NEW MEXICO 32.059987°, 104.188197°</p>	<p>CARMONA RESOURCES  </p>	<p>FIGURE 4B</p>
--	--	------------------

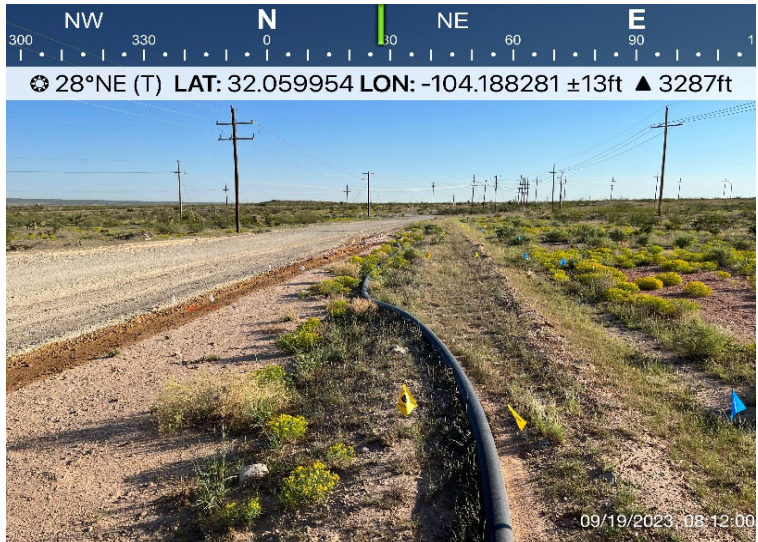
Photograph No. 2

View Northeast, area of point of release.

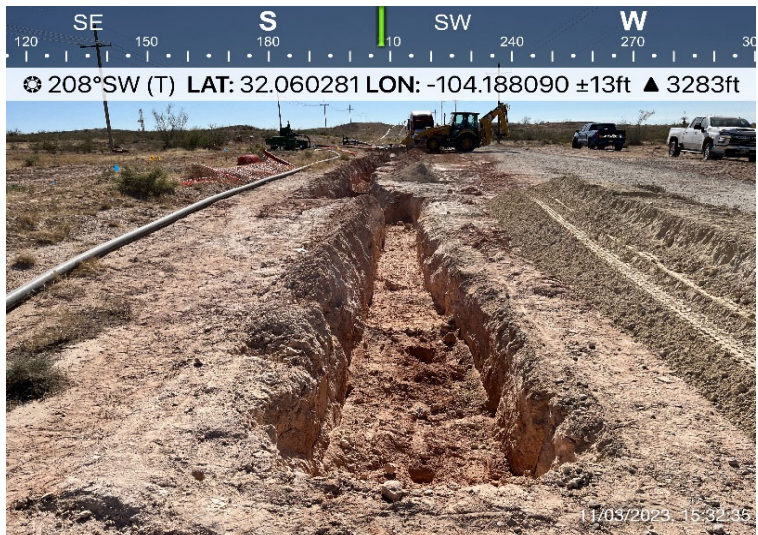
Photograph No. 3

View Southwest, area of CS-1 through CS-2.

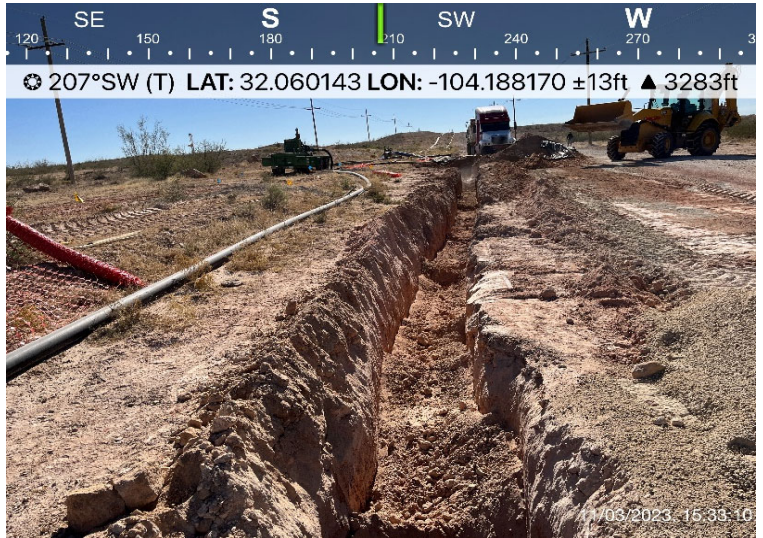
Description:
View Southwest, area of CS-3 through CS-5.
