**RE: Site Assessment, Remediation Work Plan, and Variance Request
State EF Com #001
API No. 30-025-01821
GPS: Latitude 33.389492 Longitude -103.5441055
UL "P", Section 6, Township 11S, Range 34E,
Lea County, NM
NMOCD Reference No. nAPP2323540131**

Raybaw Operating, LLC (Raybaw) has contracted Pima Environmental Services, LLC (Pima) to perform a site assessment, prepare this remediation work plan, and variance request for an unknown release that was found during an inspection at the State EF Com #001 (State). An initial C-141 was submitted on August 25, 2023, and can be found in Appendix C. This incident was assigned Incident ID nAPP2323540131, by the New Mexico Oil Conservation Division (NMOCD).

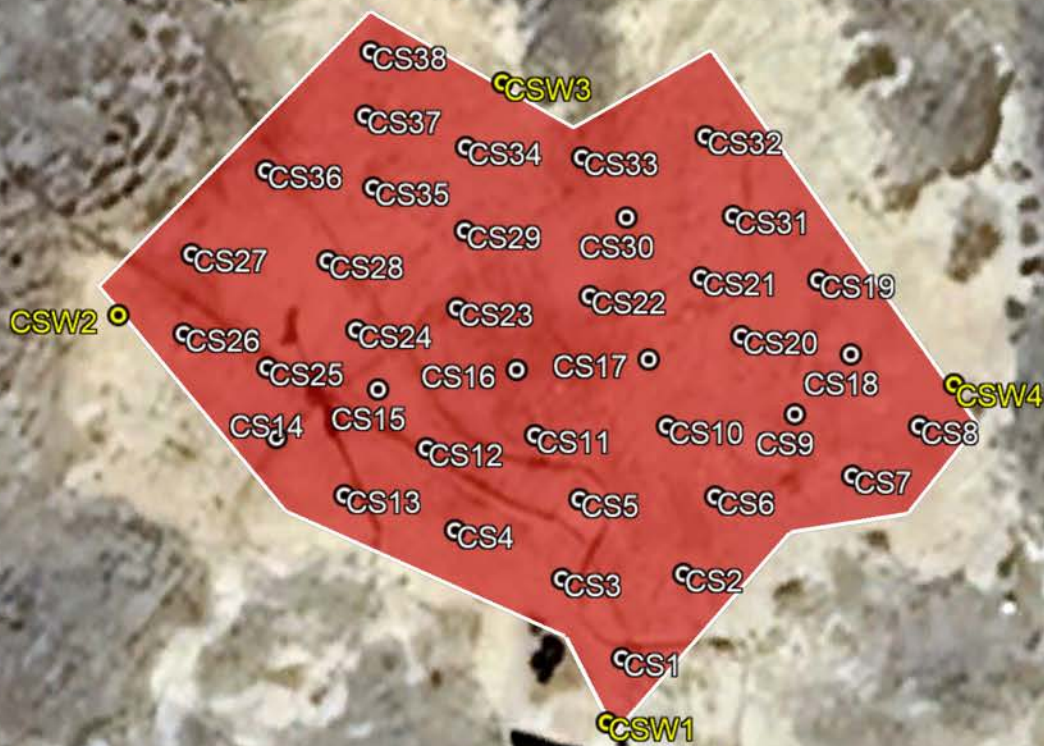
Raybaw Operating
API #30-025-01821
Lea County, NM
Variance Request Map

Based on the large area associated with this release, nAPP2323540131, Raybaw would like to request a variance regarding the number of 5-point composite confirmation samples required for closure. The current release area is approximately 15,000 feet squared, requiring 75 confirmation base samples and 4 confirmation sidewall samples, following the 200 square foot rule. We believe we can obtain an accurate representation of the remediated area by collecting 5-point composite confirmation samples every 400 square feet. If further contamination is encountered, the number of required samples will be adjusted to maintain representation of every 400 square feet. Maps and data will be adjusted to accurately reflect the field information. A Variance Request Map is included as Figure 5. A Written Demonstration of Equal Protection can be found in Figure 6.

- Composite Base Samples
- Composite Sidewall Samples
- Lack of Growth Area-15,000 SqFt

Created By	Condition	Condition Date
scwells	Remediation Plan Approved with Conditions. At time of review, OCD will not approve proposed number of samples as illustrated on Variance Request Map as site conditions may change during remediation/excavation but the variance request is approved to collect confirmation samples no more than 400 square feet. Pursuant to what was found in inspection on 8/2/2023, the 20X20 stain around wellhead (east of the pumpjack) also needs to be addressed during the remediation. Submit remediation closure report by 6/12/24.	3/14/2024

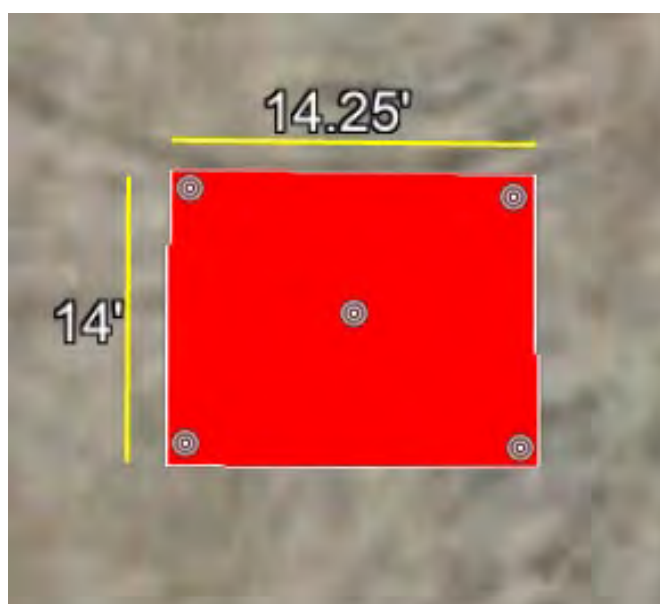
200 Square Foot

7. The impacted difference in collecting 5-point composite samples from every 400 square feet versus every 200 square feet can be seen in the following illustrations.

The purpose of this demonstration is to provide sufficient evidence that samples taken from every 400 square feet versus samples taken from every 200 square feet would provide equal or better protection of fresh water, public health, and the environment.

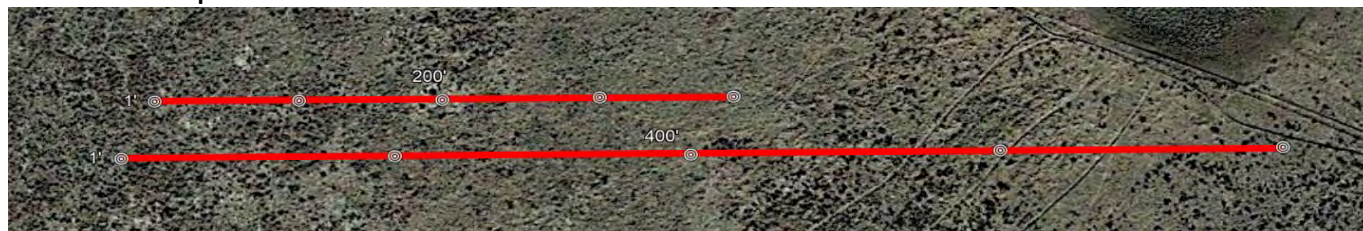
For Sidewall Samples

Top Line = 200 Square Foot

Bottom Line = 400 Square Foot
