Santo Nino 6" Steel Line
32.719745°, -104.006827°
NMOCD Reference #nAPP2234031436
Terracon Project # KH237019

RE: Release Investigation, and Closure Report

Santo Nino 6" Steel Line
Unit H, Section 30, Township 18 South, Range 30 East
32.719745°, -104.006827°
Eddy County, New Mexico
Terracon Project No. KH23019

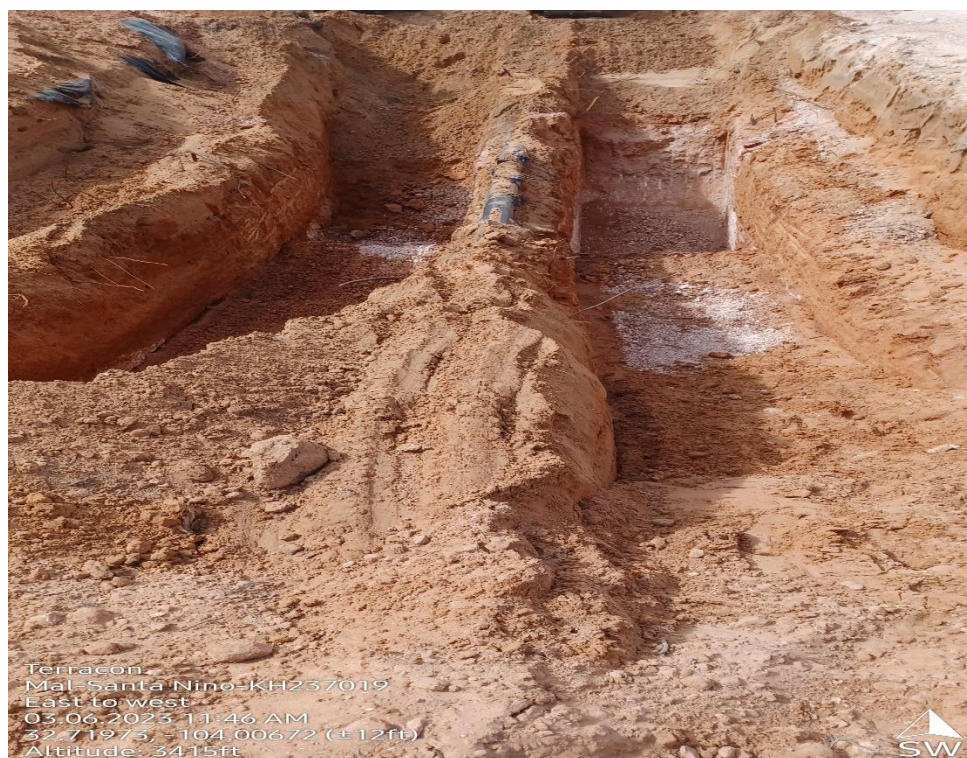
On March 6, 2023, Terracon mobilized to the site to meet Gandy Corporation (Gandy) personnel, who were to perform soil remediation activities. Areas exhibiting visual impact were excavated to a depth of approximately 4 to 5 feet bgs.

PHOTO 1: View of the excavation.

Approximately 800 cubic yards of soil were excavated and stockpiled atop a polyethylene liner pending waste characterization and disposal under an approved Form C-138. Excavation efforts ceased based on the results of removing visual impacts. Excavated materials were disposed of at Lea Land Landfill.

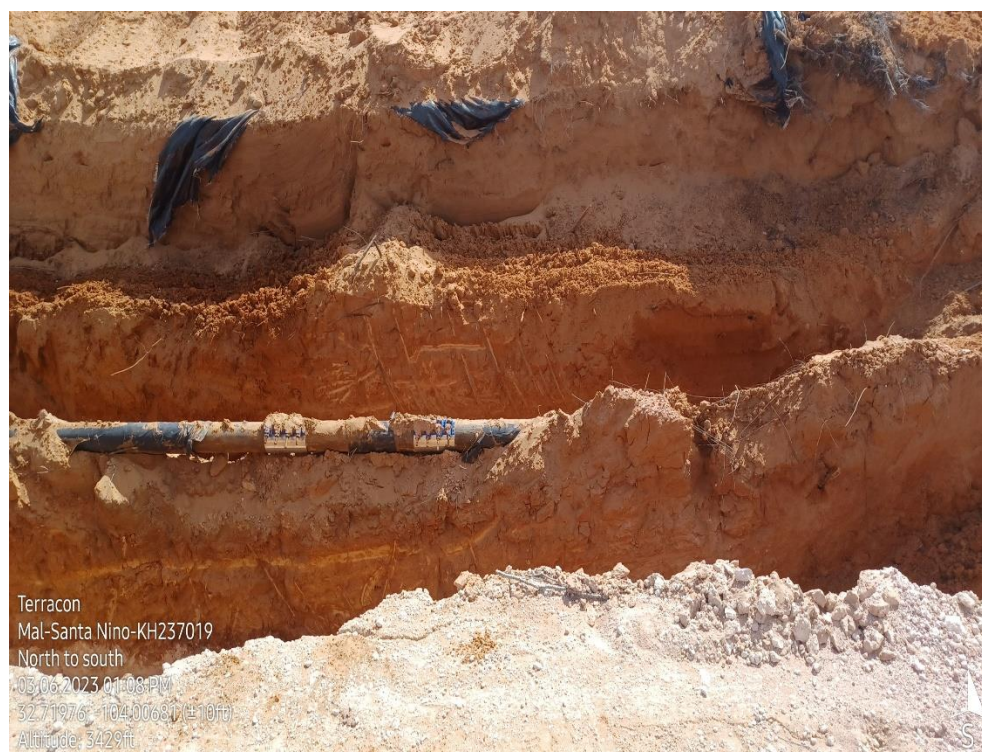
PHOTO 2: View of the excavation, south wall.

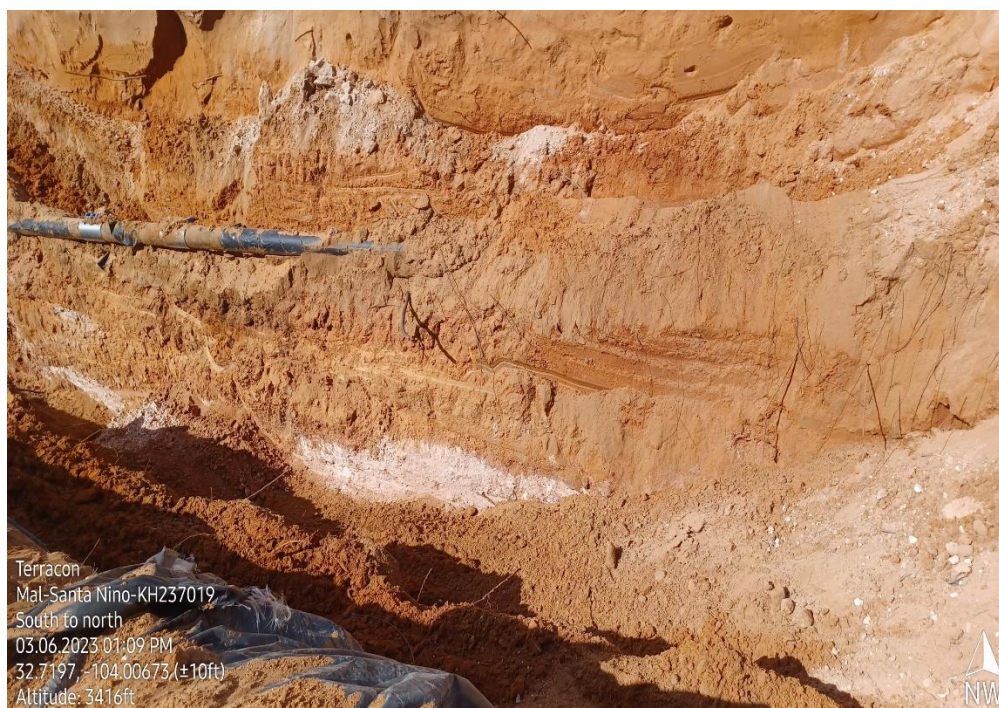
PHOTO 3: View of the excavation north wall.

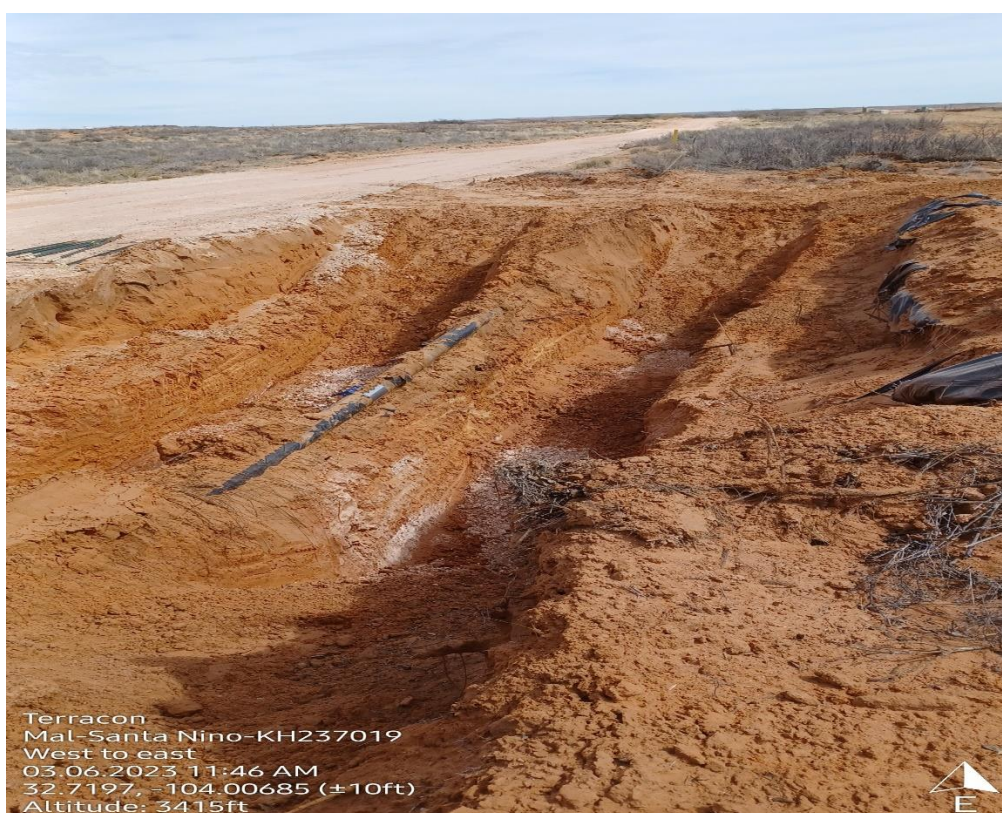
PHOTO 4: View of the entire site extent.
