Remediation Summary & Soil Closure Request

Mewbourne Oil Company Foxhole Tank Farm

Eddy County, New Mexico
Unit Letter "H", Section 25, Township 20 South, Range 28 East
Latitude 32.5471180 North, Longitude 104.123299 West
NMOCD Reference No. nAPP2219360589

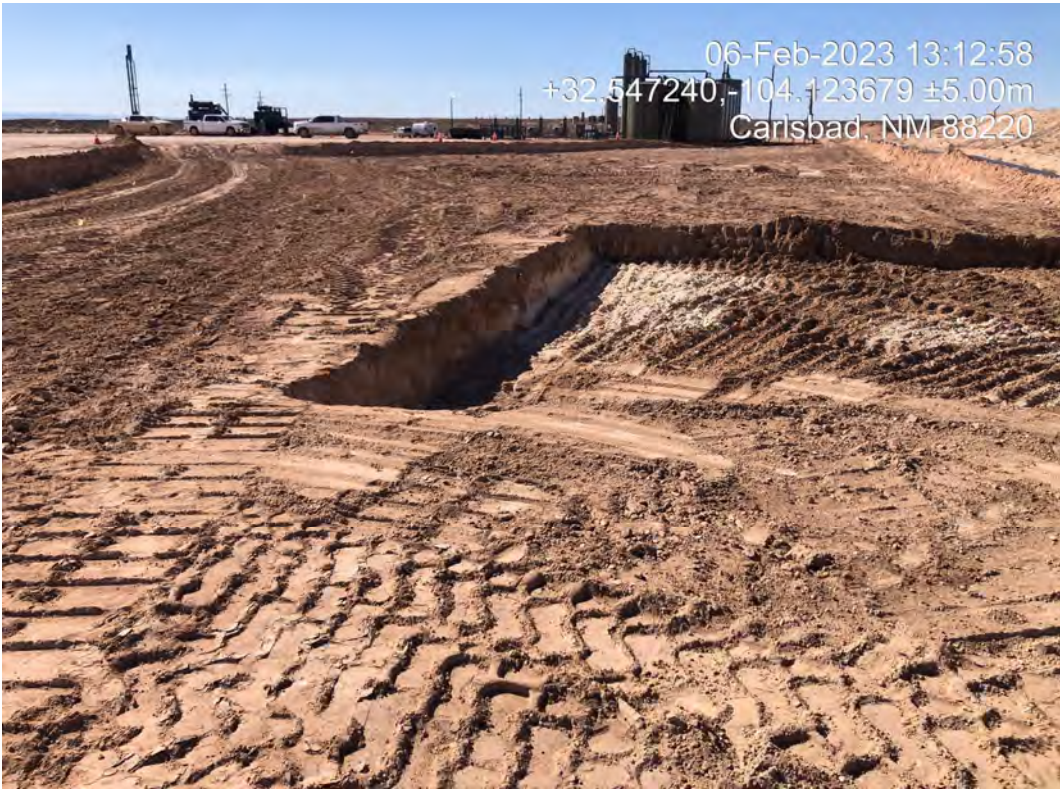
Photo Number: 1

<p>06-Feb-2023 13:12:58 +32.547240, -104.123679 ±5.00m Carlsbad, NM 88220</p>
Photo Direction: West	
Photo Description: View of the excavated area.

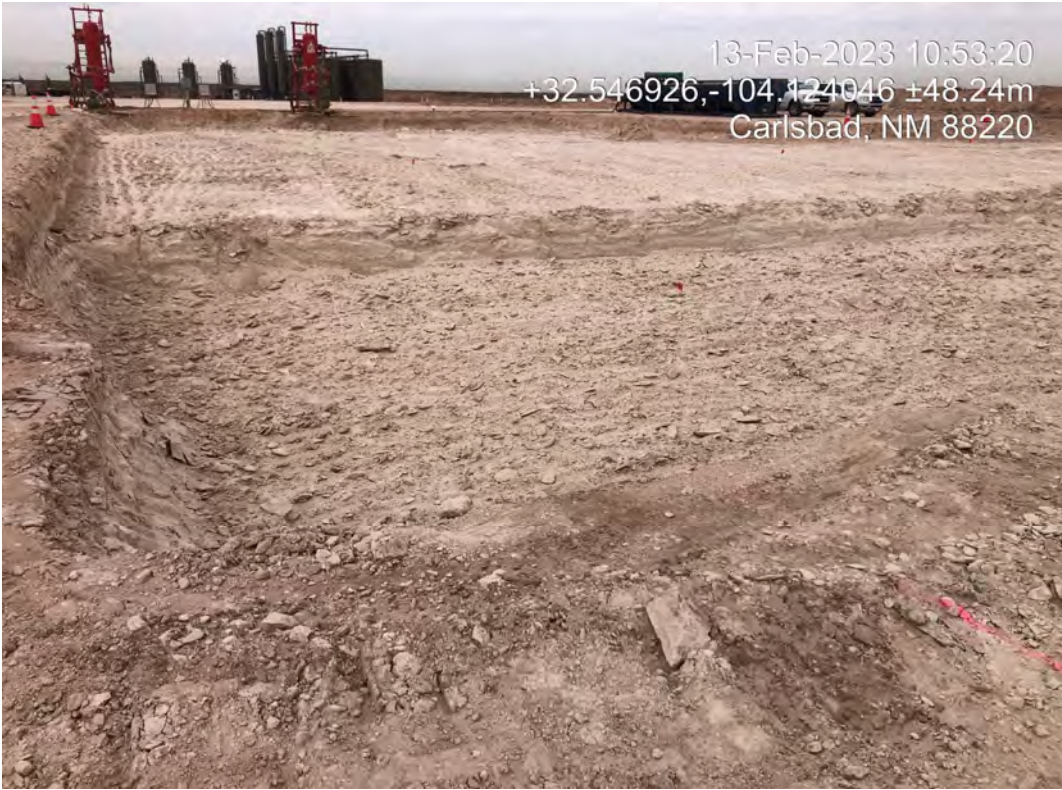
Photo Number: 4

Photo Direction: Northwest	
Photo Description: View of the excavated area.

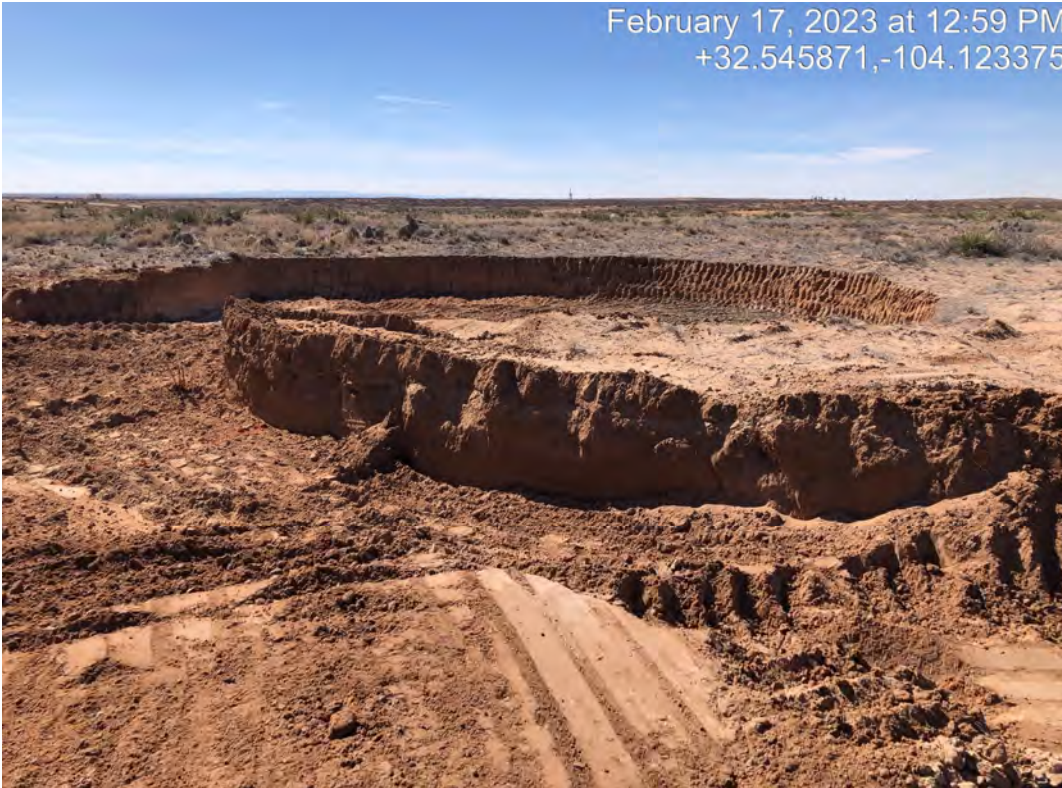
Photo Number: 6

<p>February 17, 2023 at 12:59 PM +32.545871,-104.123375</p>
Photo Direction: South	
Photo Description: View of the excavated area.

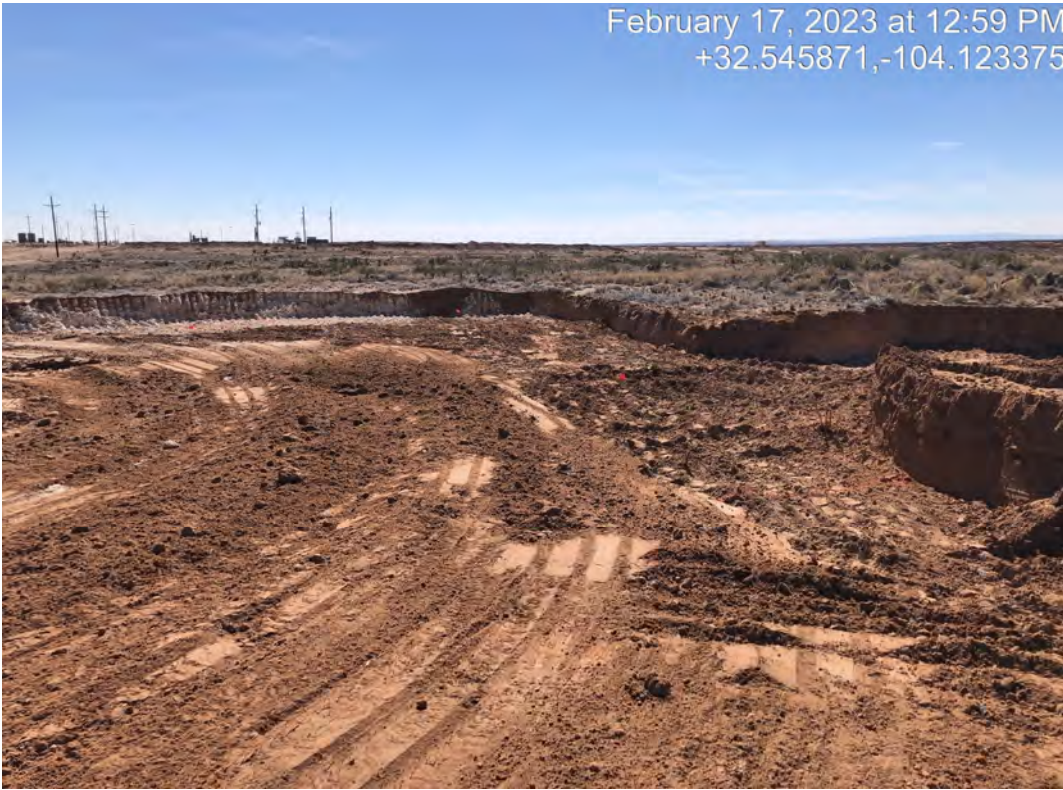
Photo Number: 7	<div>February 17, 2023 at 12:59 PM +32.545871,-104.123375</div>

Photo Direction: Southeast	
Photo Description: View of the excavated area.

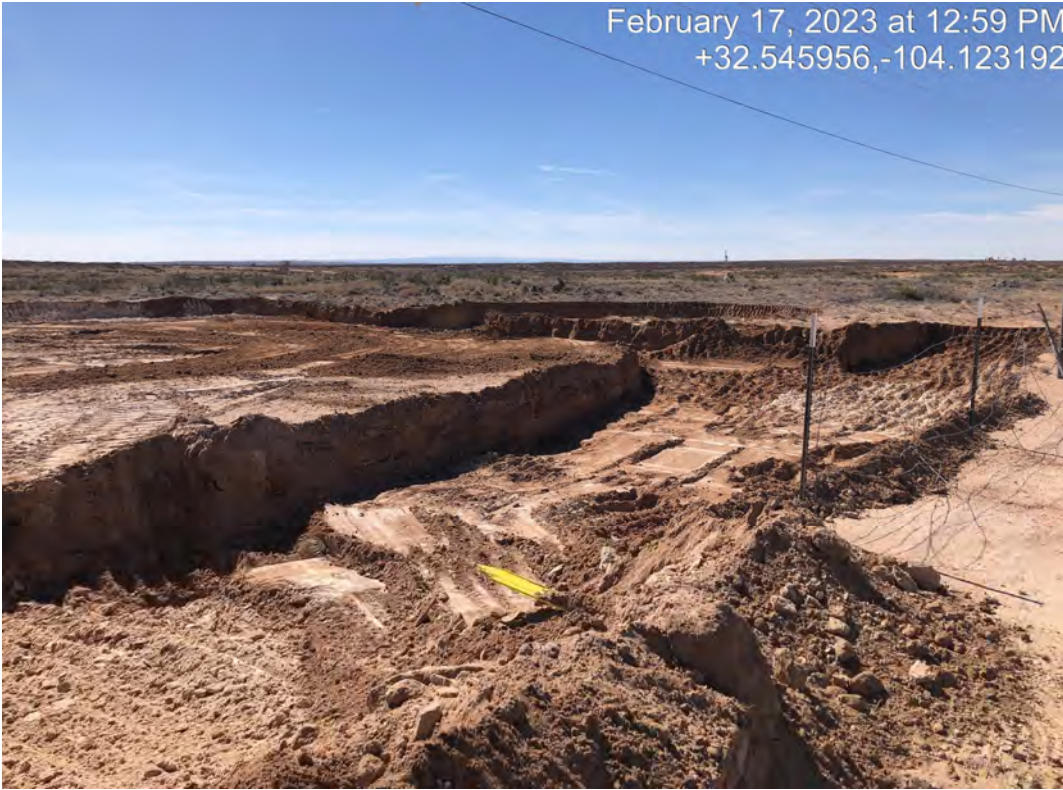
Photo Number: 8	<div>February 17, 2023 at 12:59 PM +32.545956,-104.123192</div>

Photo Direction: Southwest	
Photo Description: View of the excavated area.

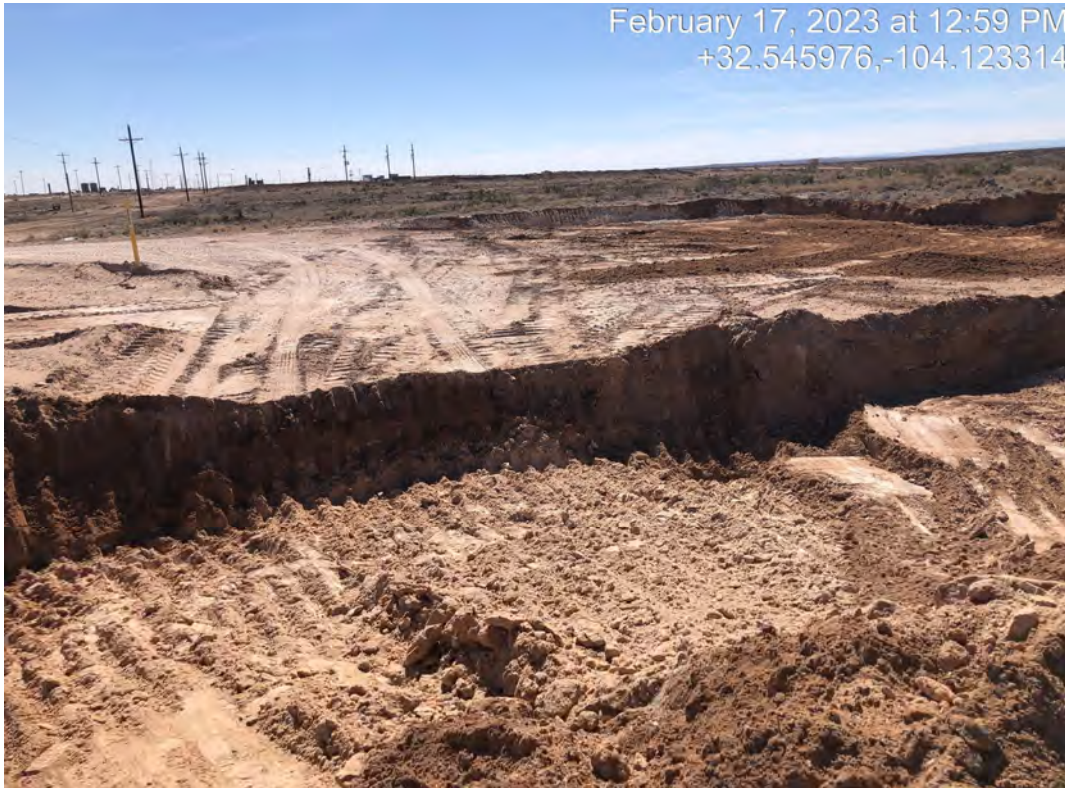
Photo Number: 9

Photo Direction: South	
Photo Description: View of the excavated area.

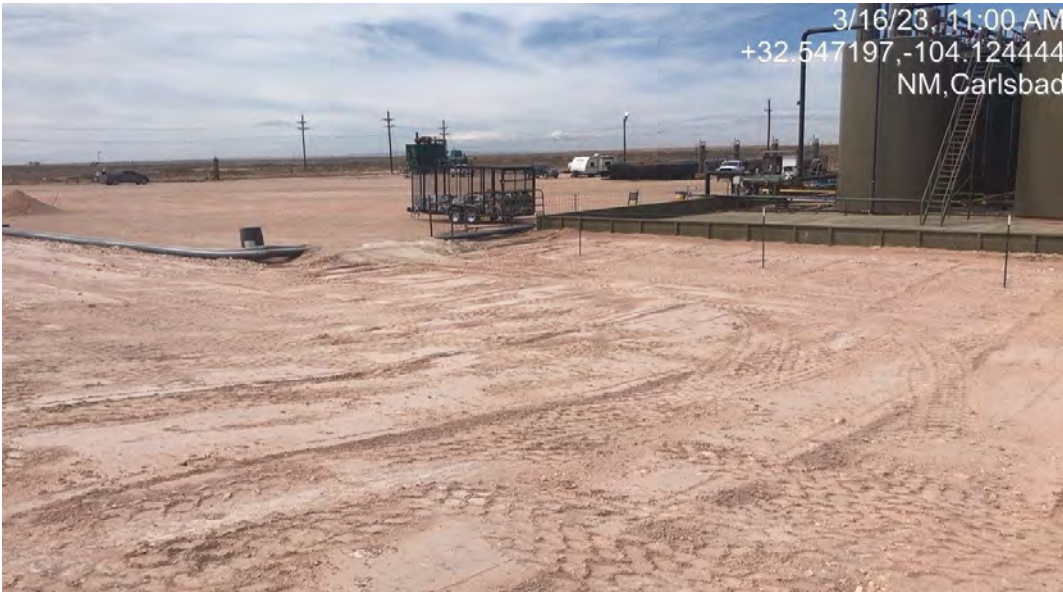
Photo Number: 11

<p>3/16/23, 11:00 AM +32.547197,-104.124444 NM, Carlsbad</p>
Photo Direction: Southwest	
Photo Description: View of the remediated area after backfill and regrading.

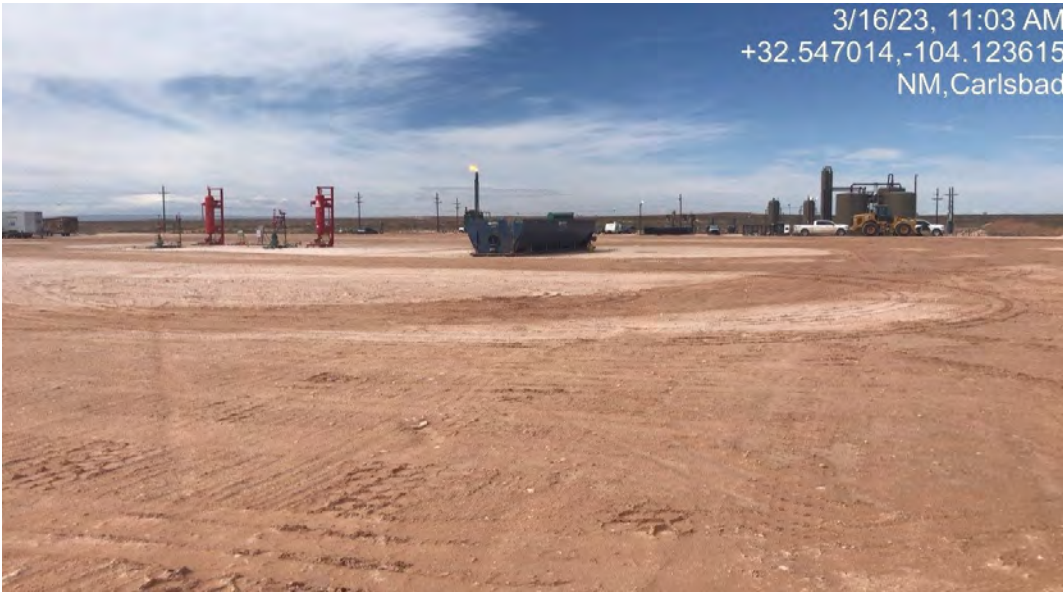
Photo Number: 15

<p>3/16/23, 11:03 AM +32.547014, -104.123615 NM, Carlsbad</p>
Photo Direction: West-Southwest	
Photo Description: View of the remediated area after backfill and regrading.

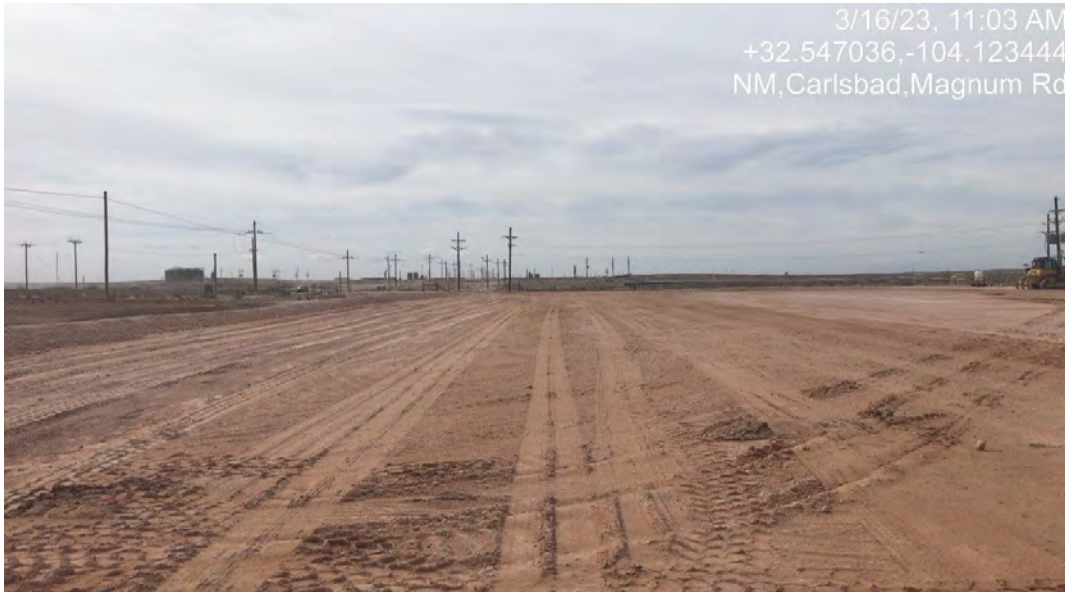
Photo Number: 17

<p>3/16/23, 11:03 AM +32.547036,-104.123444 NM, Carlsbad, Magnum Rd</p>
Photo Direction: South	
Photo Description: View of the remediated area after backfill and regrading.

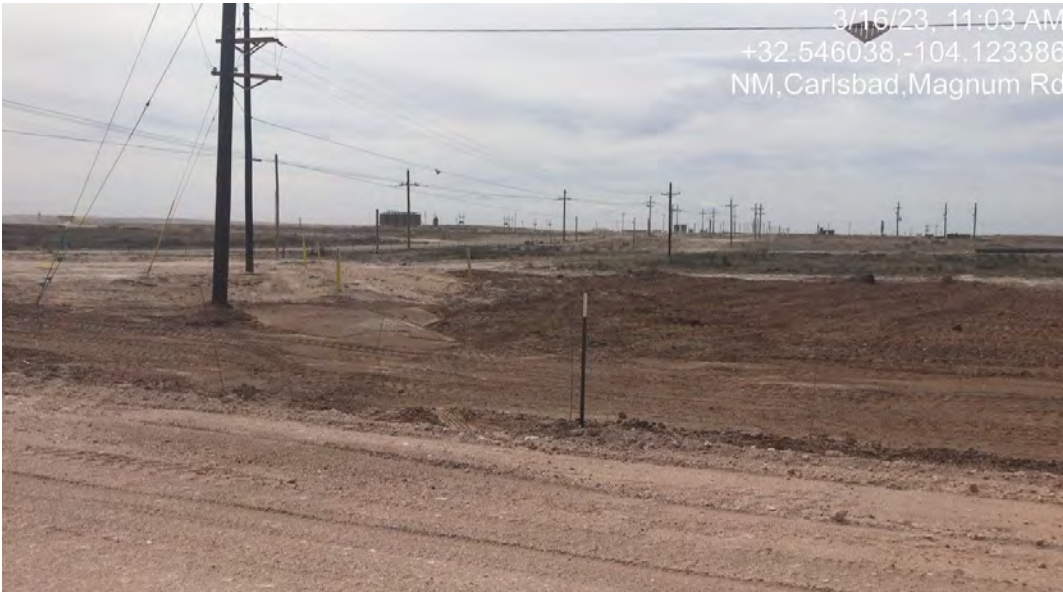
Photo Number: 19

<p>3/16/23, 11:03 AM +32.546038,-104.123386 NM, Carlsbad, Magnum Rd</p>
Photo Direction: Southeast	
Photo Description: View of the remediated area after backfill and regrading.

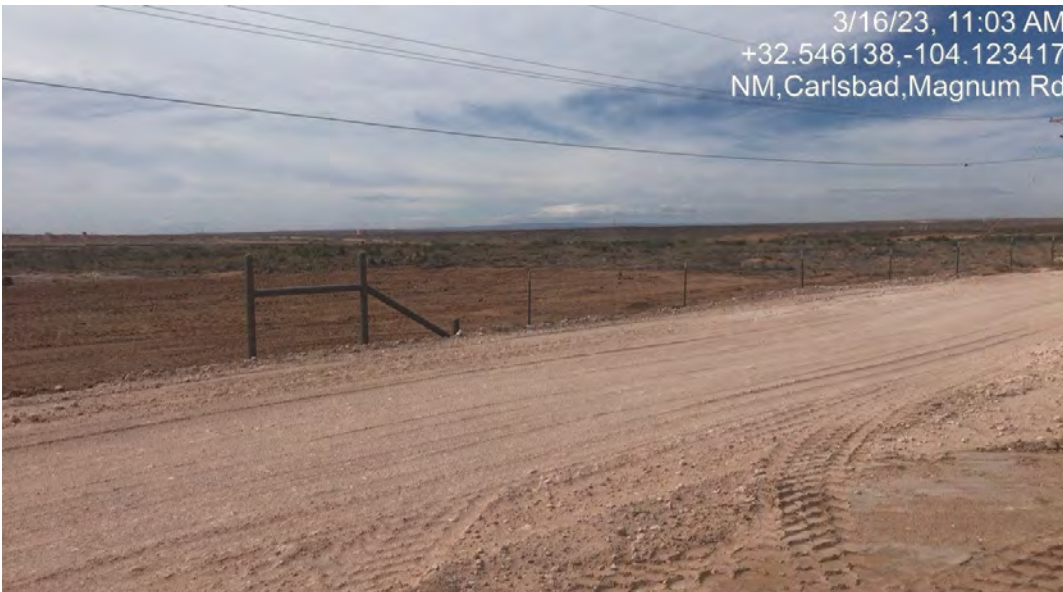
Photo Number: 20

<p>3/16/23, 11:03 AM +32.546138,-104.123417 NM, Carlsbad, Magnum Rd</p>
Photo Direction: Southwest	
Photo Description: View of the remediated area after backfill and regrading.
