**Re: Closure and Deferral Request Report  
Bloodhound 15-23-27 Fee 401H  
Unit H, S15, T23S, R27E  
Site Coordinates: 32.307960, -104.173004  
Eddy County, New Mexico  
Incident ID: nAPP2319061278**

On behalf of Devon Energy Production Company (Devon), New Tech Global Environmental, LLC (NTGE) has prepared this Closure and Deferral Request Report to document site assessment, remedial action, and sampling activities at the Bloodhound 15-23-27 Fee 401H (Site) for submittal to the New Mexico Oil Conservation Division (NMOCD) District 2 Office in Artesia, New Mexico. The Site is located in Unit H, Section 15, Township 23 South of Range 27 East in Eddy County, New Mexico. The site location with respect to the nearest town is shown in Figure 1 and the topography of the area is shown in Figure 2.

**SITE LOCATION MAP**  
 CLOSURE REPORT  
 BLOODHOUND 15 23 27 FEE #401H  
 DEVON ENERGY PRODUCTION COMPANY  
 EDDY COUNTY, NEW MEXICO

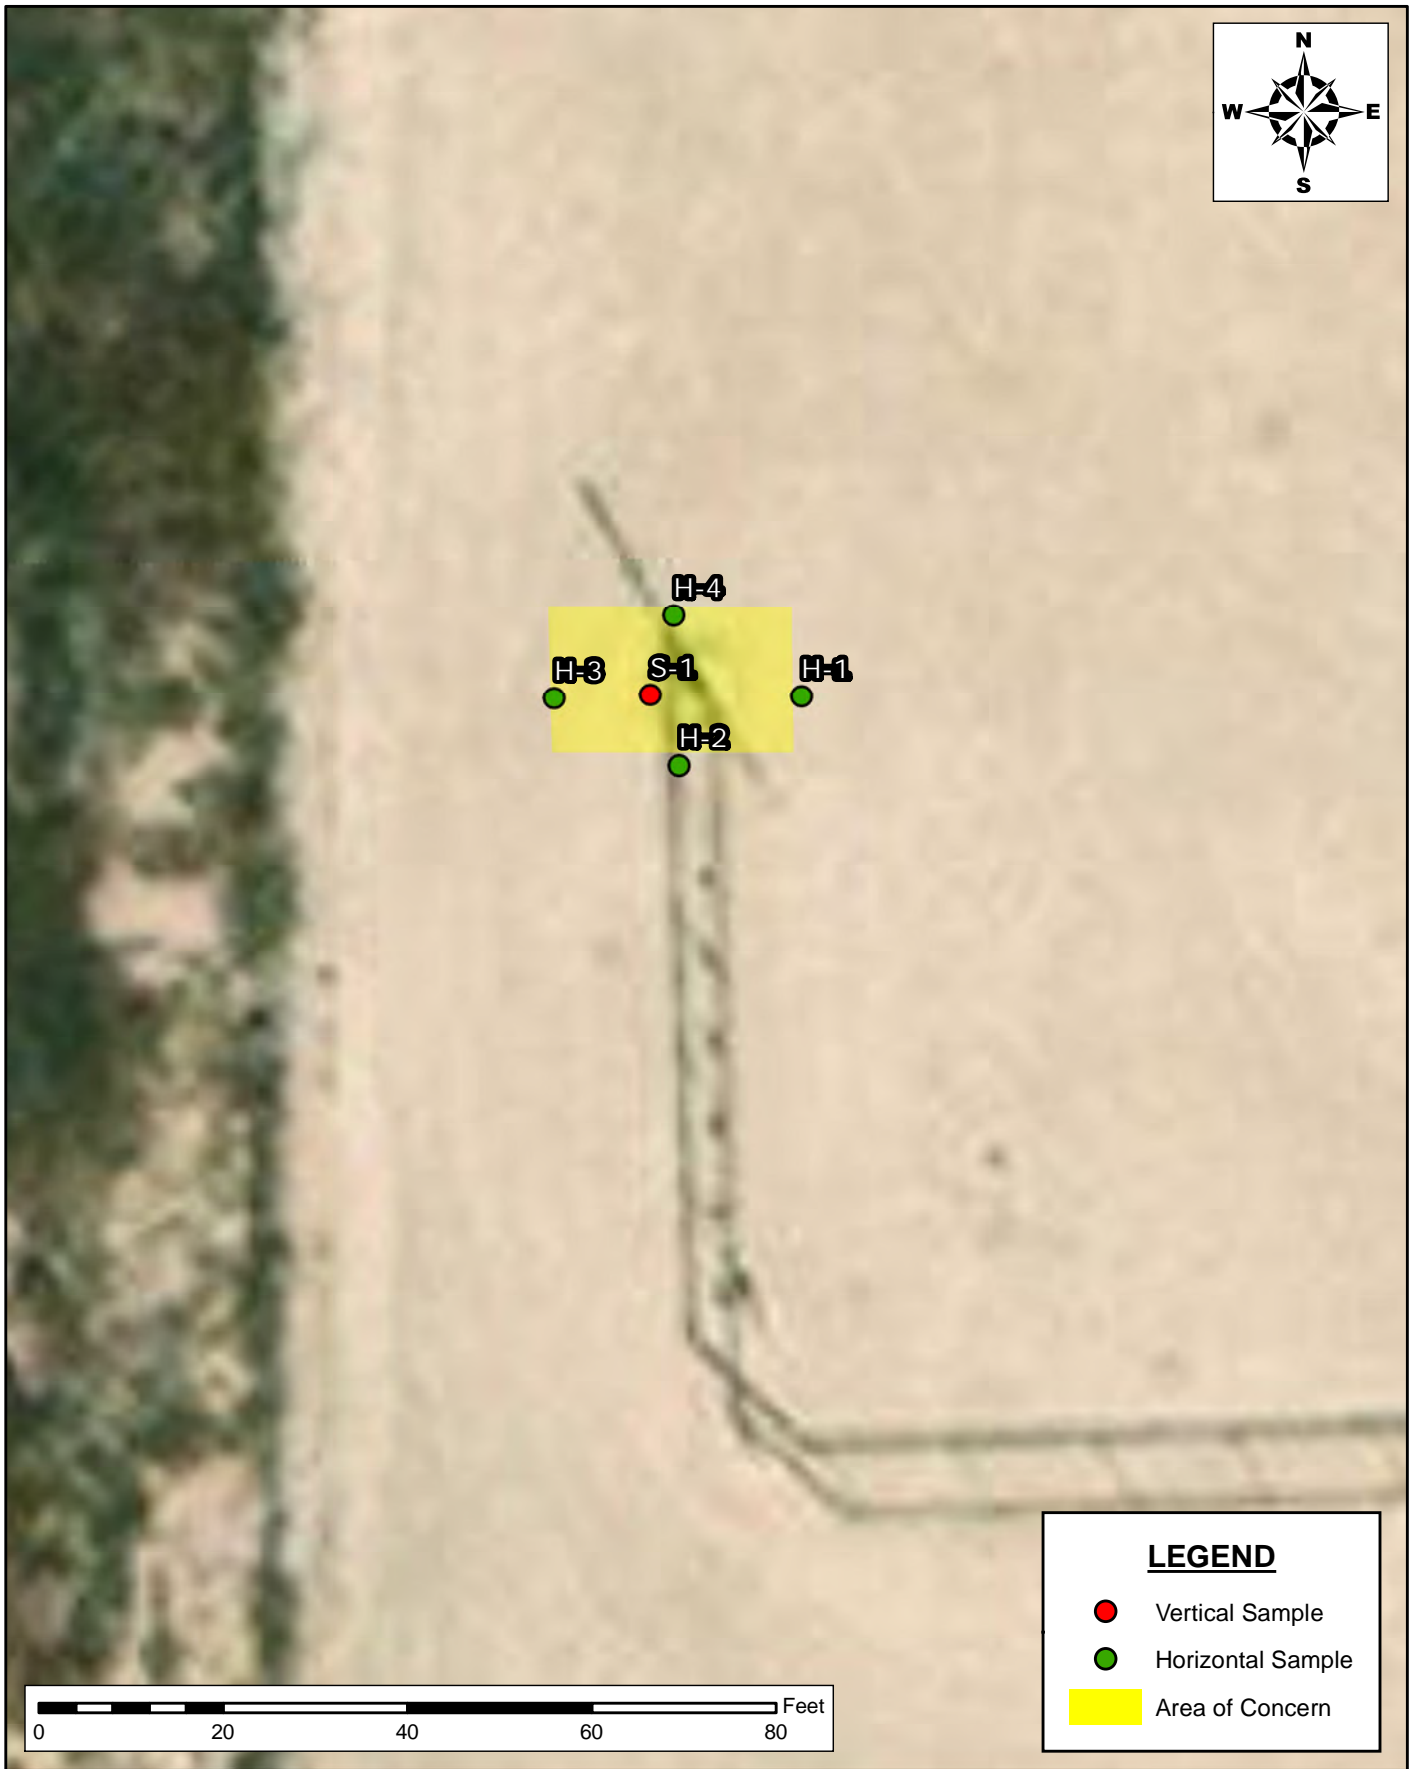
- Vertical Sample
- Horizontal Sample
- Area of Concern

Based on the initial C-141 obtained from the NMOCD, the release was discovered on July 9<sup>th</sup>, 2023. The release was due to a fire at the flare which resulted in the release of approximately 0.5 barrels (bbls) of crude oil of which none were recovered for a net loss of 0.5 bbls of crude oil. Upon discovery, the fire was extinguished, equipment was shut-in, and area was secured. The release area is shown on Figure 3.

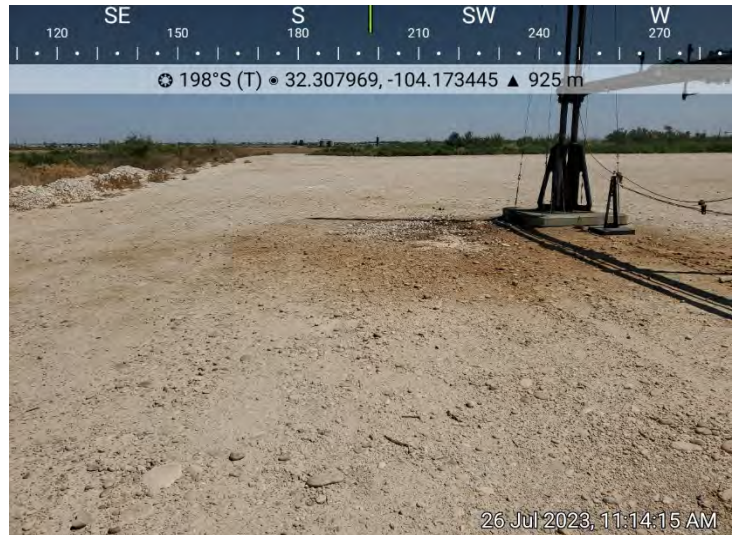
**Photograph No. 2**

**Description:**  
Area of Concern

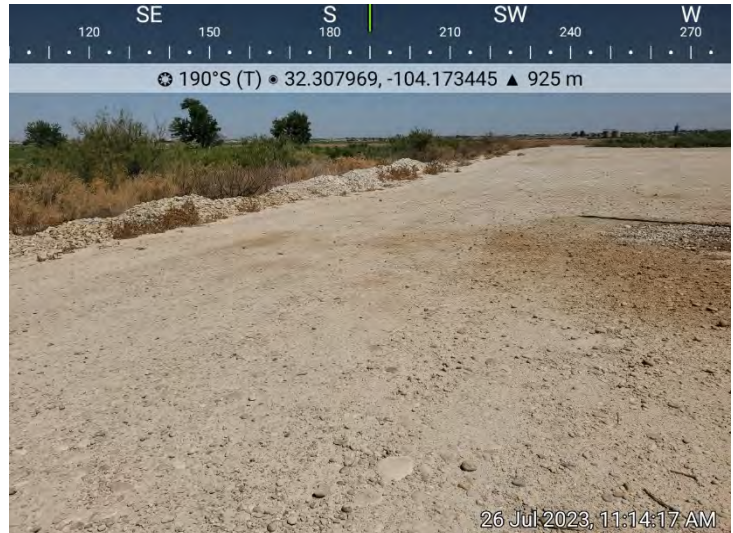
**Photograph No. 3**

**Description:**  
Area of Concern

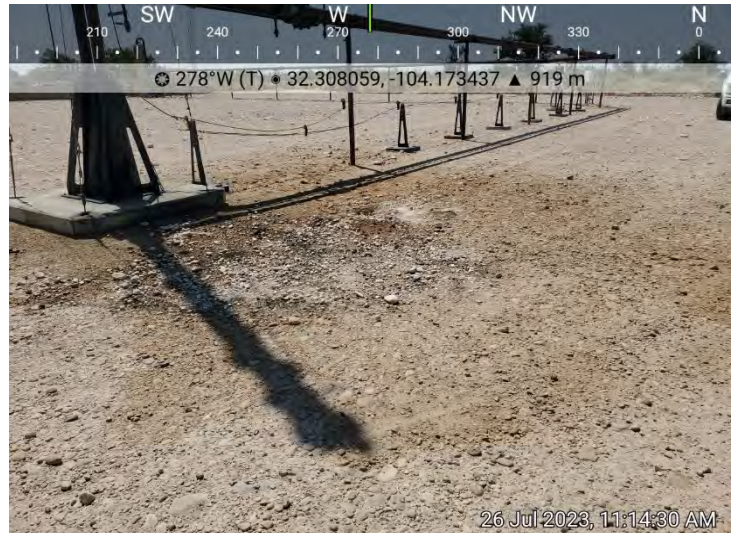
**Photograph No. 6**

**Description:**  
View of the excavation

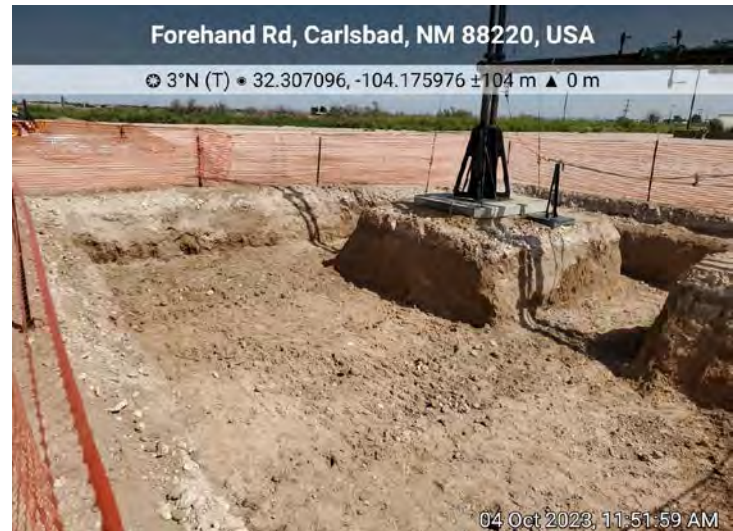
**Description:**  
View of the excavation

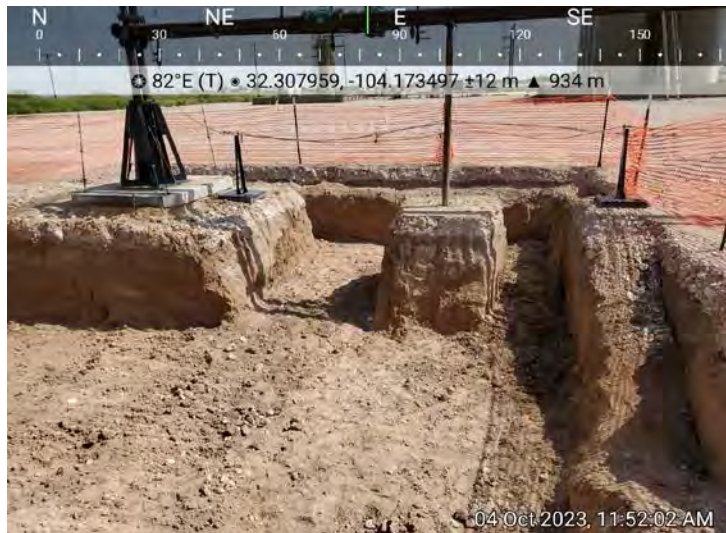
**Photograph No. 8**

**Description:**  
View of the excavation

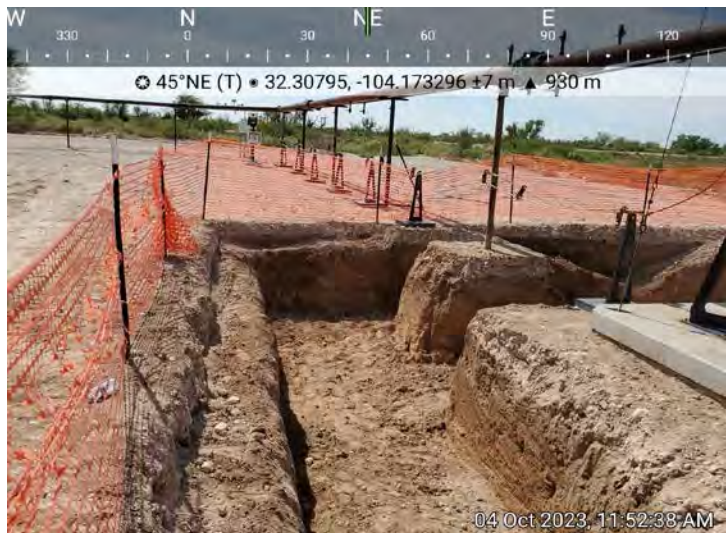
**Photograph No. 9**

**Description:**  
View of the excavation

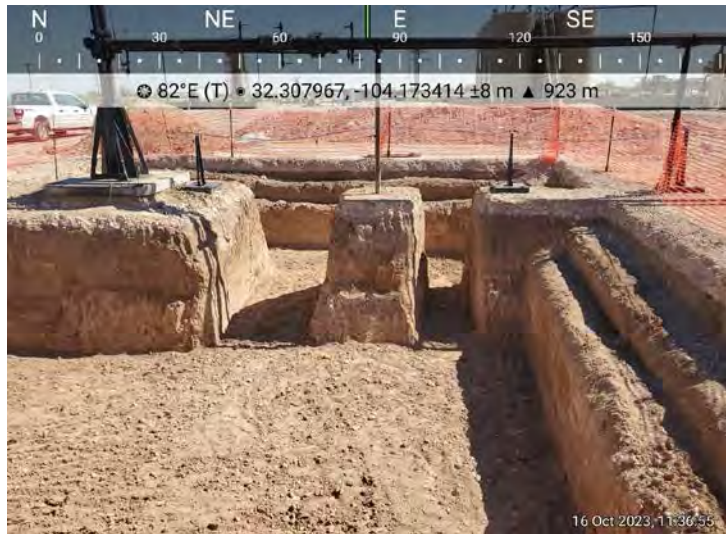
**Photograph No. 11**

**Description:**  
View of the excavation

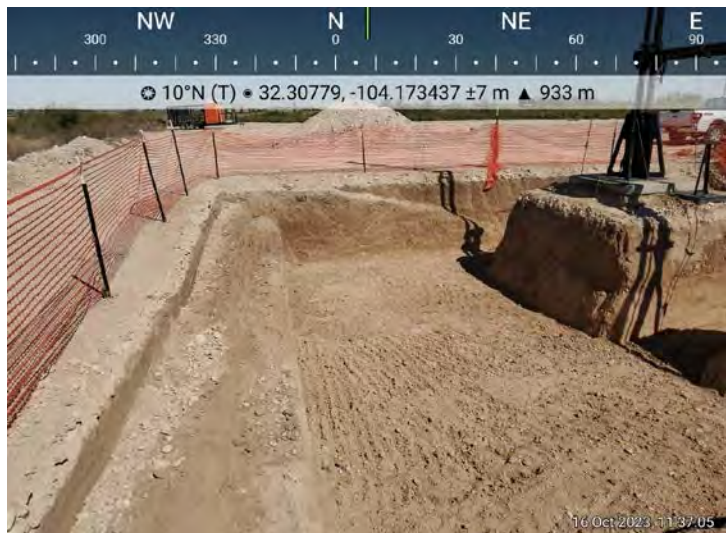
**Photograph No. 12**

**Description:**  
View of the excavation

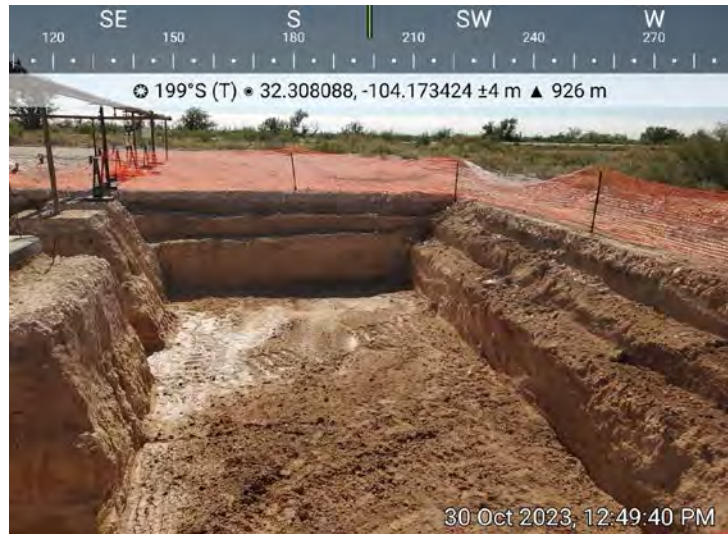
**Photograph No. 14**

**Description:**  
View of the excavation

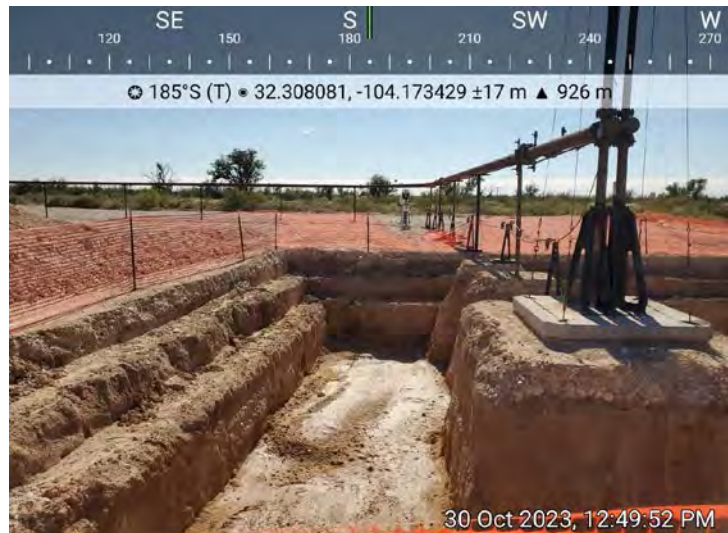
**Photograph No. 15**

**Description:**  
View of the excavation

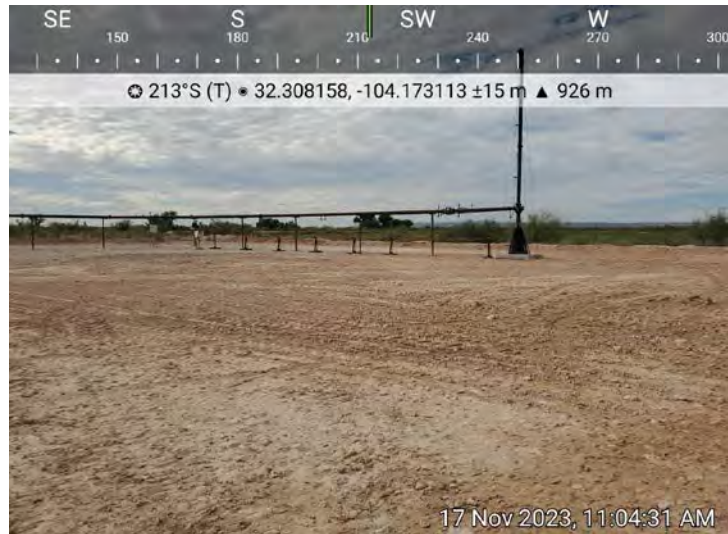
**Photograph No. 17**

**Description:**  
Backfilled excavation

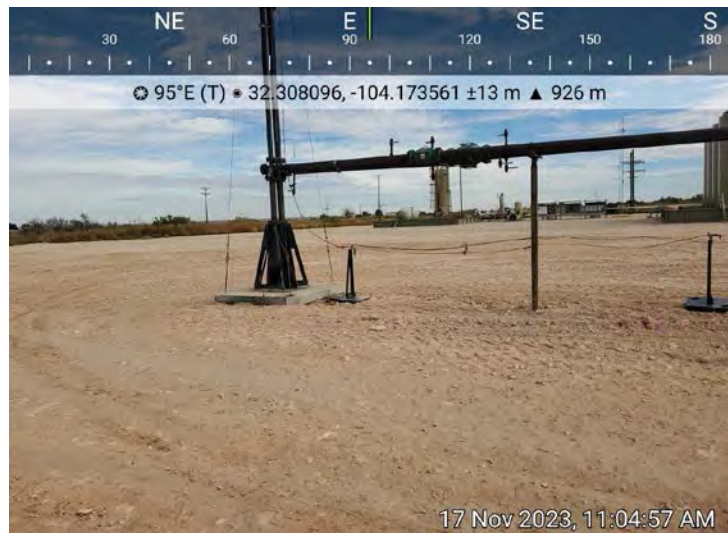
**Photograph No. 18**

**Description:**  
Backfilled excavation
