Re: Status Report – 2nd Quarter 2023
San Juan 28-7 Unit 183M
Rio Arriba County, New Mexico
OCD Incident No. NCS1901627746

On behalf of Hilcorp Energy Company (Hilcorp), Timberwolf Environmental, LLC (Timberwolf) presents this report to document remedial activities conducted during the 2nd quarter of 2023 (2Q23) at the San Juan 28-7 Unit 183M (Site).

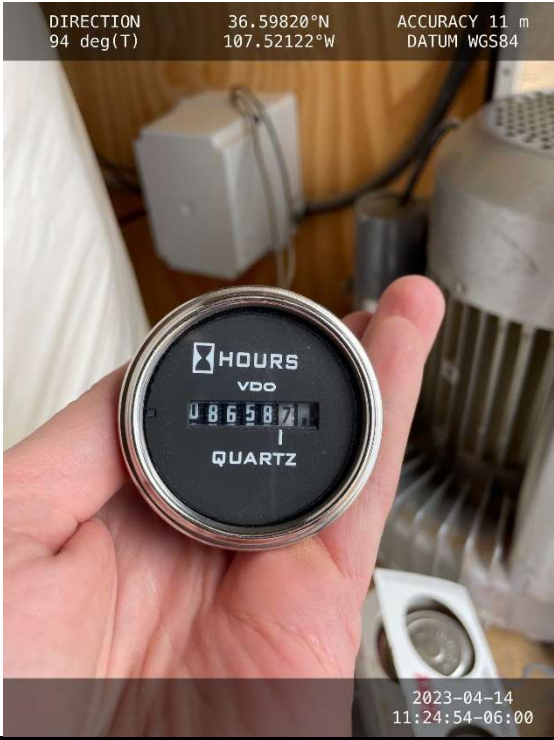
<p>DIRECTION 94 deg(T) 36.59820°N 107.52122°W ACCURACY 11 m DATUM WGS84</p> <p>2023-04-14 11:24:54-06:00</p>		
Direction: N/A			
Comments: View of hour meter on 04/14/23.			
Photo No.: 2

System runtime between the last 1Q23 reading (03/27/23) and the latest 2Q23 reading (06/21/23) is 2,029.4 hours. The available hours during this period were 2,064. The system was down for 26 hours during soil assessment activity, which was conducted on 05/08/23, leaving 2,038 available hours for system operation. This yields a runtime percentage (%) of 99.6 for 2Q23. Photographs of relevant meter readings are documented in the attached Photographic Log.

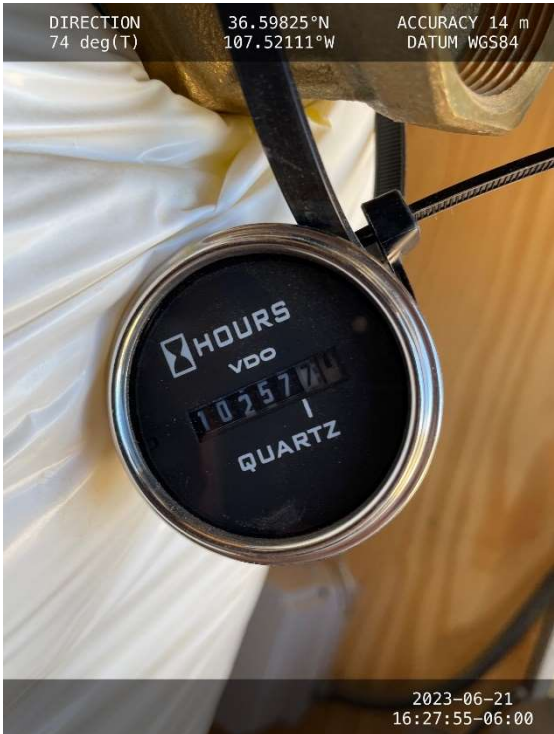
<p>DIRECTION 74 deg(T) 36.59825°N 107.52111°W ACCURACY 14 m DATUM WGS84</p> <p>2023-06-21 16:27:55-06:00</p>		
Direction: N/A			
Comments: View of hour meter on 06/21/23.

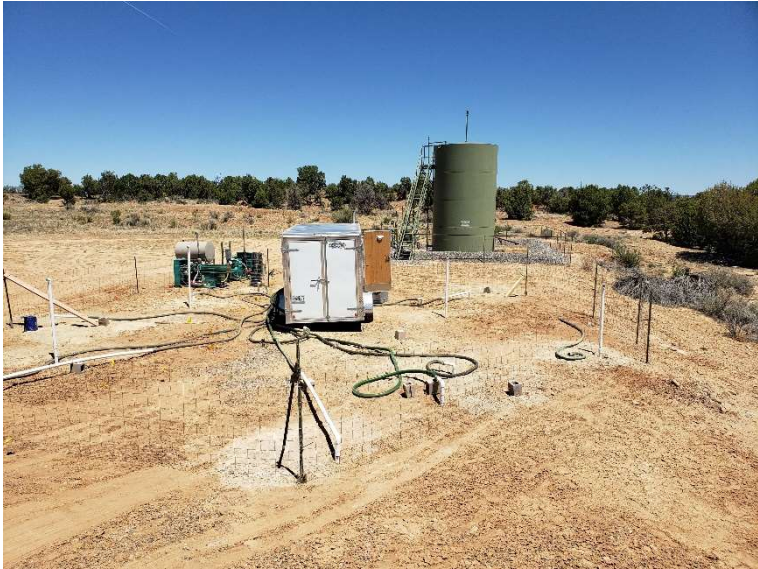
Direction: Northeast			
Comments: View of SVE system after reconfiguration following drilling activities for soil monitoring. 05/09/23 13:00			
Photo No.: 4

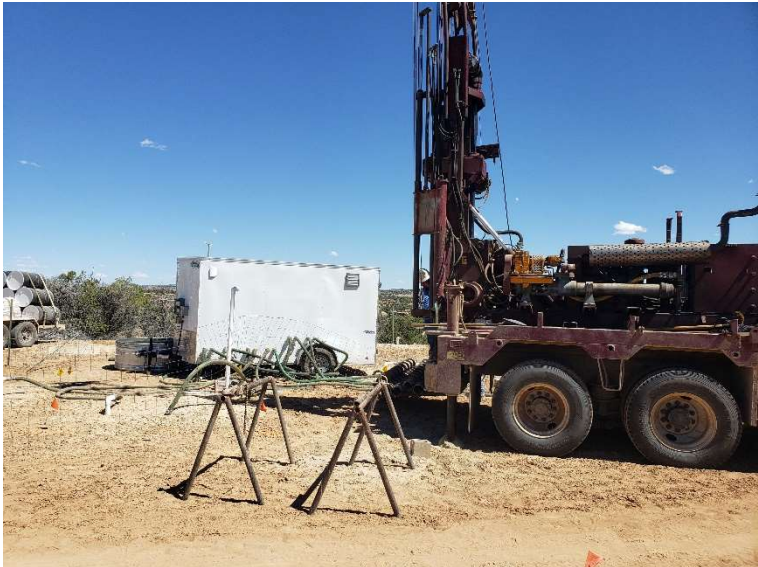
Direction: Northwest			
Comments: View of drilling activities during soil monitoring. Soil boring location for SM2. 05/08/23 15:30

The borings were installed using a rotary rig and hollow-stem augers. Three (3) soil samples were collected from each boring. Each boring was field screened for VOCs using a photoionization detector (PID). The following soil intervals from each boring were selected for laboratory analysis:
