**Re: Deferral Request  
Ogden 20509 1-3H Tank Battery  
Incident Number NAB1905943420  
Eddy County, New Mexico**

BTA Oil Producers, LLC  
Deferral Request  
Ogden 20509 1-3H Tank Battery

BTA Oil Producers, LLC  
 Ogden 20509 1-3H Tank Battery  
 Incident Number: NAB1905943420  
 Unit B, Section 29, T23S, R28E  
 Eddy County, New Mexico

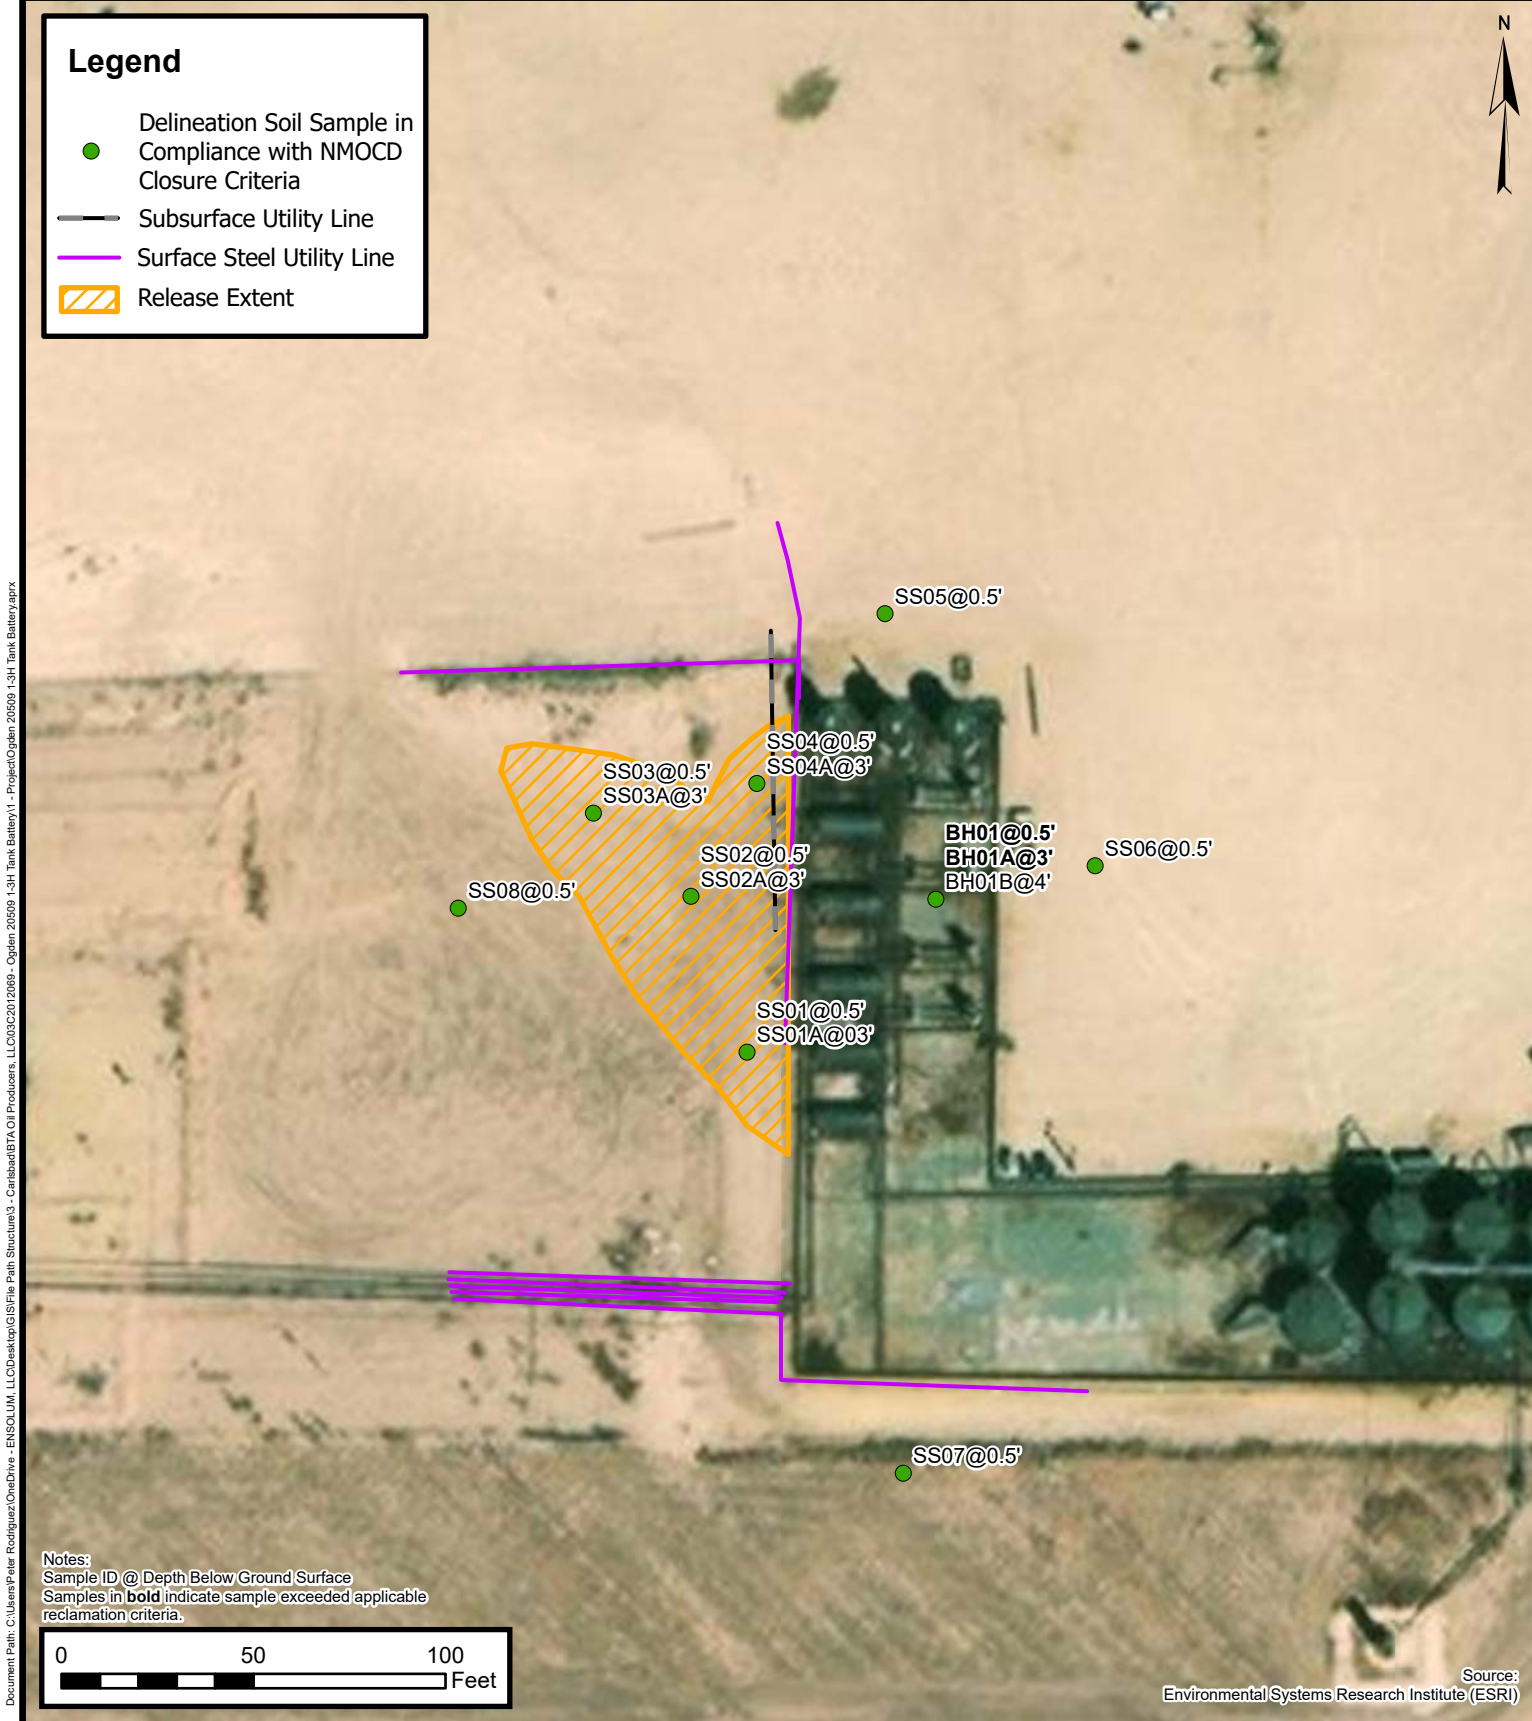
FIGURE  
**2**

The impacted soil remaining in place beneath the liner is delineated vertically by delineation soil sample BH01B, collected at 4 feet bgs, and laterally by delineation soil samples SS01 through SS08. A maximum of 954 yards of TPH and chloride impacted soil remains in place beneath the liner assuming a maximum 4-foot depth based on the delineation soil samples listed above, that were compliant with the Site Closure Criteria.

## Delineation Soil Sample Locations

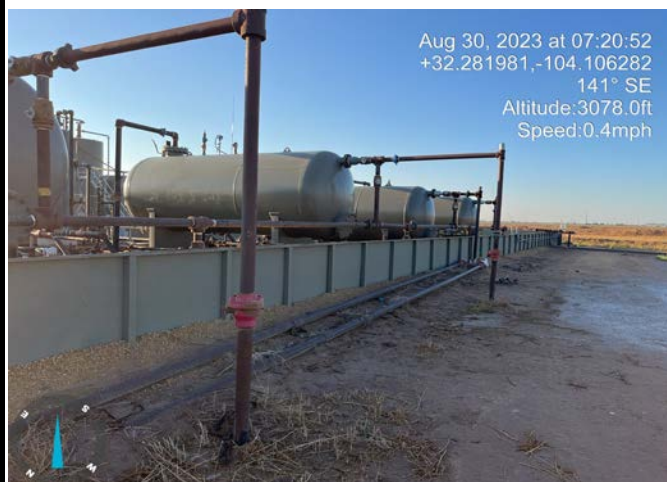
On February 7, 2019, a heater sprayed oil into the lined secondary containment and onto the adjacent pasture west of the containment. Approximately 10 barrels (bbls) of crude oil were released. A vacuum truck was dispatched to the Site to recover free-standing fluids; approximately 6 bbls of released crude oil were recovered. BTA reported the release to the New Mexico Oil Conservation Division (NMOCD) on a Release Notification Form C-141 (Form C-141) on February 20, 2019. The release was assigned Incident Number NAB1905943420.

Photograph: 1 Date: 8/30/2023  
Description: Initial release  
View: Southeast

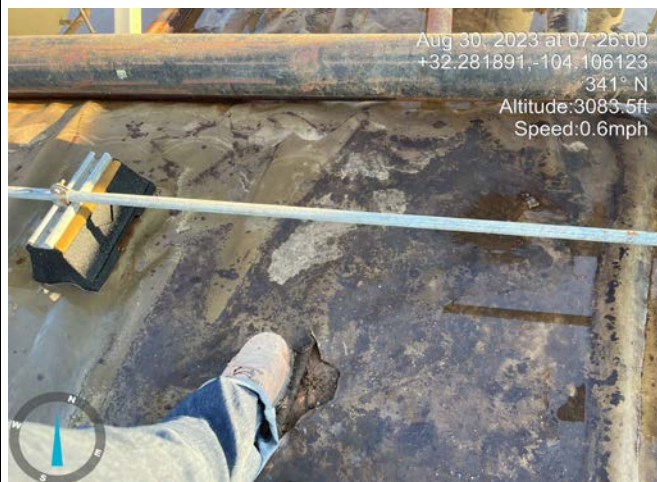
A 48-hour advance notice of the liner inspection was provided via email to the NMOCD District I office on August 28, 2023. A liner integrity inspection was conducted by Ensolum personnel on August 30, 2023. Upon inspection, a tear was identified in the liner and the liner was determined to be insufficient. One borehole (BH01) was advanced via hand auger at the location of the tear in the liner to assess for the presence or absence of impacted soil. Three discrete delineation soil samples (BH01/BH01A/BH01B) were collected from the borehole at depths of 0.5 feet, 3 feet, and 4 feet bgs, respectively. Four boreholes (SS01 through SS04) were advanced via hand auger within the overspray release extent west of the containment. Two discrete delineation soil samples were collected from the boreholes at depths of 0.5 feet and 3 feet bgs. Additionally, four delineation soil samples (SS05 through SS08) were collected around the lined containment and overspray release extent at 0.5 feet bgs to confirm the lateral release extent.

Laboratory analytical results for delineation soil samples BH01 and BH01A, collected at depths of 0.5 feet and 3 feet bgs beneath the tear in the liner, indicated TPH and/or chloride concentrations exceeded the Site Closure Criteria. Laboratory analytical results for delineation soil sample BH01B, collected at 4

Photograph: 2 Date: 8/30/2023  
Description: Damaged liner  
View: North

BTA does not believe deferment will result in imminent risk to human health, the environment, or groundwater. The release was contained laterally by the lined containment, and the impacted soil remaining in place is limited to the area immediately beneath the liner. The liner has been repaired by BTA which will restrict future vertical migration of residual impacts.

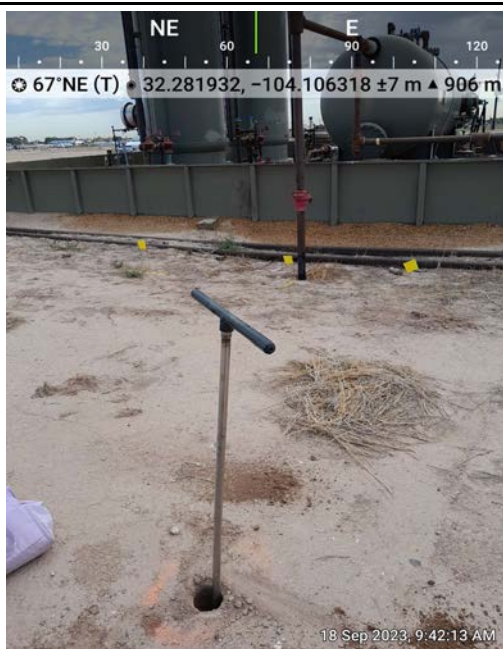
The soil samples were field screened for volatile organic compounds (VOCs) utilizing a calibrated photoionization detector (PID) and chloride using Hach® chloride QuanTab® test strips. Field screening results and observations from the boreholes were documented on lithologic/soil sampling logs, which are included as Appendix B. The soil sample locations were mapped utilizing a handheld Global Positioning System (GPS) unit and are depicted on Figure 2. Photographic documentation was completed during the Site visit and a photographic log is included as Appendix C.

Photograph: 3 Date: 9/18/2023  
Description: Delineation on pad  
View: East

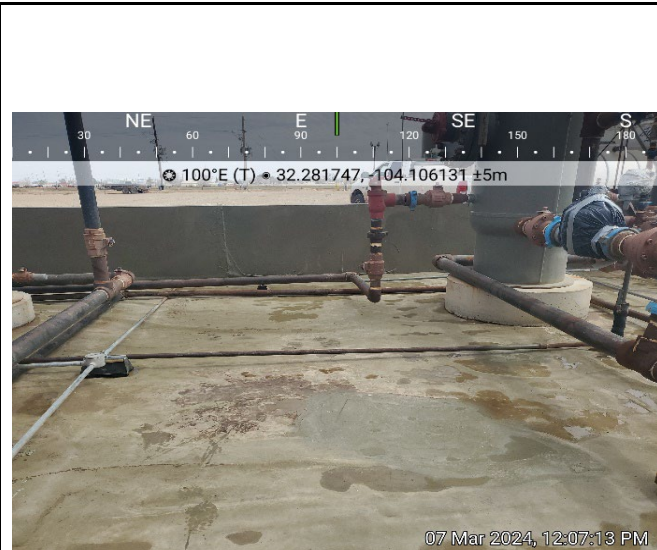
Photograph: 4 Date: 3/7/2024  
Description: Repaired liner following delineation  
View: East
