**Re: Closure Request
Rojo 18/19 & 38/39 Tank Battery
Incident Number nAPP2103447746
Lea County, New Mexico**

Ensolum, LLC (Ensolum), on behalf of BTA Oil Producers, LLC (BTA), has prepared this *Closure Request* to document assessment, excavation, and soil sampling activities performed at the Rojo 18/19 & 38/39 Tank Battery (Site). The purpose of the Site assessment, excavation, and soil sampling activities was to address impacts to soil resulting from a historical crude oil and produced water release at the Site. Based on field observations, Site assessment activities, and excavation soil sample laboratory analytical results, BTA is submitting this *Closure Request*, requesting no further action for Incident Number nAPP2103447746.

BTA Oil Producers, LLC
Closure Request
Rojo 18/19 & 38/39 Tank Battery

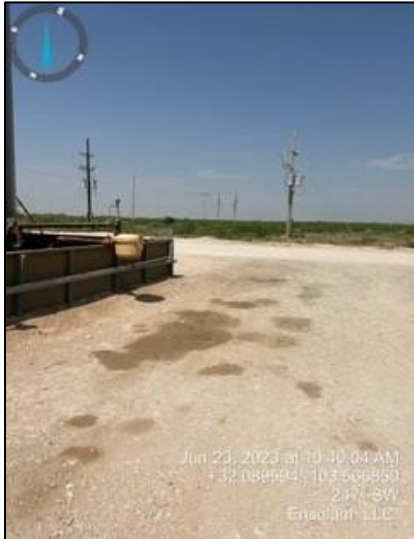
Photograph: 1 Date: 6/23/2023
Description: Soil staining in release footprint
View: West

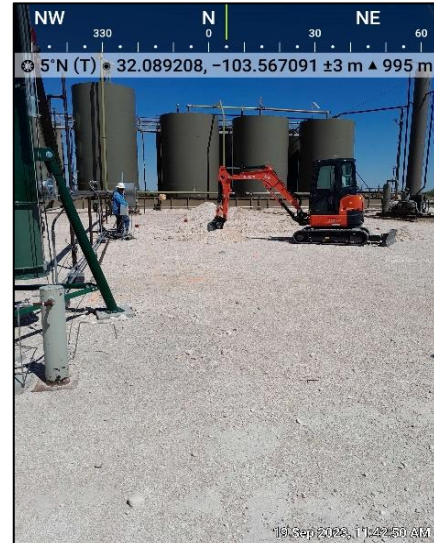
Photograph: 2 Date: 9/19/2023
Description: Excavation in progress
View: North

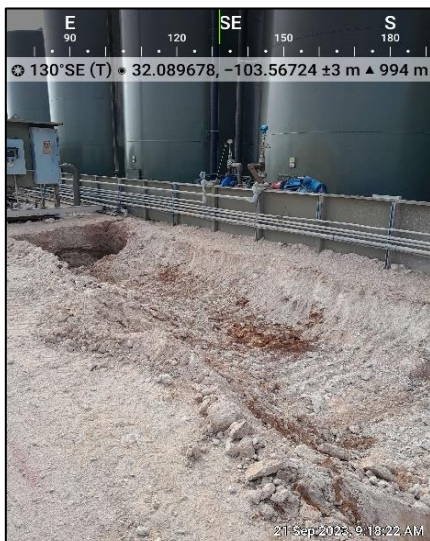
Photograph: 3 Date: 9/21/2023
Description: Completed excavation
View: Southeast

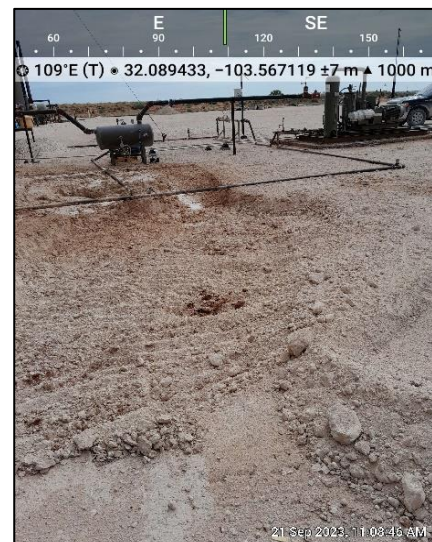
Photograph: 4 Date: 9/21/2023
Description: Completed excavation
View: East

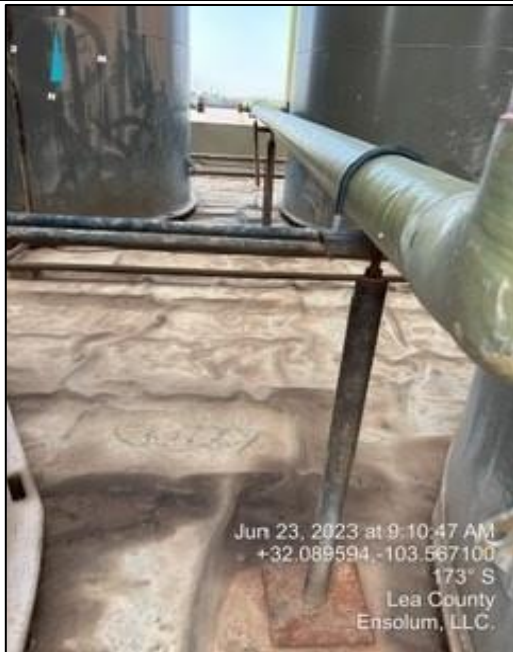
Photograph: 5 Date: 6/23/2023
Description: View of lined containment deemed to be in good condition, facing south

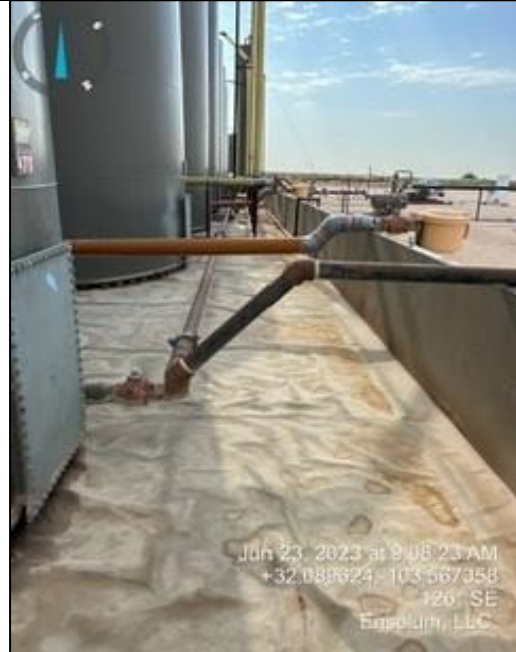
Photograph: 6 Date: 6/23/2023
Description: View of lined containment deemed to be in good condition, facing southeast

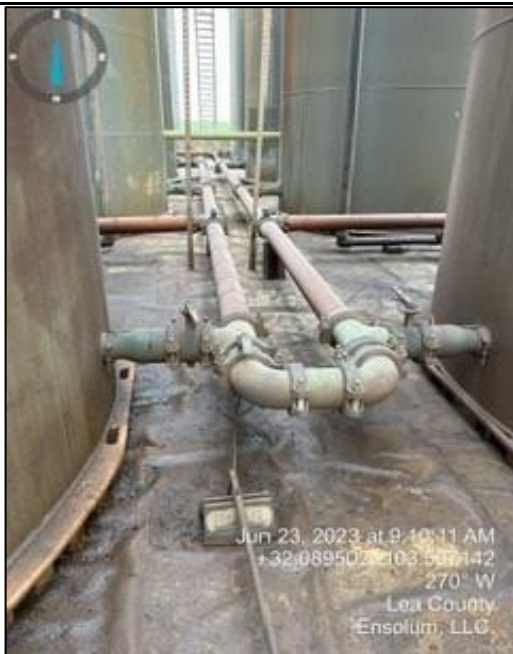
Photograph: 7 Date: 6/23/2023
Description: View of lined containment deemed to be in good condition, facing west

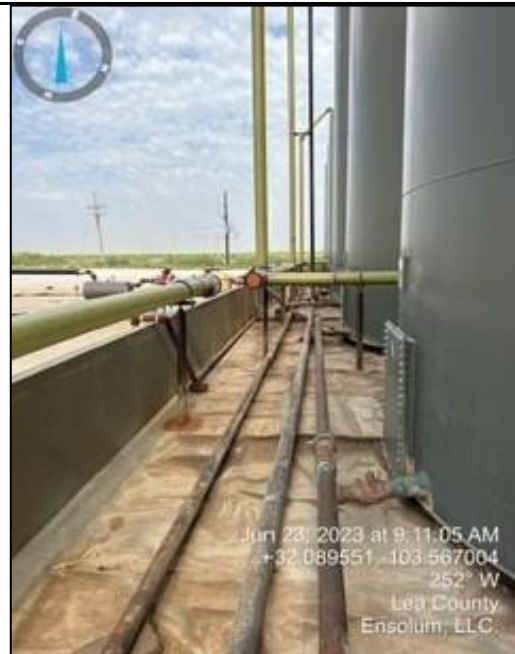
Photograph: 8 Date: 6/23/2023
Description: View of lined containment deemed to be in good condition, facing west
