Re: Liner Inspection and Closure Request

Vast State #002H - Tank Battery Release

Lea County, New Mexico Incident ID# NAPP2402930822

Liner Inspection and Closure Report March 14, 2024

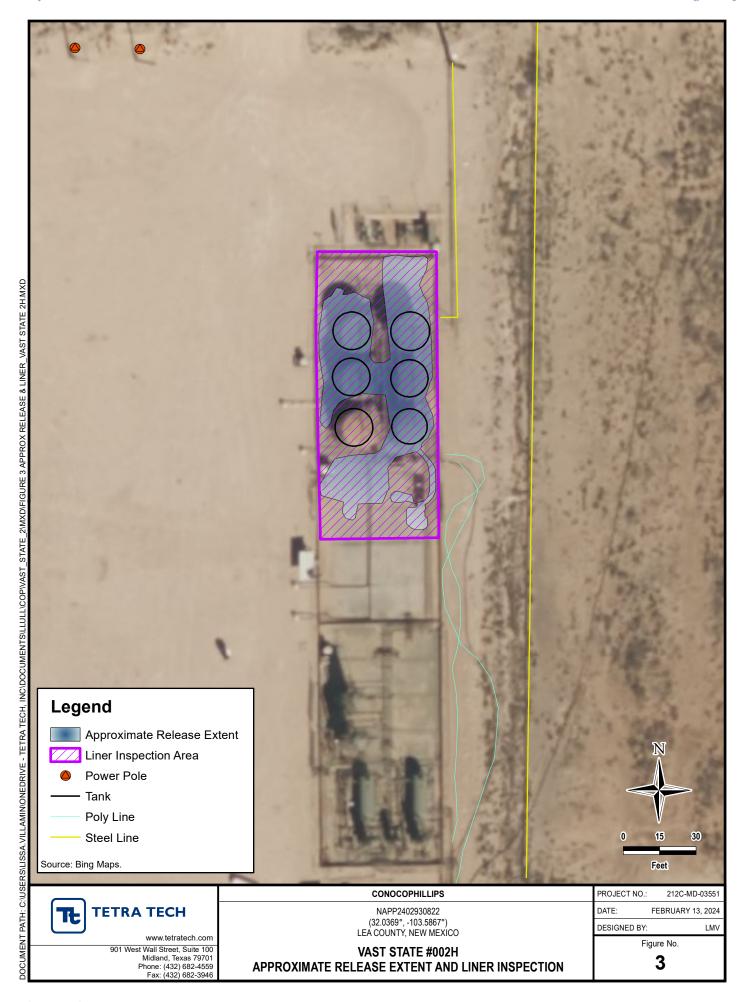
Figure 3 – Approximate Release Extent and Liner Inspection

On February 2, 2024, Tetra Tech personnel performed an inspection of the liner within the containment area of the Vast State #002H Tank Battery. This work was completed to verify the integrity of the liner. The liner was observed to underlie the entirety of the tank battery containment area. The liner was intact with no visible rips or tears and encompassed by an approximately 2-foot-tall muscle wall. The liner extended up the muscle wall and was anchored on the interior. At the time of the inspection, the liner was intact and had the ability to contain the documented release. Photographic documentation of the liner inspection is included in Appendix D.

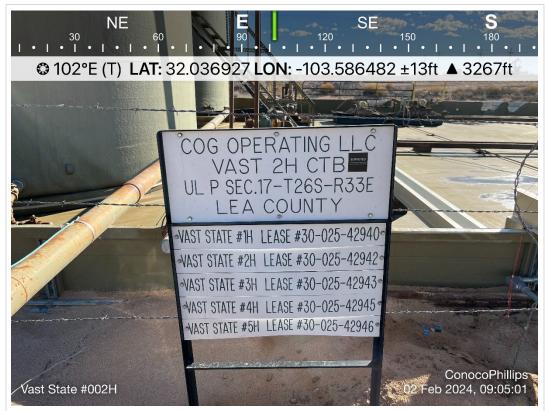
TETRA TECH, INC. PROJECT NO.	DESCRIPTION	View east of site signage. Vast 2H CTB.	1
212C-MD-03351	SITE NAME	VAST STATE #002H Release	2/2/2024

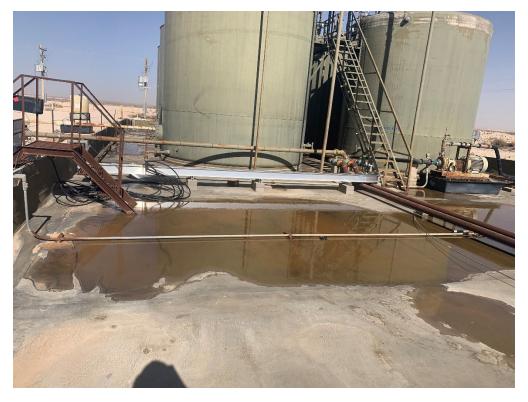
TETRA TECH, INC. PROJECT NO.	DESCRIPTION	View of pooling inside lined containment of tank battery, before liner inspection.	2
212C-MD-03351	SITE NAME	VAST STATE #002H Release	N/A

Based on photographs of the release area immediately following the release discovery (Appendix D), the released fluids pooled within the containment allowing substantial recovery of fluids by vacuum truck. The standing fluid observed in photographs lends further evidence to the integrity of the liner as a competent fluid barrier.

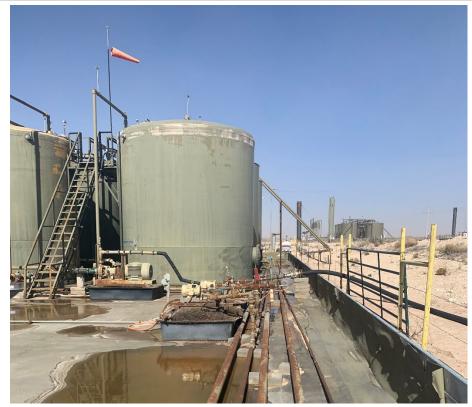
TETRA TECH, INC. PROJECT NO.	DESCRIPTION	View of pooling inside lined containment of tank battery before liner inspection.	3
212C-MD-03351	SITE NAME	VAST STATE #002H Release	N/A

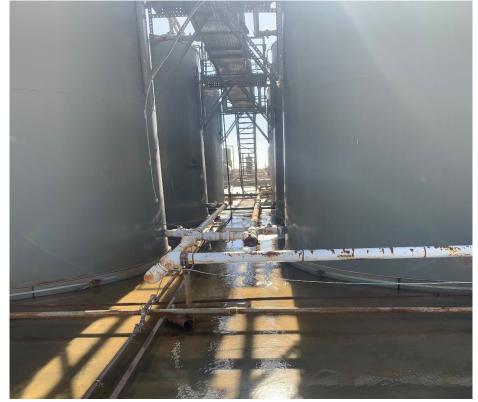
TETRA TECH, INC. PROJECT NO.	DESCRIPTION	View of pooling inside lined containment of tank battery, before liner inspection.	4
212C-MD-03351	SITE NAME	VAST STATE #002H Release	N/A

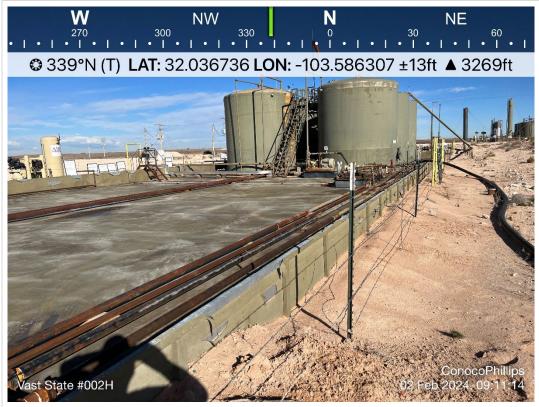
TETRA TECH, INC. PROJECT NO.	DESCRIPTION	View north-northwest of former release extent and with current lined containment area conditions.	5
212C-MD-03351	SITE NAME	VAST STATE #002H Release	2/2/2024

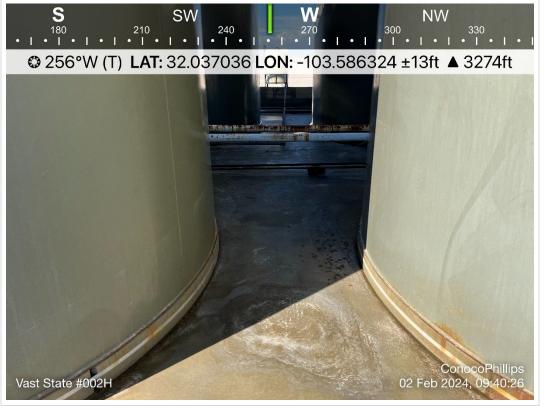
TETRA TECH, INC. PROJECT NO. 212C-MD-03351	DESCRIPTION	View southwest. View of liner integrity, no rips or tears observed.	6
	SITE NAME	VAST STATE #002H Release	2/2/2024

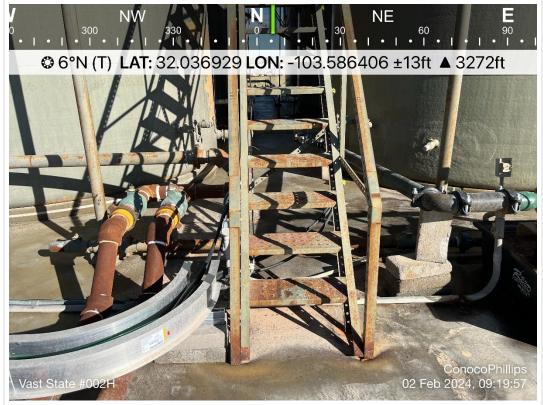
TETRA TECH, INC. PROJECT NO. 212C-MD-03351	DESCRIPTION	View north of former release extent and lined containment area conditions.	7
	SITE NAME	VAST STATE #002H Release	2/2/2024

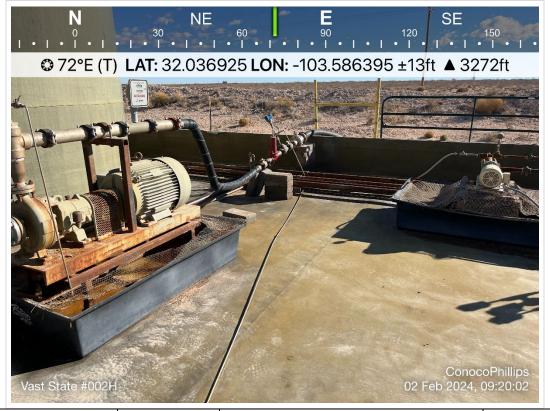
TETRA TECH, INC. PROJECT NO.	DESCRIPTION	View northeast. View of liner integrity, no rips or tears observed.	8
212C-MD-03351	SITE NAME	VAST STATE #002H Release	2/2/2024

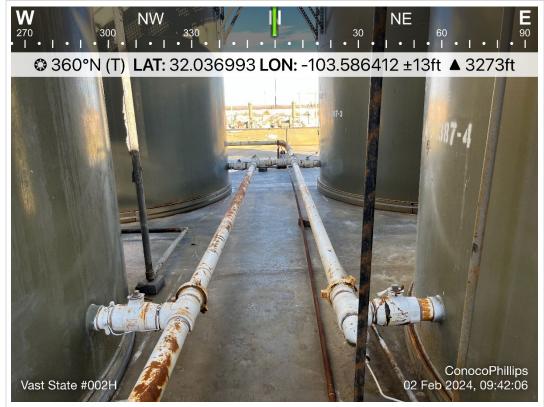
PROJECT NO.	DESCRIPTION	View north of former release extent and lined containment area conditions.	9
	SITE NAME	VAST STATE #002H Release	2/2/2024

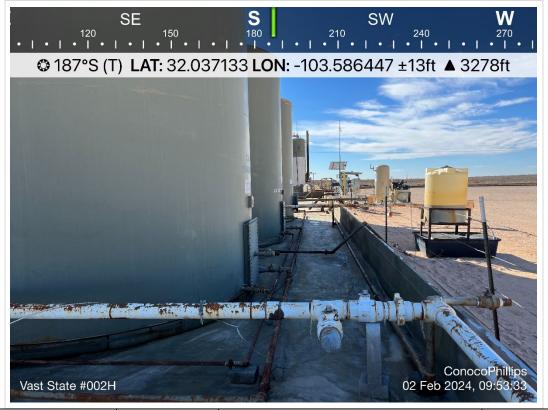
TETRA TECH, INC.	DESCRIPTION	View south of former release extent. View of liner integrity, no rips or tears observed.	10
212C-MD-03351	SITE NAME	VAST STATE #002H Release	2/2/2024

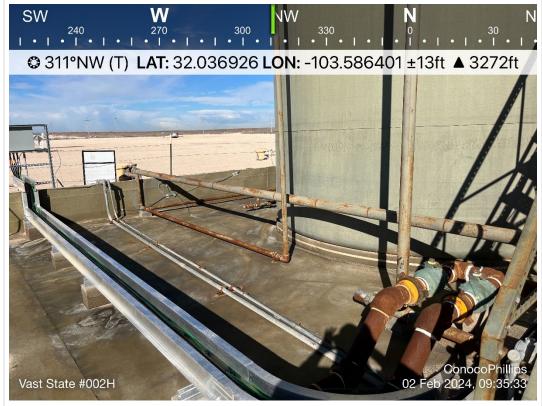
PROJECT NO.	DESCRIPTION	View north of former release extent and lined containment area conditions.	11
	SITE NAME	VAST STATE #002H Release	2/2/2024

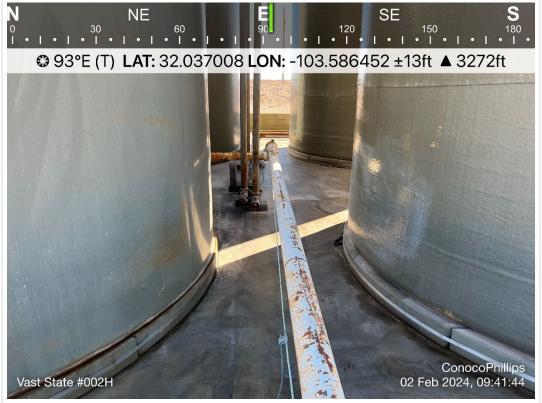
TETRA TECH, INC. PROJECT NO. 212C-MD-03351	DESCRIPTION	View east. View of liner integrity, no rips or tears observed.	12
	SITE NAME	VAST STATE #002H Release	2/2/2024
