CLOSURE VARIANCE REPORT

Ross Draw Unit #034

Eddy County, New Mexico

Incident Number nAPP2326833391

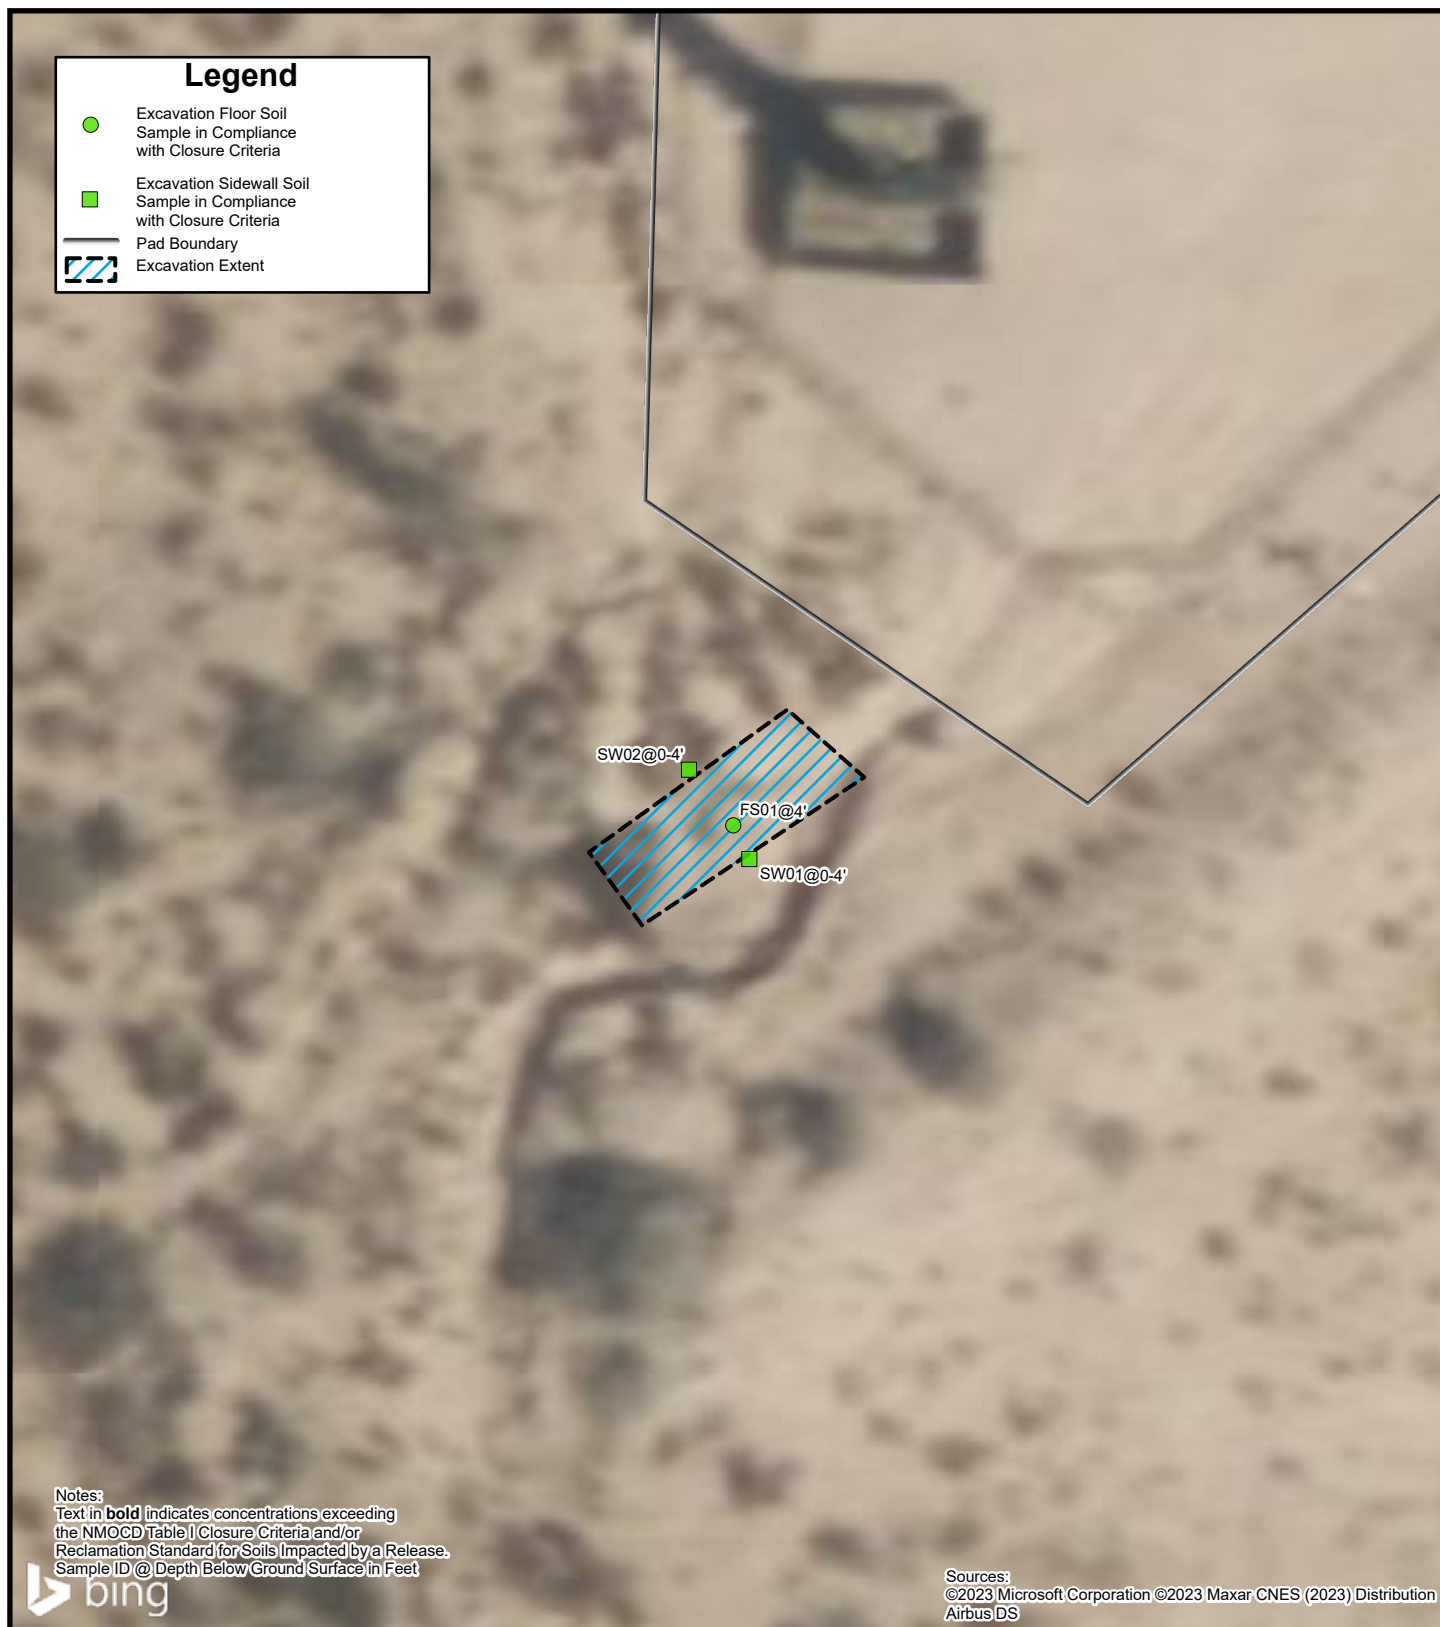
FIGURE 3

On November 20, 2023, excavation activities were performed via mechanical equipment to address residual impacts in areas to be immediately reclaimed following remediation, according to the application of the reclamation standards to the delineation soil sampling laboratory analytical results. Excavation activities were advanced within the vicinity of the PH05 location and further directed by field screening for VOCs and chloride, as previously described.

Excavation Soil Sample Locations

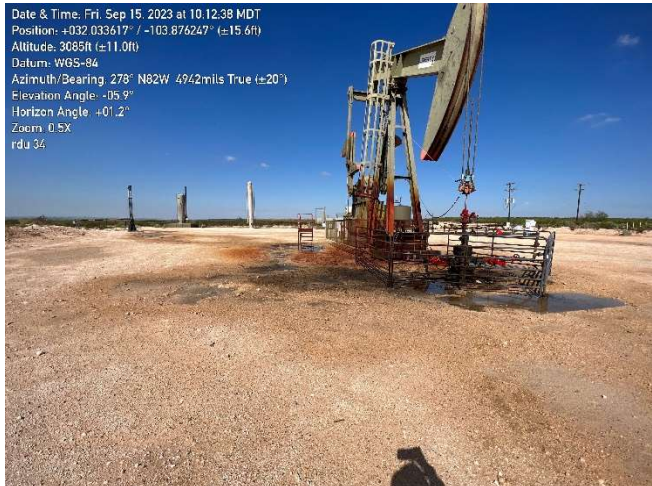
Date & Time: Fri, Sep 15, 2023 at 10:12:38 MDT
 Position: +032.033617° / -103.876247° (±15.6ft)
 Altitude: 3085ft (±11.0ft)
 Datum: WGS-84
 Azimuth/Bearing: 278° N82W 4942mils True (±20°)
 Elevation Angle: -05.9°
 Horizon Angle: +01.2°
 Zoom: 0.5X
 RDU34

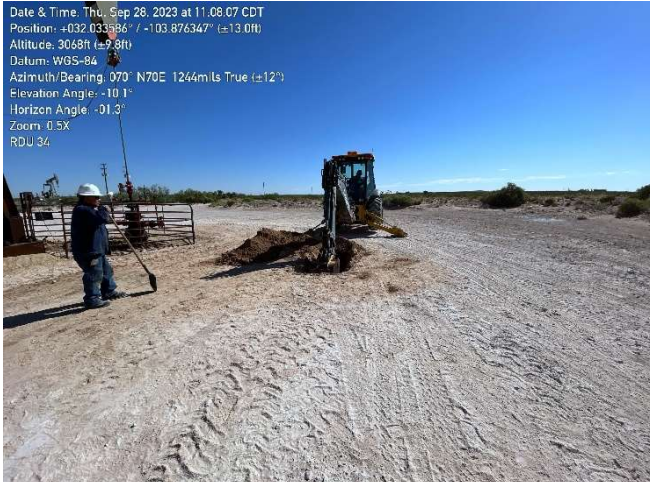
Photograph 1

Description: Northeastern view of delineation activities.

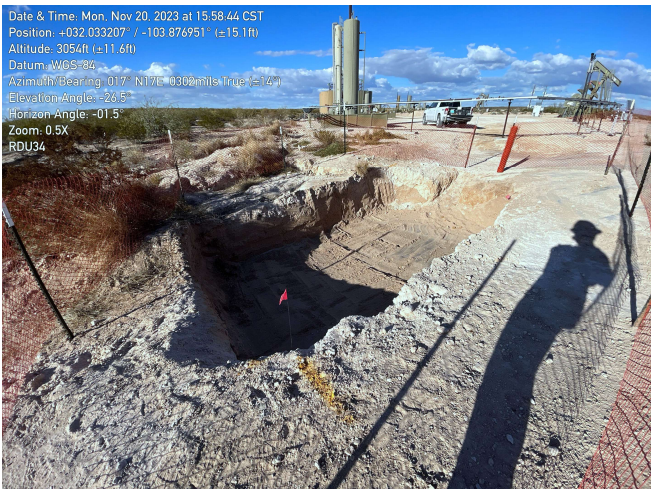
Photograph 3

Description: Northeastern view of excavation activities.
