March 25, 2024

**Re: Release Characterization and Remediation Work Plan
ConocoPhillips (Heritage COG Operating LLC)
On behalf of Spur Energy Partners, LLC (328947)
Folk Federal #002 Release
Unit Letter H, Section 17, Township 17 South, Range 29 East
Eddy County, New Mexico
Incident ID NAB1630550256**

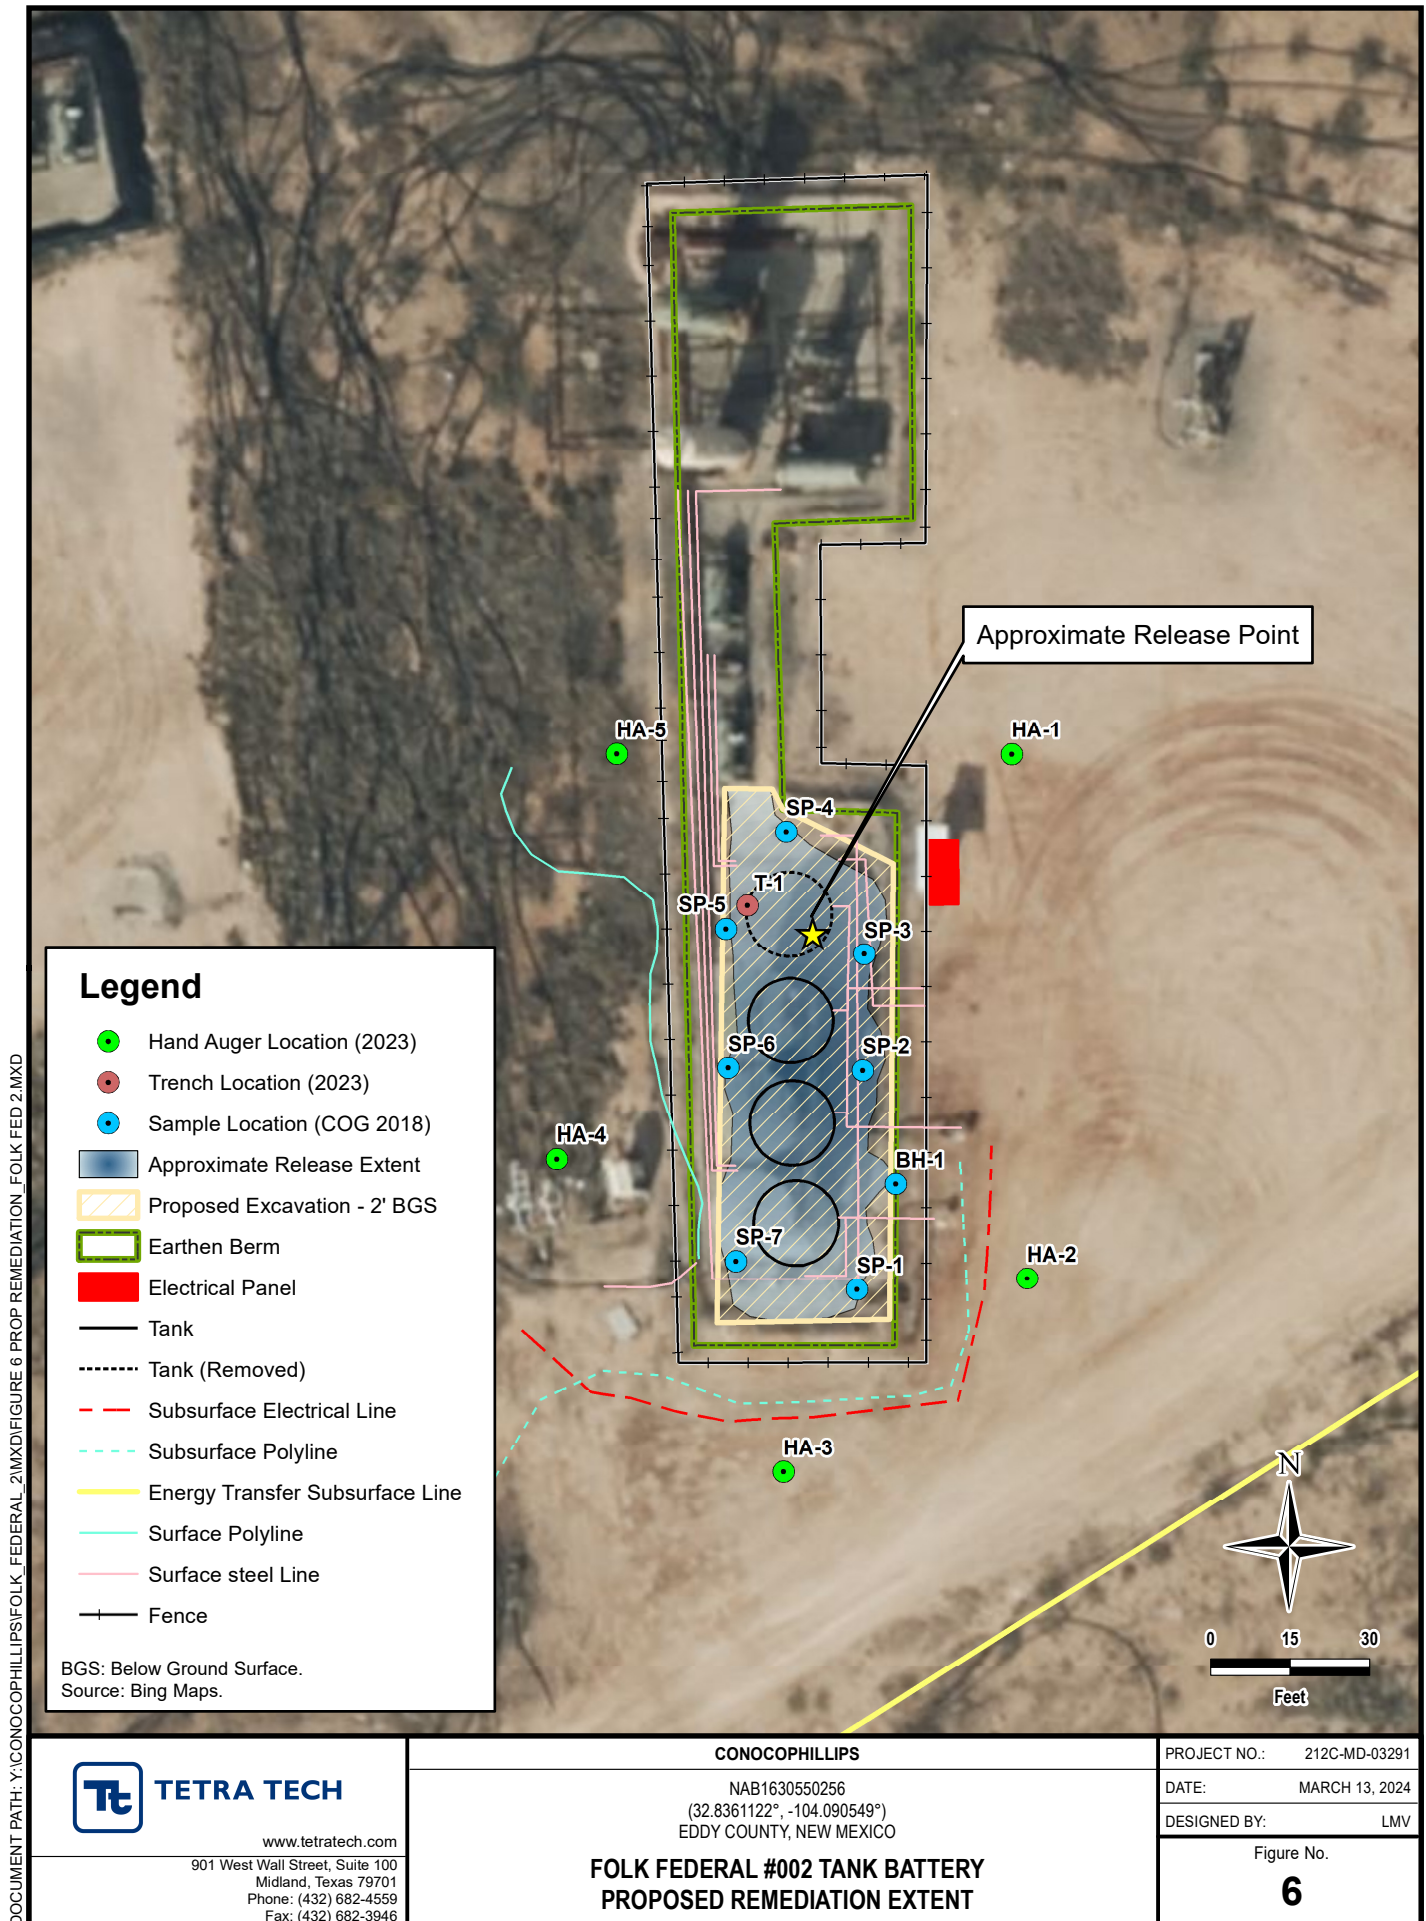
5

Tetra Tech conducted additional assessment sampling at the Site on behalf of COP to evaluate current conditions within and around the release footprint and assess remaining concentration levels in soil. On December 19-20, 2023, Tetra Tech oversaw the installation of four (4) hand auger borings (HA-1 through HA-5) to 0-1' bgs around the approximate release extent to obtain horizontal delineation. One additional trench was installed (T-1) to 2.25' bgs within the earthen berm in an accessible area of the release footprint to obtain vertical delineation. The mini-excavator met refusal at approximately 2-2.25 feet bgs. The additional sampling locations are indicated in Figure 5.

Analytical results from the December 2023 soil sampling event are summarized in Table 2. Analytical results associated with trench location T-1 exceeded the RRAL of 100 mg/kg TPH down to 2' bgs. All other analytical results were below the chloride, TPH, benzene and Total BTEX reclamation requirements of 600 mg/kg, 100 mg/kg, 10 mg/kg and 50 mg/kg, respectively. Vertical delineation was achieved. The release extent observed by Tetra Tech and sample locations are presented in Figure 5.

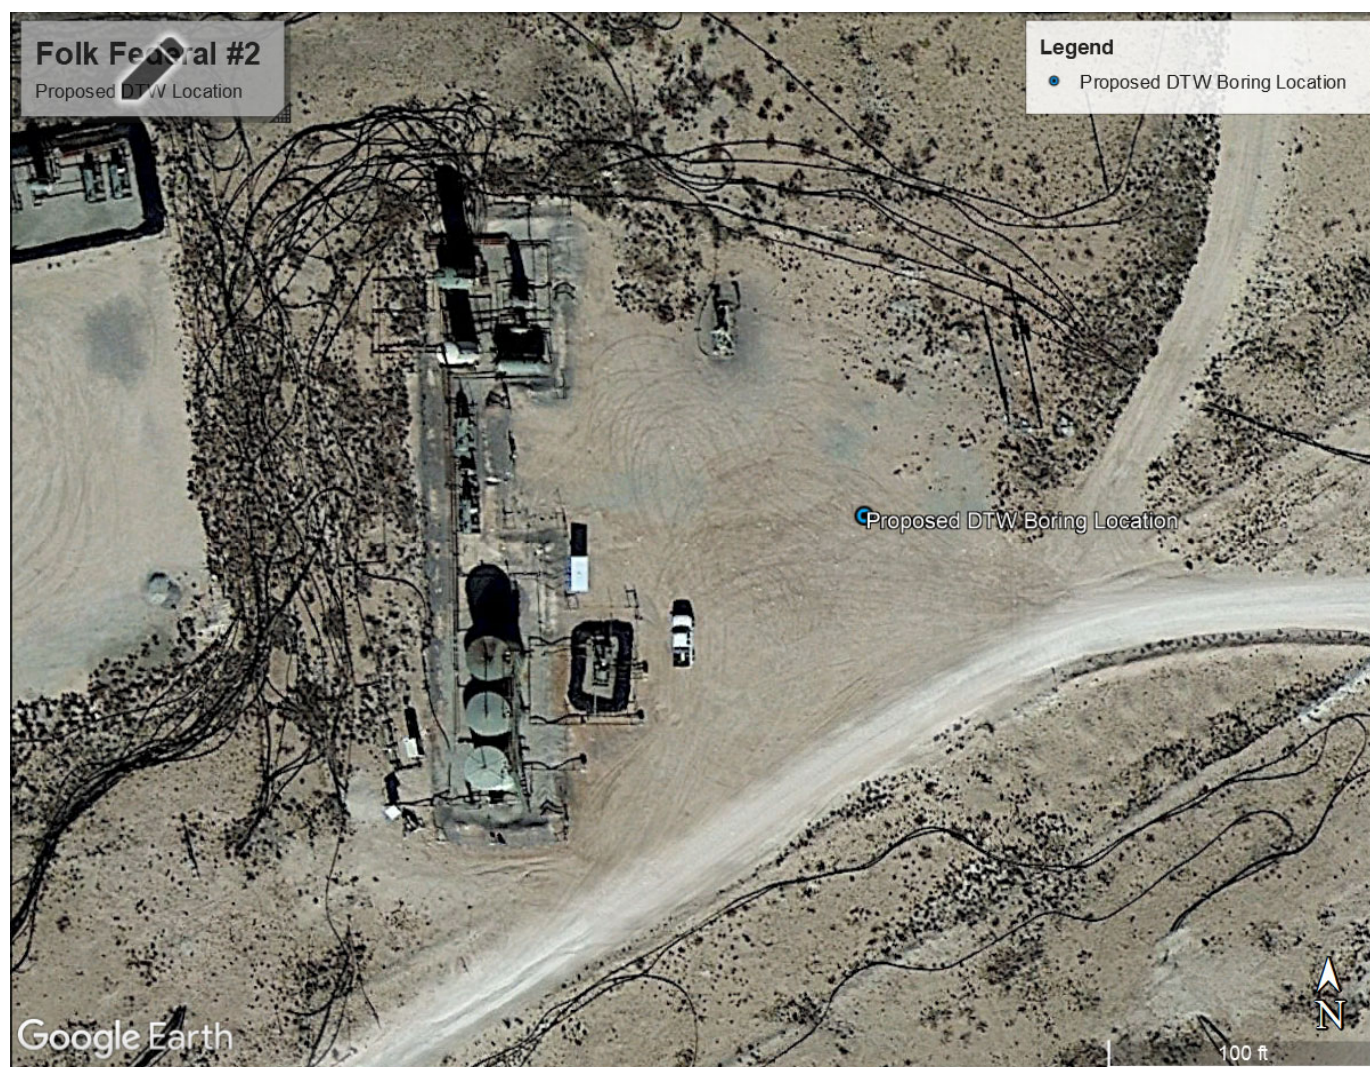
Volume Released: Approximately 18 barrels (bbls) of crude oil.

Release on Pad, inside tank battery berm.

This release was caused by a hole in the bottom of the oil tank. The tank was taken out of service and the valves going to it were closed. Vacuum trucks were immediately dispatched to recover all standing fluid.

This release occurred and remained within the bermed area of the facility. The contaminated gravel has been removed and replaced with fresh gravel. Concho will have the spill site sampled to delineate any possible contamination from the release and we will present a remediation work plan to the NMOCD for approval prior to any significant remediation work.

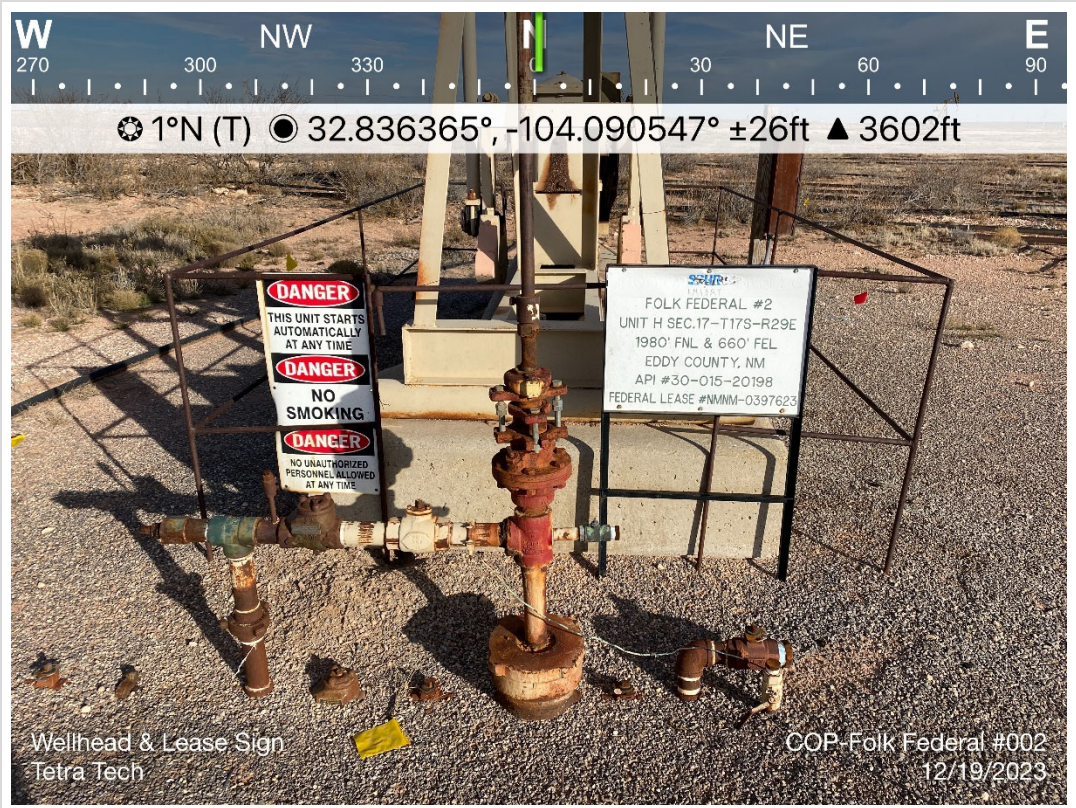
TETRA TECH, INC. PROJECT NO. 212C-MD-03291	DESCRIPTION	View north. View of well head.	1
	SITE NAME	Folk Federal #002 Release	12/19/2023

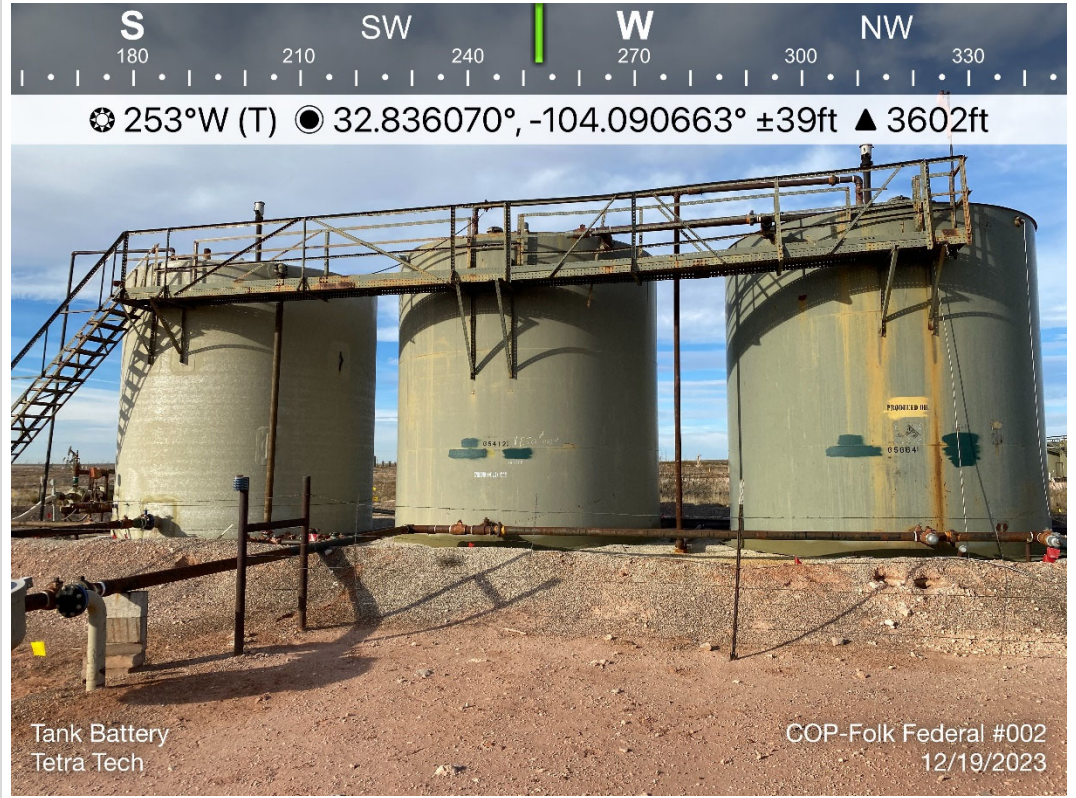
TETRA TECH, INC. PROJECT NO. 212C-MD-03291	DESCRIPTION	View southwest. View of tank batteries and subsurface lines.	2
	SITE NAME	Folk Federal #002 Release	12/19/2023

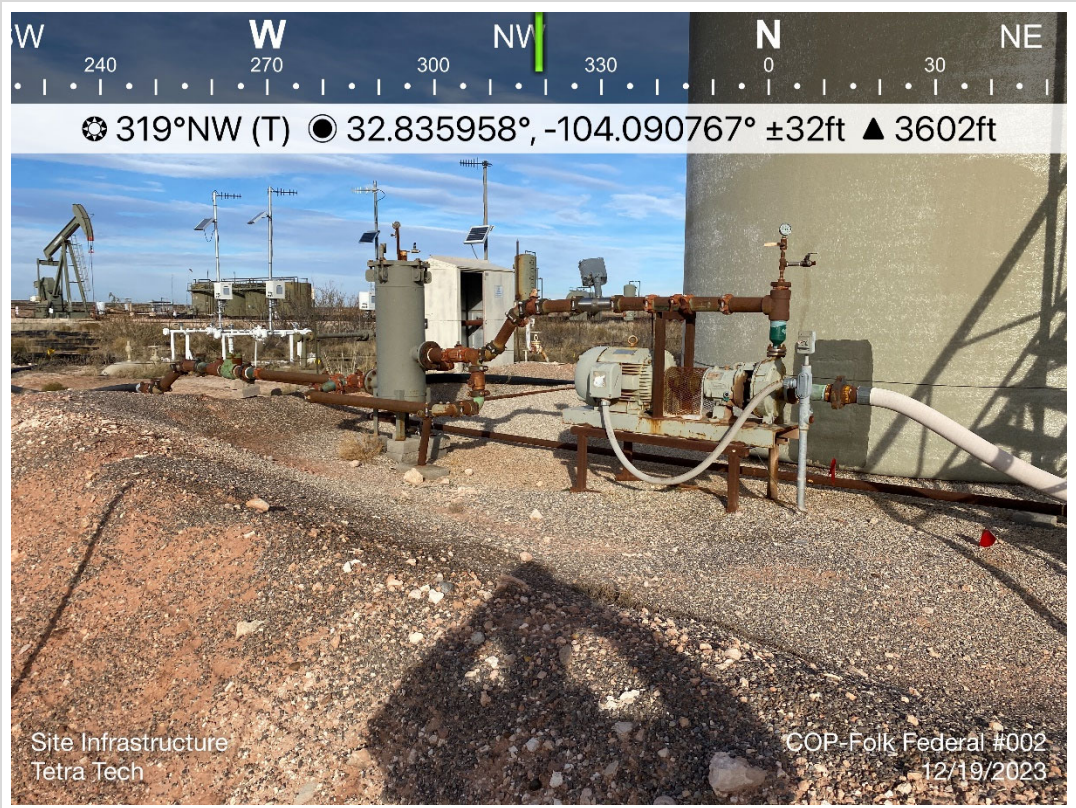
TETRA TECH, INC. PROJECT NO. 212C-MD-02832	DESCRIPTION	View northwest. View of site conditions and view of approximate release area.	3
	SITE NAME	Folk Federal #002 Release	12/19/2023

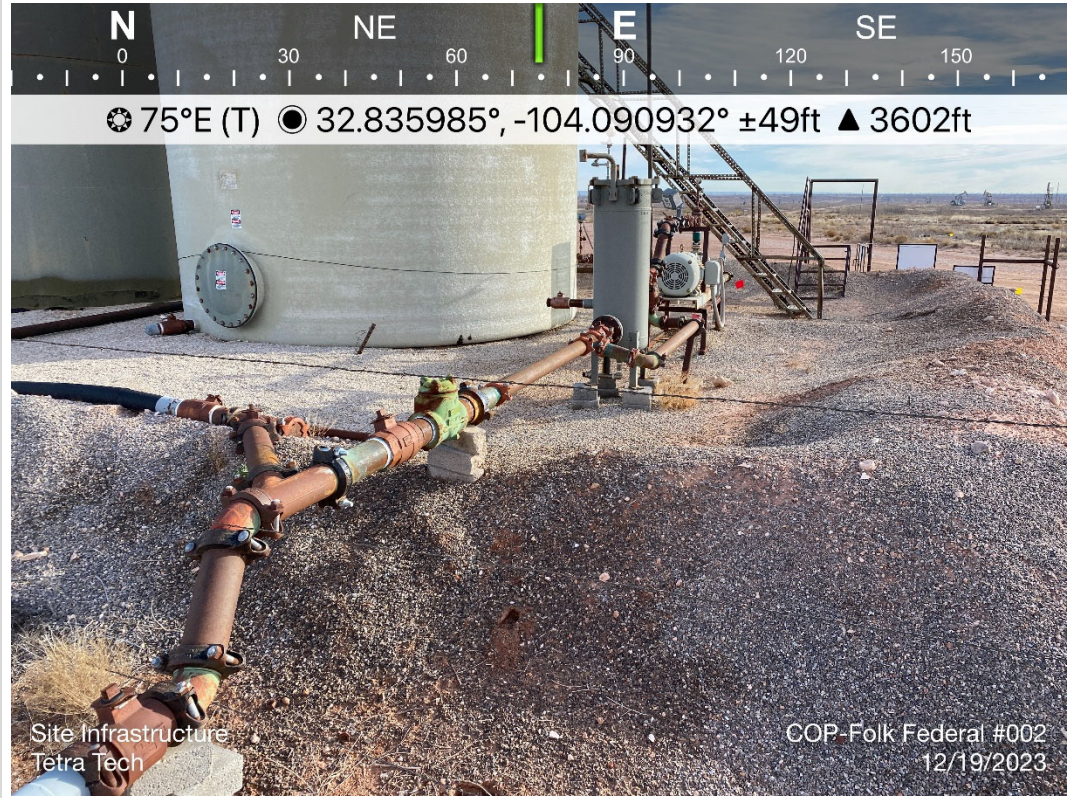
TETRA TECH, INC. PROJECT NO. 212C-MD-02832	DESCRIPTION	View east. View of site conditions and view of approximate release area.	4
	SITE NAME	Folk Federal #002 Release	12/19/2023

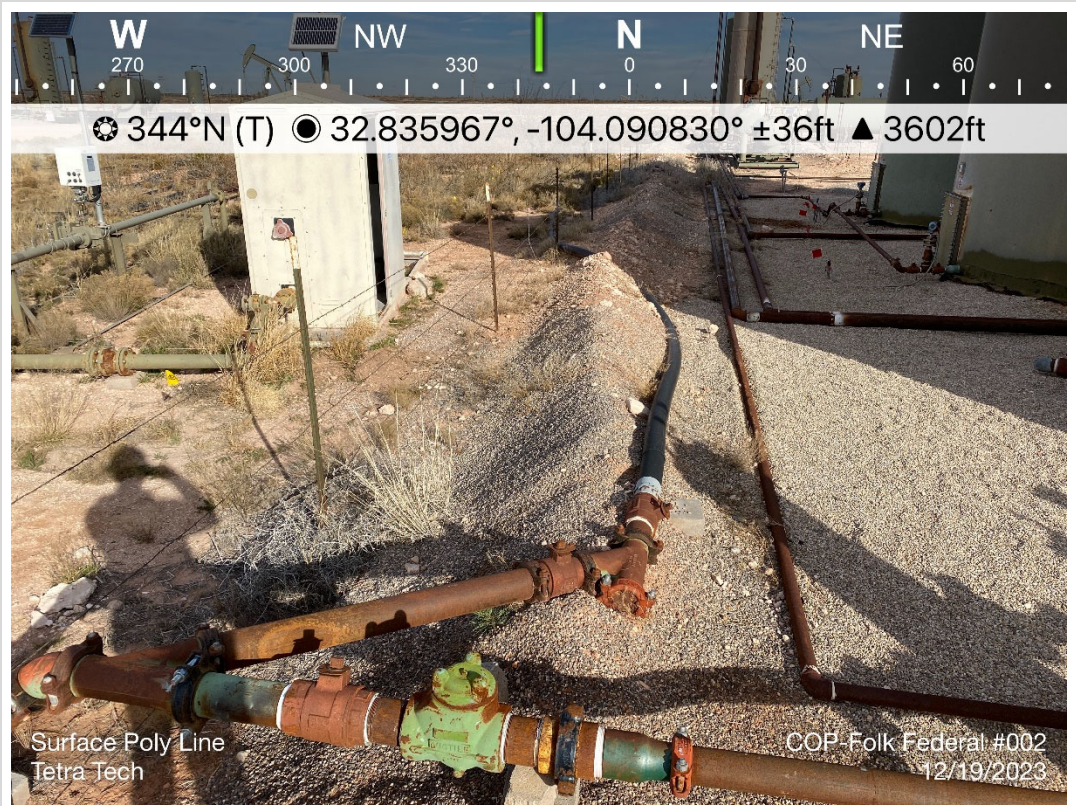
TETRA TECH, INC. PROJECT NO. 212C-MD-03291	DESCRIPTION	View north. View northwest of production equipment.	5
	SITE NAME	Folk Federal #002 Release	12/19/2023

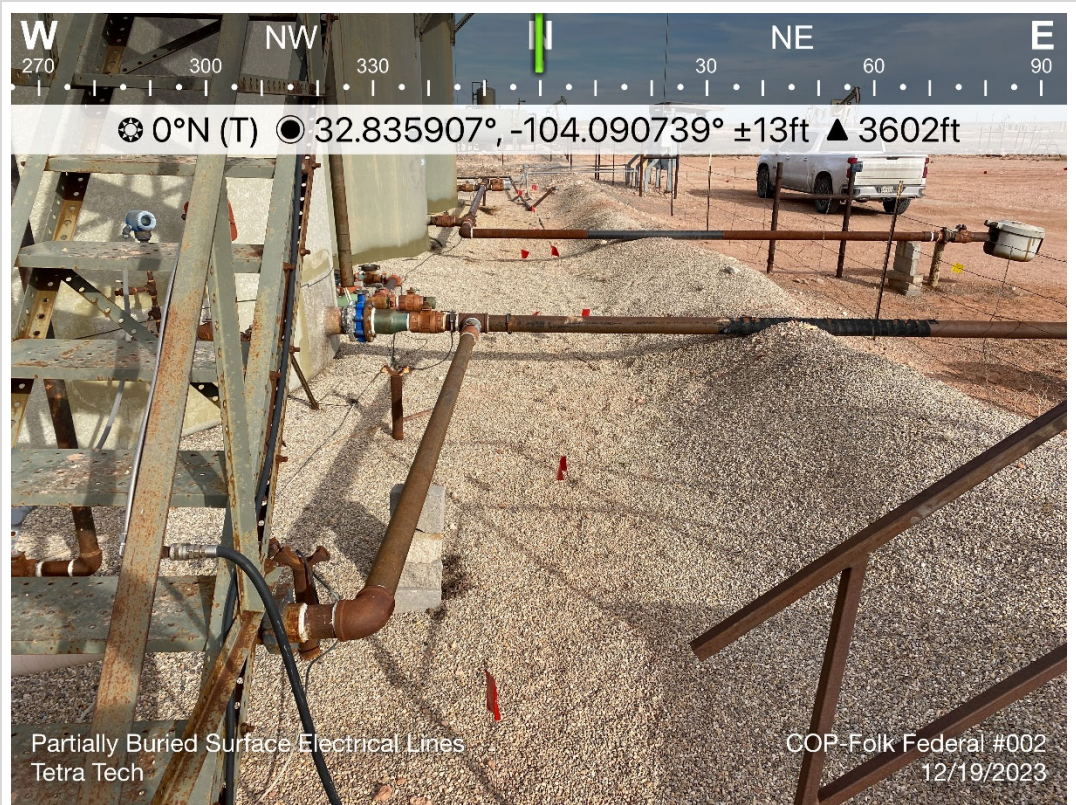
TETRA TECH, INC. PROJECT NO. 212C-MD-03291	DESCRIPTION	View north. View inside tank battery berm and production equipment.	6
	SITE NAME	Folk Federal #002 Release	12/19/2023

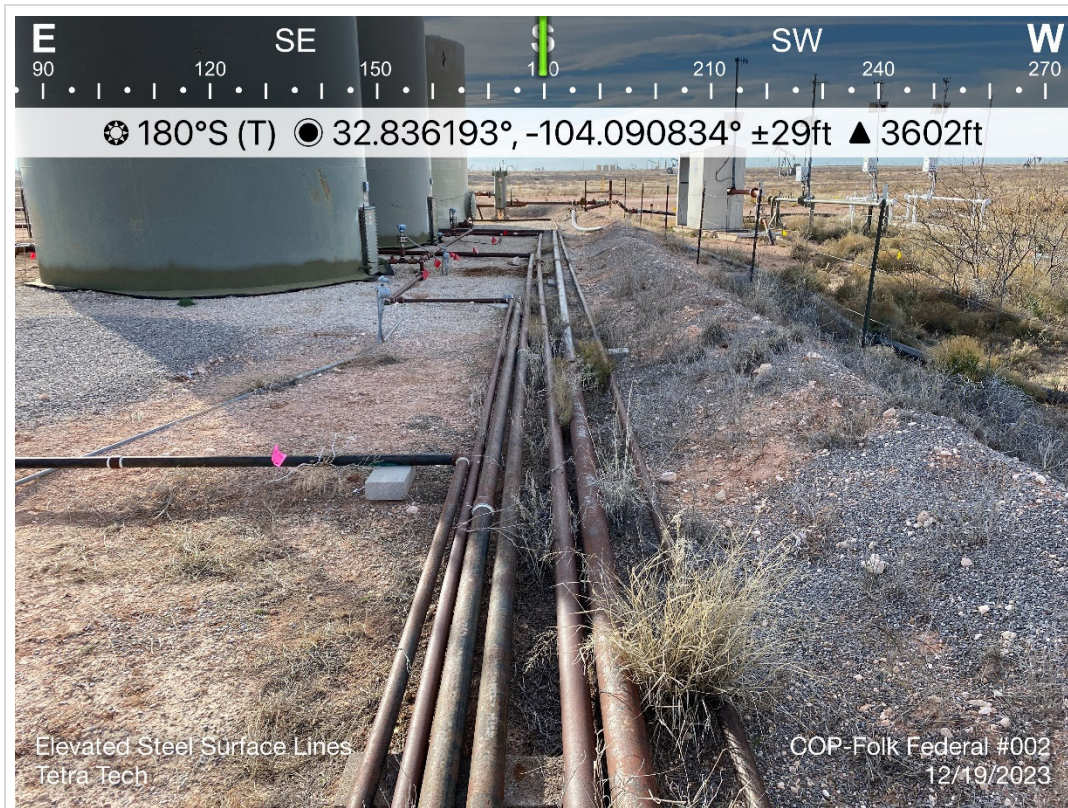
TETRA TECH, INC. PROJECT NO. 212C-MD-03291	DESCRIPTION	View south. View of tank batteries and surface steel lines.	7
	SITE NAME	Folk Federal #002 Release	12/9/2023

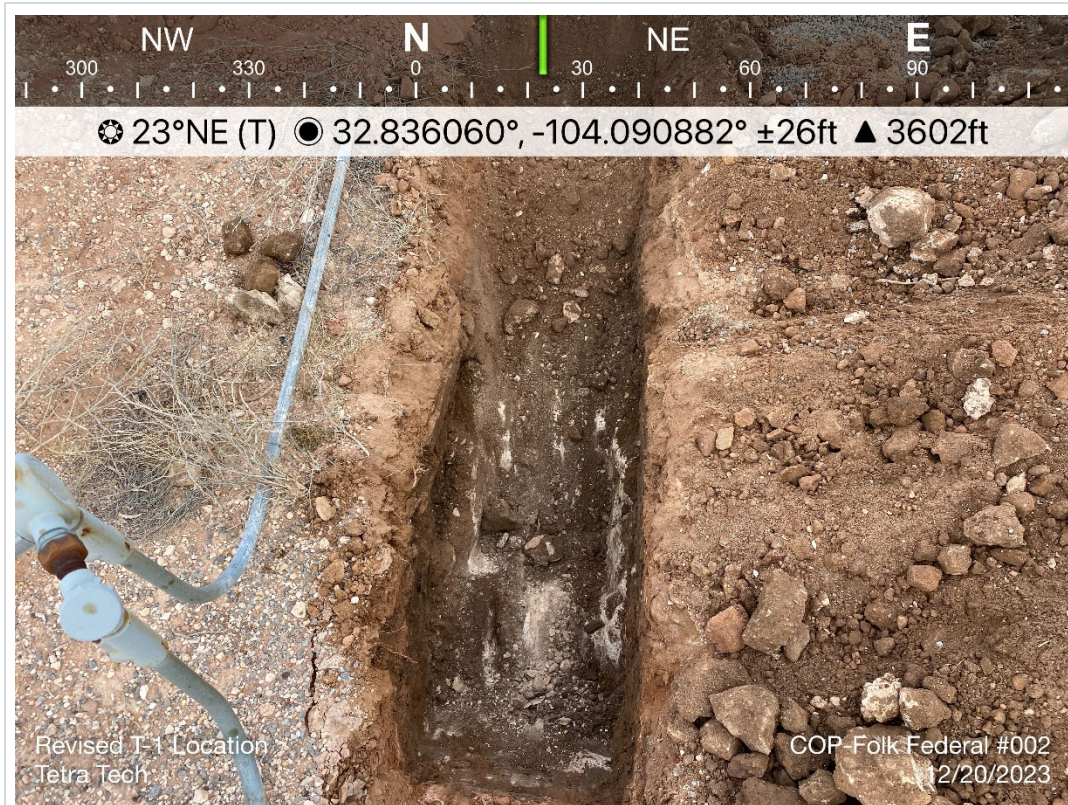
TETRA TECH, INC. PROJECT NO. 212C-MD-03291	DESCRIPTION	View north northeast. View of assessment activities.	8
	SITE NAME	Folk Federal #002 Release	12/20/2023
