According to the C-141 Initial Report, the release occurred on October 18, 2023, and was caused by a free water knockout (FWKO) overfilling causing fluid to be released out of the flare leading to a fire off pad. Approximately 0.06 bbls of oil and 1.11 bbls of produced water were reported and no fluids were recovered due to the fire. The provided spill calculator indicates an irregular release area of approximately 5,250 square feet. This release extent was identified based on information provided by ConocoPhillips representatives and a review of photographs collected at the release area. The approximate release extent is shown in Figure 3. The New Mexico Oil Conservation Division (NMOCD) approved the initial C-141 on October 23, 2023, and assigned the release Incident ID NAPP2329636934. The C-141 is included as Appendix A.

The **Airacuda 31 Fed 2H Flare Fire Release** was caused by a FWKO overfilling causing fluid to be released out of the flare leading to a fire off pad. The release extent is predominantly on-pad but does have a small pasture component in ROW. Assessment activities to begin October 30th.

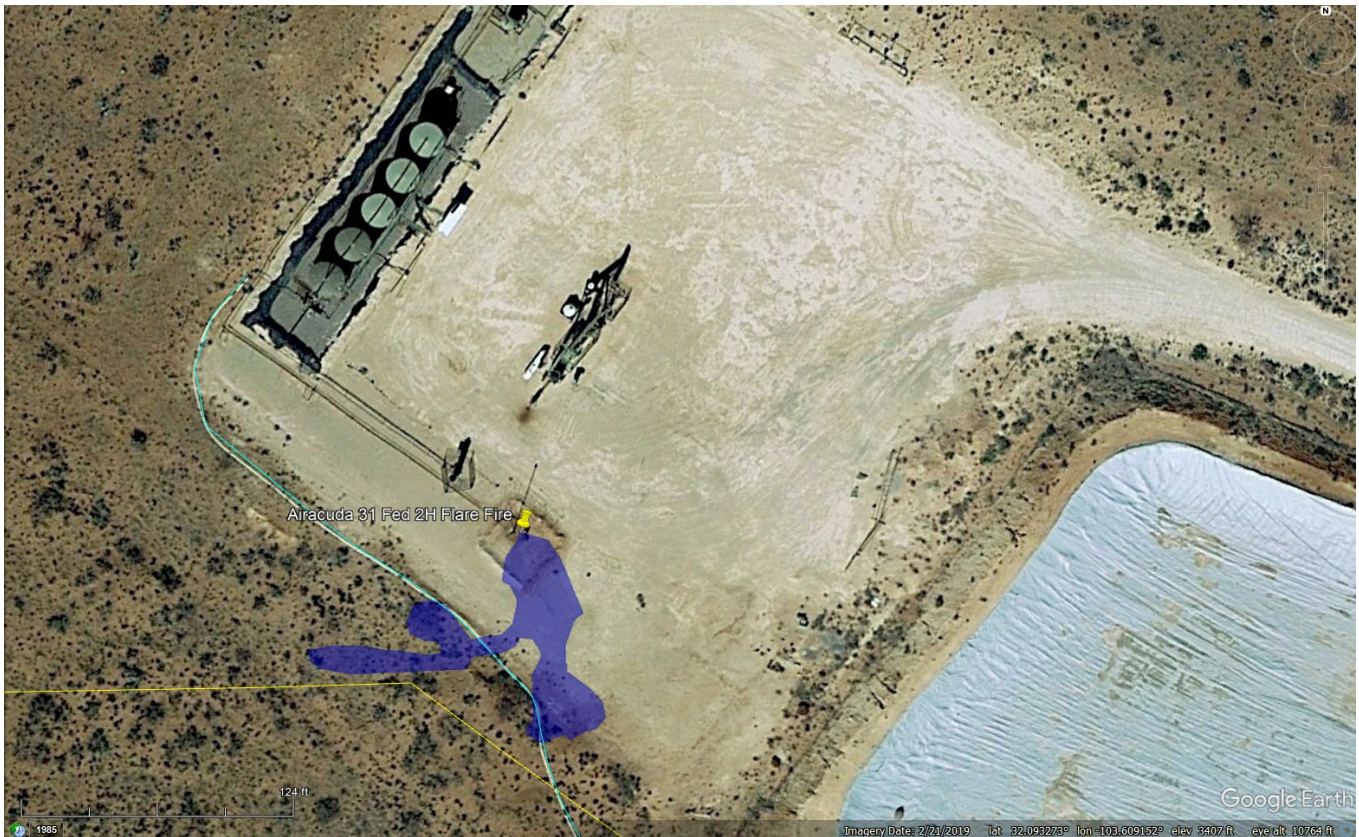
Release in Pasture and On-Pad

Volume Released: Approximately 0.06 barrels (bbls) of crude oil and 1.11 bbls of produced water were released.

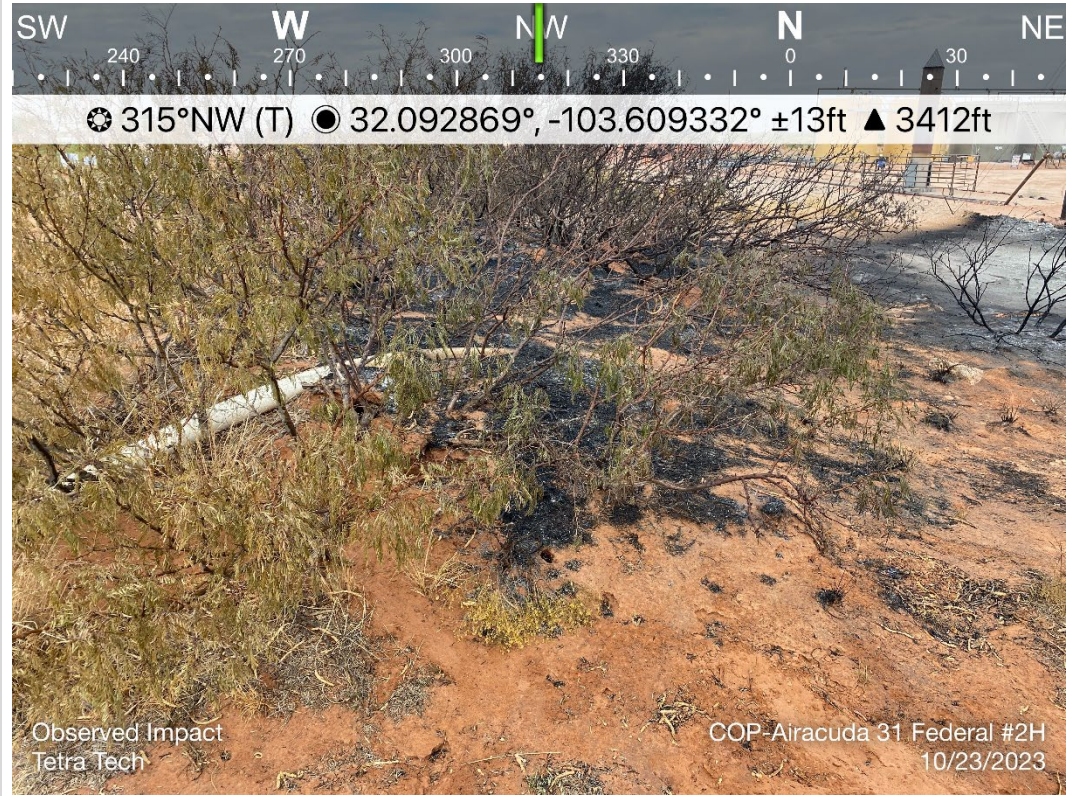
Observed Impact
Tetra Tech

TETRA TECH, INC. PROJECT NO. 212C-MD-03266	DESCRIPTION	View northwest of approximate release extent and surface polyline. Scorched surface and burnt vegetation observed.	2
	SITE NAME	AIRACUDA 31 FEDERAL 2H FLARE FIRE Release	10/23/2023

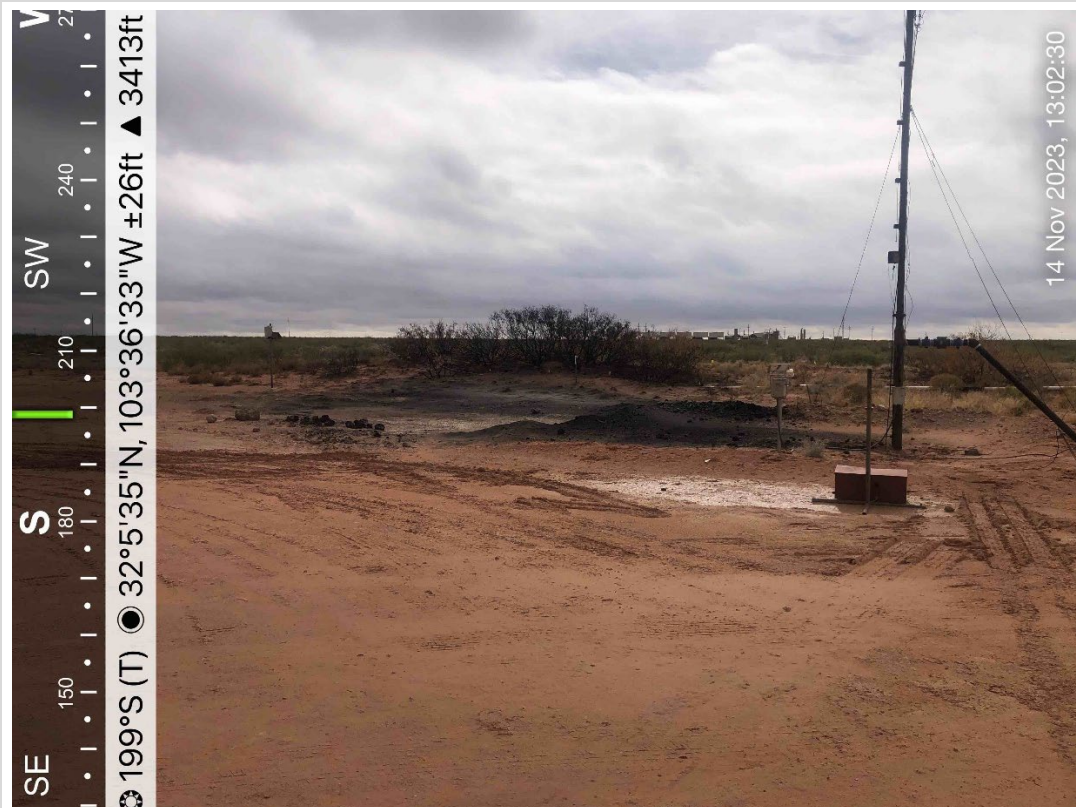
TETRA TECH, INC. PROJECT NO. 212C-MD-03266	DESCRIPTION	View south-southwest. View of approximate release point. View of release before surface scrape.	9
	SITE NAME	AIRACUDA 31 FEDERAL 2H FLARE FIRE Release	11/14/2023

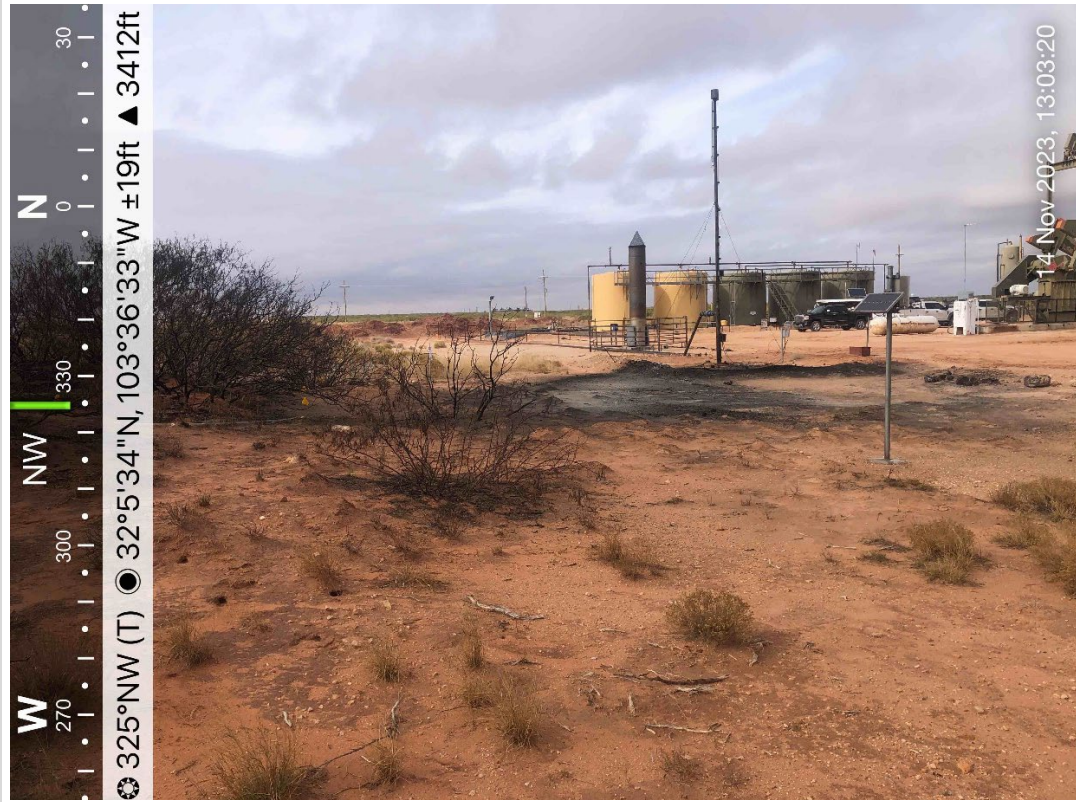
TETRA TECH, INC. PROJECT NO. 212C-MD-03266	DESCRIPTION	View northwest of site conditions before surface scrape.	10
	SITE NAME	AIRACUDA 31 FEDERAL 2H FLARE FIRE Release	11/16/2023

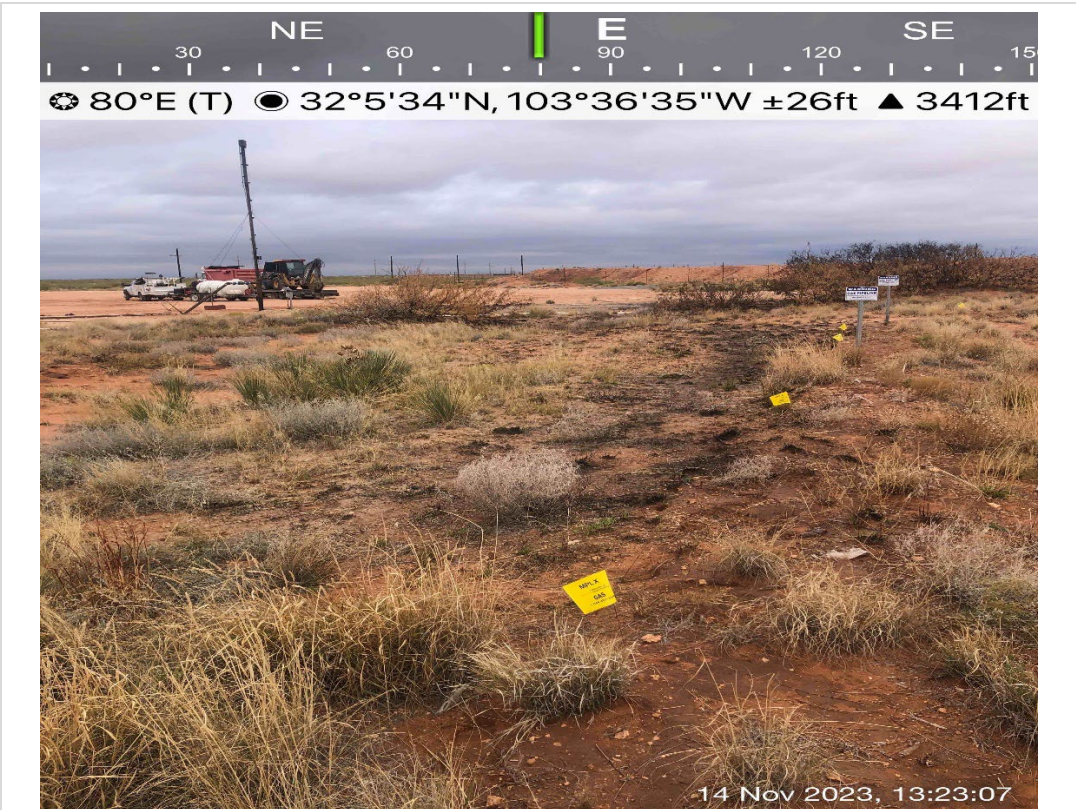
TETRA TECH, INC. PROJECT NO. 212C-MD-03266	DESCRIPTION	View northeast. View site conditions before surface scrape of approximate release area.	9
	SITE NAME	AIRACUDA 31 FEDERAL 2H FLARE FIRE Release	11/14/2023

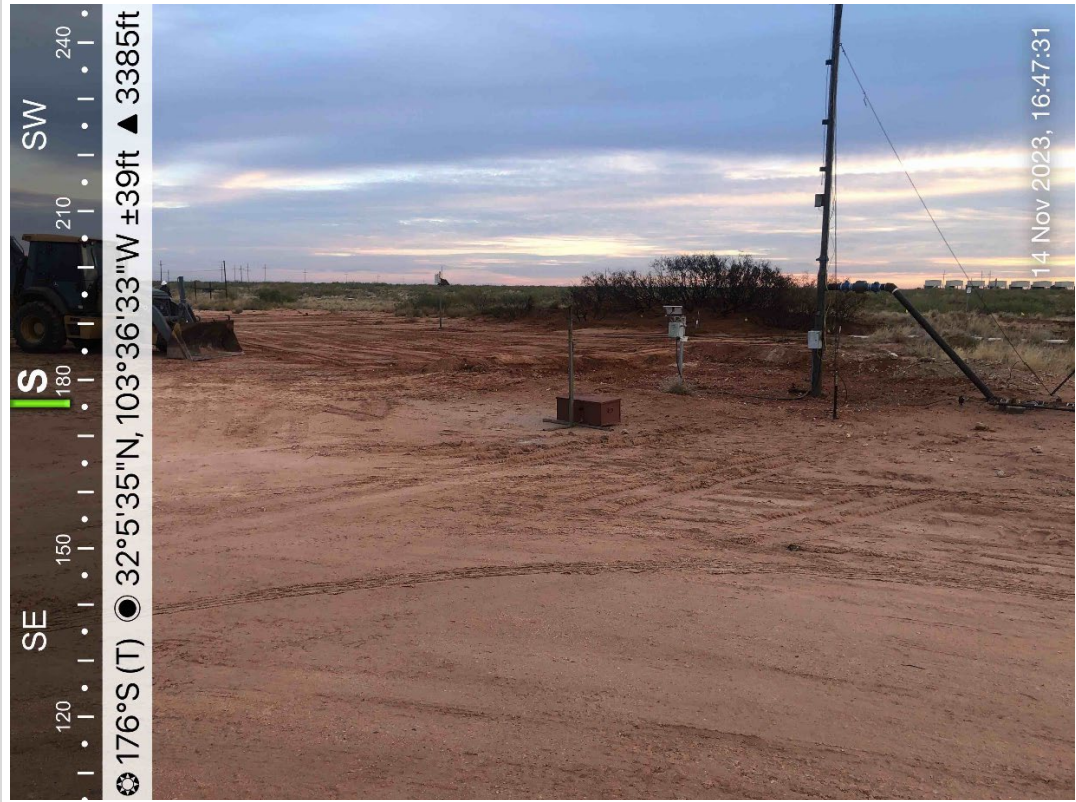
TETRA TECH, INC. PROJECT NO. 212C-MD-03266	DESCRIPTION	View south of site conditions following surface scrape. View of release point.	10
	SITE NAME	AIRACUDA 31 FEDERAL 2H FLARE FIRE Release	11/16/2023

The observed release extent consisted of approximately 3,476 square feet; however, the surface scrape was conducted over an area of approximately 5,000 square feet. As shown, in Appendix E, the release was limited to the shallow surface and was not consistent in shape. Samples were collected such that each discrete sample (horizontal and vertical) was representative of approximately 200 square feet of remediated area. A total of eight (8) floor sample locations and eight (8) sidewall sample locations were used during the sampling activities. Confirmation sidewall sample locations were labeled with "SW"-#, and confirmation floor sample locations were labeled with "FS"-#. Analytical results for all confirmation soil samples (floor and sidewall) were below the applicable Site RRALs for chloride, BTEX, and TPH. The results of the 2023 confirmation sampling events are summarized in Table 2. Laboratory analytical data is included in Appendix D. The initial response remedial action was successful in removing the contaminant mass to meet the standards of Table I of 19.15.29.12 NMAC.

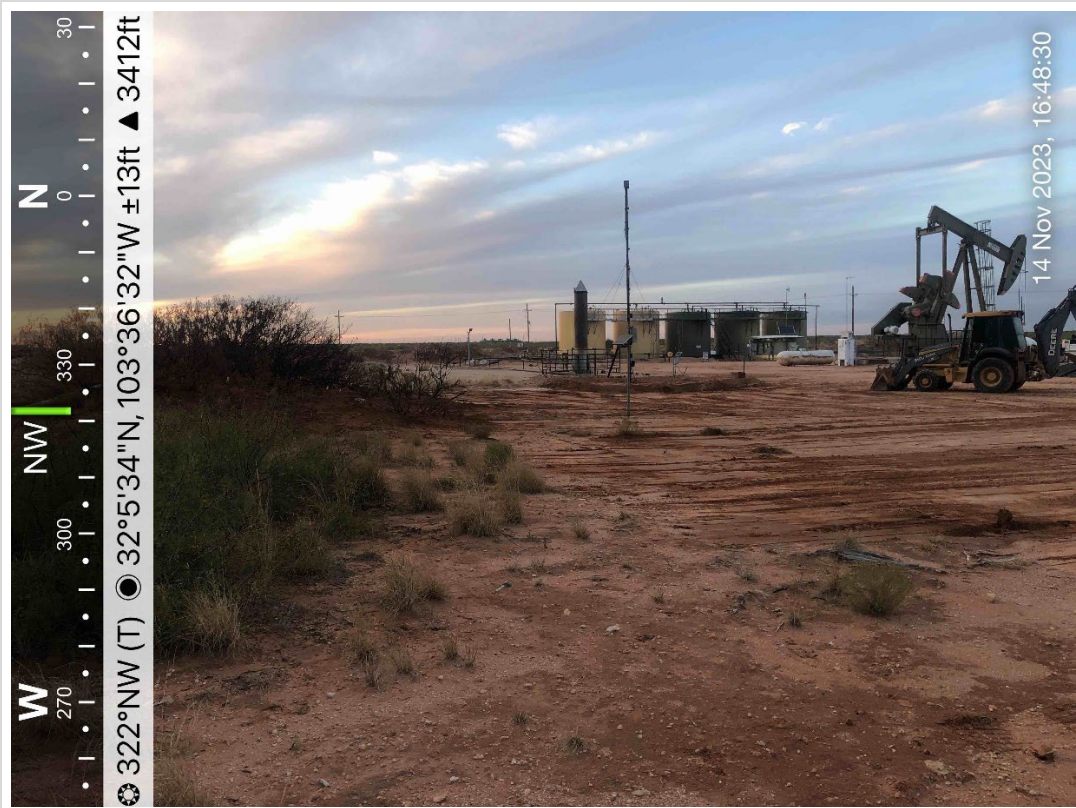
TETRA TECH, INC. PROJECT NO. 212C-MD-03266	DESCRIPTION	View northwest. View following surface scrape of approximate release area.	9
	SITE NAME	AIRACUDA 31 FEDERAL 2H FLARE FIRE Release	11/14/2023

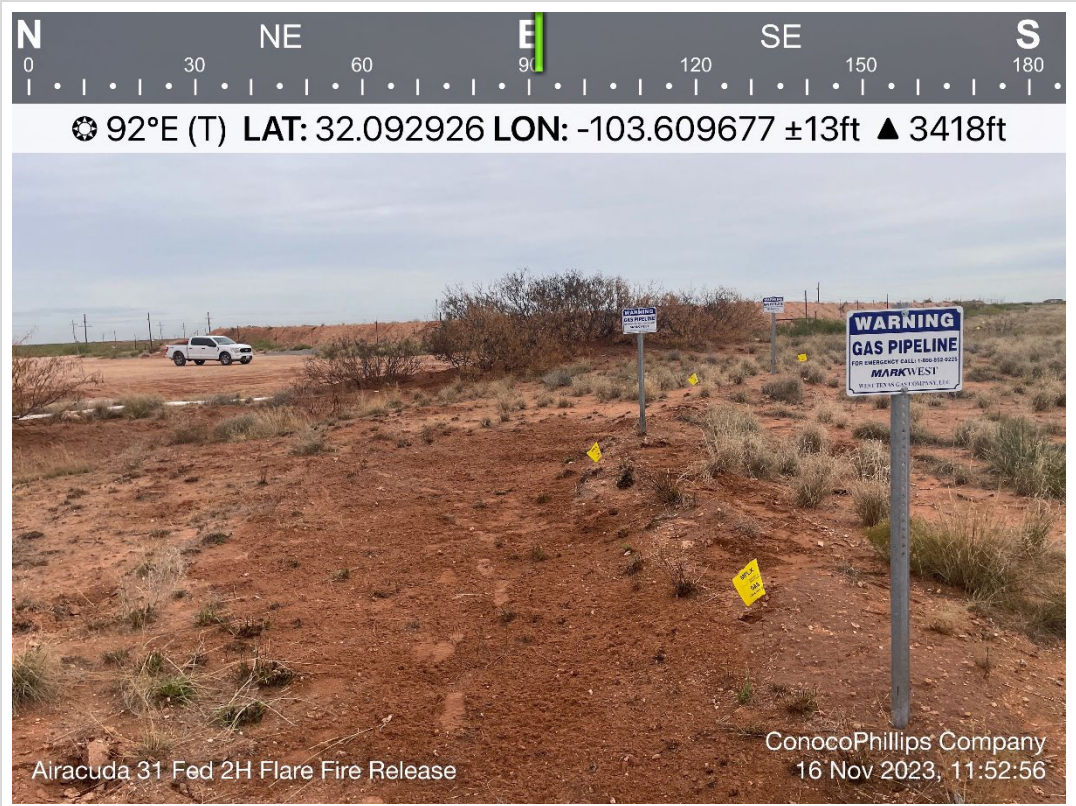
TETRA TECH, INC. PROJECT NO. 212C-MD-03266	DESCRIPTION	View east of site conditions following surface scrape.	11
	SITE NAME	AIRACUDA 31 FEDERAL 2H FLARE FIRE Release	11/16/2023

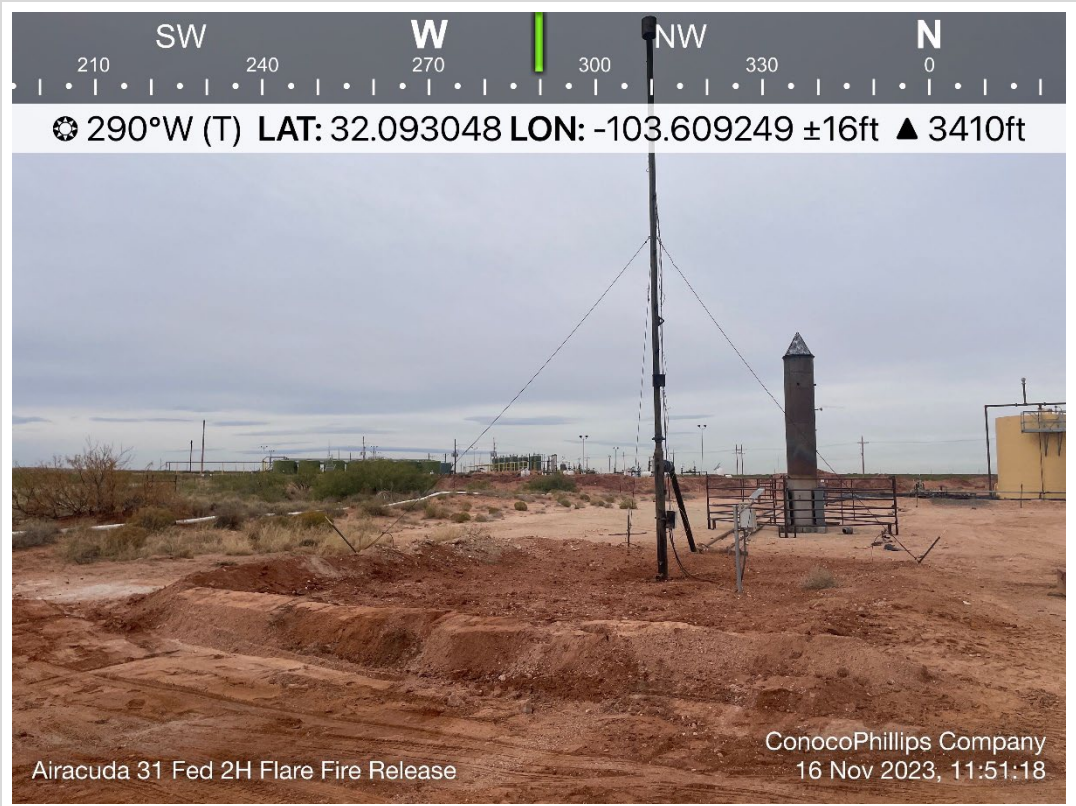
TETRA TECH, INC. PROJECT NO. 212C-MD-03266	DESCRIPTION	View west-northwest of site conditions following surface scrape near approximate release point.	13
	SITE NAME	AIRACUDA 31 FEDERAL 2H FLARE FIRE Release	11/16/2023

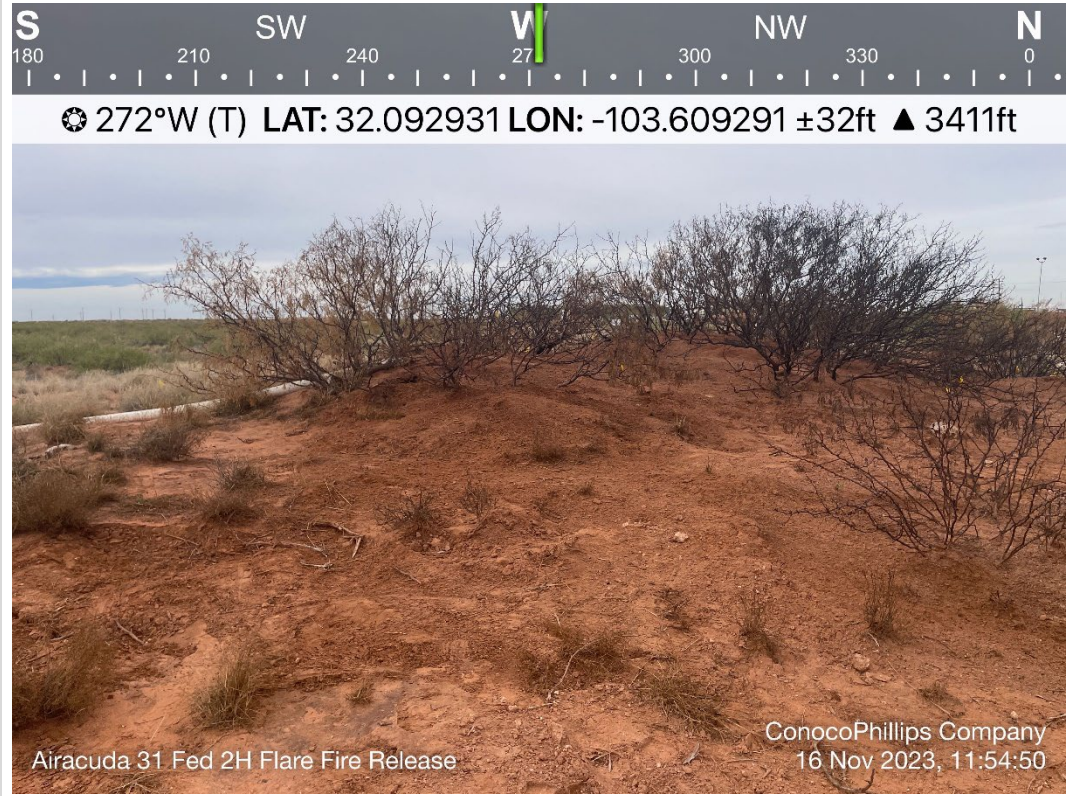
TETRA TECH, INC. PROJECT NO. 212C-MD-03266	DESCRIPTION	View west of site conditions following surface scrape.	14
	SITE NAME	AIRACUDA 31 FEDERAL 2H FLARE FIRE Release	11/16/2023
