Fighting Okra CTB 3

RE: Liner Inspection and Closure Report
Fighting Okra 18 CTB 3
API No. N/A
GPS : Latitude 32.05002 Longitude -103.516
UL- D, Section 18, Township 26S, Range 34E
Lea County, NM
NMOCD Reference No. NAPP2330747660

SITE PHOTOGRAPHS
DEVON ENERGY – LINER INSPECTION
Fighting Okra 18 CTB 3

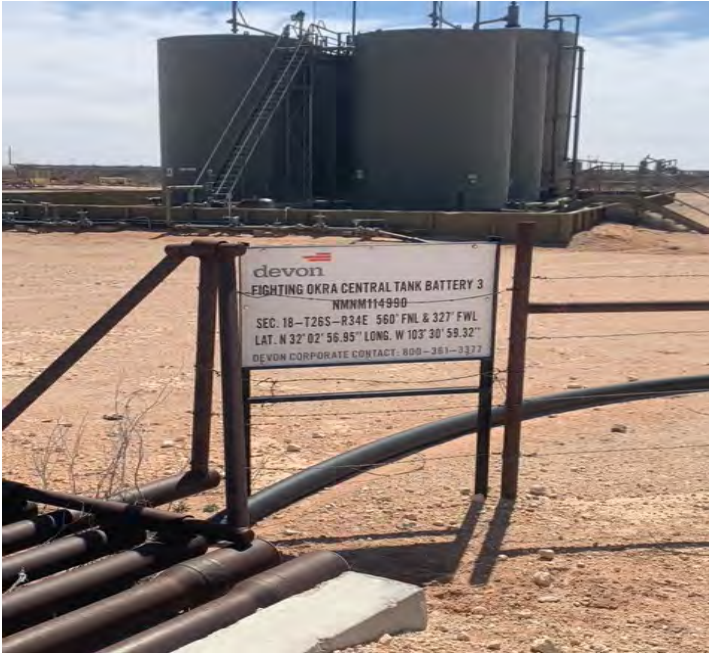
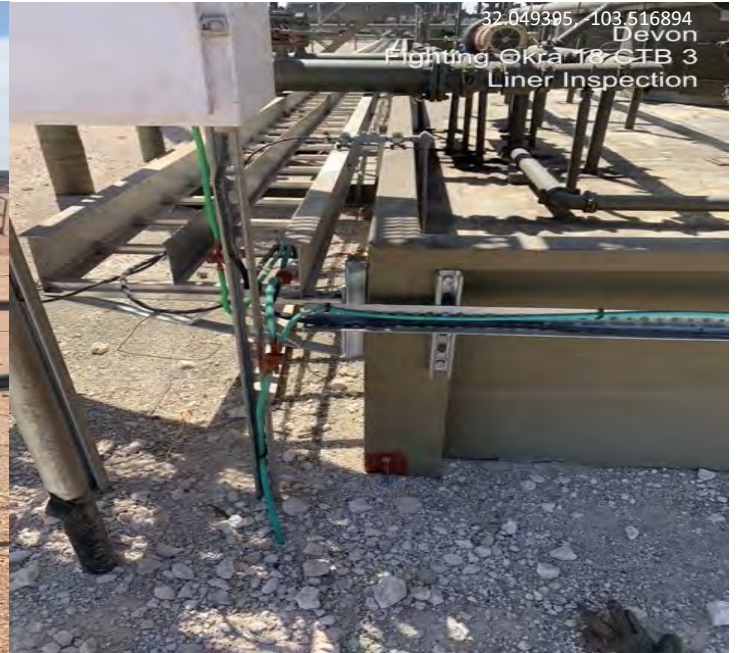
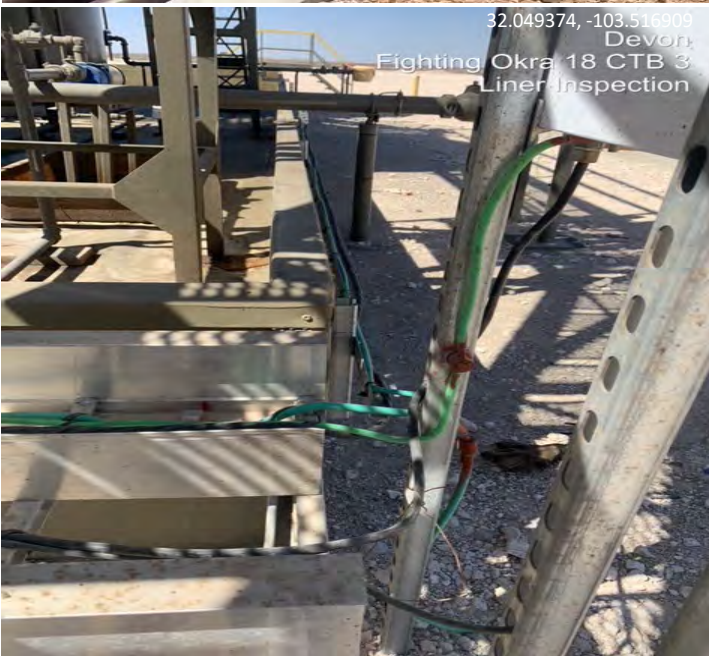
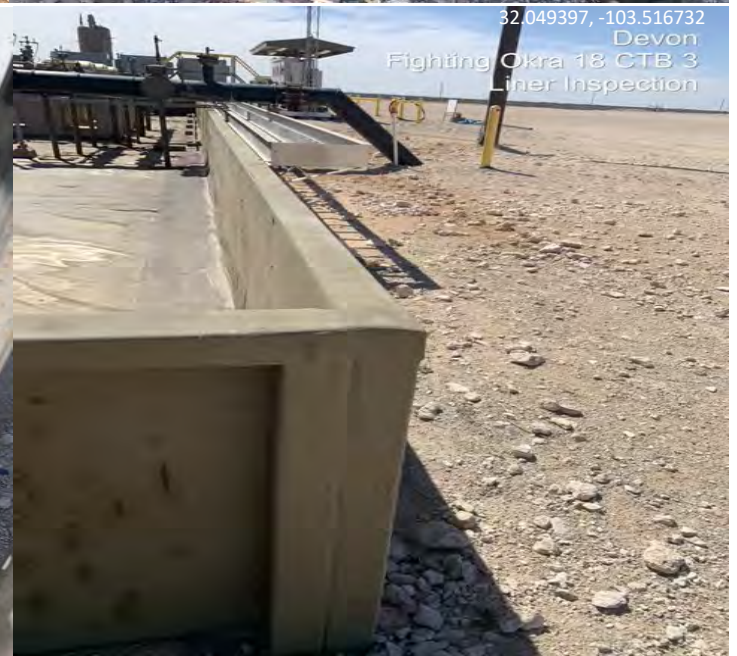
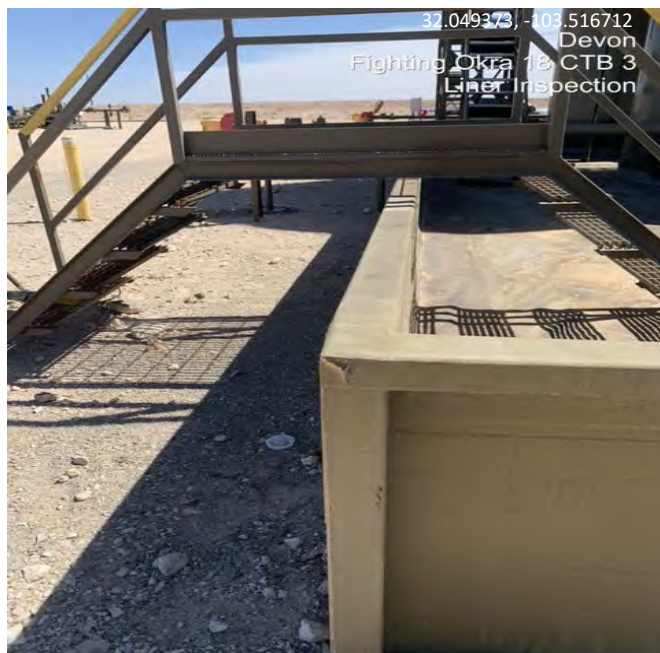
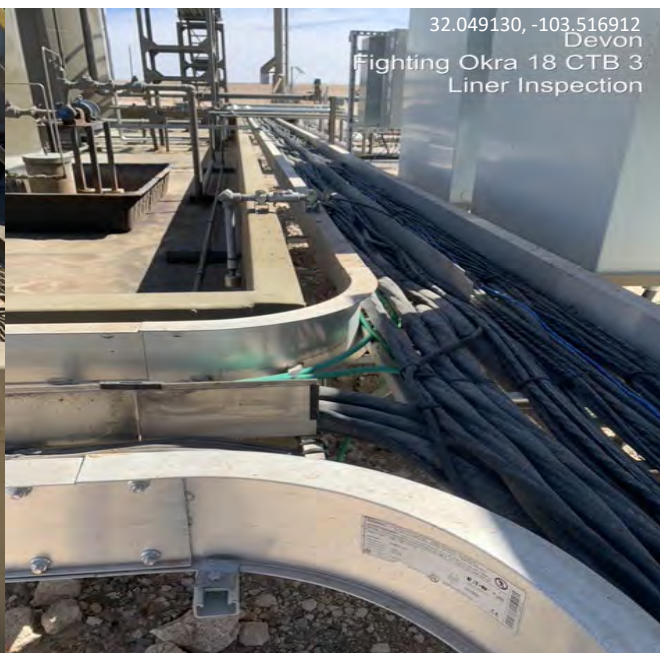
Liner Inspection

On March 14, 2024, after submitting the 48-hour notification application ID:322160 to the NMOCD, Pima Environmental conducted a liner inspection at this location. Pima concluded that this liner and containment maintained its integrity and was able to retain the fluids. The liner inspection form and photographic documentation can be found in Appendix C.

Visualization	Yes	No	Comments
Is there a tear in the liner?		X	
Are there holes in the liner?		X	
Is the liner retaining any fluids?		X	
Does the liner have integrity to contain a leak?	X
