Facility Name & Number:		Sopapilla SWD Flex Leak				
Asset Area:		hConcho, Lea County				
Release Discovery Date & Time:		5/25/2021				
Release Type:		Produced Water				
Provide any known details about the event:		Lat 32.29802, Lon -103.56710,SWD flex line damaged by unknown party, OFF LOCATION				
Spill Calculation - Subsurface Spill - Rectangle						
Was the release on pad or off-pad?					See reference table below	
Has it rained at least a half inch in the last 24 hours?					See reference table below	
Convert Irregular shape into a series of rectangles	Length (ft.)	Width (ft.)	Depth (in.)	Soil Spilled-Fluid Saturation	Estimated volume of each area (bbl.)	Total Estimated Volume of Spill (bbl.)
Rectangle A	24.0	23.0	8.00	15.12%	65.504	9.904
Rectangle B					0.000	0.000
Rectangle C					0.000	0.000
Rectangle D					0.000	0.000
Rectangle E					0.000	0.000
Rectangle F					0.000	0.000
Rectangle G					0.000	0.000

BACKGROUND

TABLE 1
SUMMARY OF ANALYTICAL RESULTS
INITIAL SOIL ASSESSMENT- NAPP2115525504
HERITAGE CONCHO
SOPAPILLA STATE 2D CTB FLEX LINE RELEASE
LEA COUNTY, NEW MEXICO

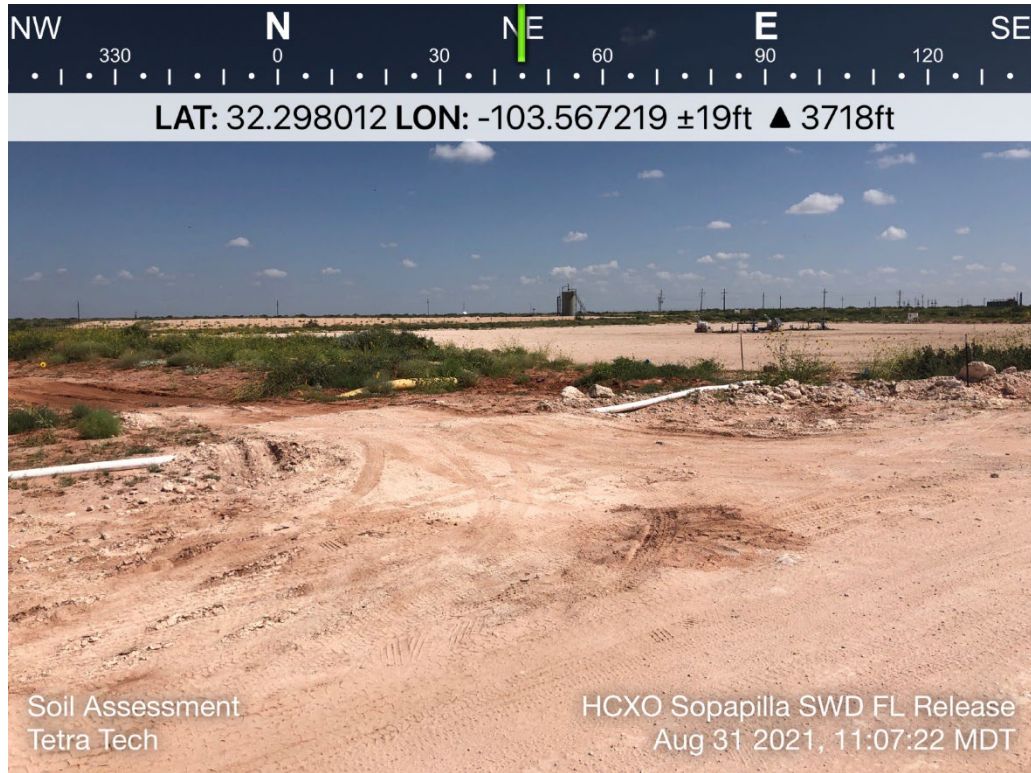
TETRA TECH, INC. PROJECT NO. 212C-MD-02532A	DESCRIPTION	View northeast of the release area near the flowline running to the Sopapilla SWD. Partially buried surface polyline.	1
	SITE NAME	ConocoPhillips Sopapilla SWD Release	8/31/2021

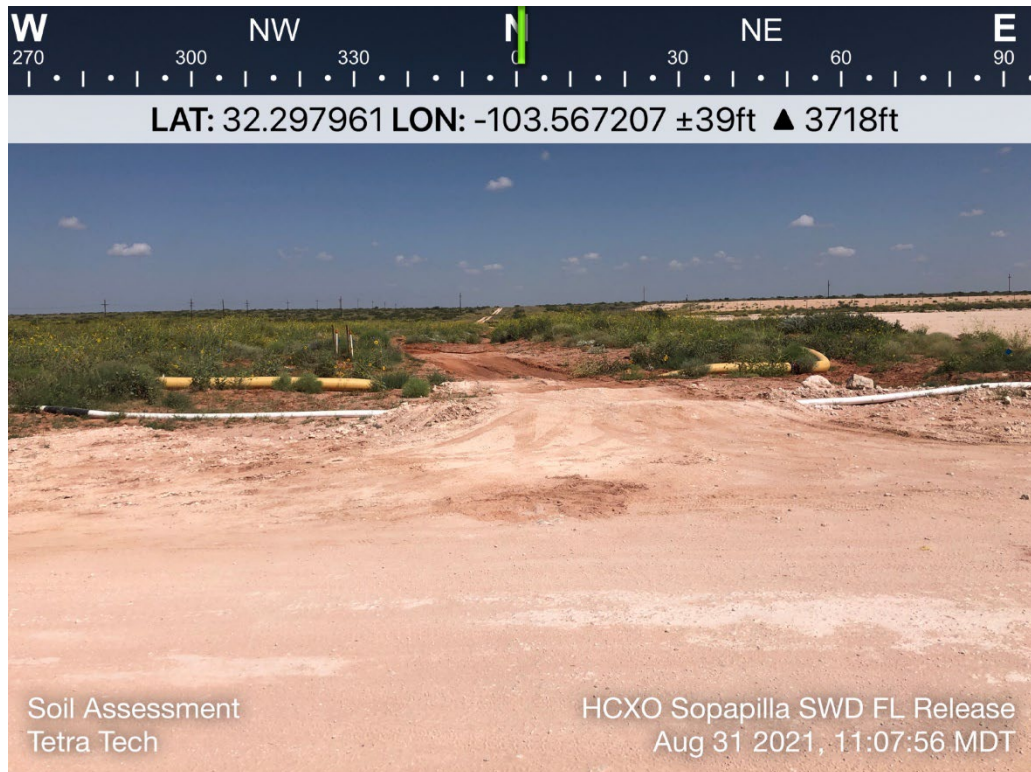
TETRA TECH, INC. PROJECT NO. 212C-MD-02532A	DESCRIPTION	View north of the release area near the flowline running to the Sopapilla SWD. Partially buried surface polyline.	2
	SITE NAME	ConocoPhillips Sopapilla SWD Release	8/31/2021

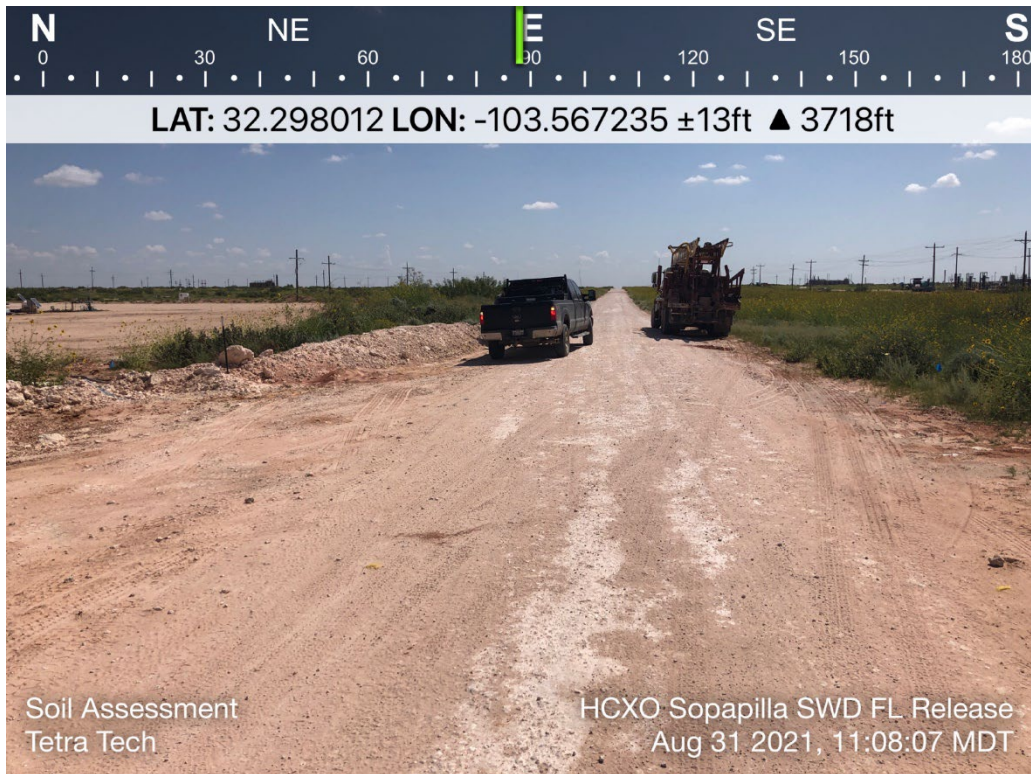
TETRA TECH, INC. PROJECT NO. 212C-MD-02532A	DESCRIPTION	View of the release area near the flowline running to the Sopapilla SWD.	3
	SITE NAME	ConocoPhillips Sopapilla SWD Release	8/31/2021

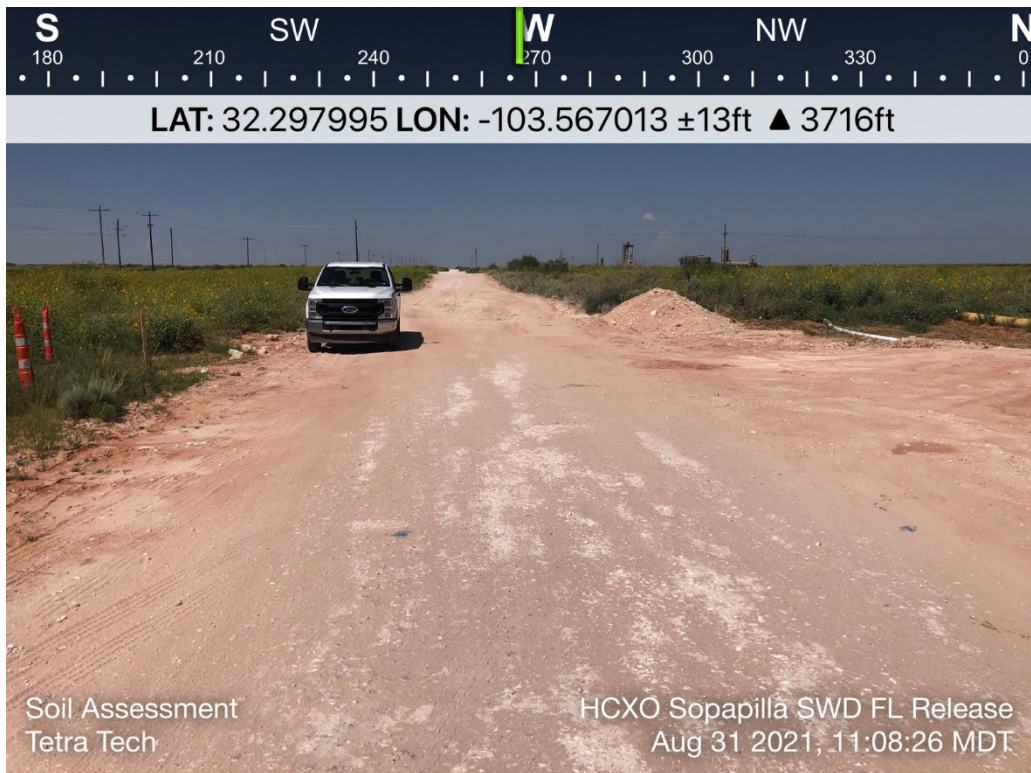
TETRA TECH, INC. PROJECT NO. 212C-MD-02532A	DESCRIPTION	View of the release area near the flowline running to the Sopapilla SWD.	4
	SITE NAME	ConocoPhillips Sopapilla SWD Release	8/31/2021

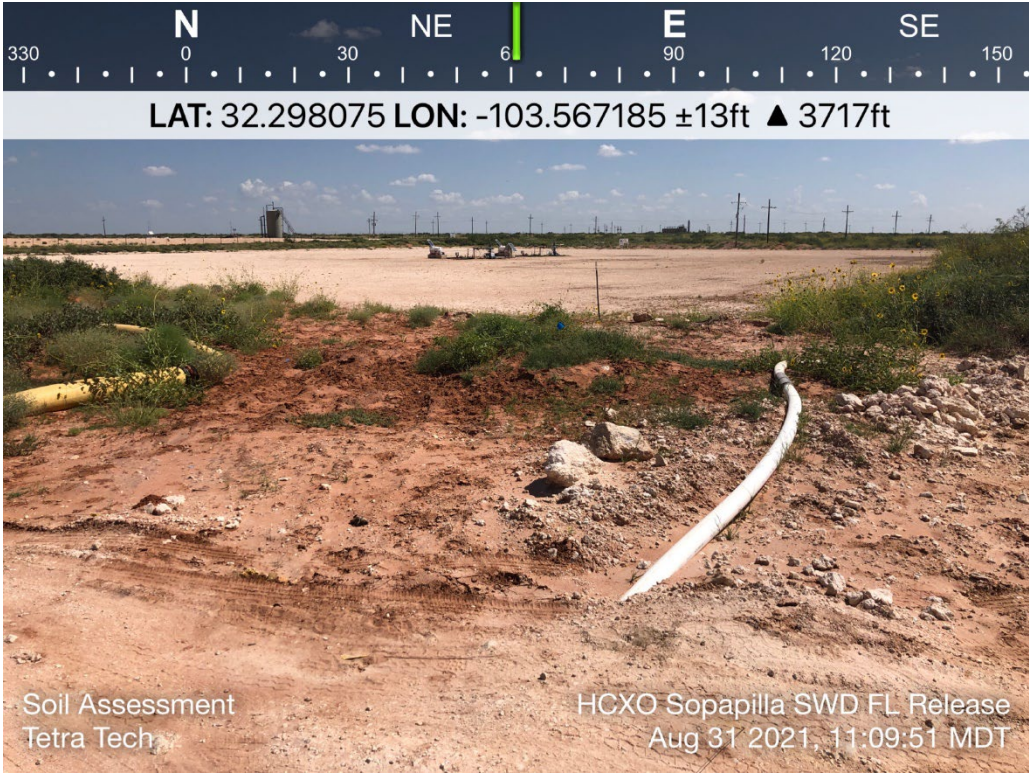
TETRA TECH, INC. PROJECT NO. 212C-MD-02532A	DESCRIPTION	View of the release area near the flowline running to the Sopapilla SWD. Partially buried surface polyline.	5
	SITE NAME	ConocoPhillips Sopapilla SWD Release	8/31/2021

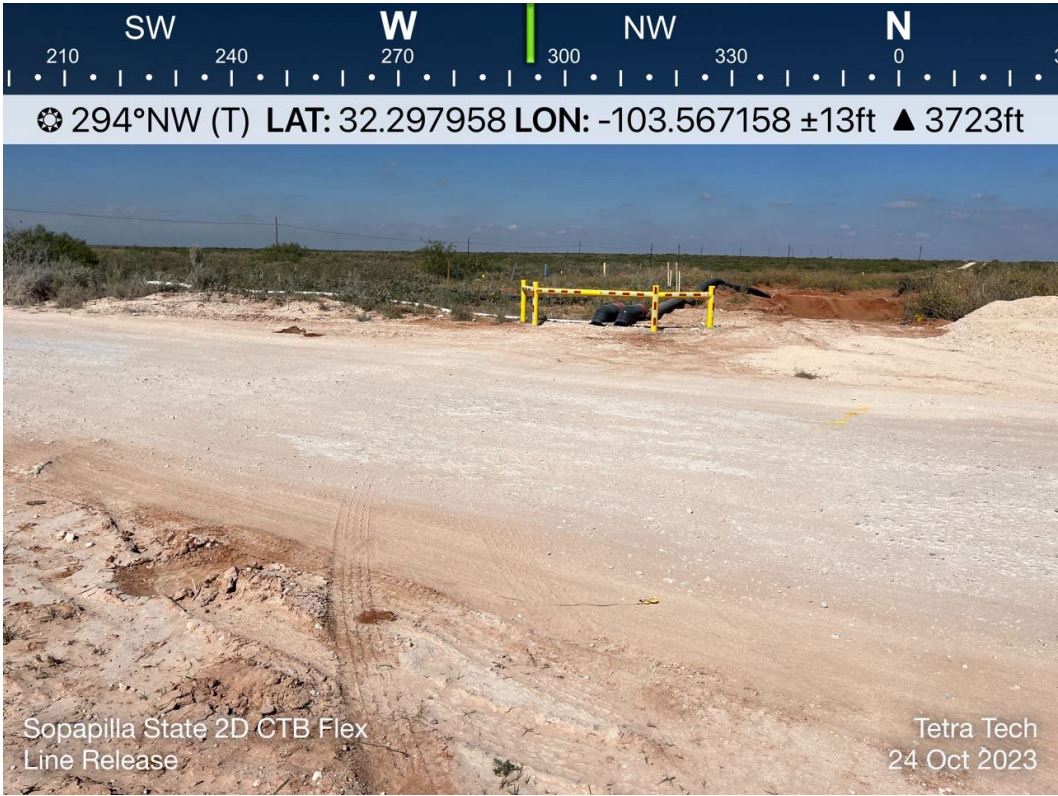
TETRA TECH, INC. PROJECT NO. 212C-MD-03252	DESCRIPTION	View west-northwest of approximate release area near the flowline running to the Sopapilla SWD. Lay flat lines and surface polyline.	6
	SITE NAME	Sopapilla State 2D CTB Flex Line Release	10/24/2023

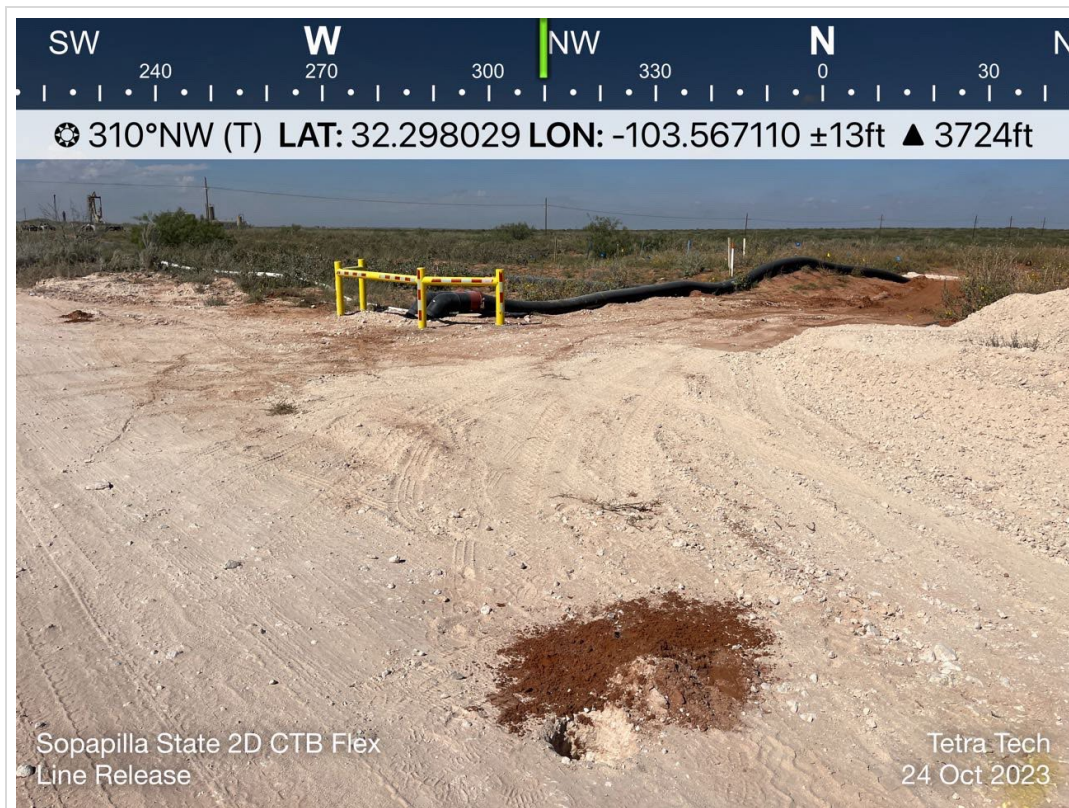
TETRA TECH, INC. PROJECT NO. 212C-MD-03252	DESCRIPTION	View west-northwest of hand auger locations in approximate release area near the flowline running to the Sopapilla SWD. Lay flat lines and surface polyline.	7
	SITE NAME	Sopapilla State 2D CTB Flex Line Release	10/24/2023

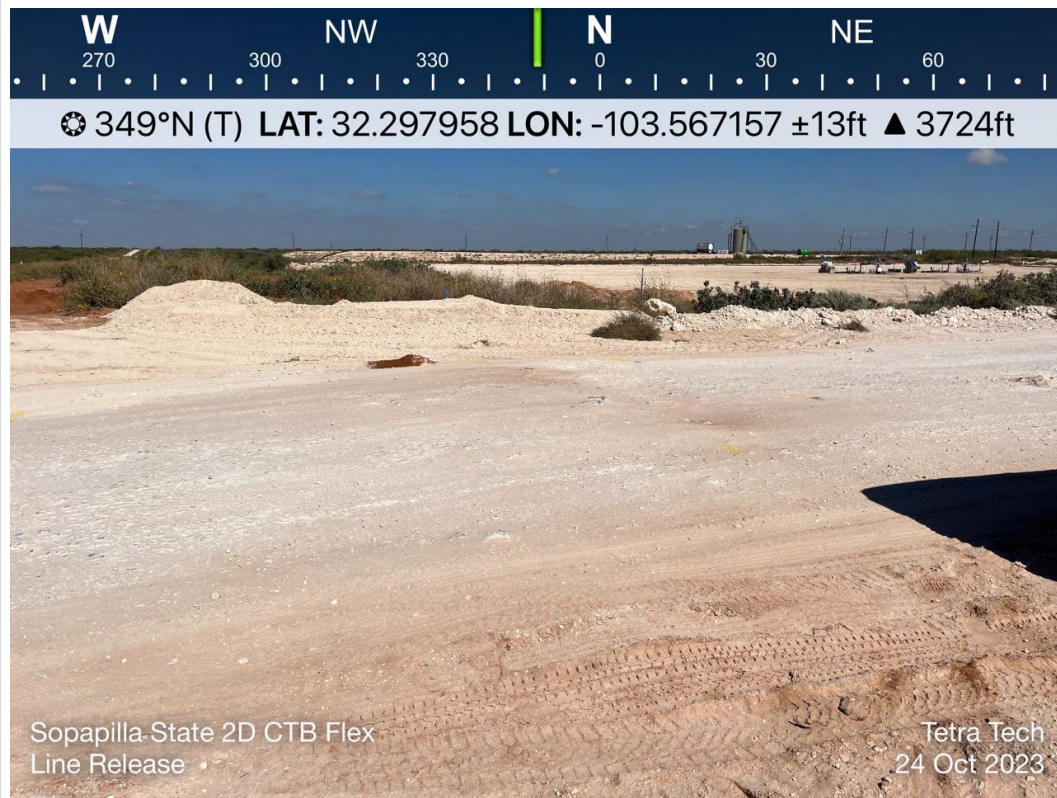
TETRA TECH, INC. PROJECT NO. 212C-MD-03252	DESCRIPTION	View north-northwest of approximate release area near the flowline running to the Sopapilla SWD. View of 2023 site assessment activities.	8
	SITE NAME	Sopapilla State 2D CTB Flex Line Release	10/24/2023

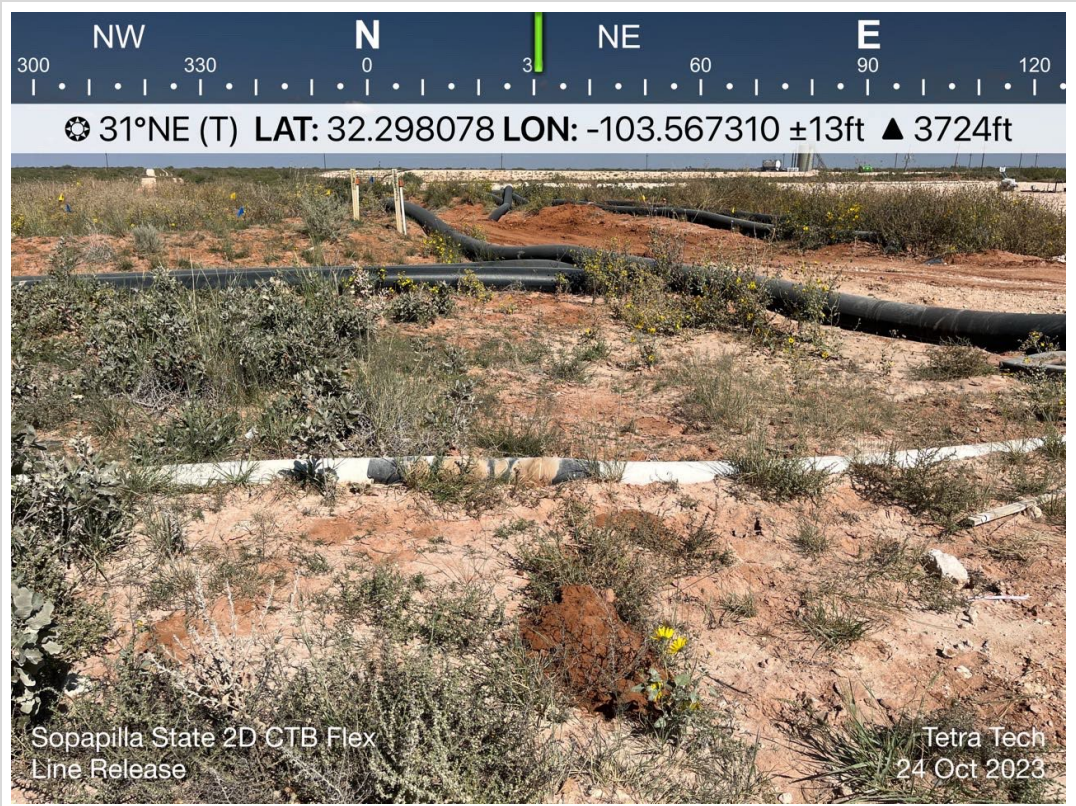
TETRA TECH, INC. PROJECT NO. 212C-MD-03252	DESCRIPTION	View north-northeast of approximate release area near the flowline running to the Sopapilla SWD. Mass of lay flat lines and repaired surface flowline.	9
	SITE NAME	Sopapilla State 2D CTB Flex Line Release	10/24/2023

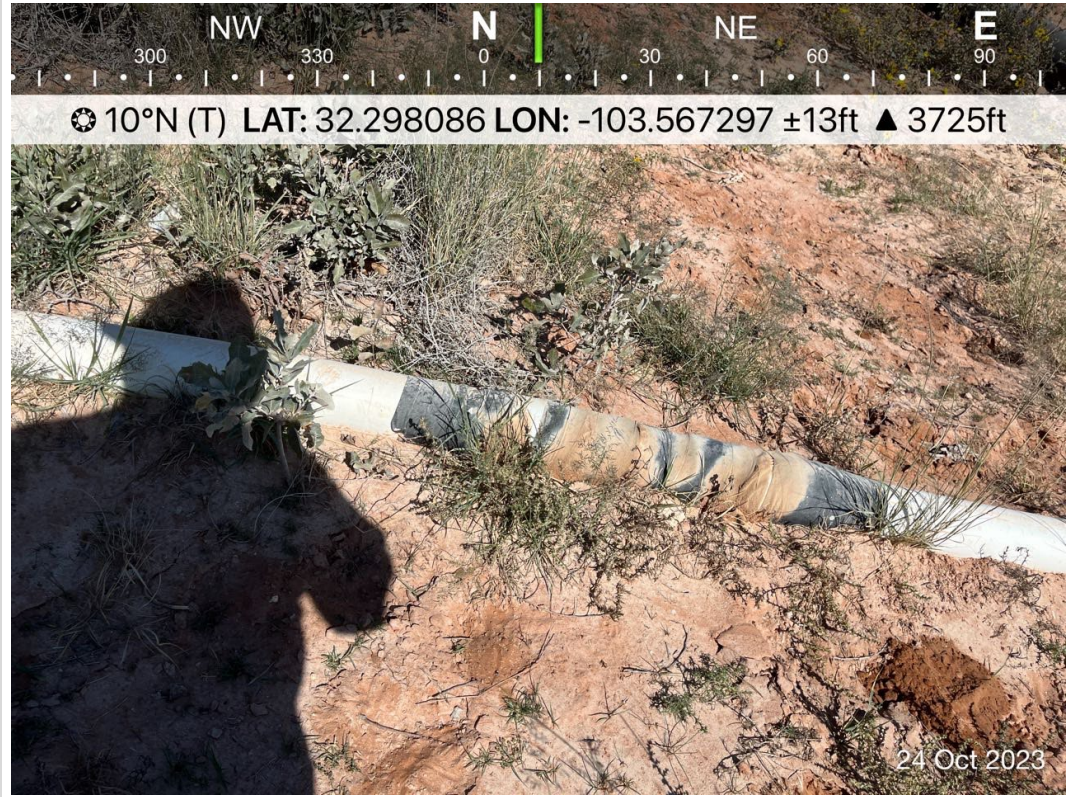
TETRA TECH, INC. PROJECT NO. 212C-MD-03252	DESCRIPTION	View north-northeast of approximate release area near the flowline running to the Sopapilla SWD. View of repaired surface flow line.	10
	SITE NAME	Sopapilla State 2D CTB Flex Line Release	10/24/2023

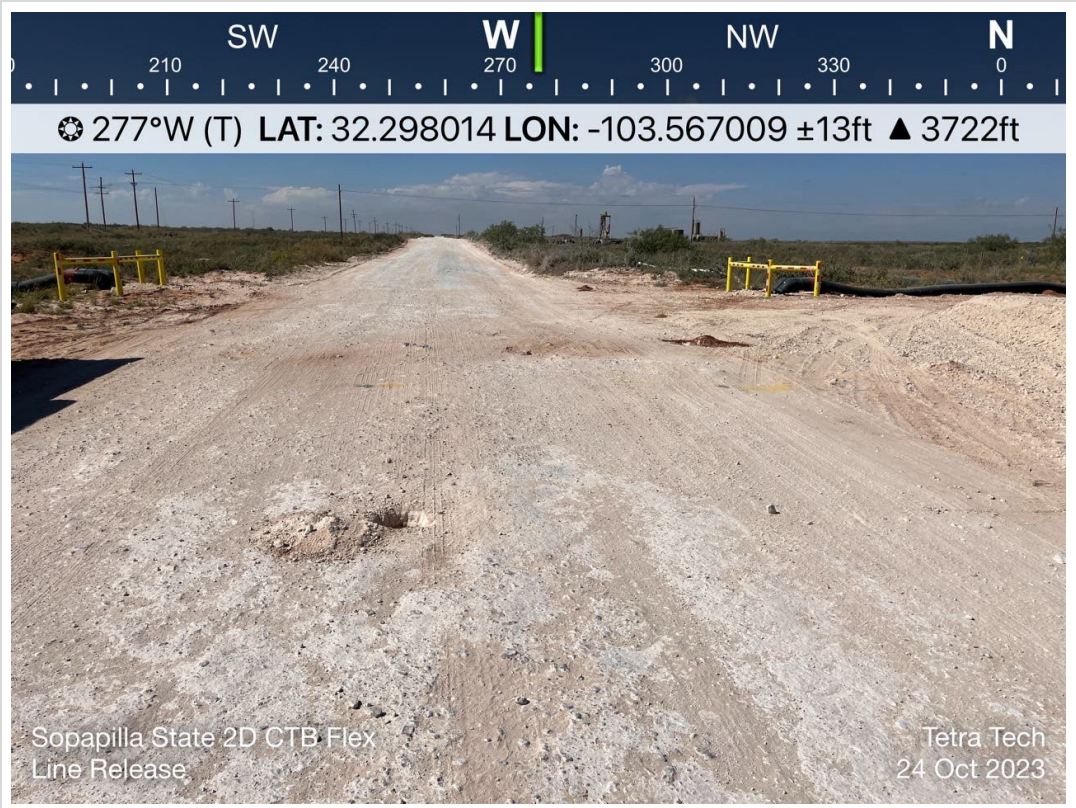
TETRA TECH, INC. PROJECT NO. 212C-MD-03252	DESCRIPTION	View west of approximate release area near the flowline running to the Sopapilla SWD.	11
	SITE NAME	Sopapilla State 2D CTB Flex Line Release	10/24/2023
