CLOSURE REQUEST REPORT

**Benson Shugart Waterflood Unit #011
Eddy County, New Mexico
Incident Number nMCS0124834063**

**Prepared For:
Chevron USA, Inc.
6301 Deauville Blvd.
Midland, TX 79706**

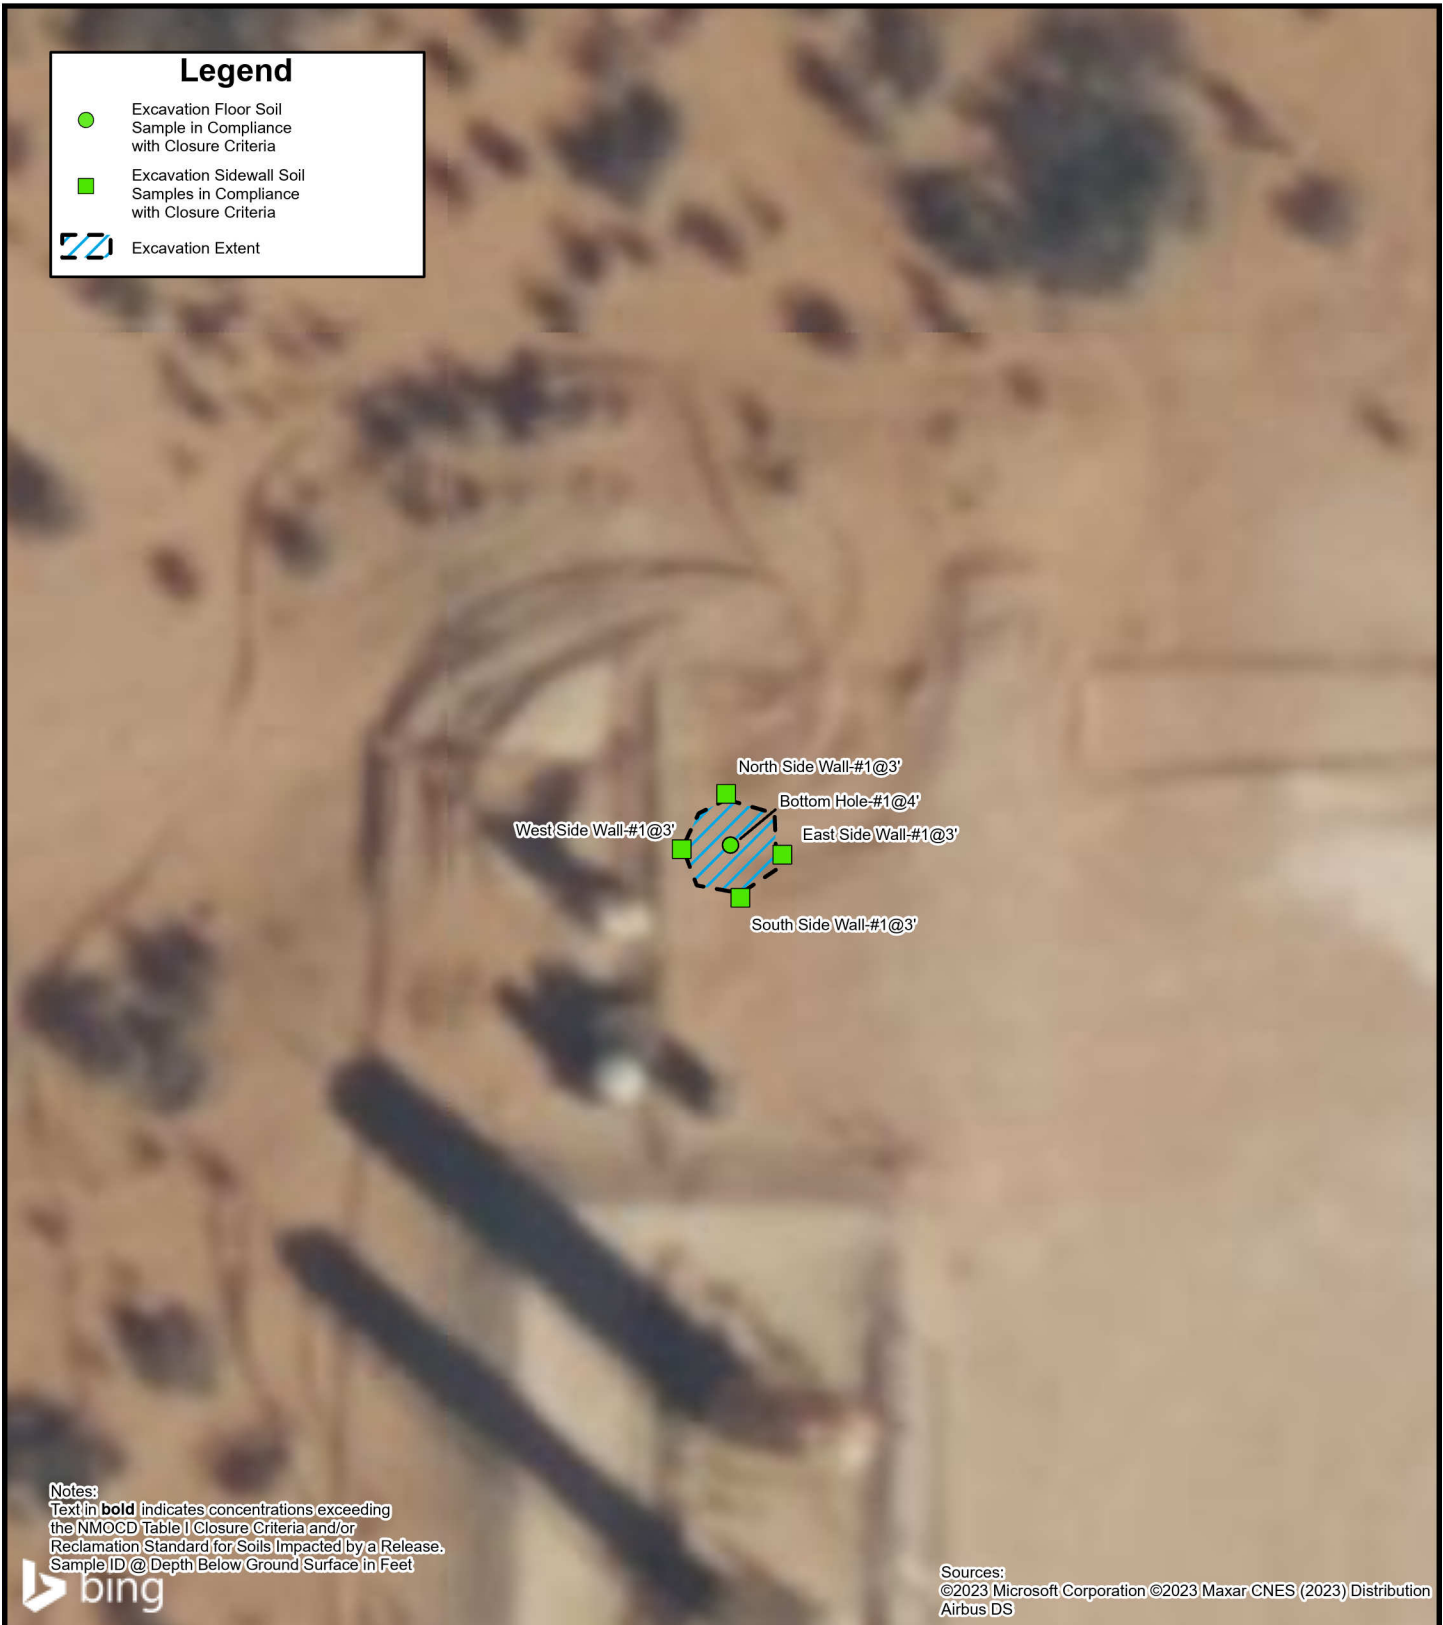
FIGURE 2

Excavation Soil Sample Locations

Following the removal of residual soil impacts, Etech collected 5-point composite confirmation excavation soil samples at a sampling frequency of 200 square feet from the excavation floor and sidewalls. The 5-point composite samples were comprised of five equivalent aliquots homogenized in a 1-gallon, resealable plastic bag. The samples were then placed into lab provided pre-cleaned glass jars, packaged with minimal void space, labeled, and immediately placed on ice. The soil samples were transported under strict chain-of-custody procedures to Permian Basin Environmental Laboratory (PBELAB) in Midland, Texas, for analysis of COCs. The location of confirmation excavation soil samples is shown in **Figure 2** in **Appendix A**.

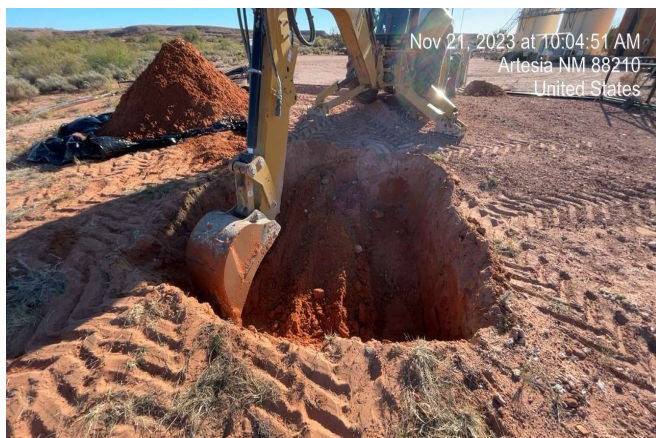
**Photograph 1****Date: 11/21/2023**

Description: Southeastern view of excavation activities.

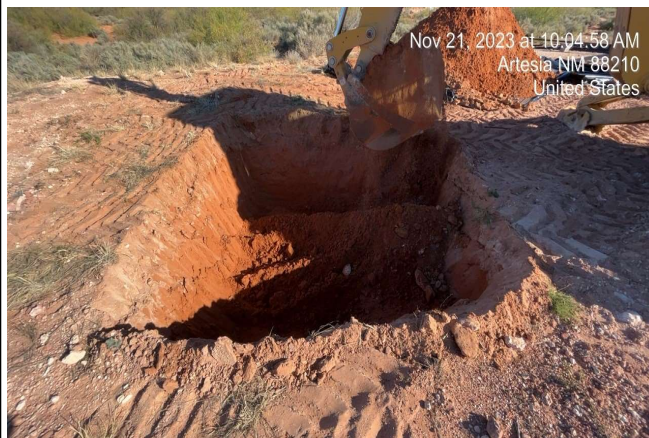
**Photograph 2****Date: 11/21/2023**

Description: Northern view of excavation activities.

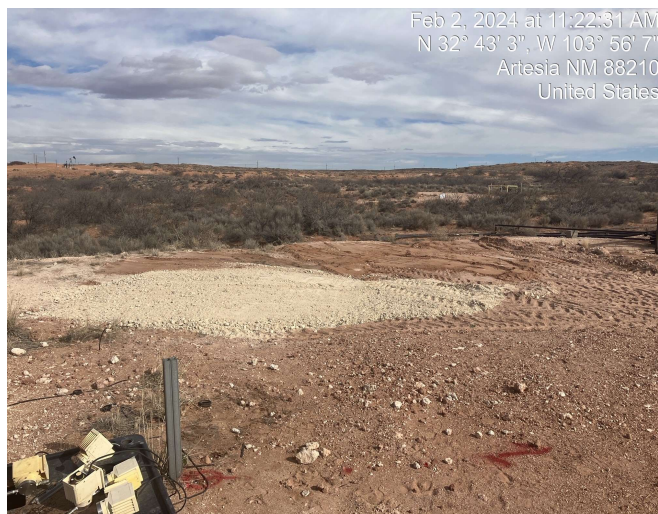
**Photograph 3****Date: 02/02/2024**

Description: Northwestern view of restoration activities.

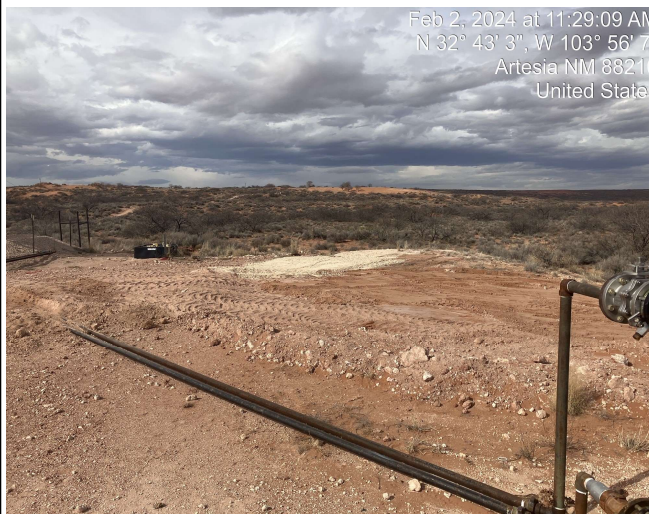
**Photograph 4****Date: 02/02/2024**

Description: Southwest view of restoration activities.

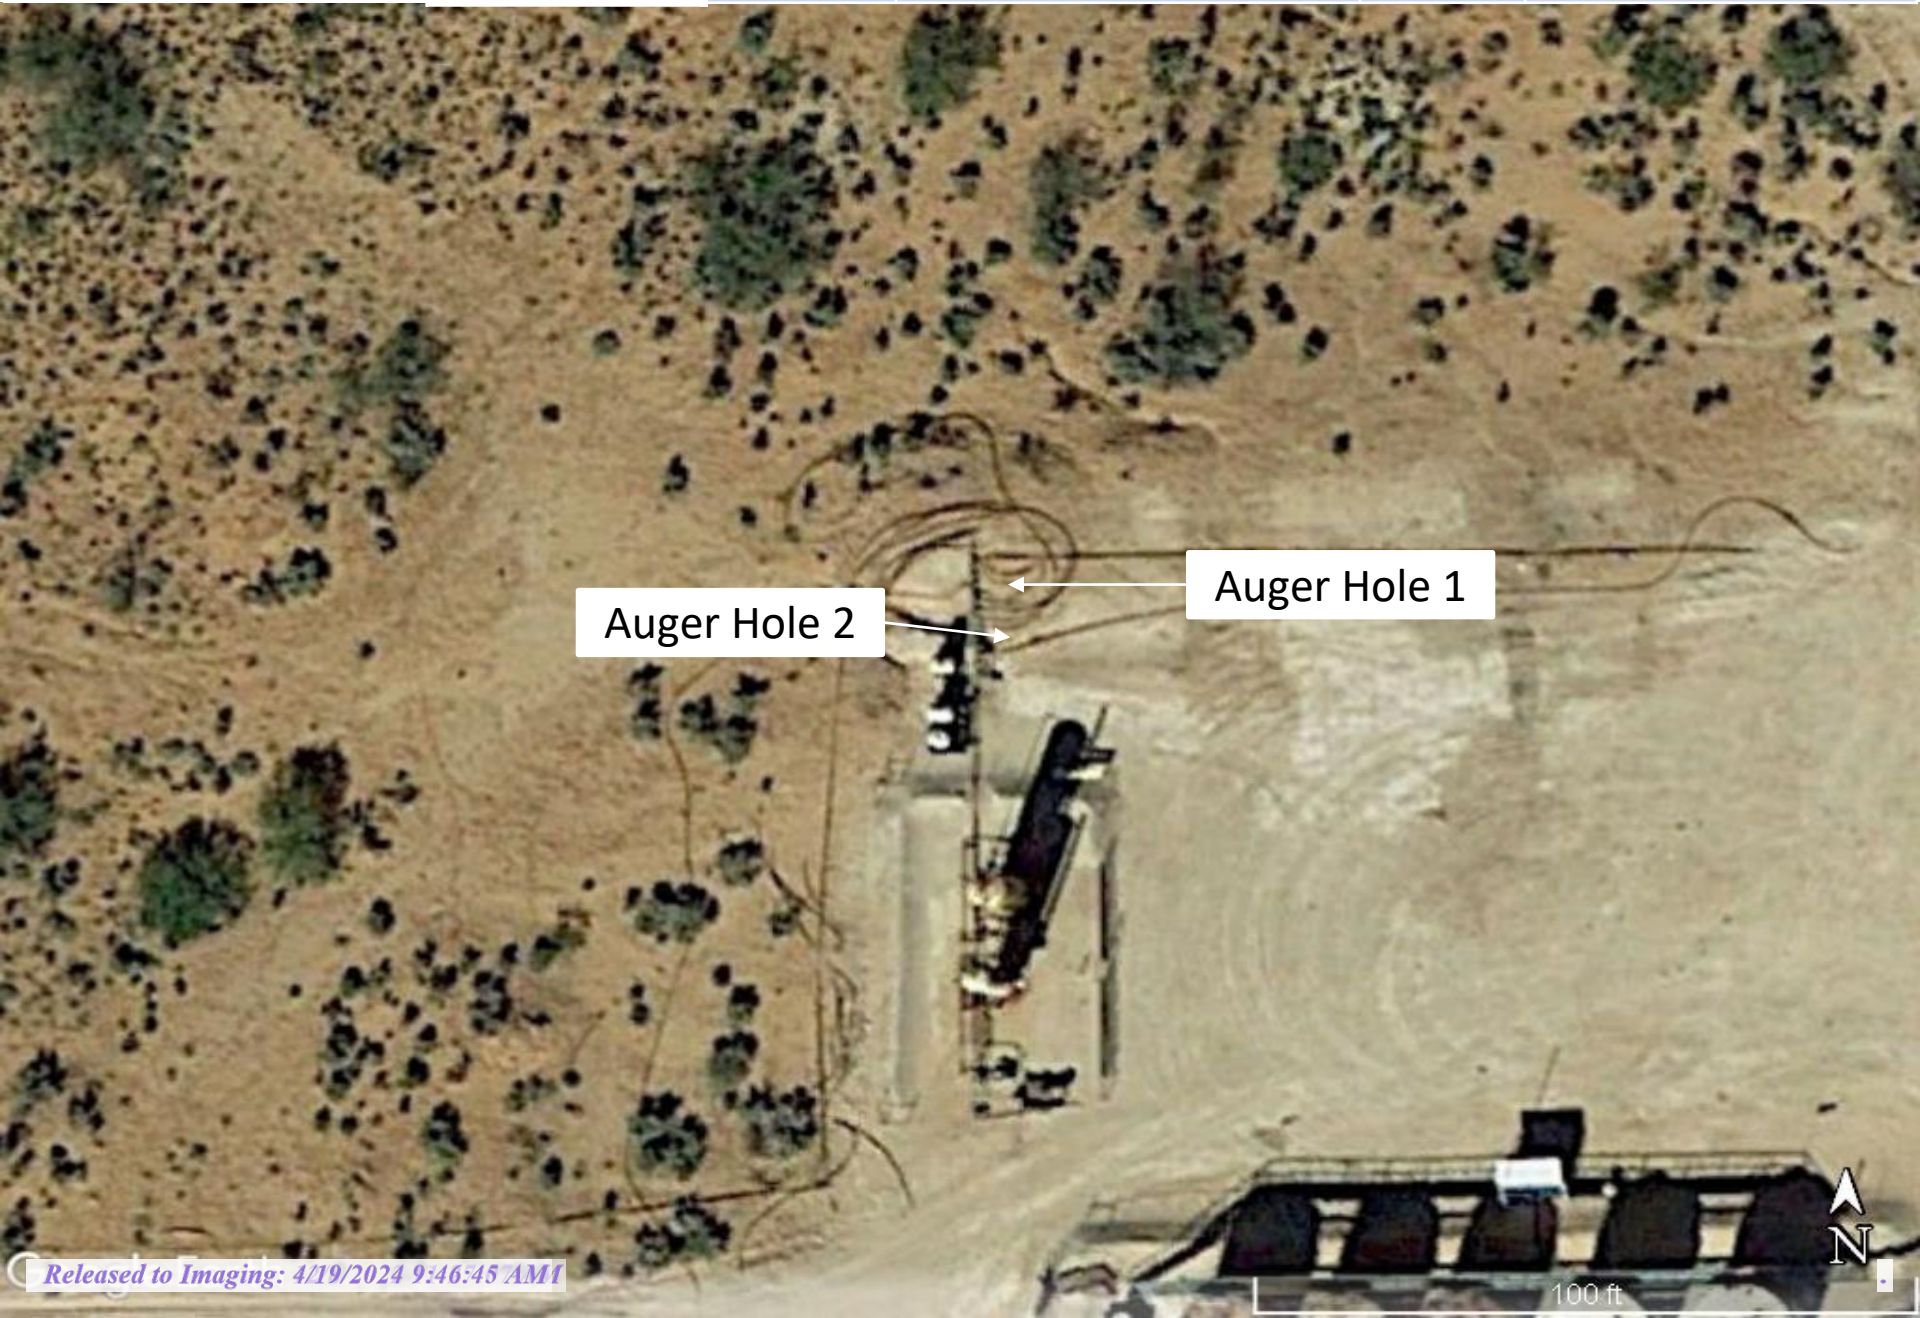
Figure 3

Site and Sample Location Map
