Remediation and Closure Report

Marquardt Federal #011H, 12H, 17H, 18H CTB Incident# nAPP2402475049 Eddy County, New Mexico

March 7, 2024

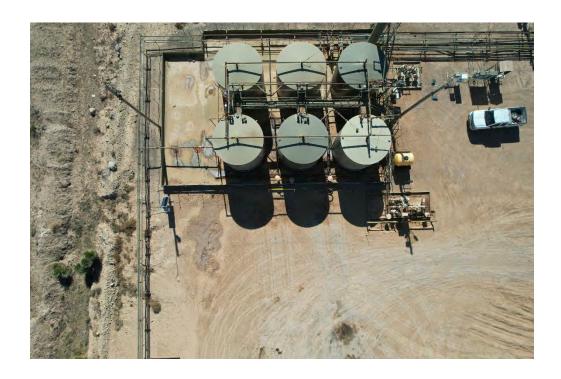
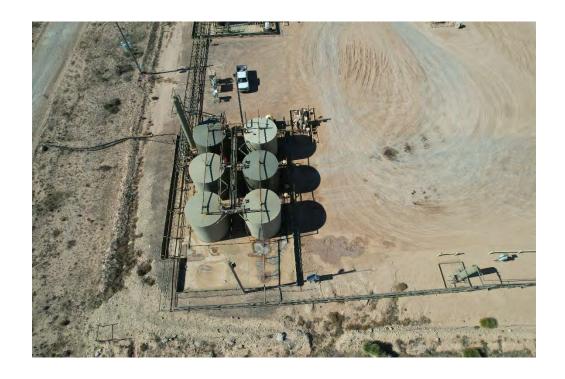
INITIAL PHOTOGRAPHS

On January 11, 2024, the lease operator arrived on location and found the produced water tank load line hose was left hooked up and the valve cracked open allowing 5.5 barrels (bbls) of produced water to be released into the lined containment as well as onto the well pad. A total of 1.5 bbls of produced water was recovered.

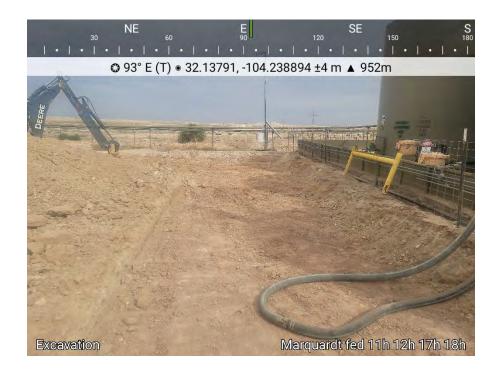
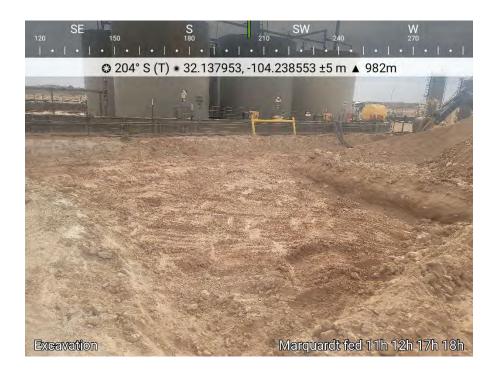
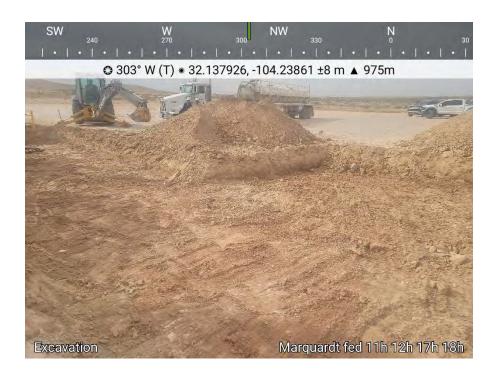
EXCAVATION PHOTOGRAPHS

- The impacted areas near sample points S-1 through S-5 were excavated to a total depth of 2-feet BGS.
- Composite confirmation samples were obtained from the bottom and sidewalls of the excavated area every 200-square foot.
- All the excavated material (approximately 80yds) was hauled to Lea Land, a NMOCD approved solid waste disposal facility.
- The excavated area on the well pad were backfilled with new caliche at depth and brought to grade, machine compacted and contoured to match the surrounding location.
- The Final C-141 formally documenting the remedial actions will be submitted with this report.
- Photographic documentation of all phases of this project are in Appendix IV.

H&R mobilized personnel to begin remediation activities of the location. Composite confirmation samples were collected from the bottom and sidewalls of the excavation every 200-square foot and transported to Cardinal Laboratory for analysis. The results of that analysis are presented in the following data table. Confirmation sampling locations and excavation dimensions are illustrated on the Confirmation Sample Map, Appendix I. Before, during, and after photographs of the project are attached in Appendix IV. The complete laboratory report can be found in Appendix V.

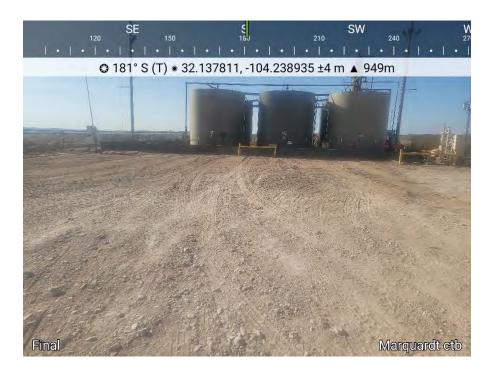
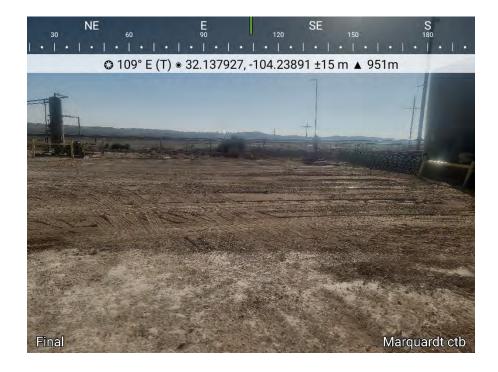
FINAL PHOTOGRAPHS

Based on the results of our remediation and confirmation sampling activities, no further actions were needed.
