Re: Site Assessment, Remediation, and Closure Report
Skelly Unit #836
API No. 30-015-37909
GPS: Latitude 32.83875 Longitude -103.85935
U/L "C", Sec. 15, T17S, R31E
Eddy County, NM
NMOCD Ref. No. nAPP2334530152

Paragon Environmental, LLC (Paragon) has been contracted by Spur Energy Partners (Spur) to perform a spill assessment and conduct remediation activities for the release site known as the Skelly Unit #836 (Skelly). Details of the release are summarized below:

Skelly Unit #836
API# 30-015-37909
Eddy County, NM
Site Map

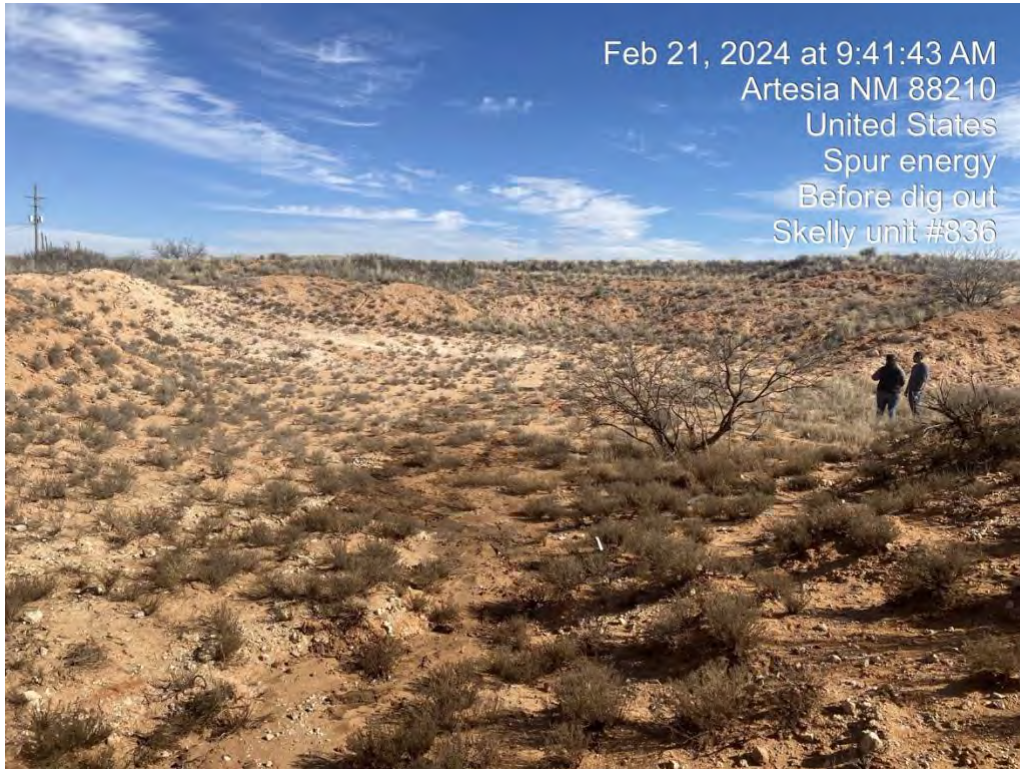
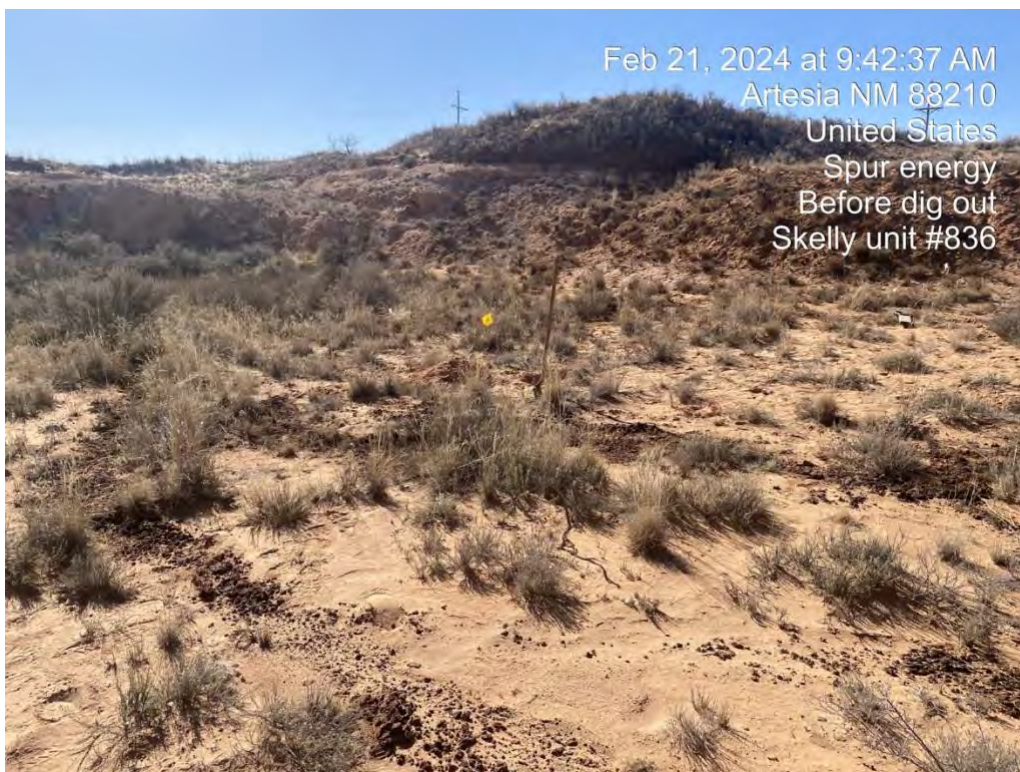
**Photographic Documentation
Before**

Release Details			
Type of Release:	Crude Oil/Produced Water	Volume of Release:	26 bbls
		Volume Recovered:	24 bbls
Source of Release:	Poly Line	Date of Release:	12/8/23
Was Immediate Notice Given?	Yes	If, Yes, to Whom?	NMOCD Portal
Was a Watercourse Reached?	No	If Yes, Volume Impacting Watercourse:	N/A
Surface Owner:	State	Mineral Owner:	
Poly line developed a hole due to corrosion, resulting in the release in the pasture.
