RE: Liner Inspection and Closure Report
Alaska 29 Fee Battery
API No. 30-015-39102
GPS: Latitude 32.71442 Longitude -104.40536
UL- N, Section 29, Township 18S, Range 26E
NMOCD Reference No. NAPP2405353367

Liner Inspection Form

ALASKA 29 FEE BATTERY

LINER INSPECTION –

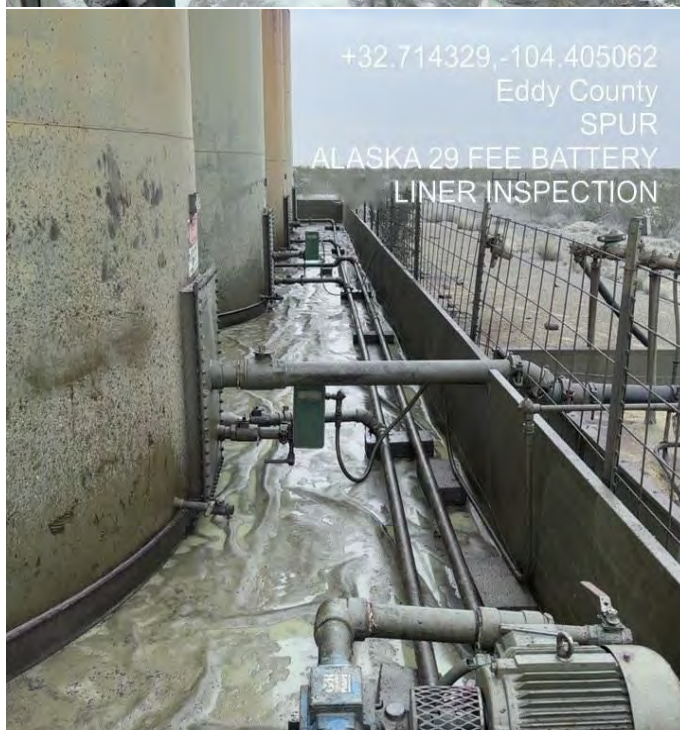
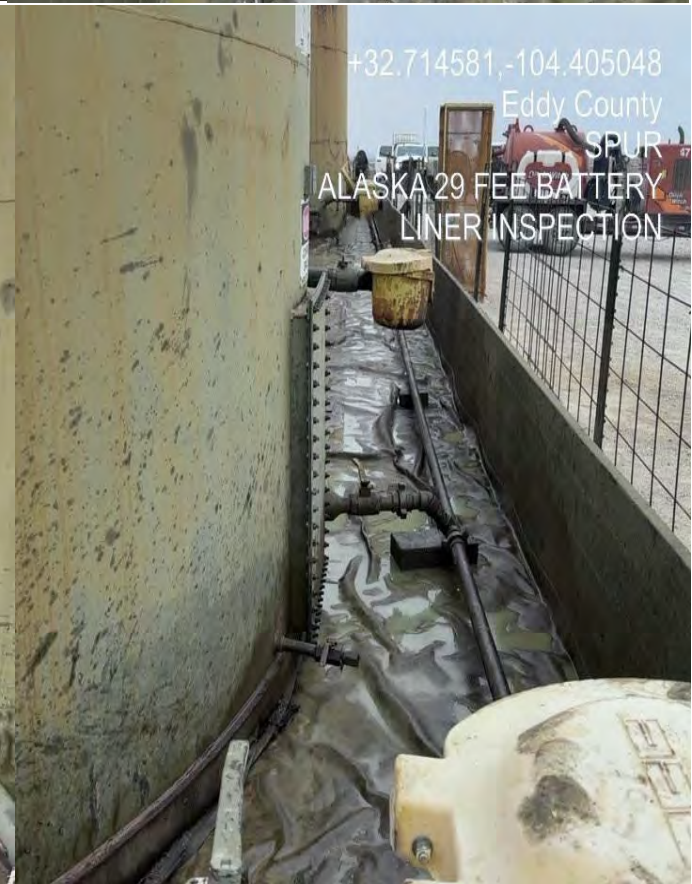
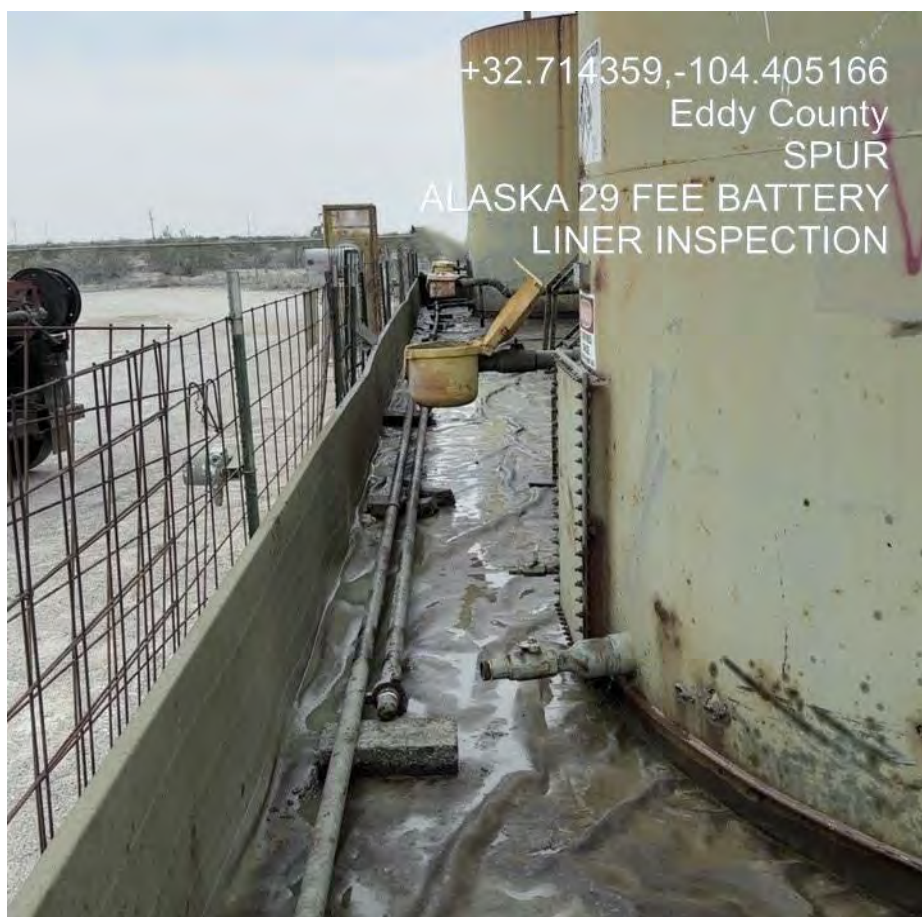
On February 28, 2024, Pima Environmental conducted a liner inspection at this location. We concluded that this liner and containment maintained its integrity and was able to retain the fluids. The liner inspection form and photographic documentation can be found in Appendix C.

Visualization	Yes	No	Comments
Is there a tear in the liner?		X	
Are there holes in the liner?		X	
Is the liner retaining any fluids?	X		The inspection images of the liner reveal residual fluid resulting from the remediation event involving power washing.
Does the liner have integrity to contain a leak?	X
