Remediation Summary and Closure Request

**FAE II Operating, LLC
Sholes B 25 #1 Battery
Lea County, New Mexico
Unit Letter "H", Section 25, Township 25 South, Range 36 East
Latitude 32.105561 North, Longitude 103.215109 West
NMOCD Incident # nAPP2327553474**

March 2024

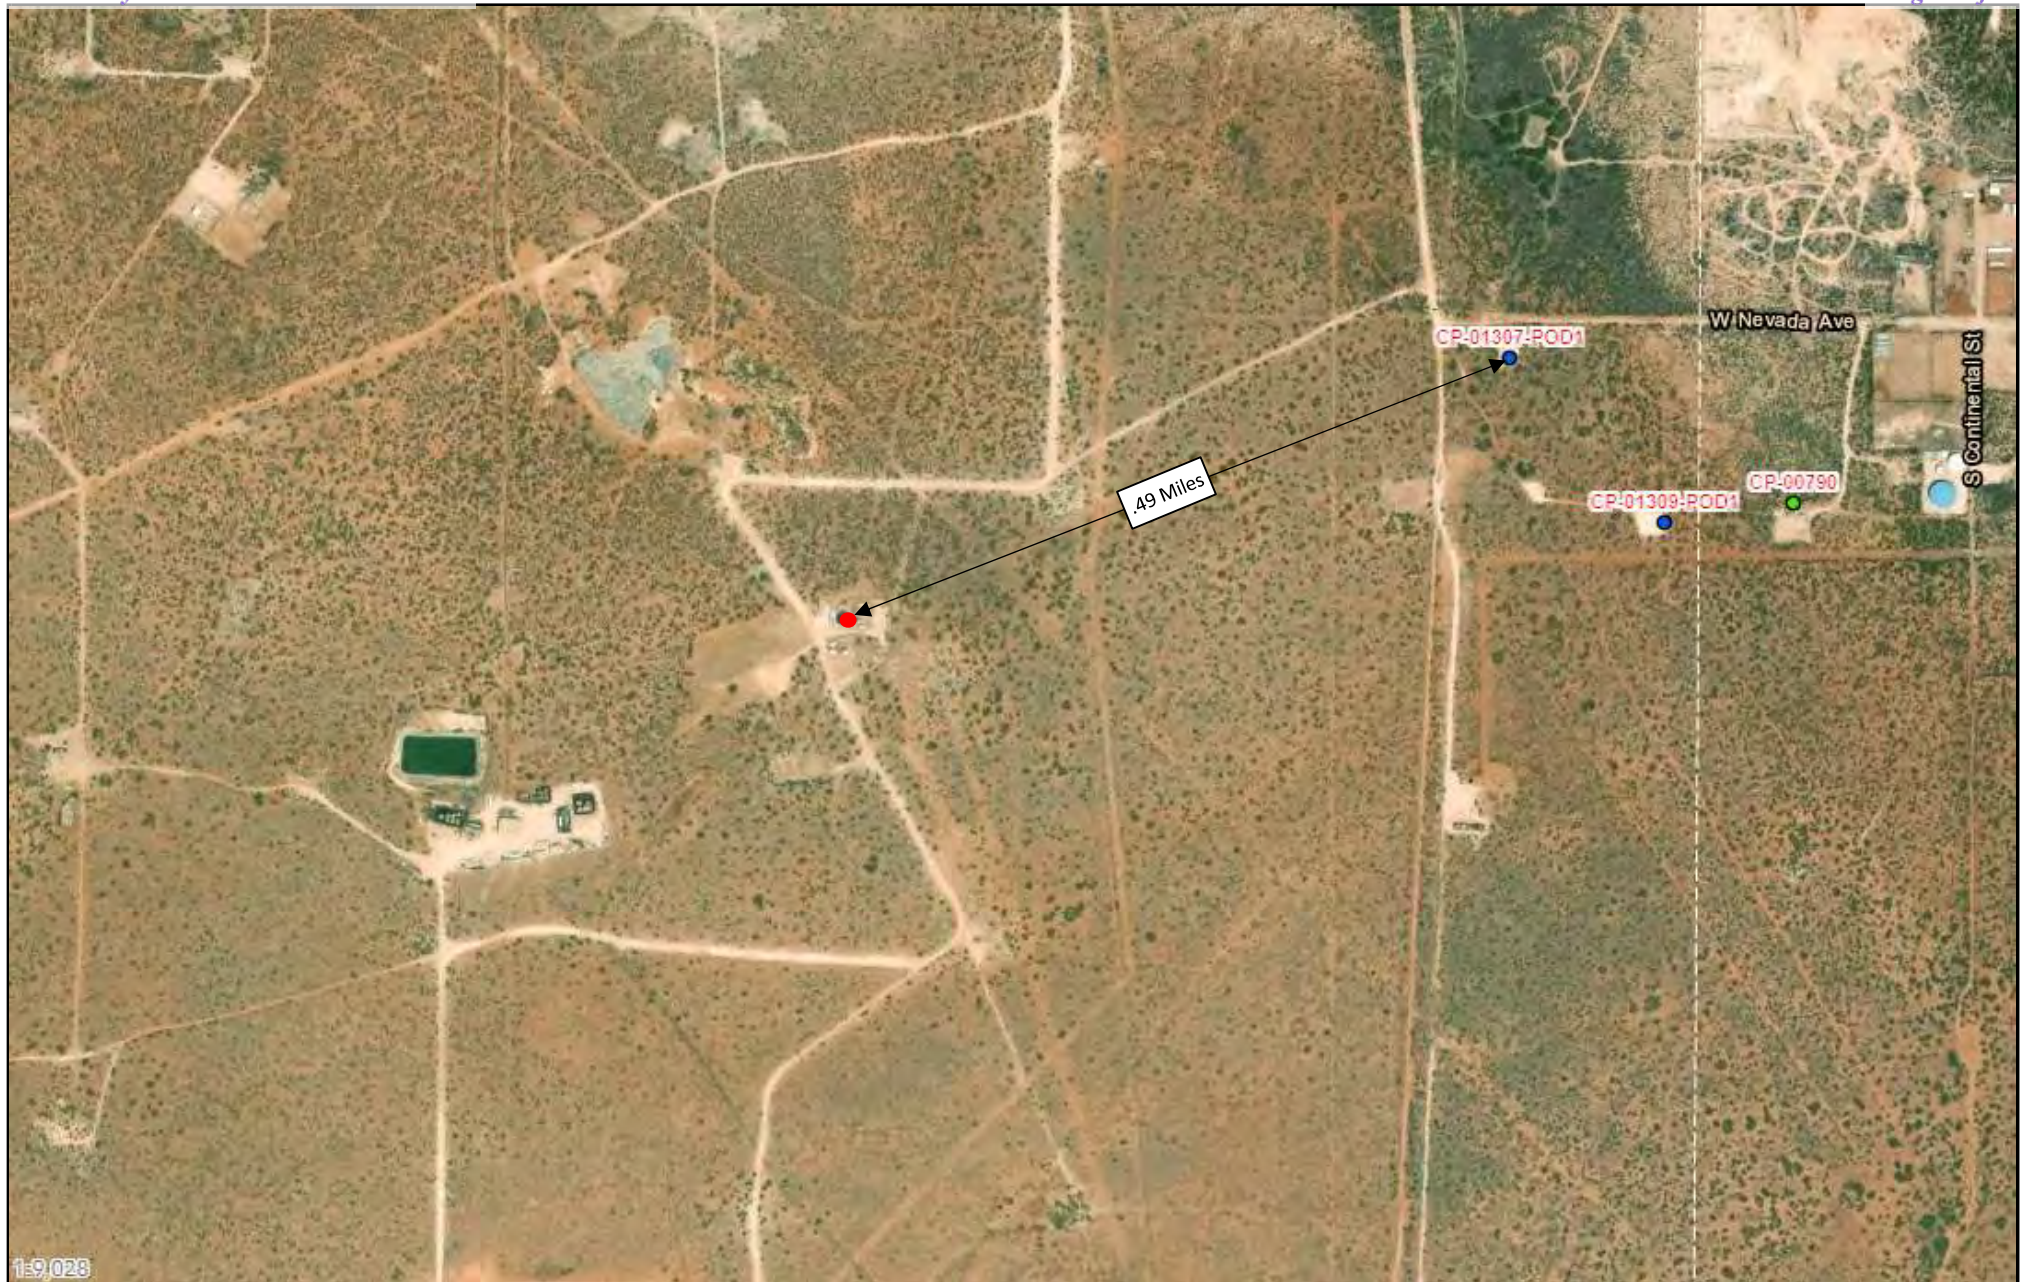
Figure 2

A search of the New Mexico Office of the State Engineer (NMOSE) and United States Geological Survey (USGS) groundwater databases was completed in an effort to determine the horizontal distance to known water sources within a half mile radius of the Release Site. Approximate depth to groundwater was determined using maintained and published water well data. Karst mapping indicates the site is located in a Karst designated area. Karst and Wetland Maps are provided as Attachment I. Depth to groundwater information is provided as Attachment V and the results are depicted on Figures 2 & 3.

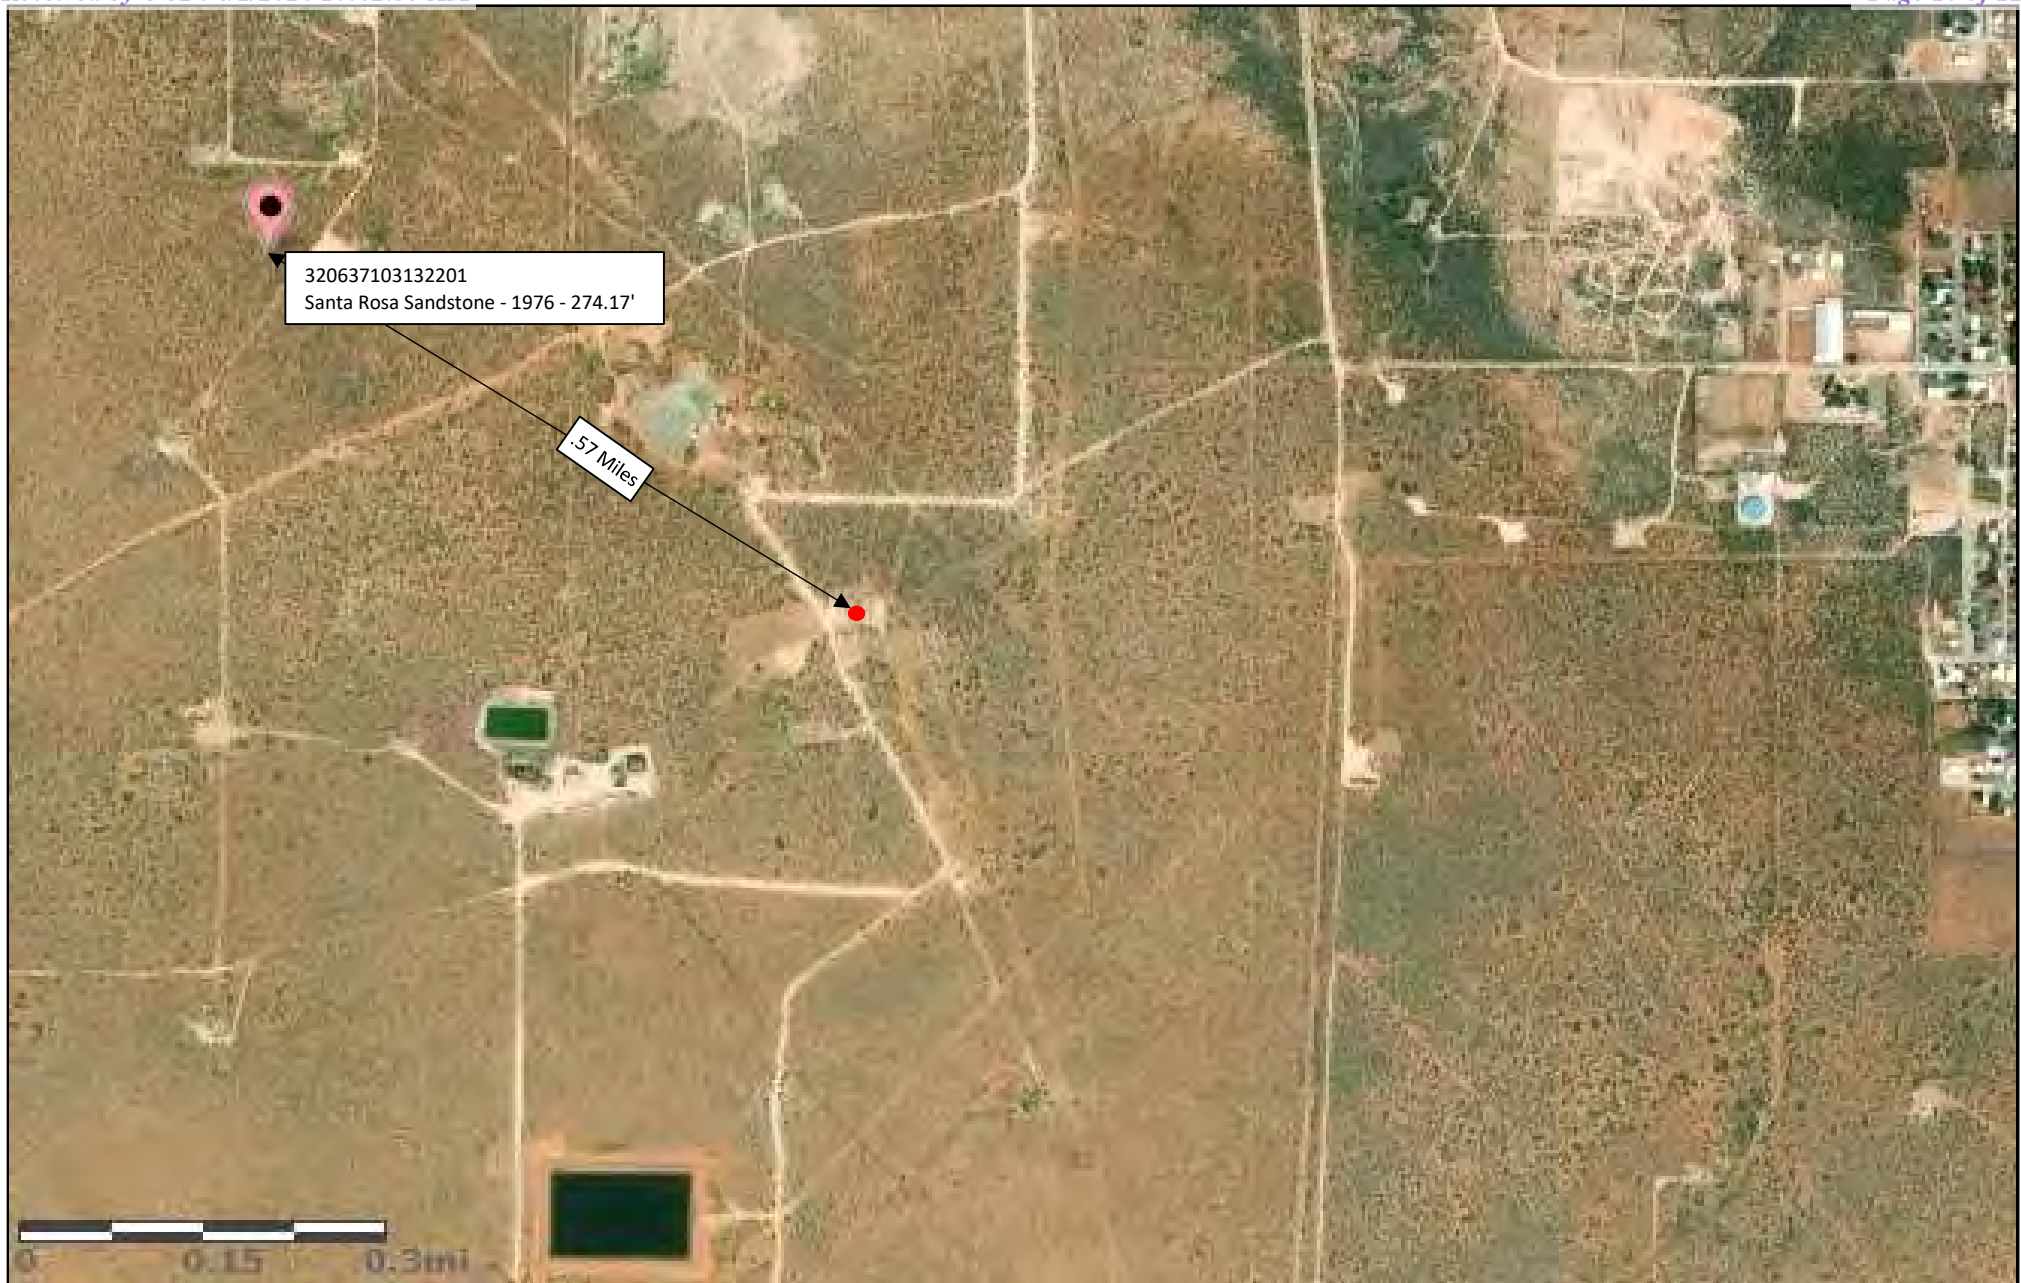
**Figure 3**

USGS Well Locations Map
FAE II Operating, LLC
Sholes B 25 #1 Battery
GPS: 32.105561, -103.2151
Lea County

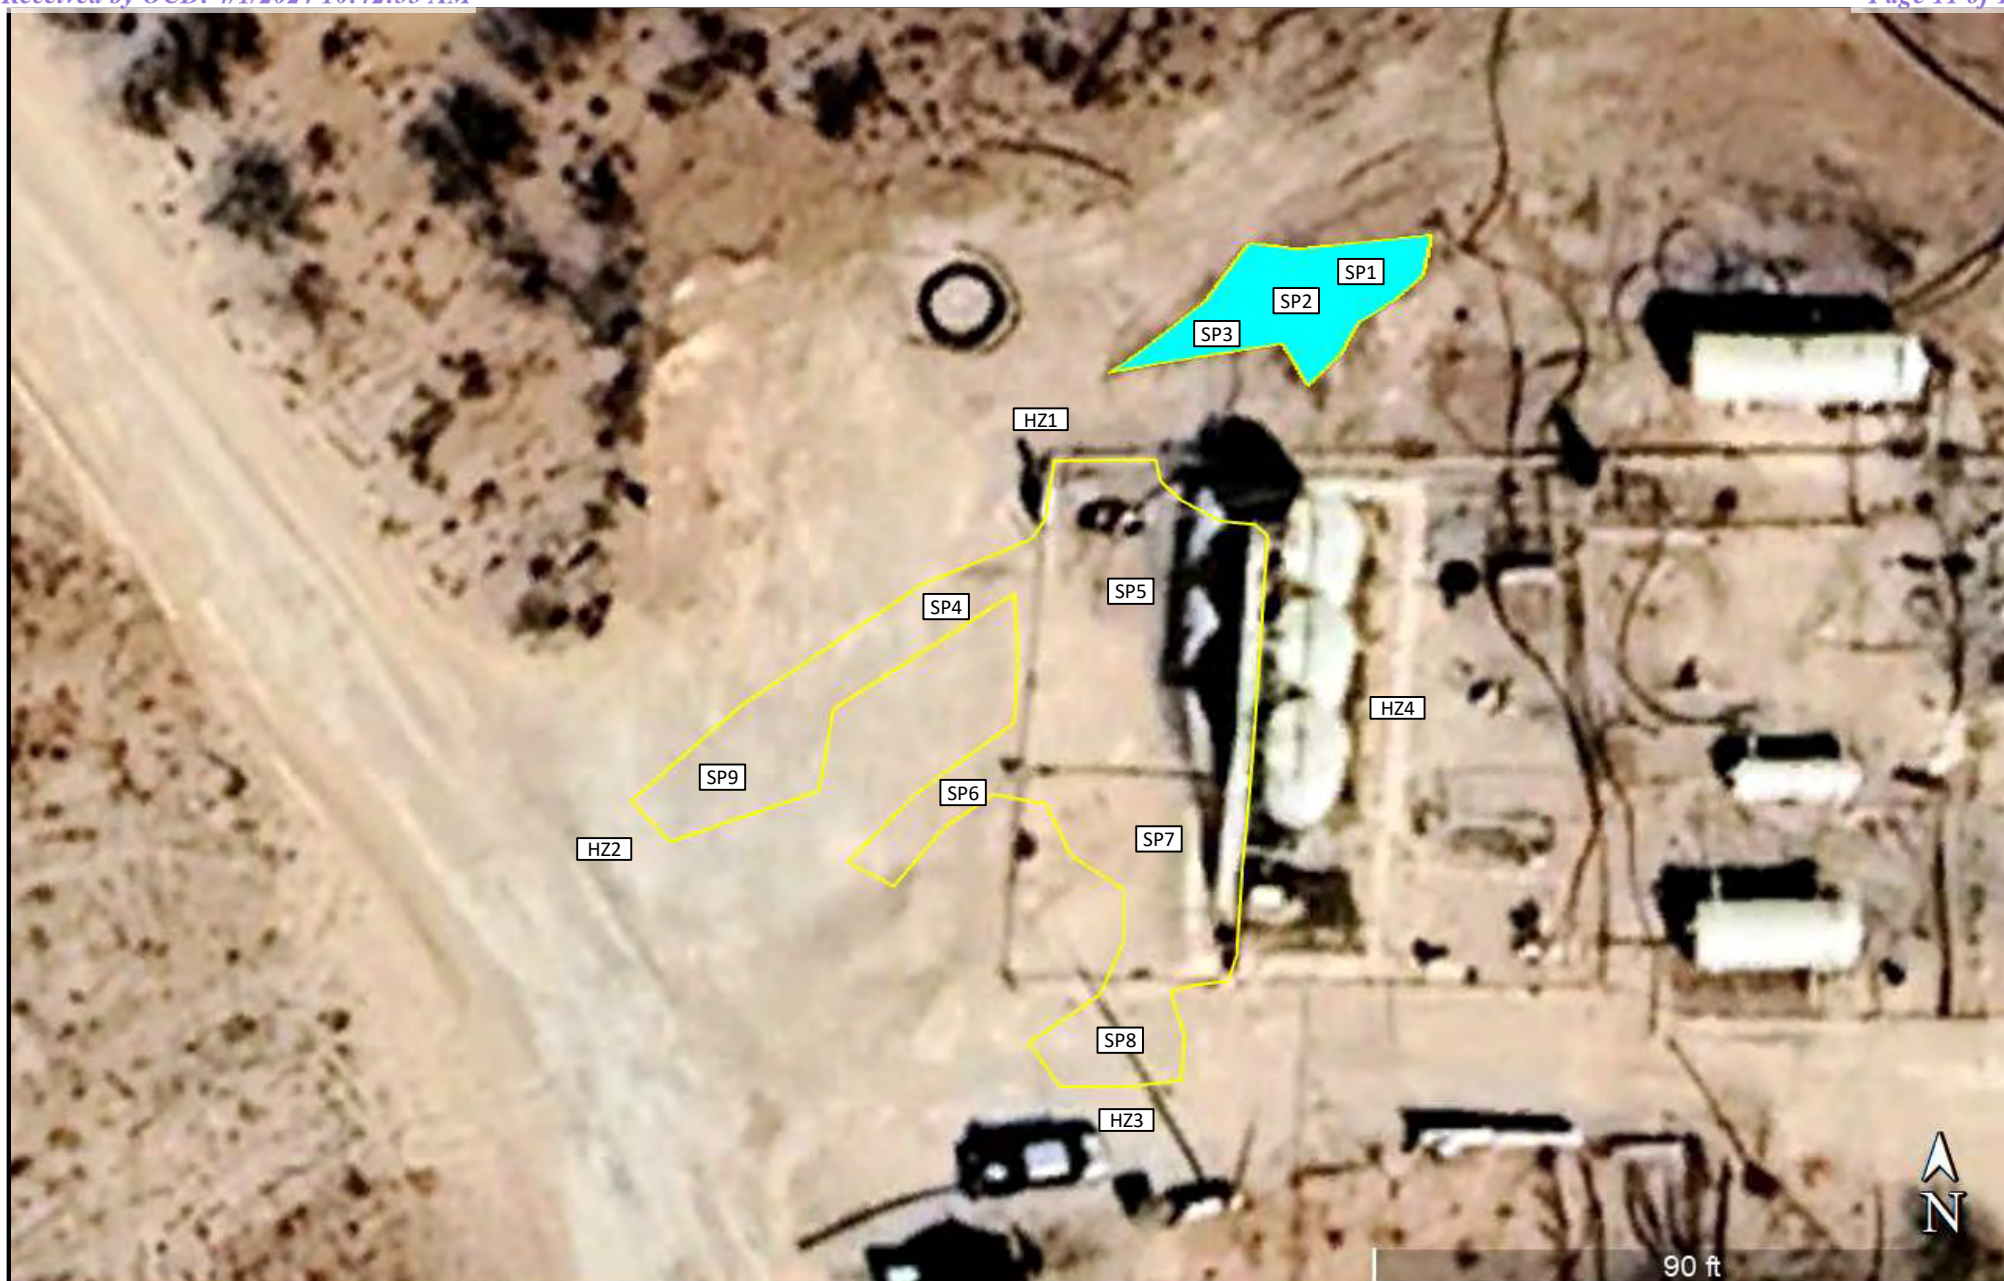
**Figure 4**

Based on field observations and field test data noted above and provided in Attachment IV, seventeen representative soil samples were selected for laboratory analysis. Delineation soil samples SP1 through SP9, HZ1 through HZ4, were submitted to the laboratory for analysis of BTEX, TPH, and chloride. Laboratory analytical results indicated contaminant concentrations were below the NMOCD Closure Criteria in each of the submitted samples, with the exception of SP1 at four feet bgs, SP2 at three feet bgs, and SP4-SP7, each at Surface, which exhibited TPH and/or chloride concentrations in excess of NMOCD Closure Criteria.

Delineation Sample Map
FAE II Operating, LLC
Sholes B 25 #1 Battery
GPS: 32.105561, -103.215109
Lea County

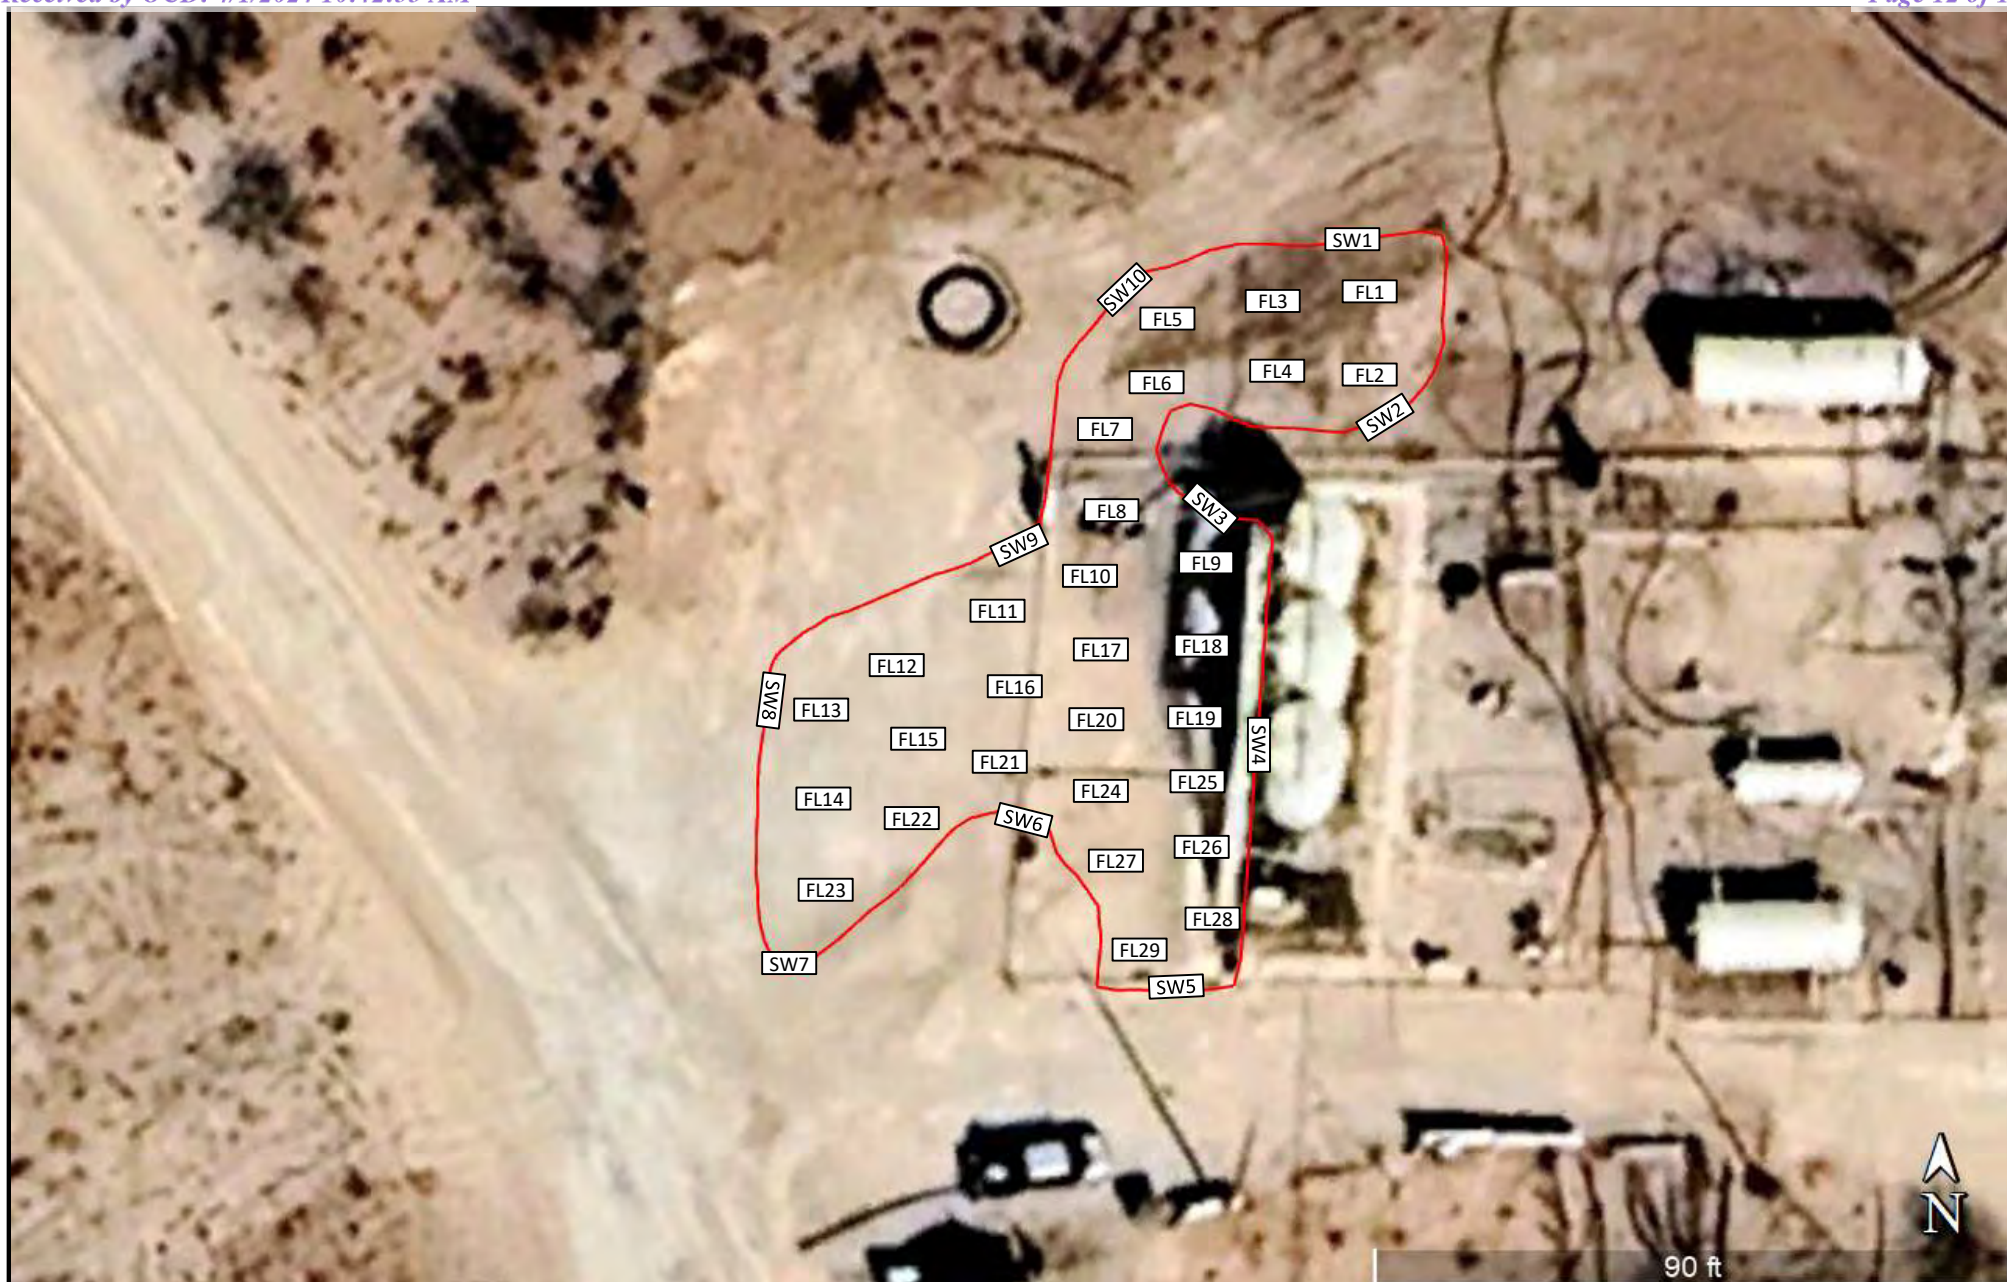
**Figure 5**

Excavation Sample Map
 FAE II Operating, LLC
 Sholes B 25 #1 Battery
 GPS: 32.105561, -103.215109
 Lea County

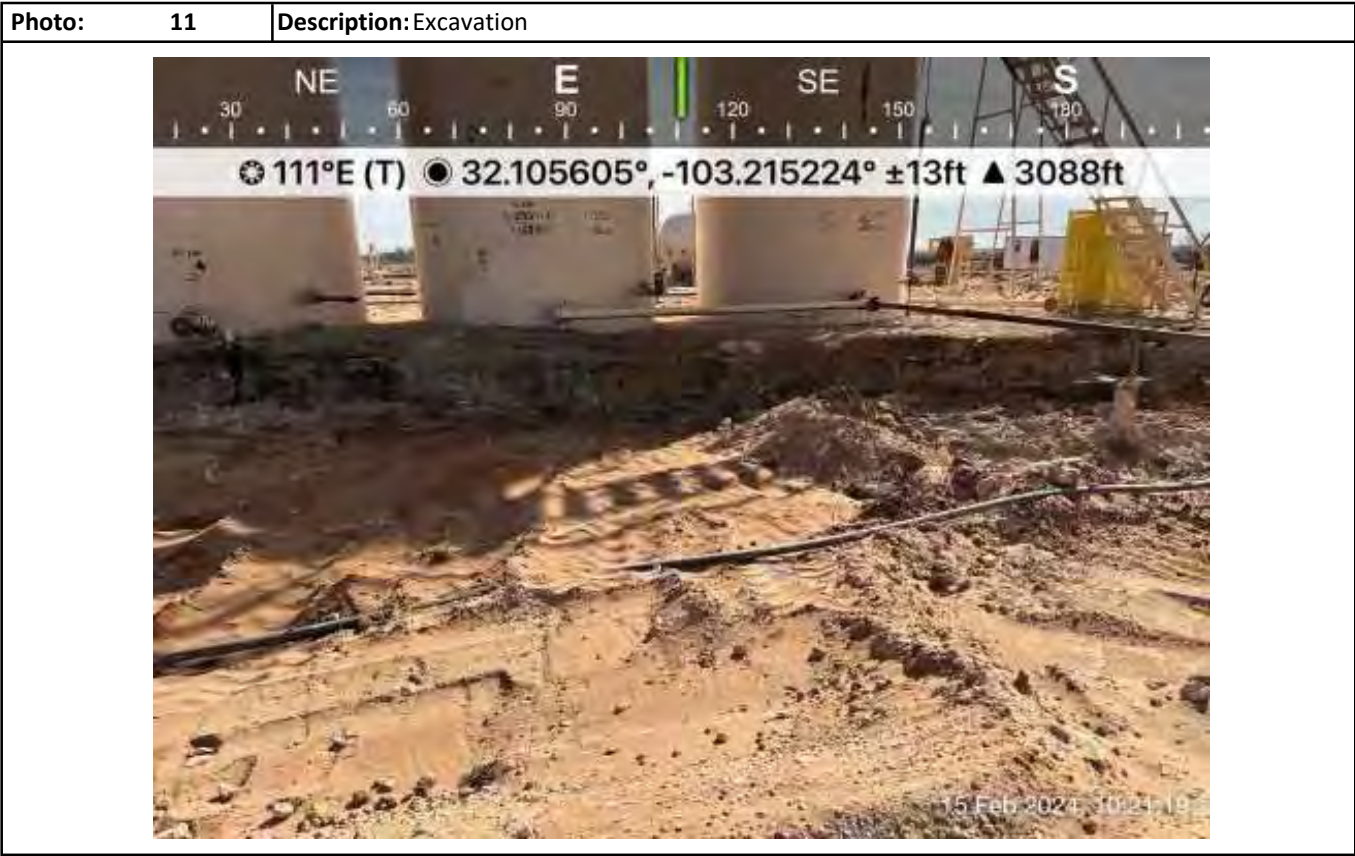
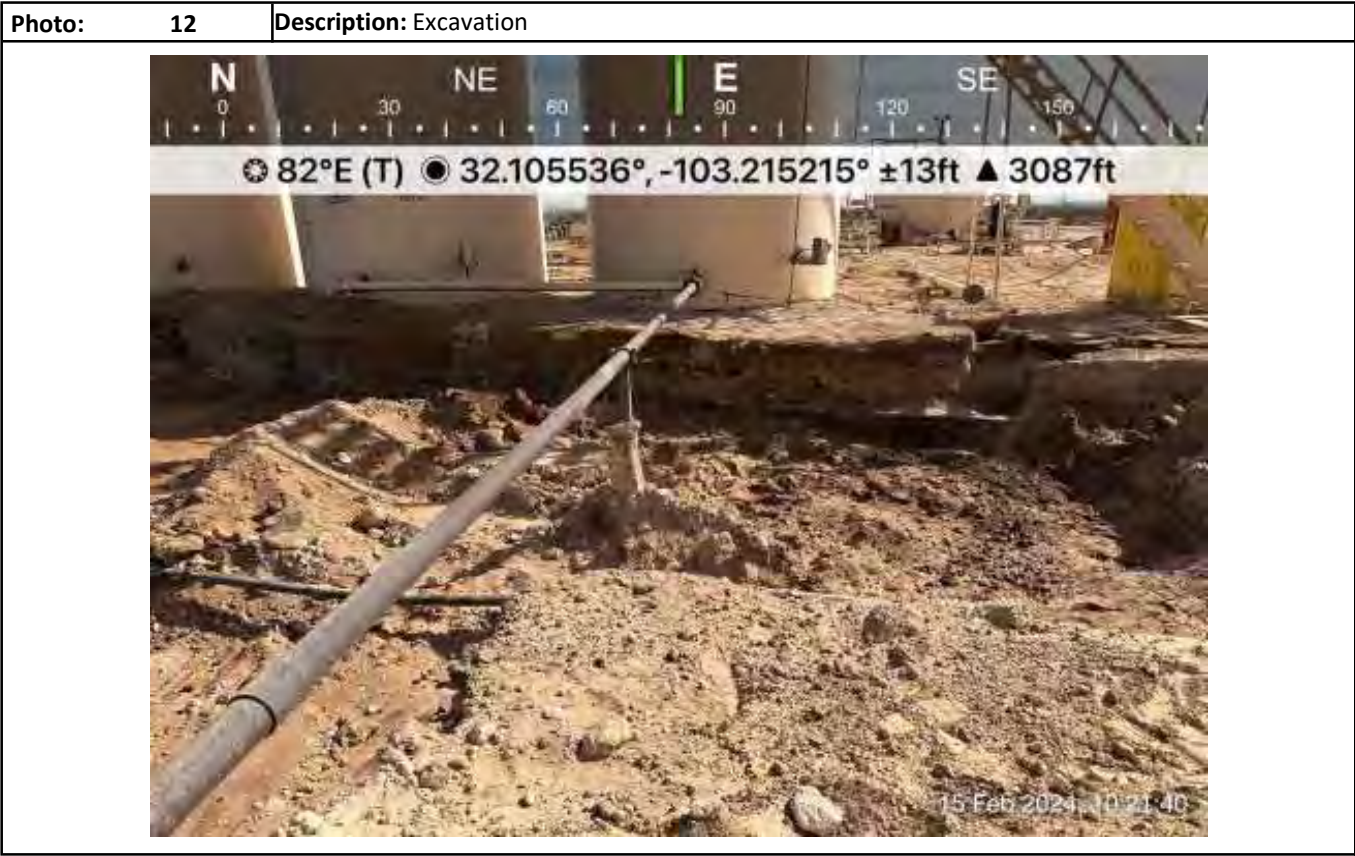
Photo:	13	Description: Backfill
<div><div>South East Elevation</div><div>☉ 295°NW (T) ● 32.105479°, -103.215203° ±13ft ▲ 3100ft</div>
