CLOSURE REPORT

Trunk 3A (07/12/23)
Unit Letter G, S28 T28N R12W
San Juan County, New Mexico

New Mexico EMNRD OCD Incident ID No. NAPP2320632087

Ensolum Project No. 05A1226263

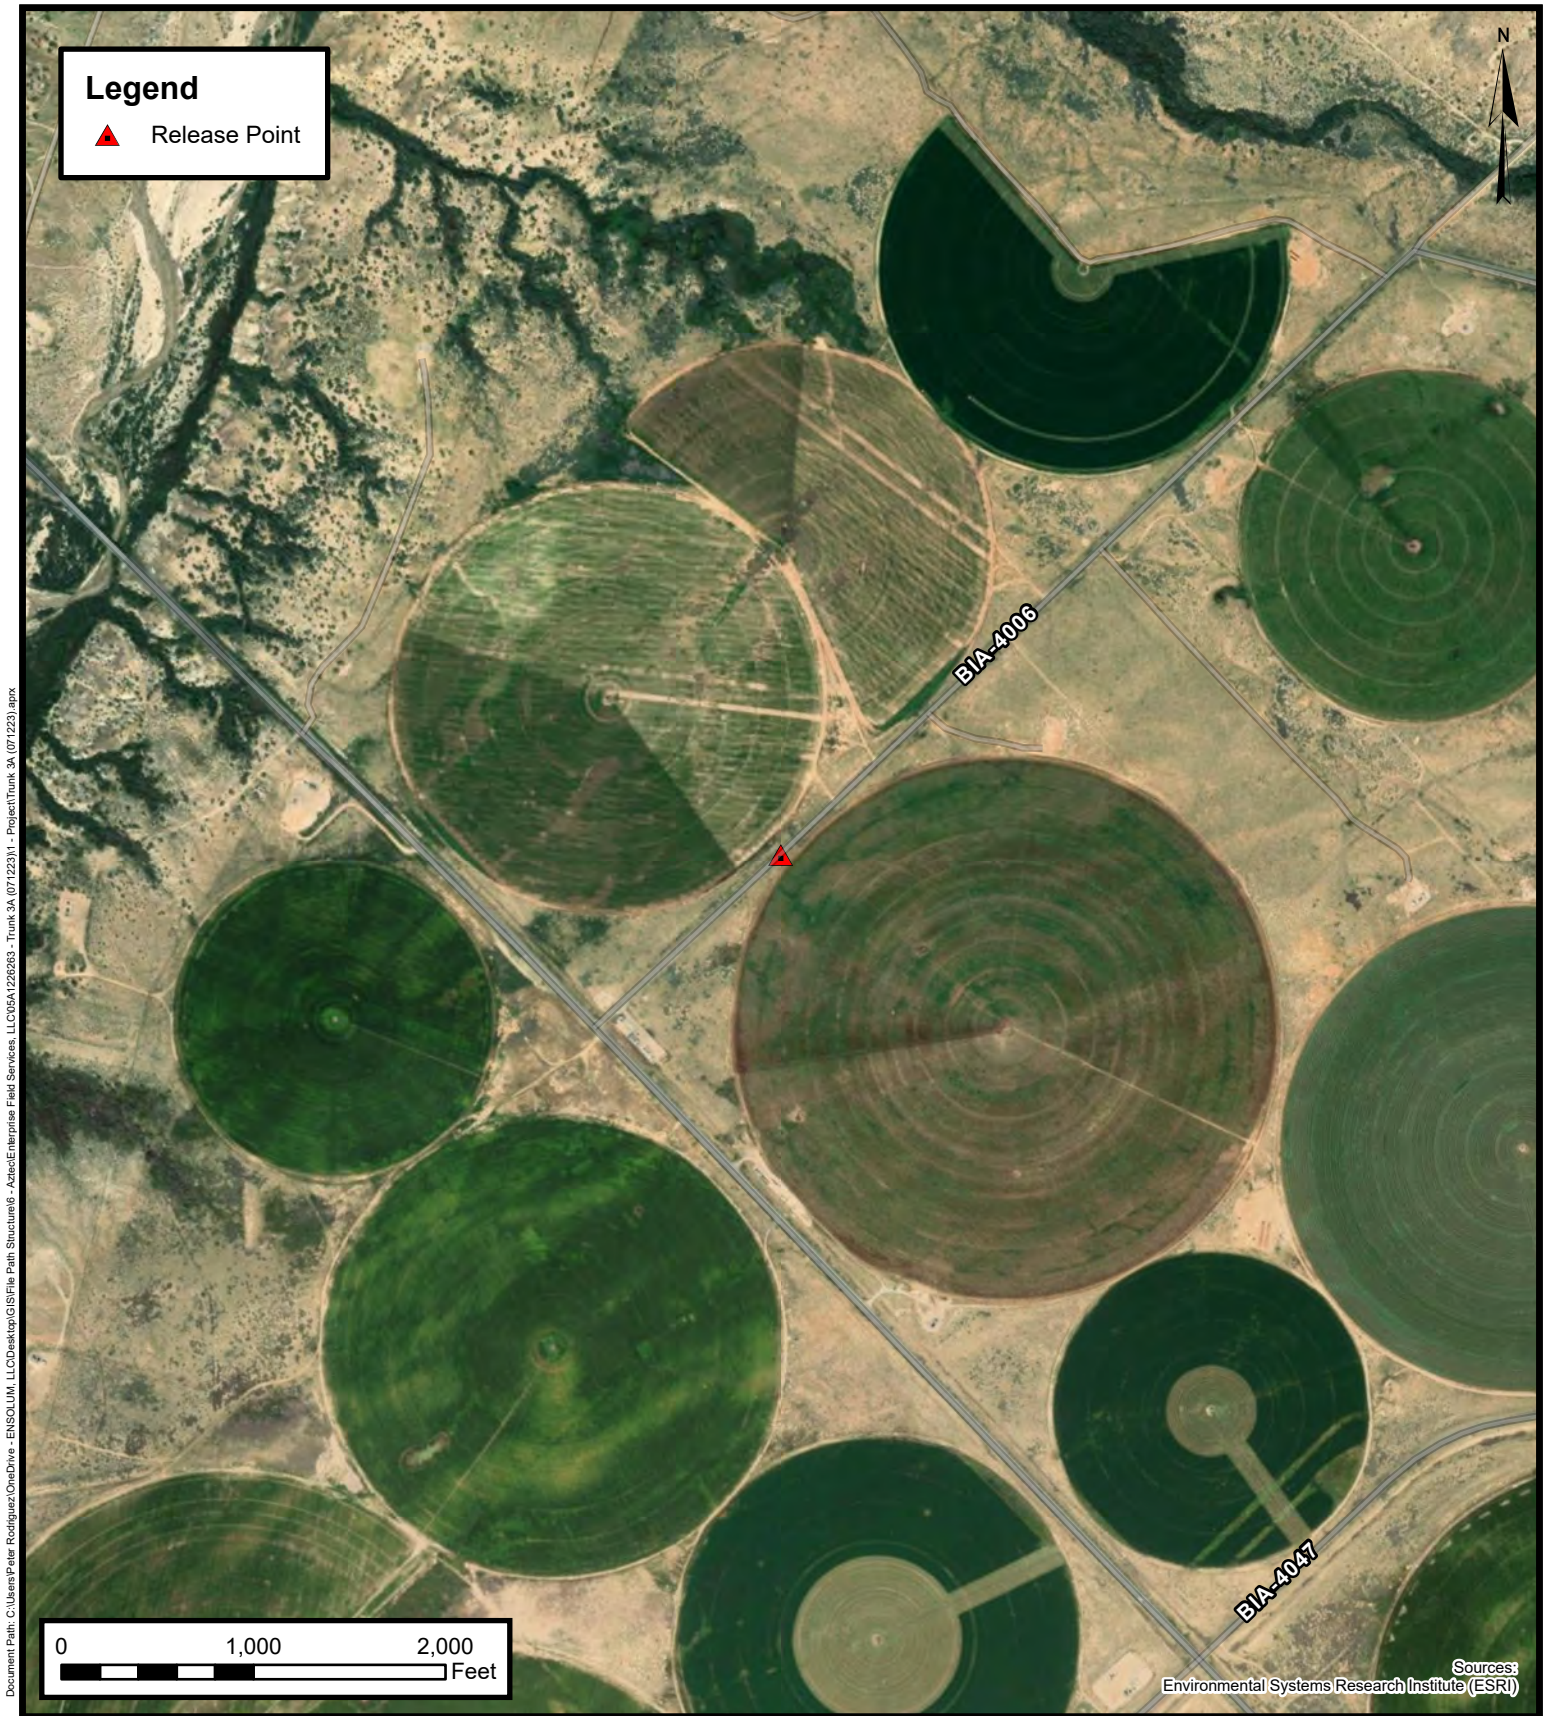
FIGURE

Site Vicinity Map

A **Topographic Map** depicting the location of the Site is included as **Figure 1**, and a **Site Vicinity Map** is included as **Figure 2** in **Appendix A**.

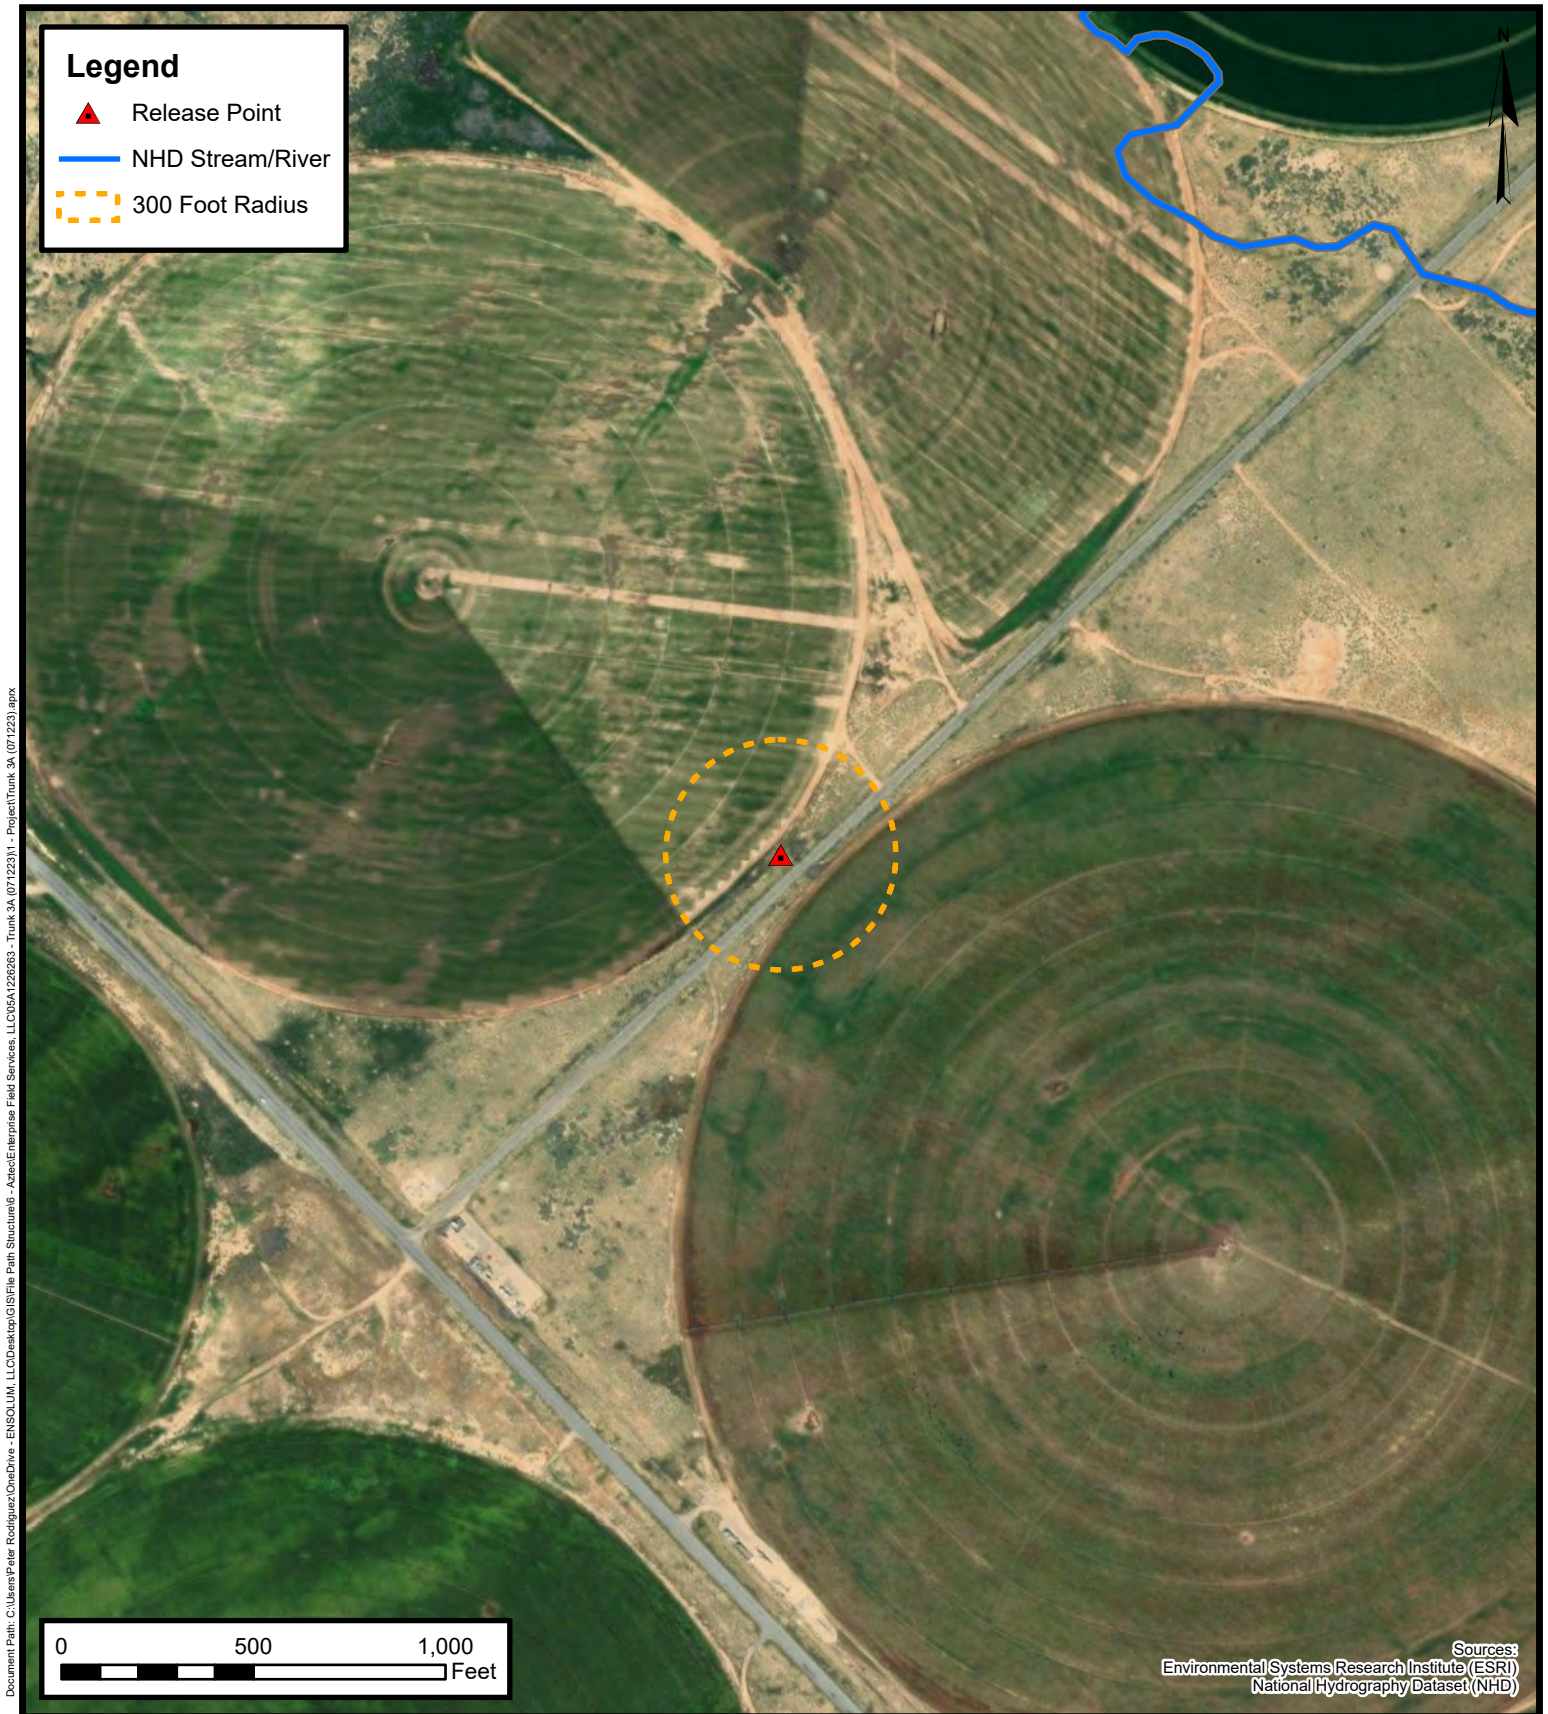
FIGURE
C

300 Foot Radius Watercourse and Drainage Identification

- The Site is not located within 300 feet of a NM EMNRD OCD-defined continuously flowing watercourse or significant watercourse (**Figure C, Appendix B**).

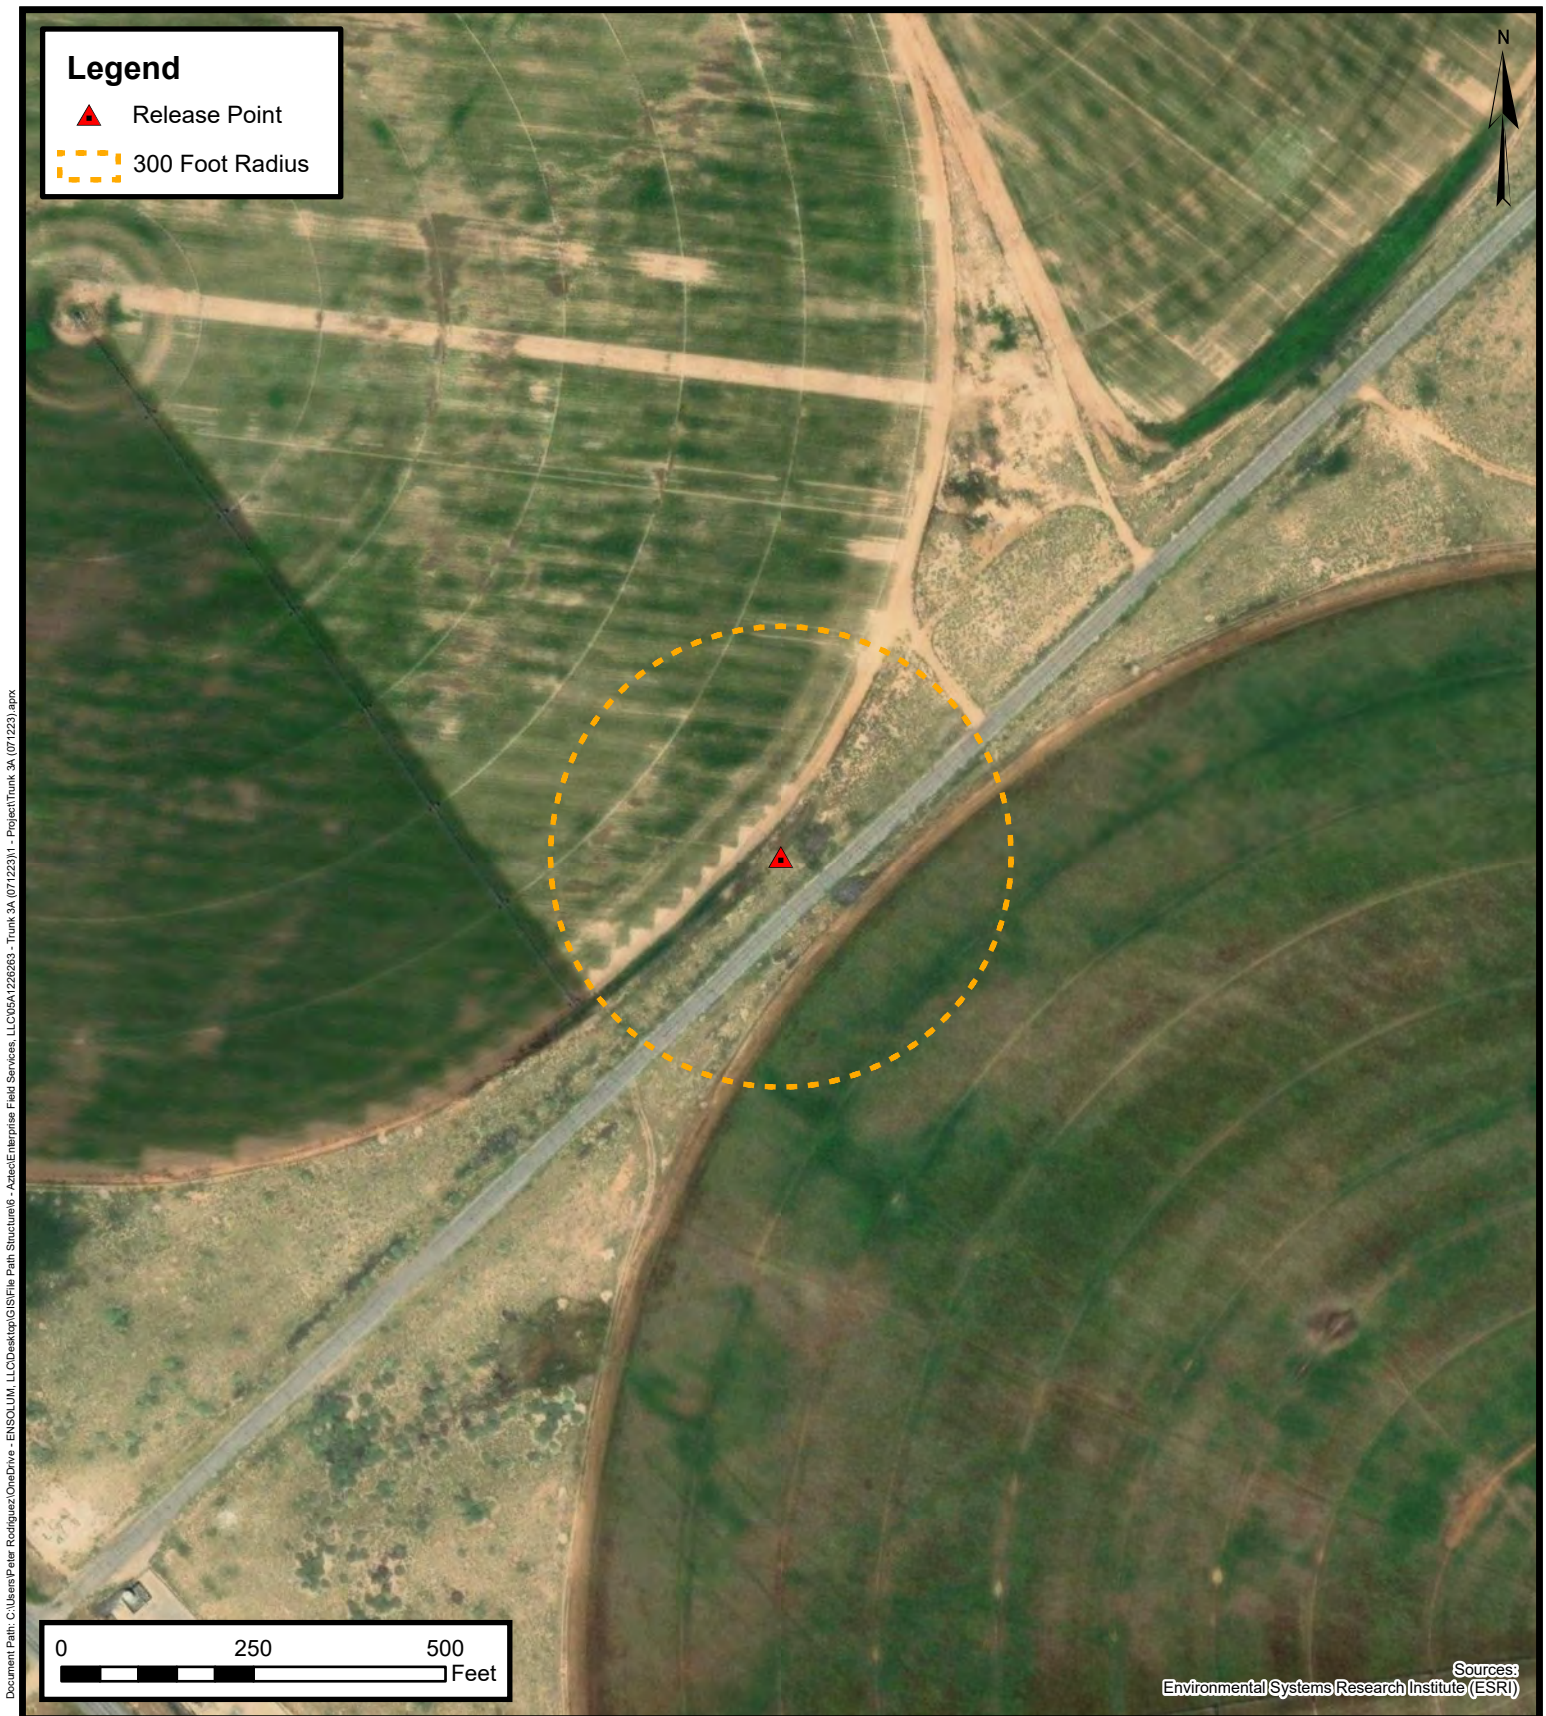
**FIGURE
D**

300 Foot Radius Occupied Structure Identification

- The Site is not located within 200 feet of a lakebed, sinkhole, or playa lake.
- The Site is not located within 300 feet of a permanent residence, school, hospital, institution, or church (**Figure D, Appendix B**).

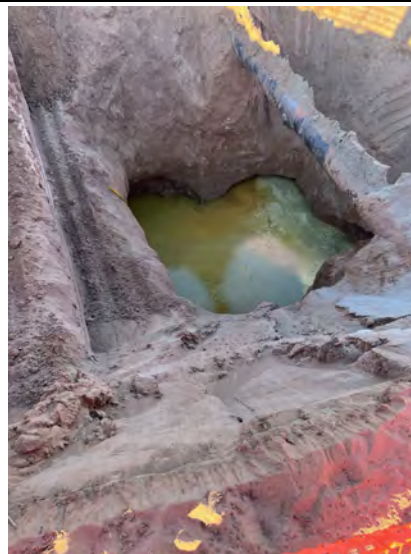
**Photograph 1**

Photograph Description: View of the in-process excavation activities (first excavation).

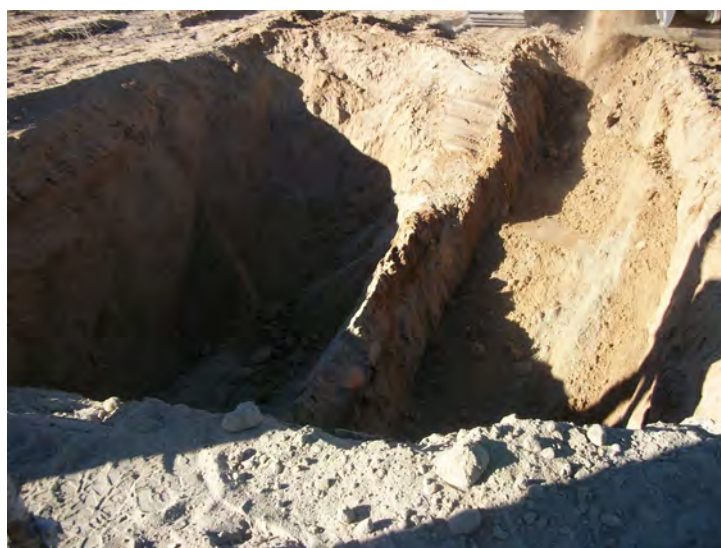
**Photograph 2**

Photograph Description: View of the in-process excavation activities (first excavation).

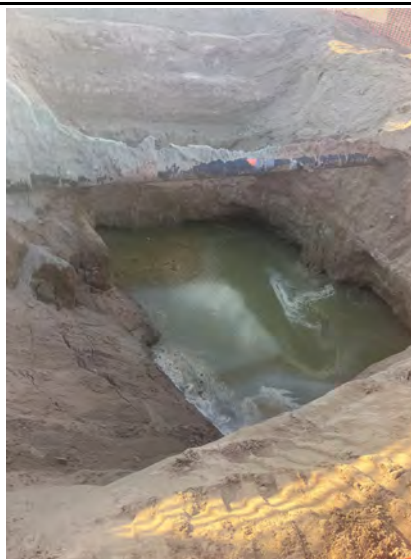
**Photograph 3**

Photograph Description: View of the final excavation (first excavation).

The first excavation measured approximately 15 feet long and 15 feet wide at the maximum extents. The maximum depth of the excavation measured approximately 16.5 feet bgs. The second excavation measured approximately 23.5 feet long and 15 feet wide at the maximum extents. The maximum depth of the second excavation measured approximately 16 feet bgs. The lithology encountered during the completion of remediation activities consisted primarily of silty sand.

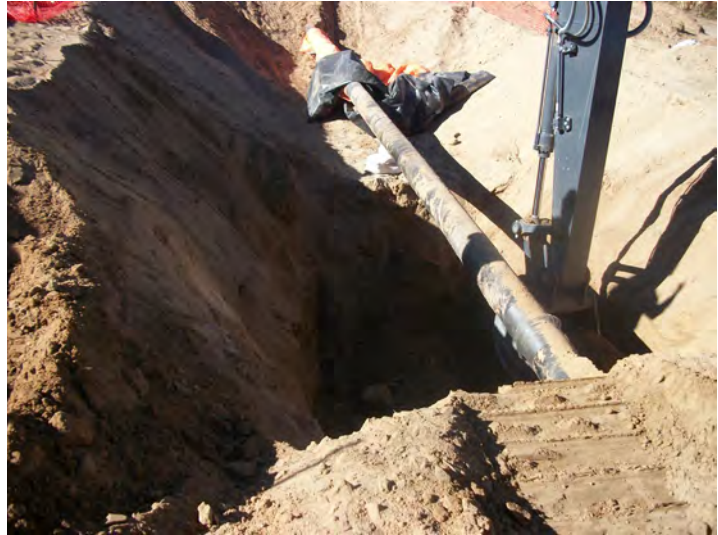
**Photograph 4**

Photograph Description: View of the in-process excavation activities (second excavation).

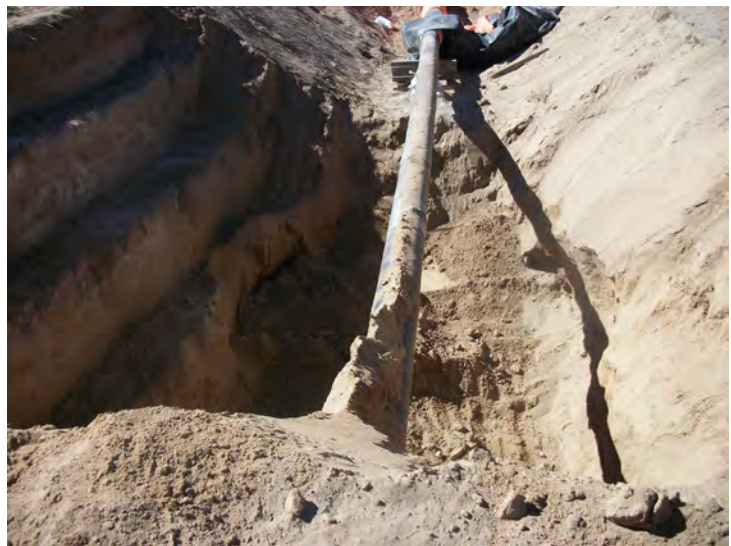
**Photograph 5**

Photograph Description: View of in process excavation (second excavation).

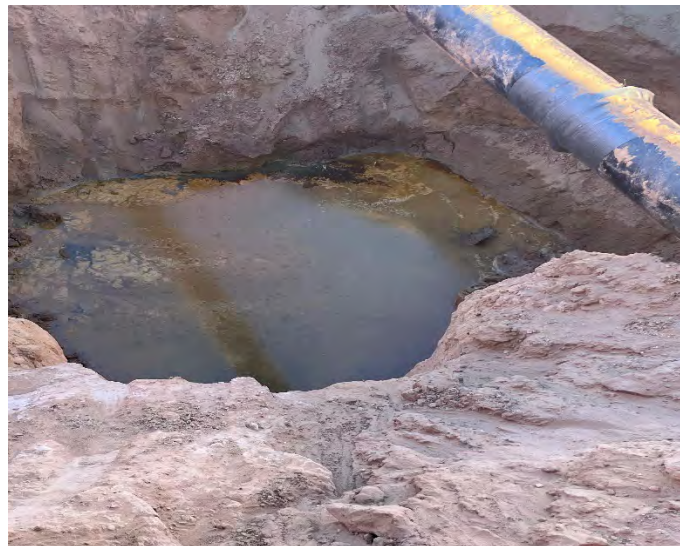
**Photograph 6**

Photograph Description: View of the final excavation (second excavation).

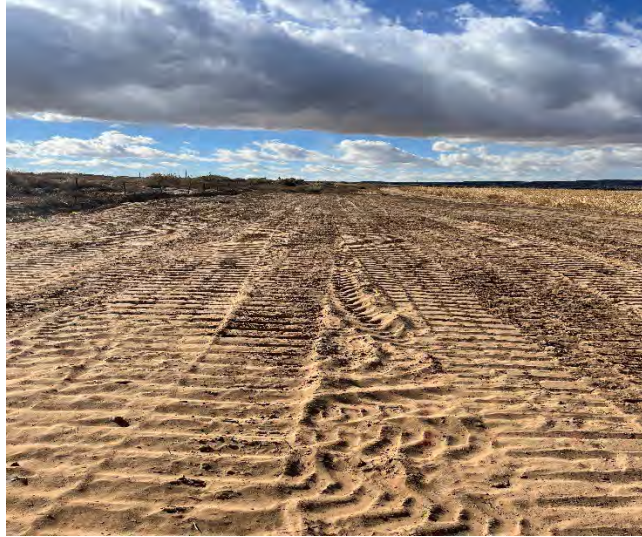
Photograph 7

Photograph Description: View of the site after initial restoration.

The excavations were backfilled with imported fill and then contoured to the surrounding topography.
