Re: Site Assessment and Closure Report
Bragg 10 Fee #1H
API No. 30-015-41462
GPS: Latitude 32.6682816 Longitude -104.3772125
UL "M", Sec. 10, T19S, R26E
Eddy County, NM
NMOCD Ref. No. NAPP2236229593

Paragon Environmental, LLC (Paragon) has been contracted by Spur Energy Partners (Spur) to perform a spill assessment, conduct remediation activities and write a closure report for the release site known as the Bragg 10 Fee #1H (Bragg). Details of the release are summarized below:

Spur Energy Partners

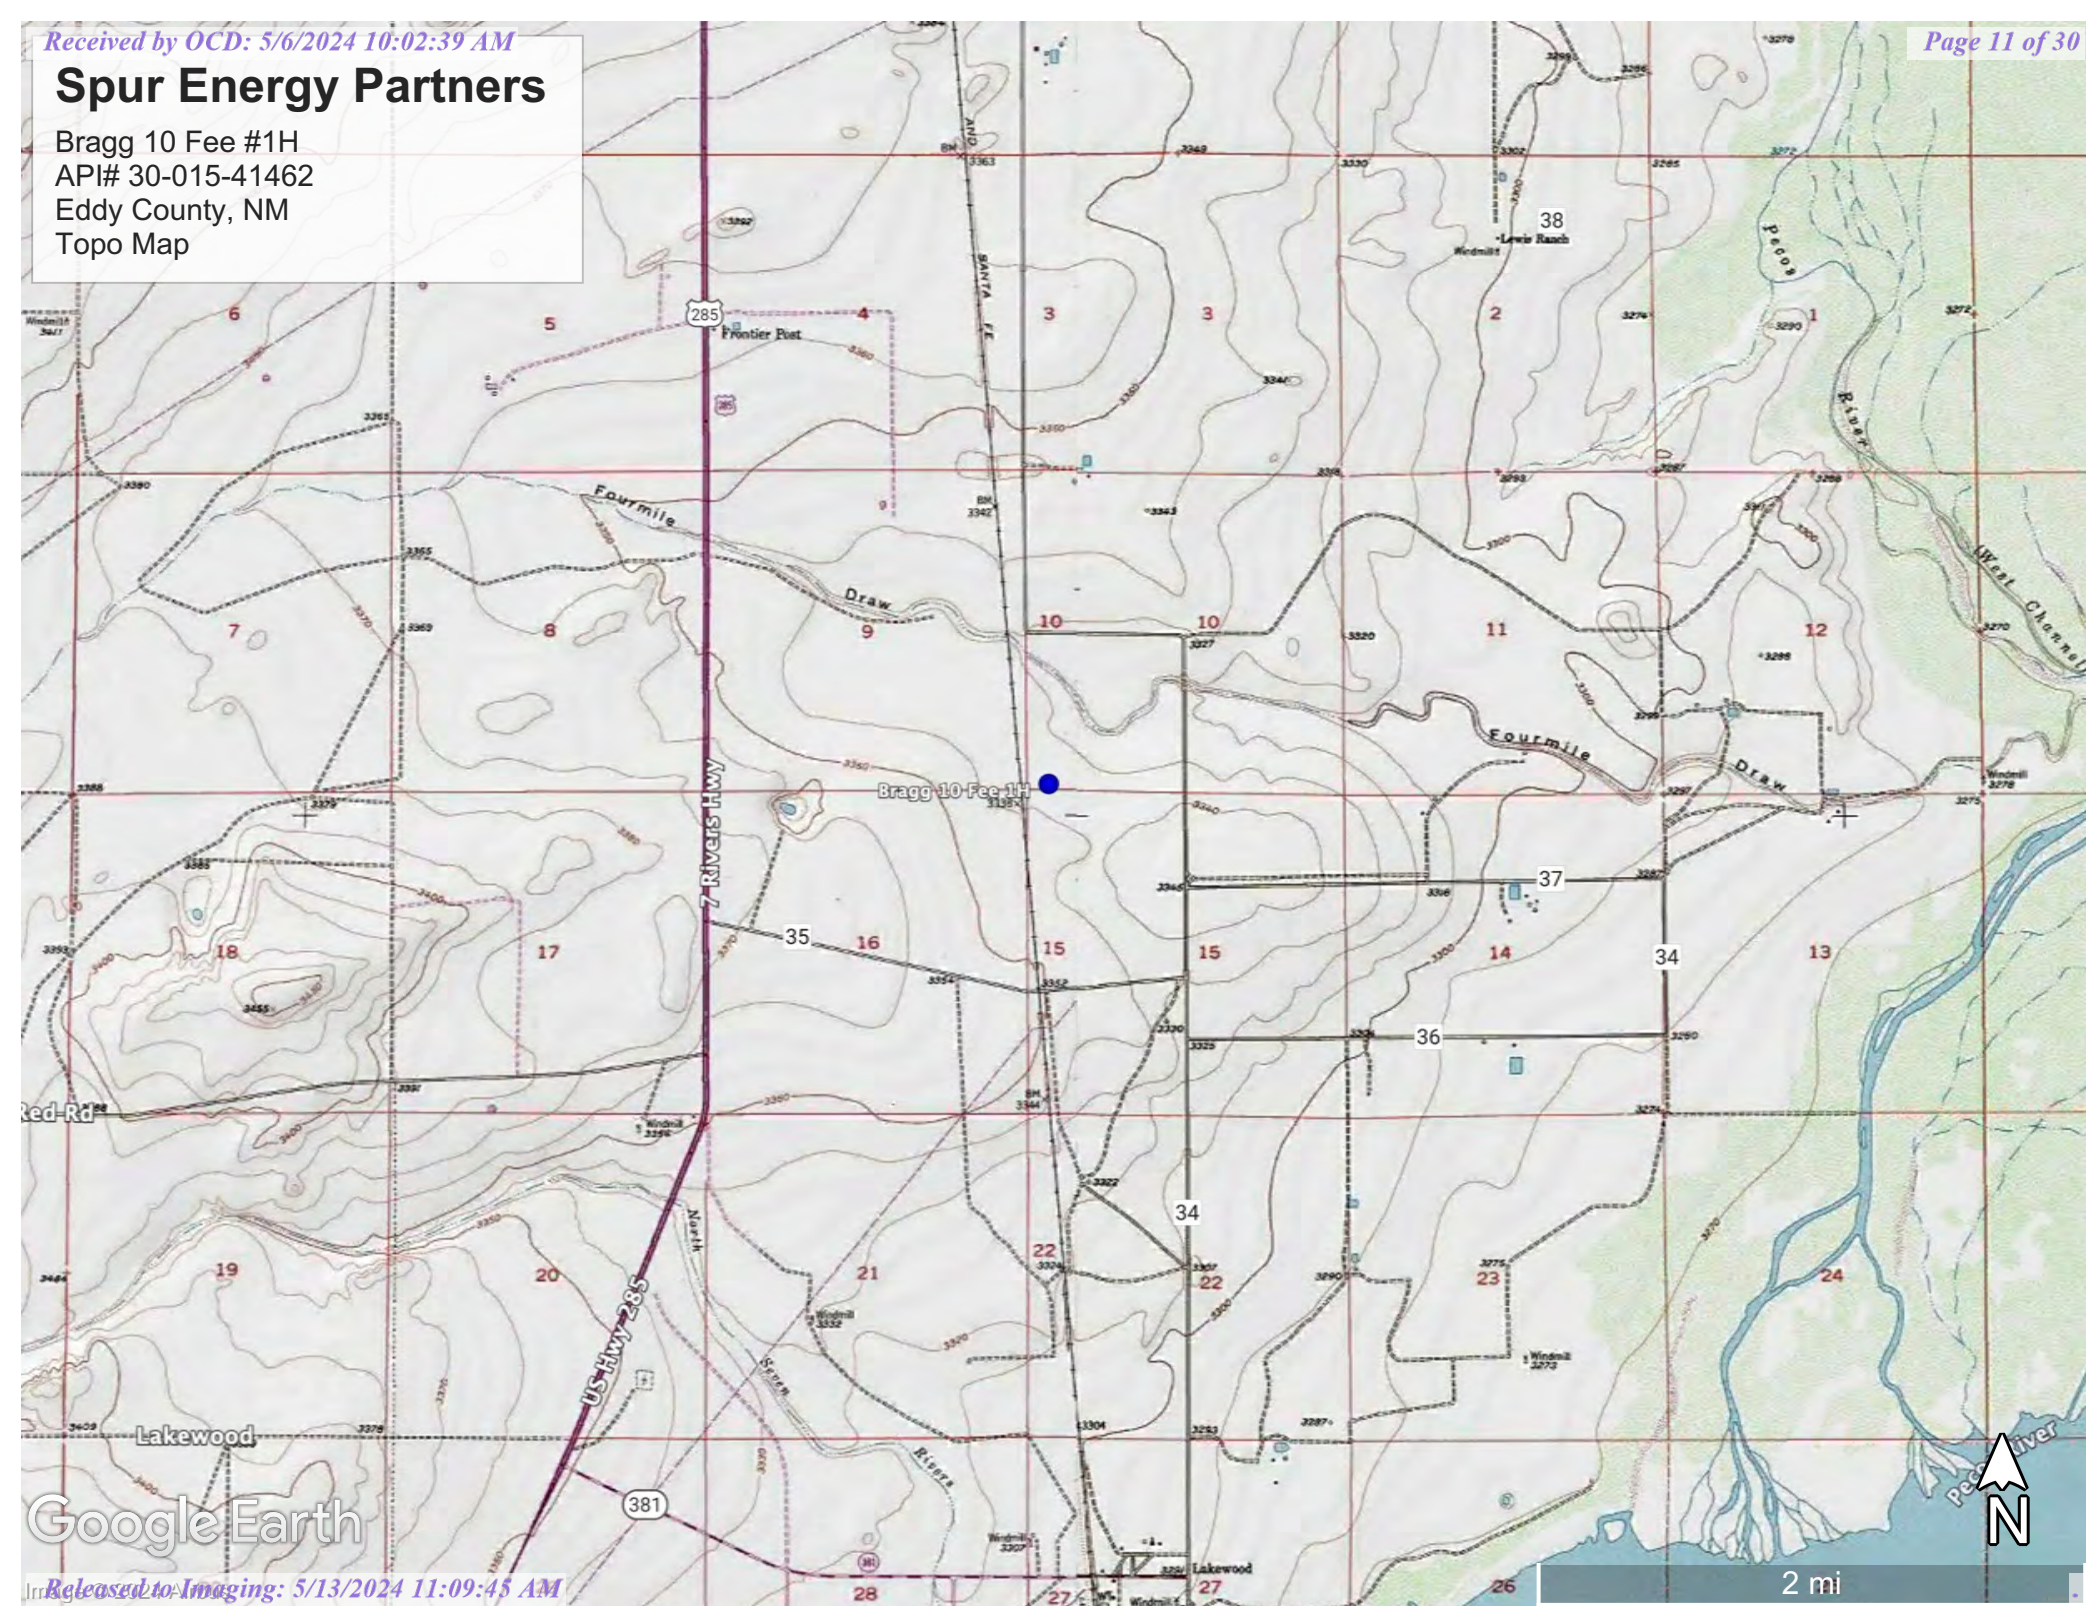
Bragg 10 Fee #1H
API# 30-015-41462
Eddy County, NM
Topo Map

Topographical and Aerial Maps are provided in Figures #2 and #4.

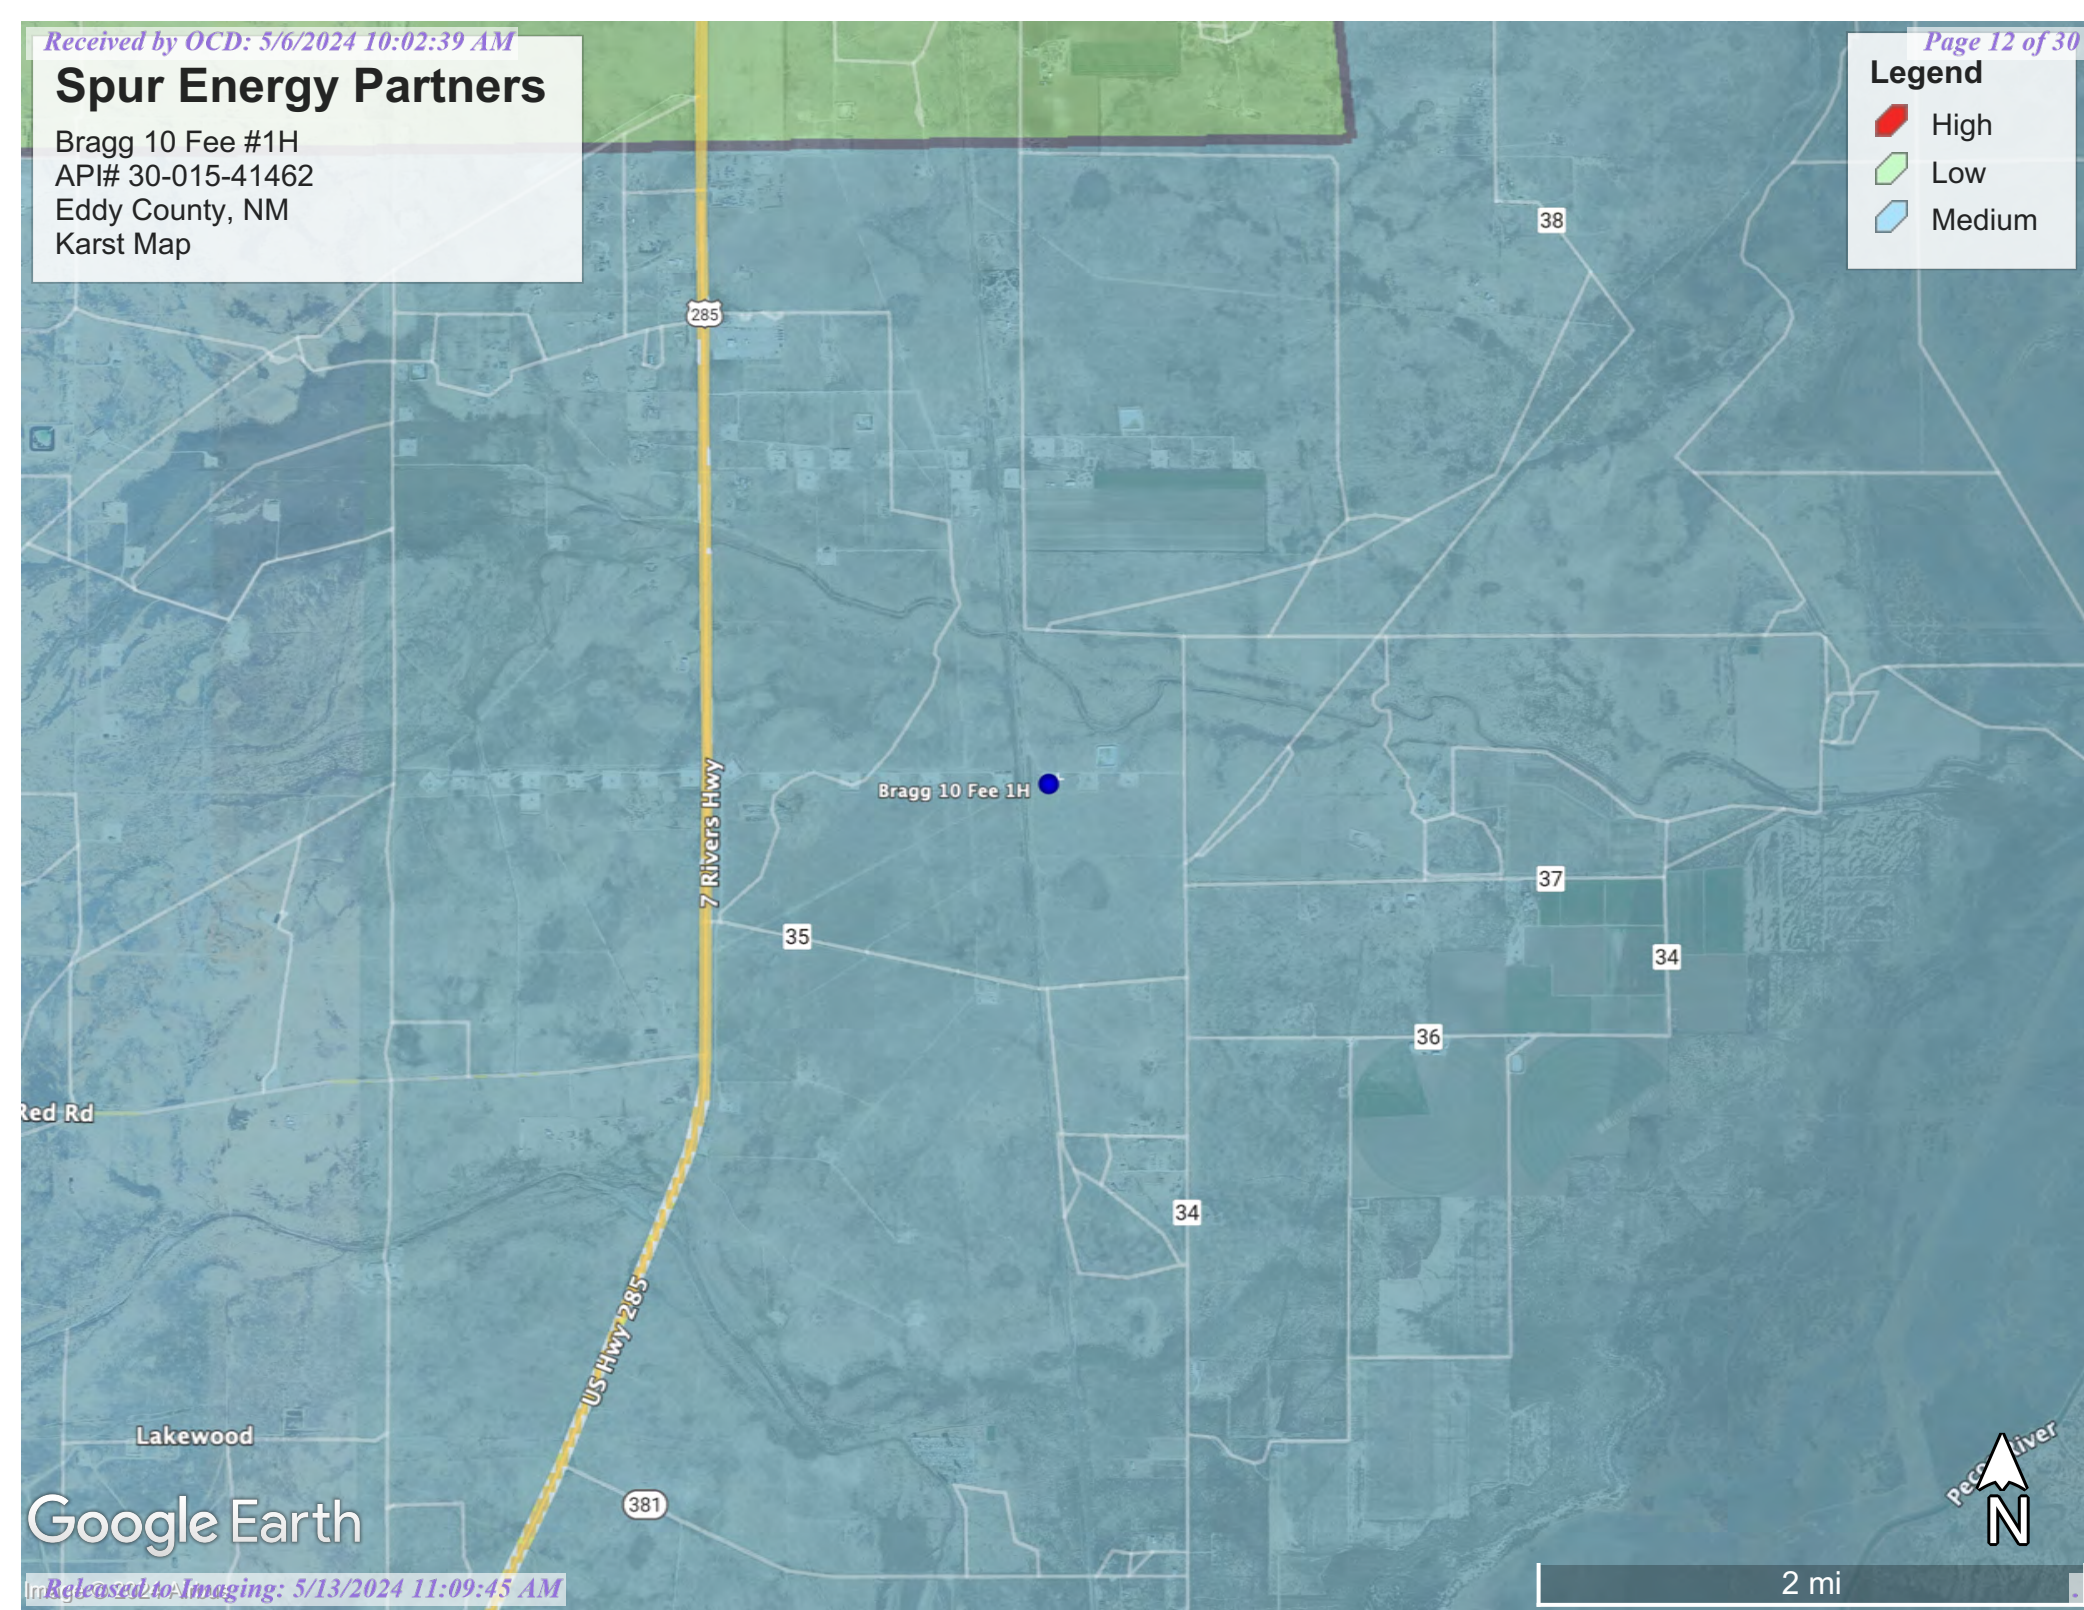
Bragg 10 Fee #1H
API# 30-015-41462
Eddy County, NM
Karst Map

Per the New Mexico Bureau of Geology and Mineral Resources, the geology is in the Quaternary Formation- and is made up of Piedmont alluvial deposits (Holocene to lower Pleistocene)—Includes deposits of higher gradient tributaries bordering major stream valleys, alluvial veneers of the piedmont slope, and alluvial fans. May locally include uppermost Pliocene deposits (QP). The soil in this area is made up of Reagan Loam, with 0 to 3 percent slopes, according to the United States Department of Agriculture Natural Resources Conservation Service. The drainage courses in this area are well-drained. There is NOT a high potential for karst geology to be present around the Bragg (Figure #3).

The Soil Survey and FEMA Flood Map are provided in Appendix B. A Karst Map is provided in Figure #3.

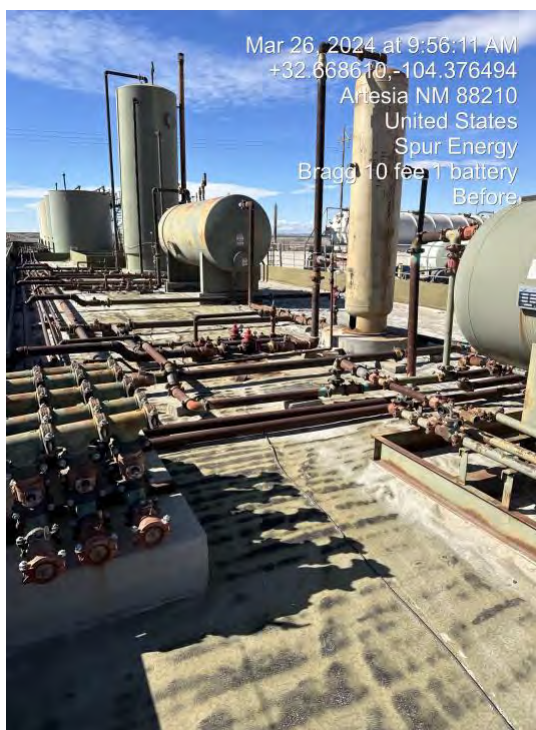
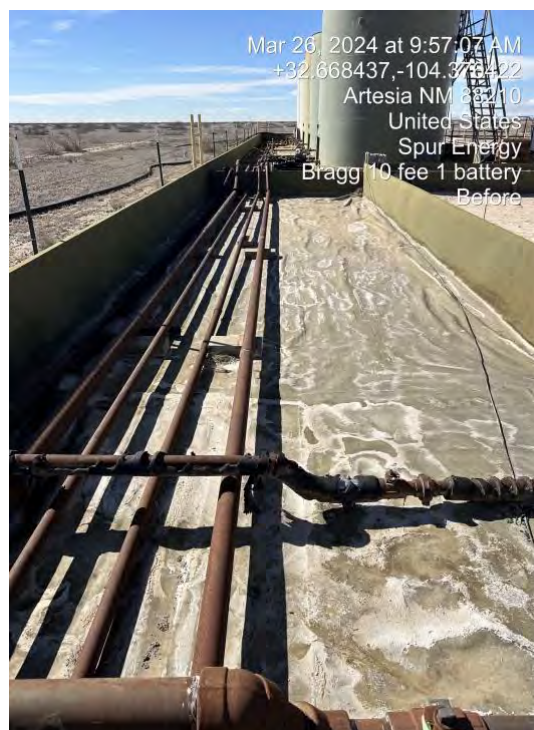
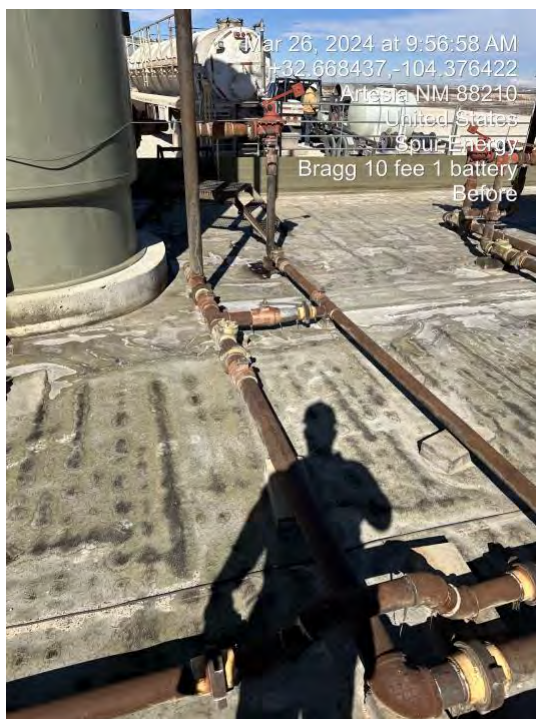
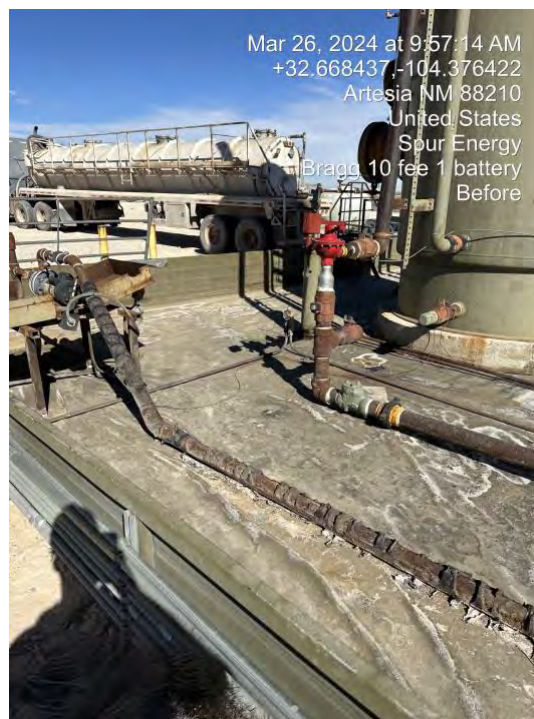
Before

On March 26, 2024, Paragon conducted a site visit to evaluate the site. Upon arrival, we found that it was a falcon lined containment. There was no evidence that any fluids had breached the containment, therefore no samples were taken. However, there was still an area of the containment that needed to be cleaned.

- We utilized a vac truck, power washer and hand crew to clean up the residue and staining of the liner.
- The surface staining affected an area measured app 930 S/F.
- After the cleaning was performed, a notification was submitted, and a liner inspection was performed to ensure the liner was intact. The liner inspection sheet can be found in Appendix C.

Comments: liner is cleaned up and looks good
