Re: Site Characterization Report and Closure Request

Hargrave RR F3
San Juan County, New Mexico
Harvest Four Corners, LLC
NMOCD Incident Number: nAPP2401664896

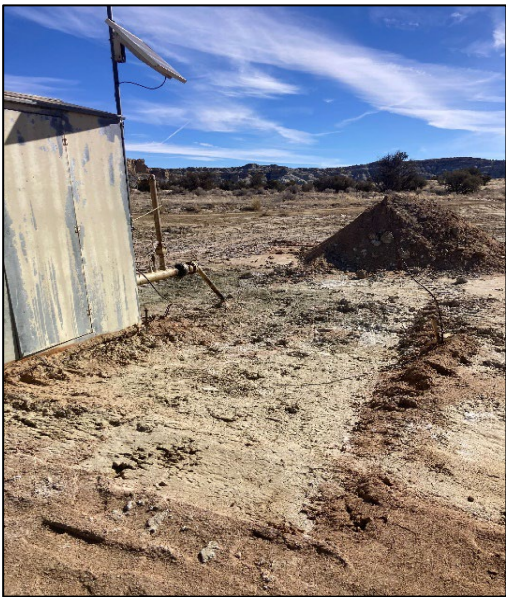
Photograph: 1
Description: Excavation extent
View: East
Date: 2/7/2024

In response to the release, Harvest personnel excavated all soil visibly impacted then collected two, 5-point composite samples, one from the floor, labeled “Bottom” and one from the sidewalls, labeled “Sidewalls” of the excavation on February 7, 2024. A *Notification for (Final) Sampling of a Release* (C-141N) was submitted by Harvest and accepted by the NMOCD on February 2, 2024 (Appendix B). The final excavation footprint was 12 feet by 12 feet and 0.5 feet deep. A photographic log of the excavation is attached as Appendix C. Samples were submitted to Eurofins Environment Testing (Eurofins) for analysis of BTEX following United States Environmental Protection Agency (EPA) Method 8021B, TPH following EPA Method 8015M/D, and chloride following EPA Method 300.0.

Composite soil samples collected from the floor and sidewalls did not contain COC concentrations exceeding NMOCD Table 1 Closure Criteria. Concentrations of BTEX, TPH, and chloride were all below their respective laboratory reporting limit. Laboratory analytical results from the excavation sampling event are summarized in Table 1, with the complete laboratory analytical report attached in Appendix D.

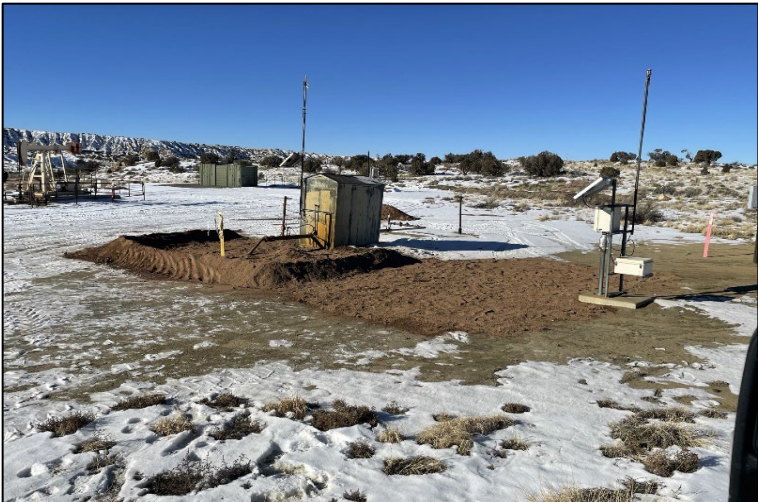
Photograph: 4
Description: Berm around release area
View: West
Date: 1/15/2024

On January 15, 2024, Harvest personnel discovered a natural gas leak caused by a freeze in the pipeline. An estimated 1,010 thousand cubic feet (MCF) of natural gas was released before the line was shut in and repairs were made. The release was reported to the New Mexico Oil Conservation Division (NMOCD) on January 16, 2024, on a Form C-141, *Release Notification and Corrective Action*. The release was assigned NMOCD Incident Number nAPP2401664896.
