TOMB RAIDER 1 FED 1H BATTERY

OCD INCIDENT nAPP2330624700

Re: **Remediation Closure Request**  
**Tomb Raider 1 Fed 1H Battery**  
**Tracking #: NAPP2330624700**

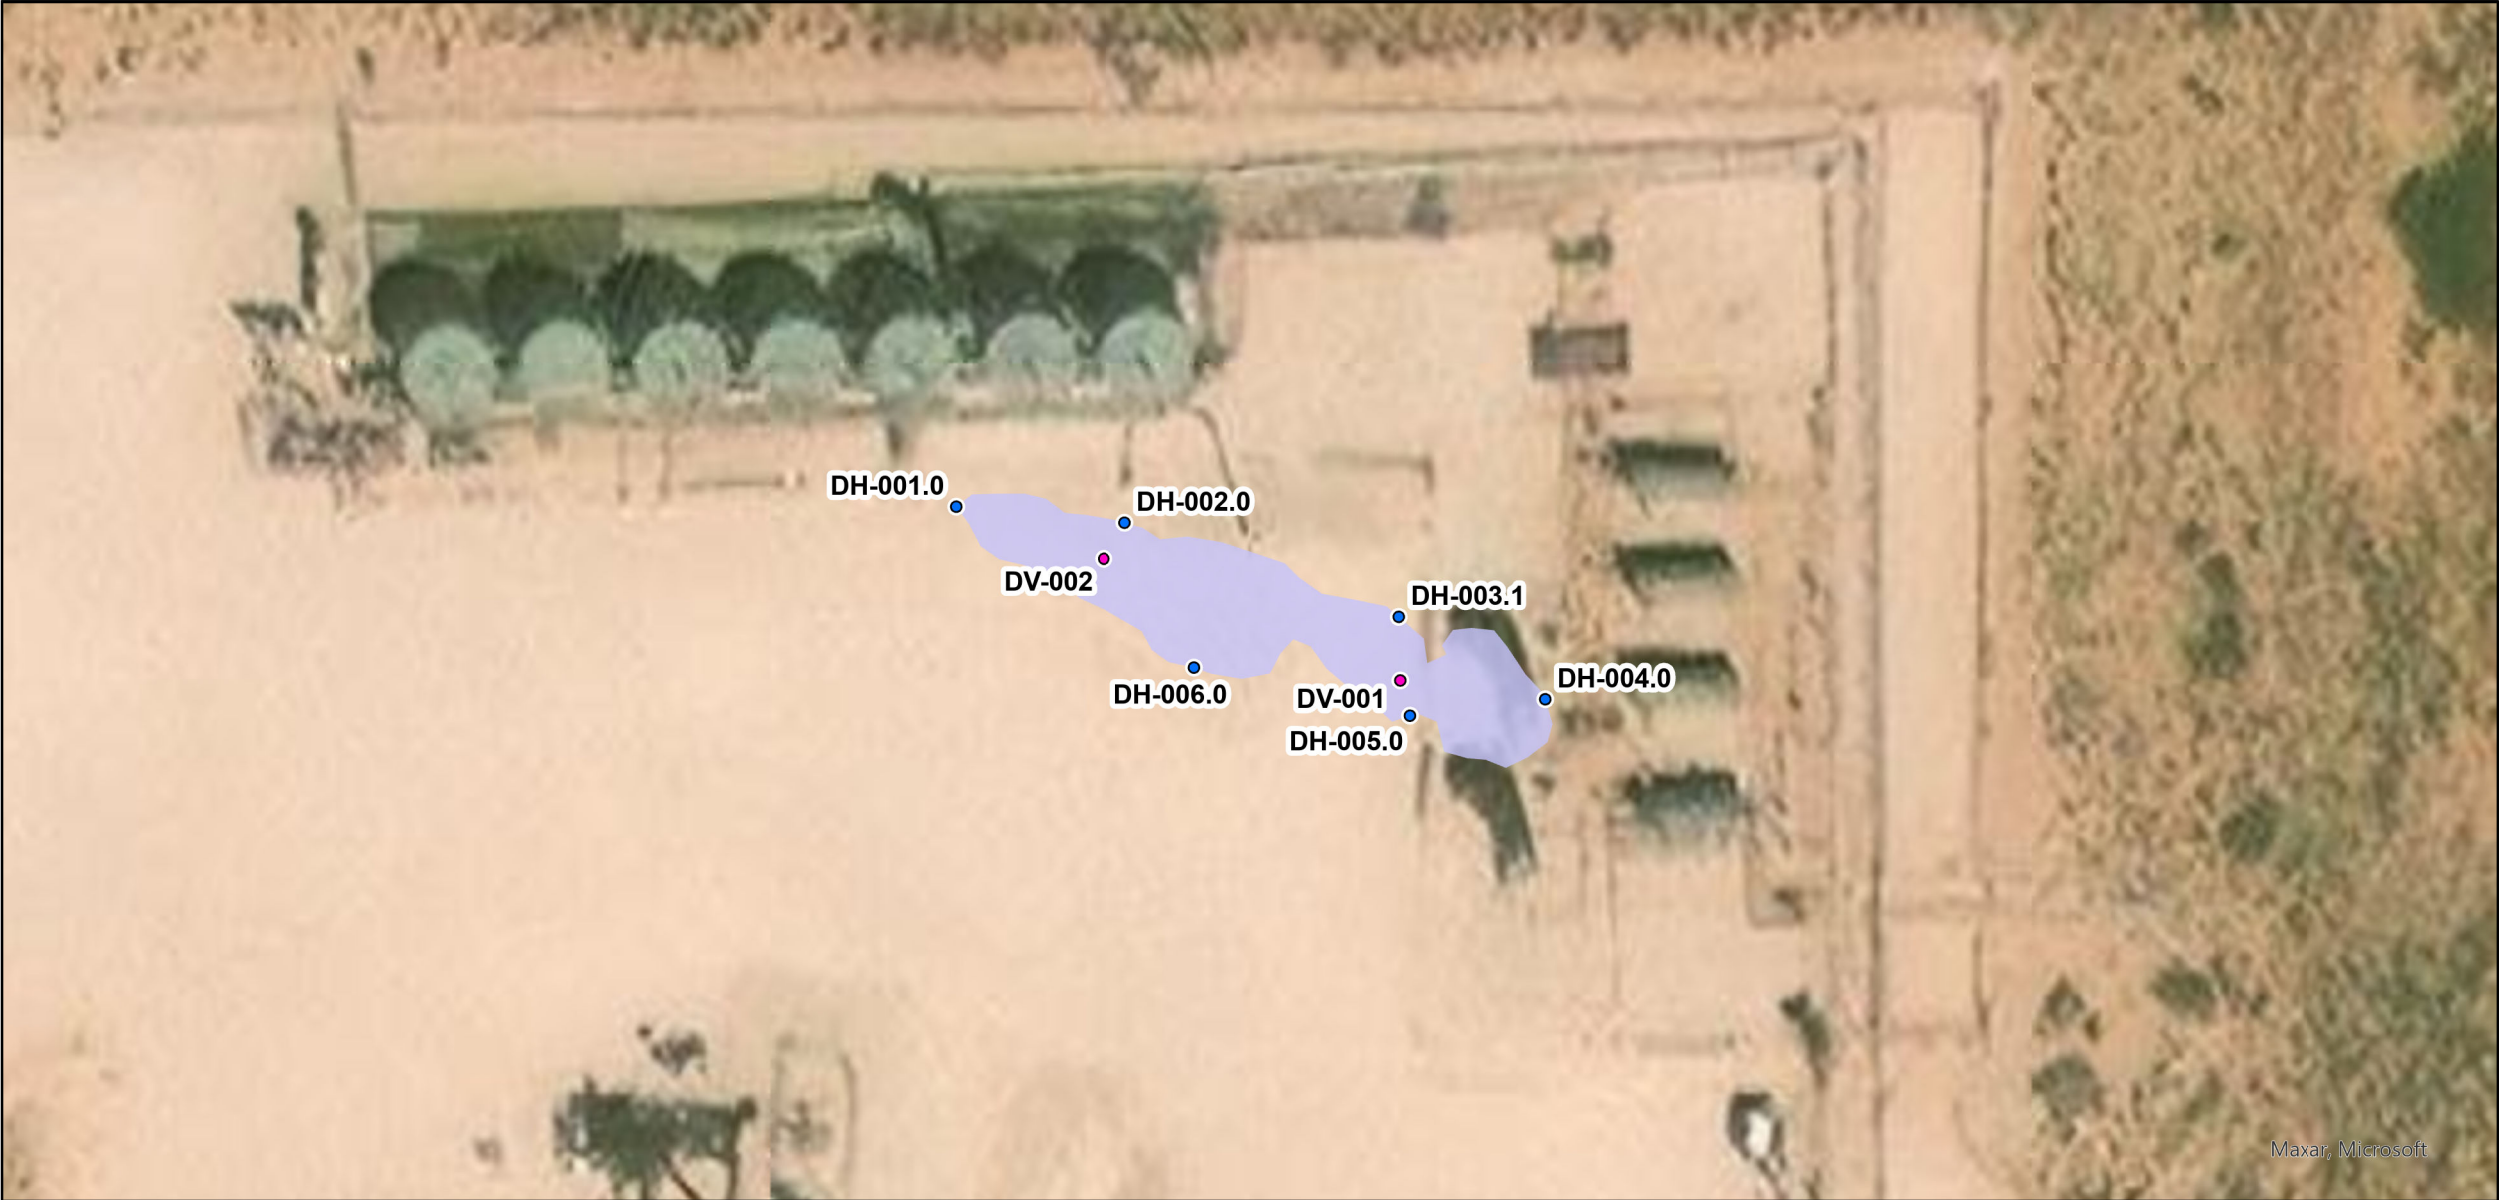
**Delineation Map**  
**Devon Energy Production Company, LP**  
**Tomb Raider 1 Fed 1H Battery**  
**32.3401207, -103.7293257**  
**Eddy County, New Mexico**  
**NMOCD Reference # NAPP2330624700**

- Vertical Delineation
- Horizontal Delineation
- Release Area

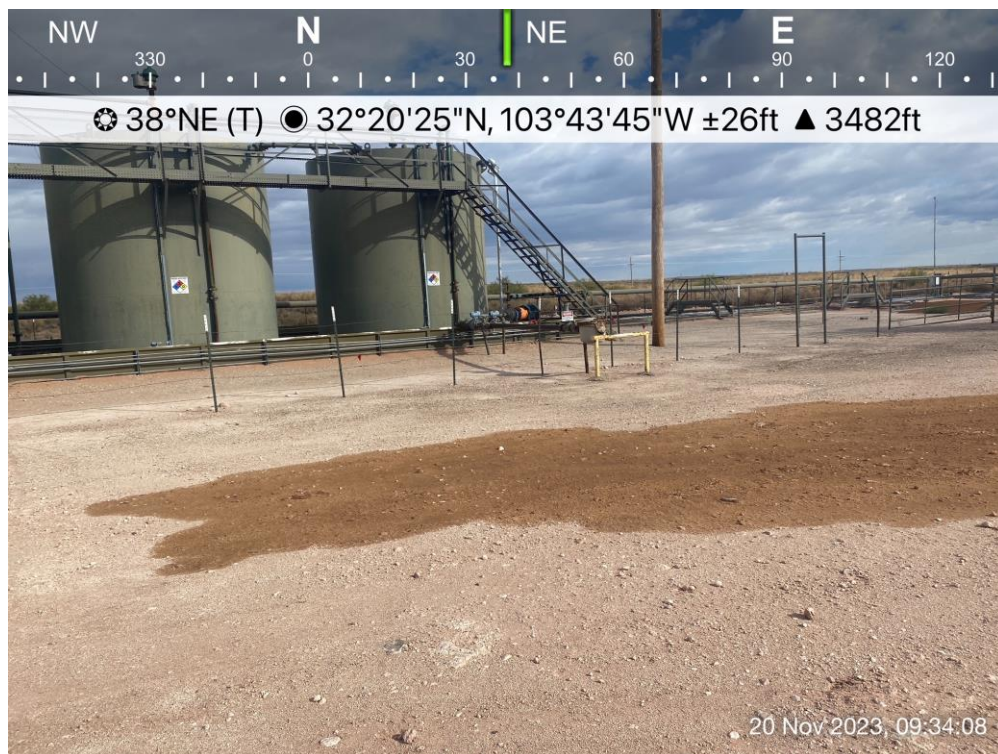
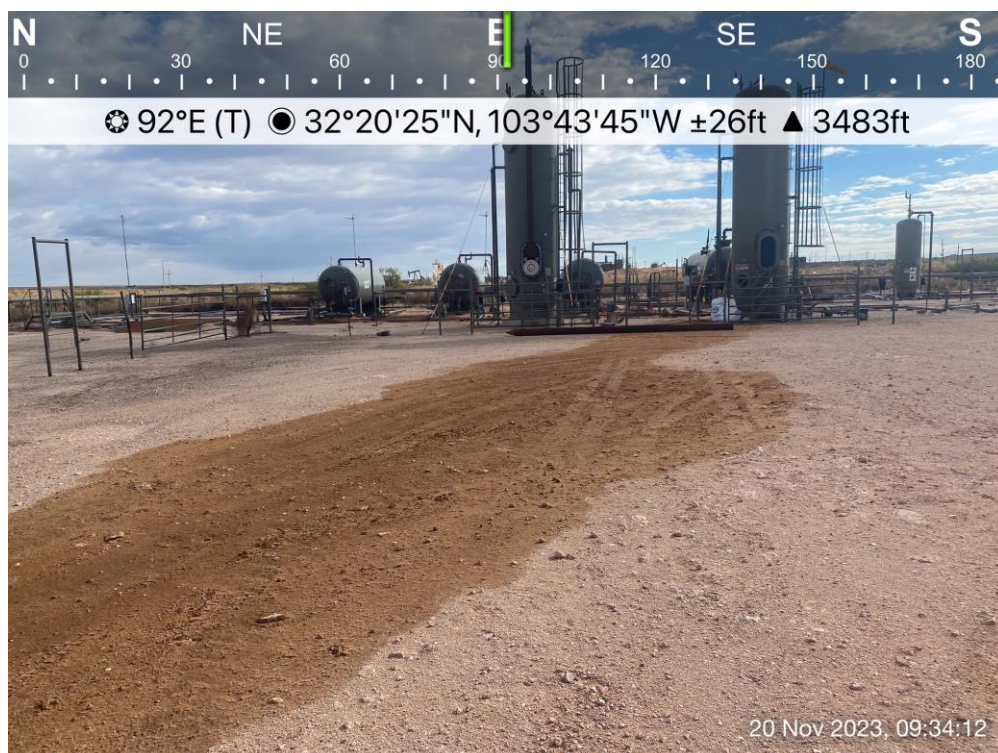
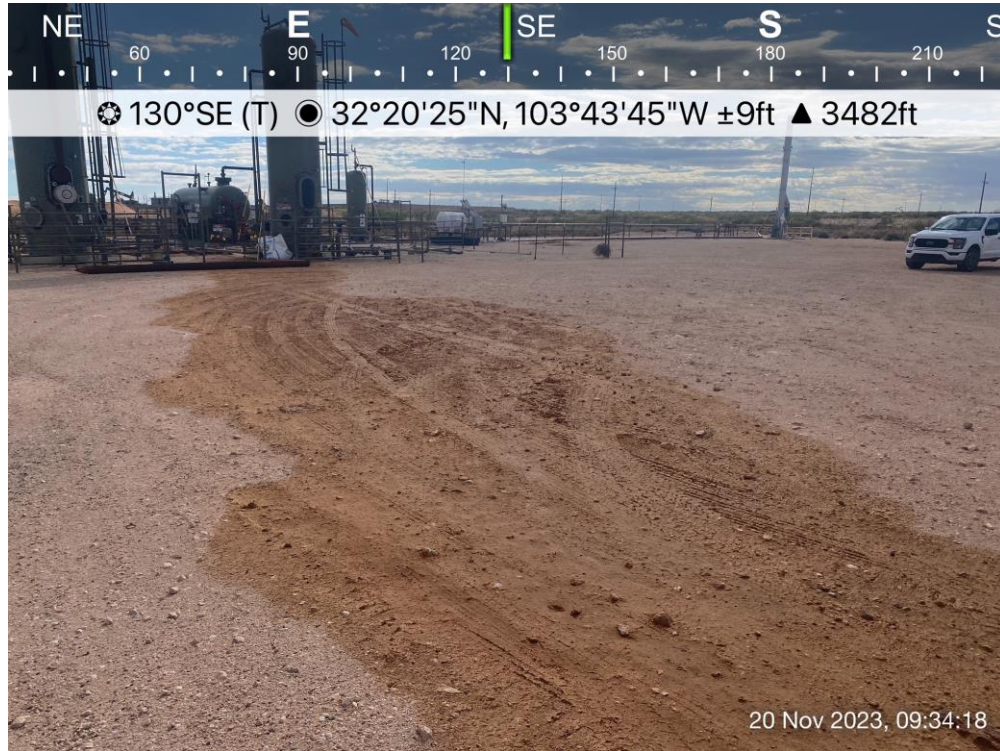
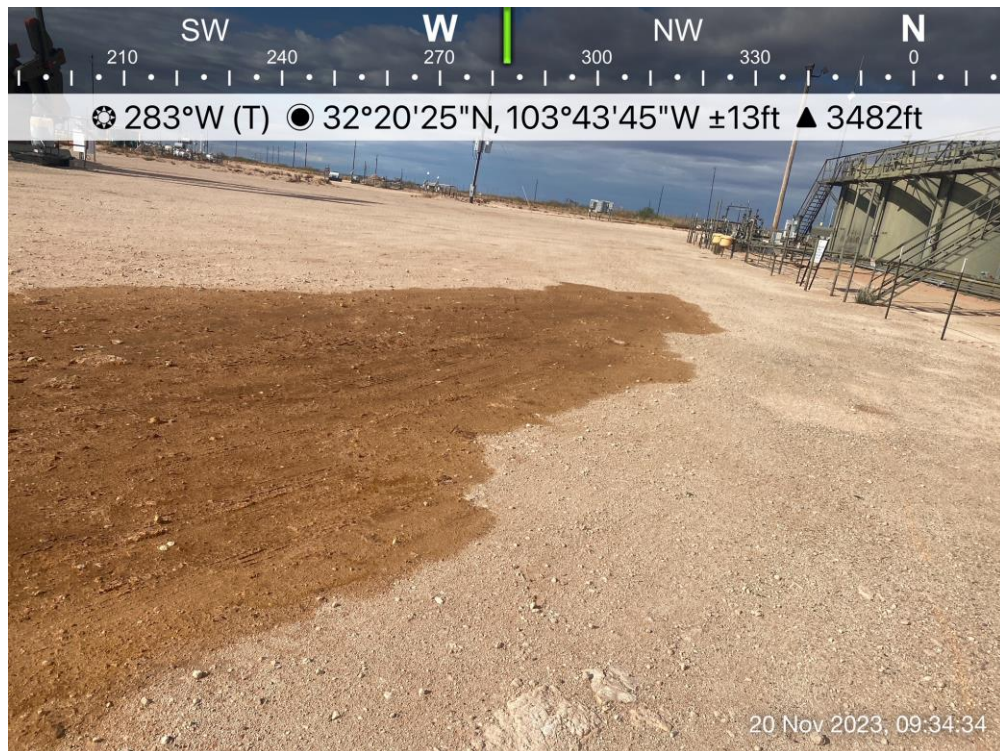
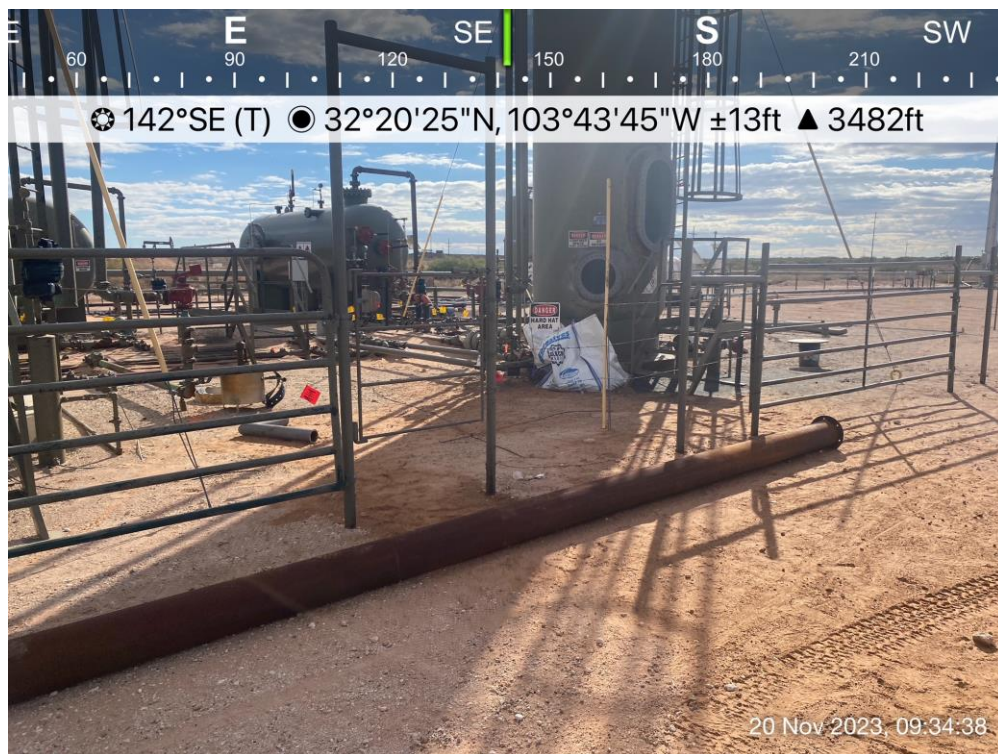
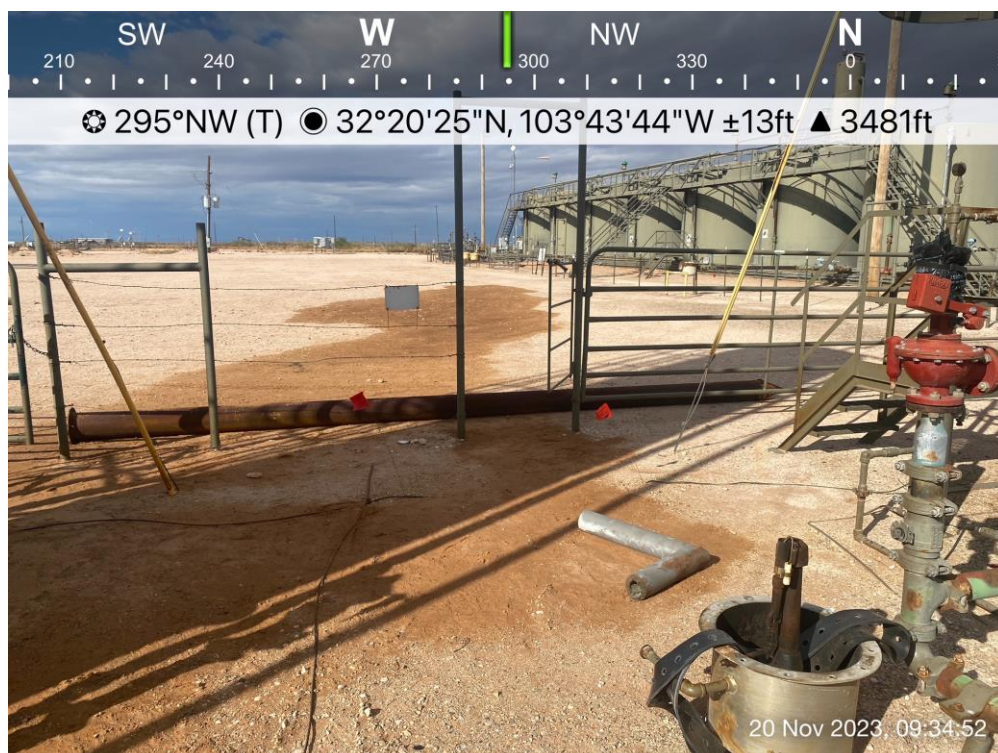
## Initial Release

On 11/02/2023, Devon Energy Production Company, LP reported a release at the Tomb Raider 1 Fed 1H Battery. The release resulted from a fire tube on the south heater leaking oil. Approximately 1,562 sqft. of the Pad was found to be damp upon initial inspection.
