Alley Cat 17 CTB 3

OCD incident nAPP2327225644

Re: Site Assessment, Remediation, and Closure Report
Alley Cat 17 CTB 3
API No. N/A
GPS: Latitude 32.308509 Longitude -103.695694
UL - J, 17, T23S, R32E
Lea County, NM
NMOCD Ref. No. NAPP2327225644

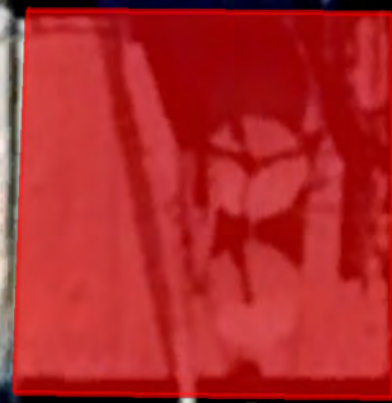
Devon Energy
API: N/A
Eddy County, NM
Site Map Liner

On December 15, 2023, after submitting the 48-hour notification application ID:294179 to the OCD, Pima Environmental conducted a liner inspection at this location. Pima concluded that this liner and containment maintained its integrity and was able to retain the fluids. The liner inspection form and photographic documentation can be found in Appendix D.

Liner 3,274 Sqft

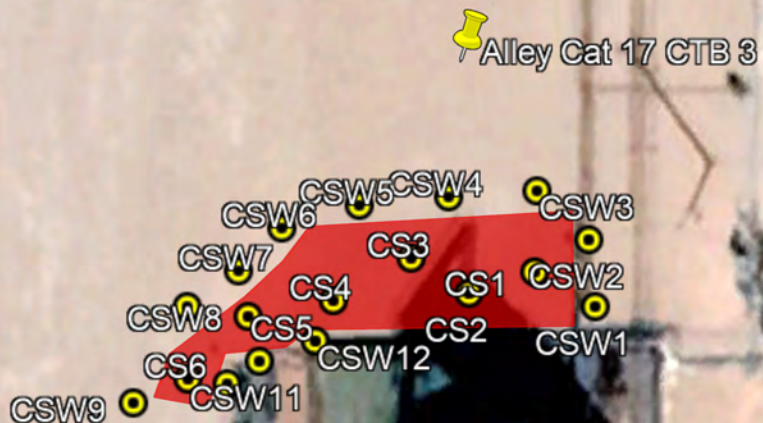
Devon Energy
API:N/A
Eddy County, NM
Confirmation Sample Map

On December 15, 2023, after sending a 48-hour notification, application ID:294188 (Appendix C), Pima returned to the site to collect confirmation samples of the excavation. The results of this sampling event can be found in the following table. A Confirmation Sample Map can be found in Figure 5.

Based on the sample results, the bottoms and sidewalls were below NMOCD Closure Criteria 19.15.29 NMAC. The contaminated material was sufficiently removed then transported to an NMOCD approved disposal site. The excavation was then backfilled with clean like material, machine compacted and returned to its previous state. See Appendix D for Photographic Documentation.

On December 1, 2023, the Devon Construction Department mobilized personnel and equipment to begin immediate remediation activities. They began excavating the area to a depth of 3' BGS. The contaminated soil 133 cubic yards was hauled to an approved, lined disposal facility and clean backfill material was brought in.
