**Mattie Price Flowline Release
Section 06, Township 17S, Range 38E
Lea County, New Mexico**

**Remediation Report,
Request for Backfill Approval and Closure
nAPP2402549174**

April 24, 2024

**Safety & Environmental Solutions, Inc.
703 East Clinton Street
Hobbs, New Mexico 88240
(575) 397-0510**

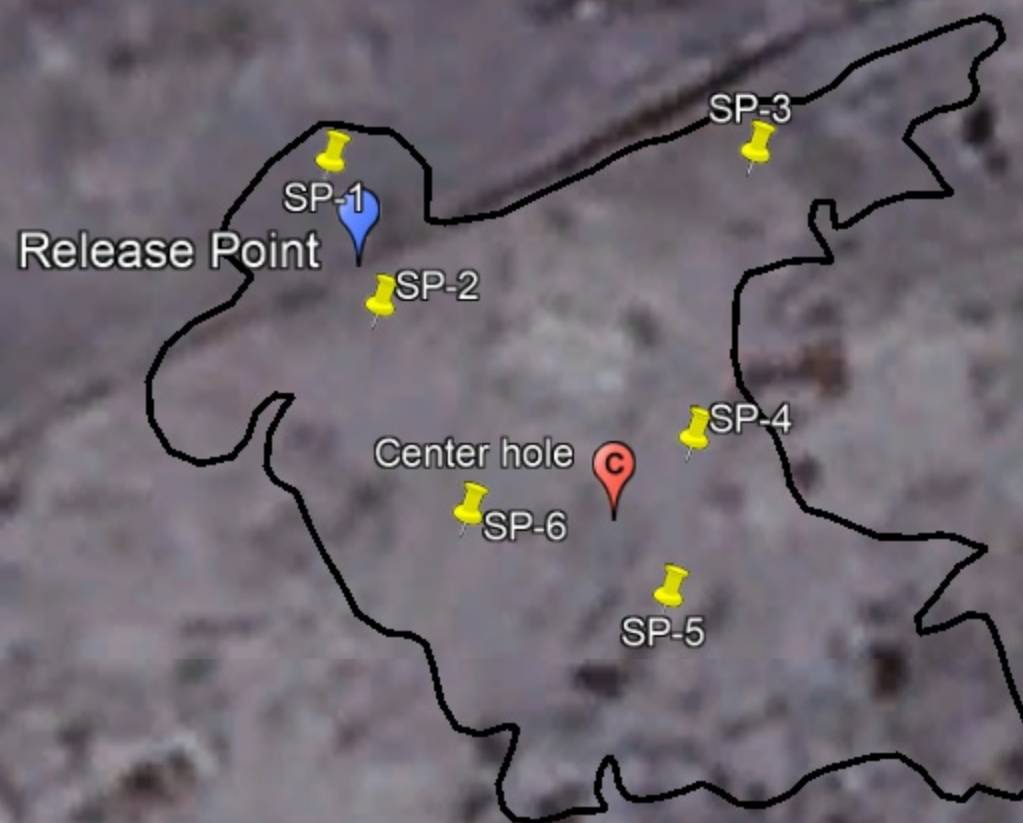
Initial Sampling Locations

Hand Auger/Backhoe Sampling February 9
Center Hole Trackhoe Sampling February 13

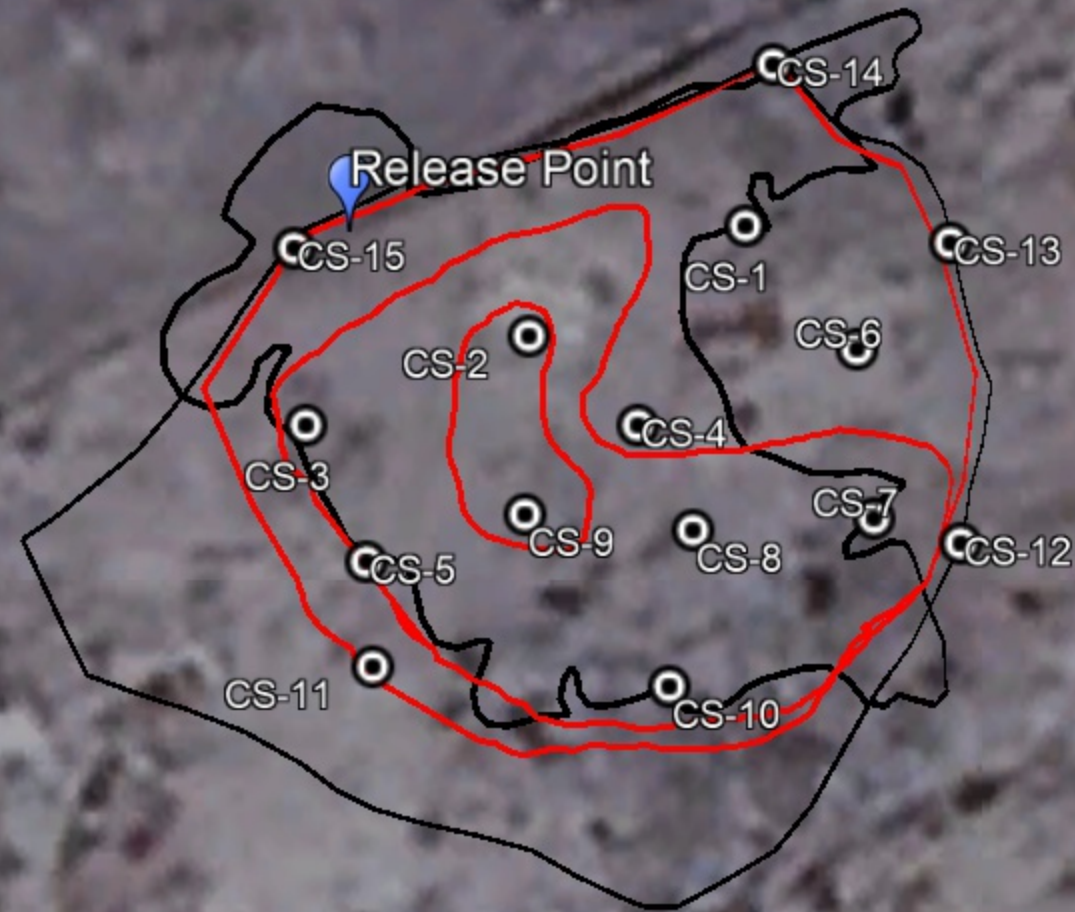
Confirmation Sampling Locations

March 5 and 20, 2024

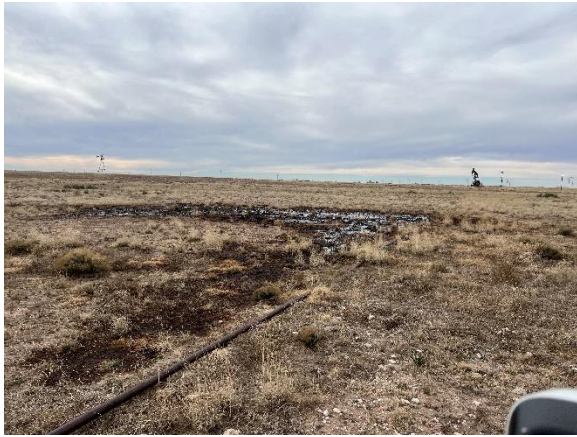
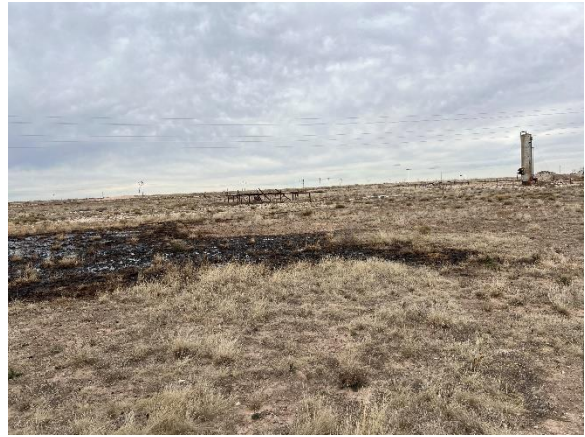
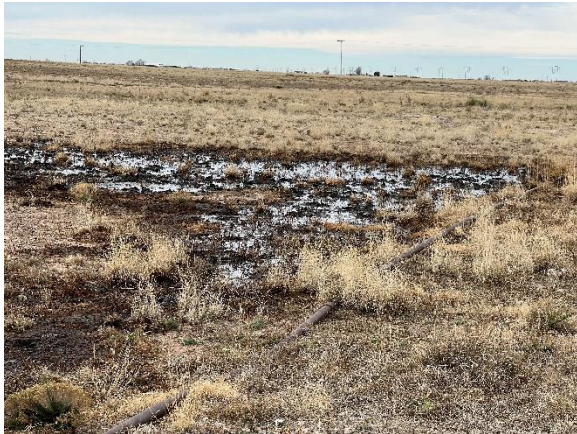
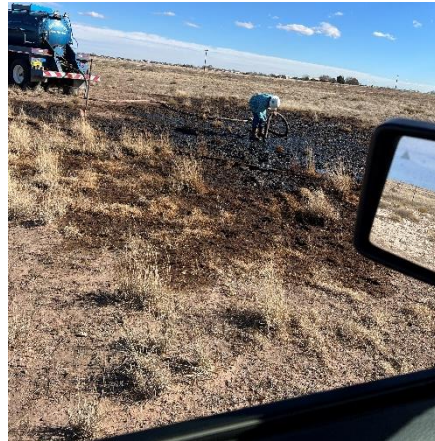
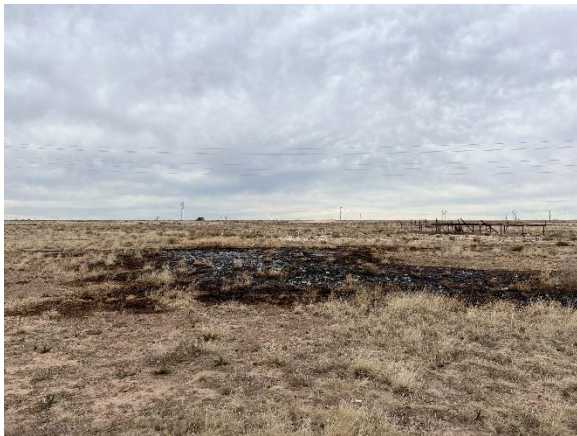
**Osborn Heirs Company
Site photographs**

January 25, 2024
