RE: Closure Request Letter
WPX Energy Permian, LLC
RDX 21-13
Incident Number nMLB1113027936
Eddy County, New Mexico

Etech Environmental & Safety Solutions, Inc. (Etech), on behalf of WPX Energy Permian, LLC (WPX), presents the following Closure Request Letter (CRL) to document that No Further Action is warranted for an inadvertent release of frac water and crude oil at the RDX 21-13 (Site) (**Figure 1 in Appendix A**), based on previous remediation efforts coordinated with the Bureau of Land Management (BLM) and the subsequent BLM approval documented on a Form 3160-5 *Sundry Notices and Reports on Wells* (Form 3160). It was determined by the BLM that the final excavation confirmation soil sample results were sufficient for closure of Incident Number nMLB1113027936, however, no further communication with the New Mexico Oil Conservation Division (NMOCD) has been documented. Since the completion of remediation efforts, the Site has been plugged and abandoned and approved by the BLM for Final Abandonment (**Figure 2 in Appendix A**). All communications and documentation of completed remediation efforts and investigation is included in **Appendix B**.

Sampling Report

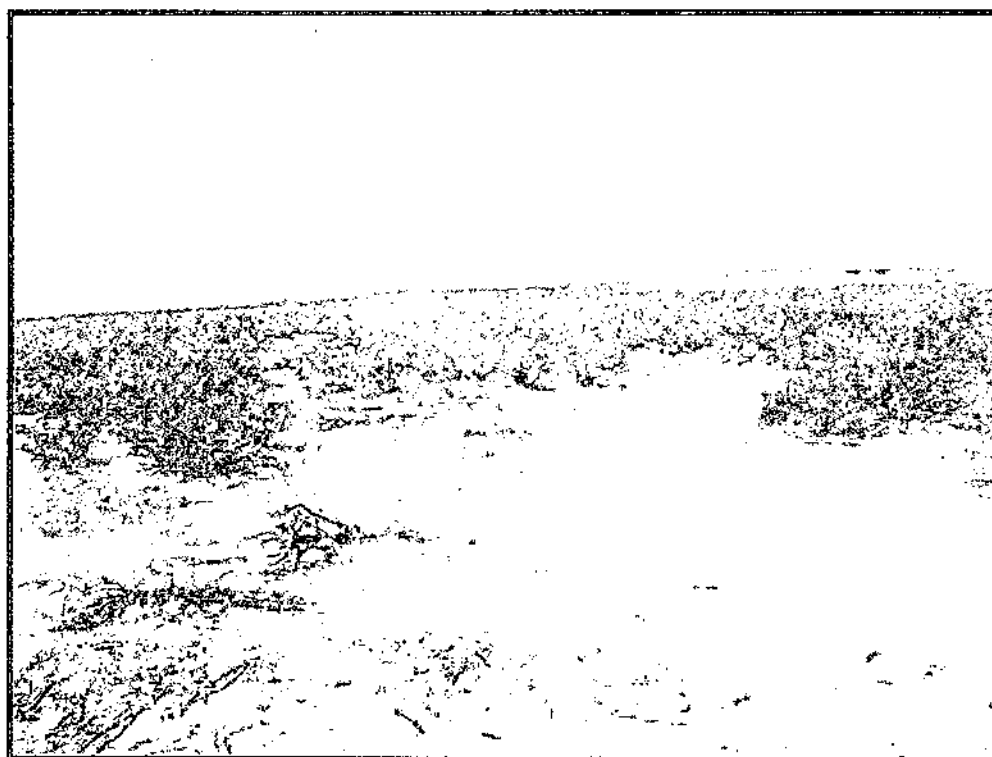
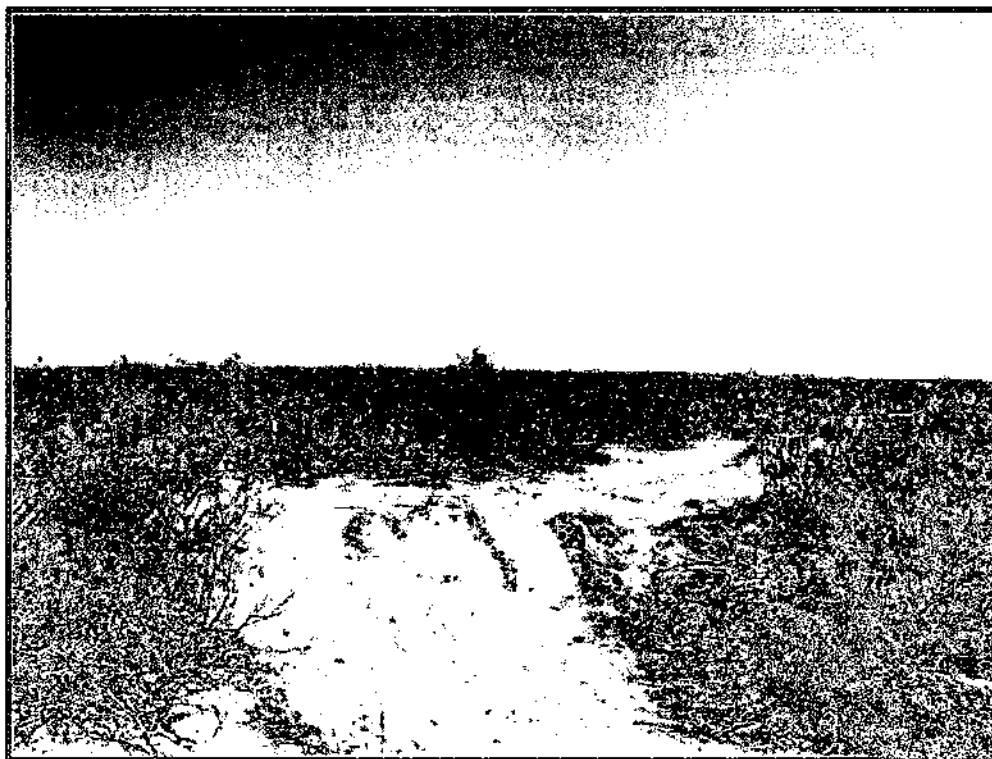
Excavated area facing north

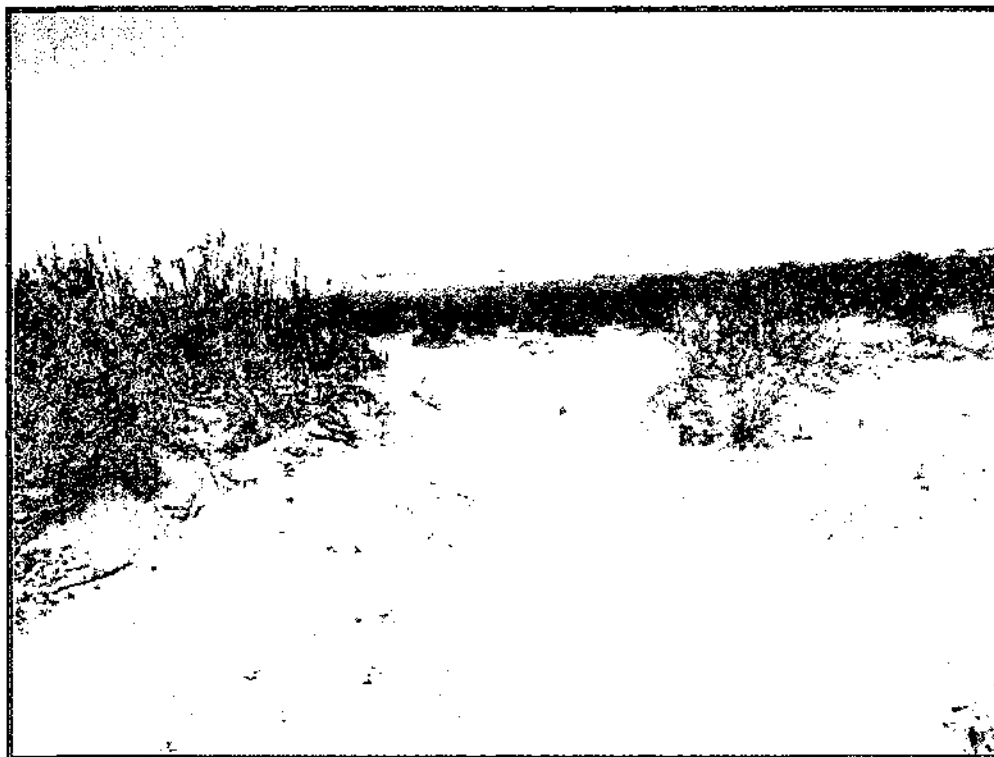
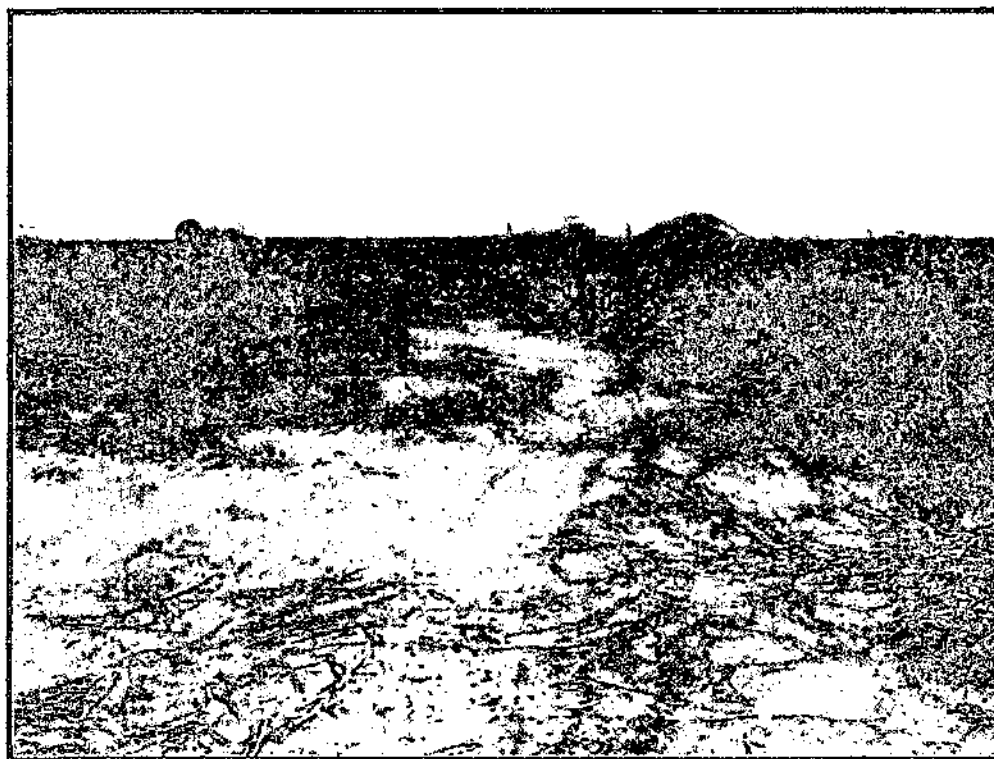
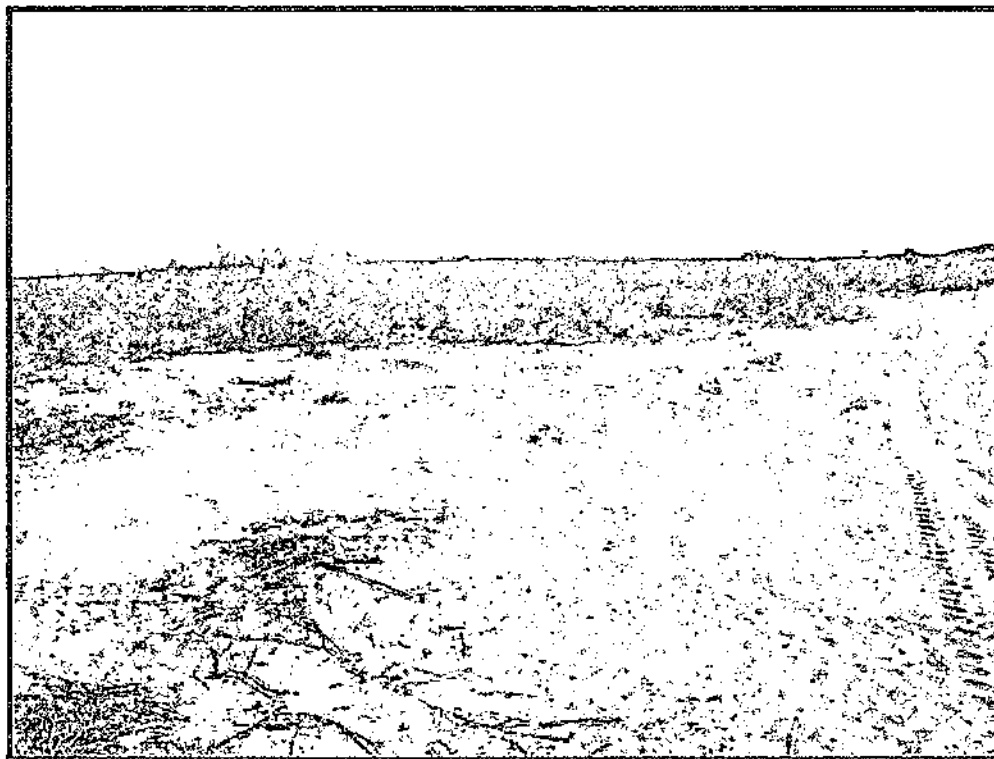
Excavated area facing northeast

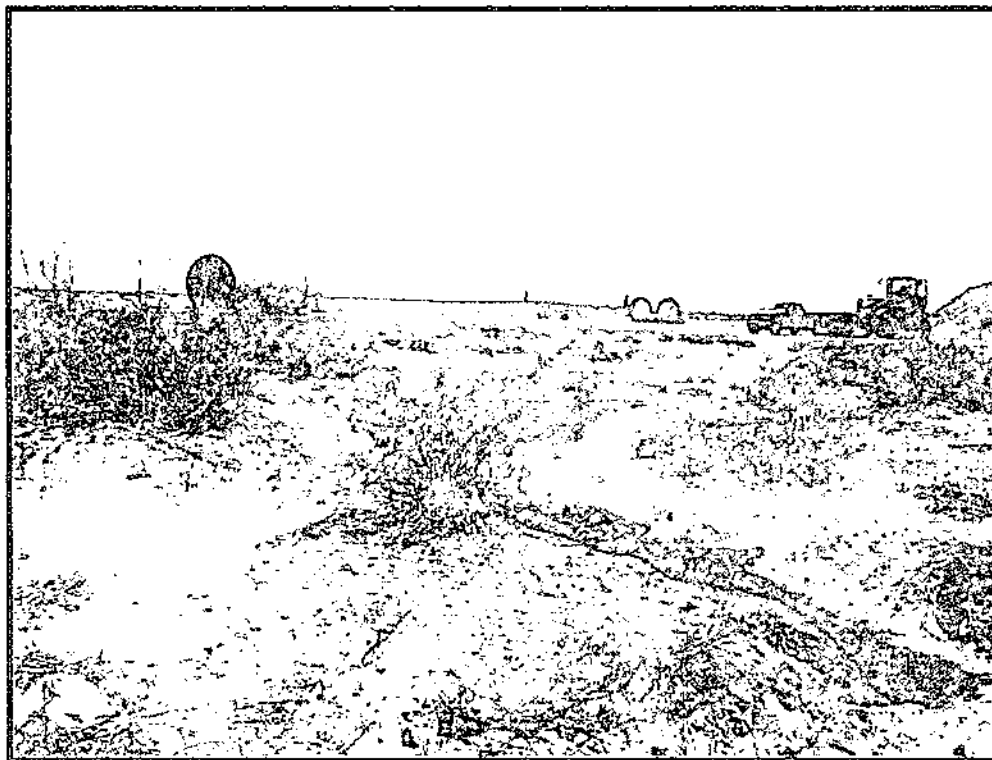
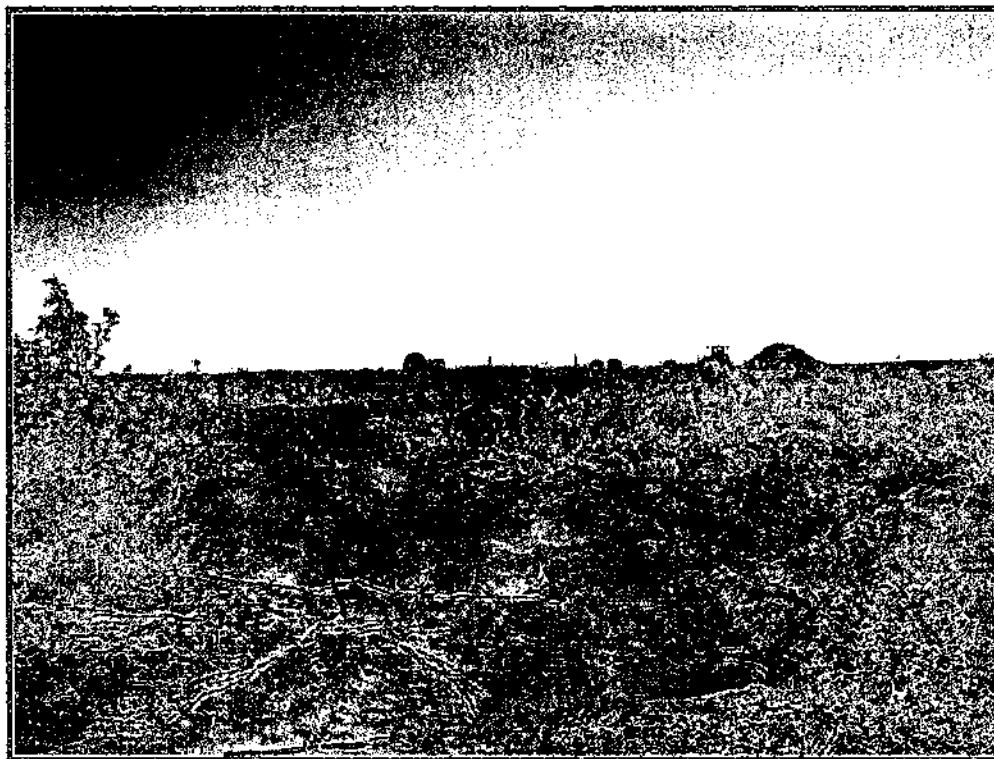
Excavated area facing east

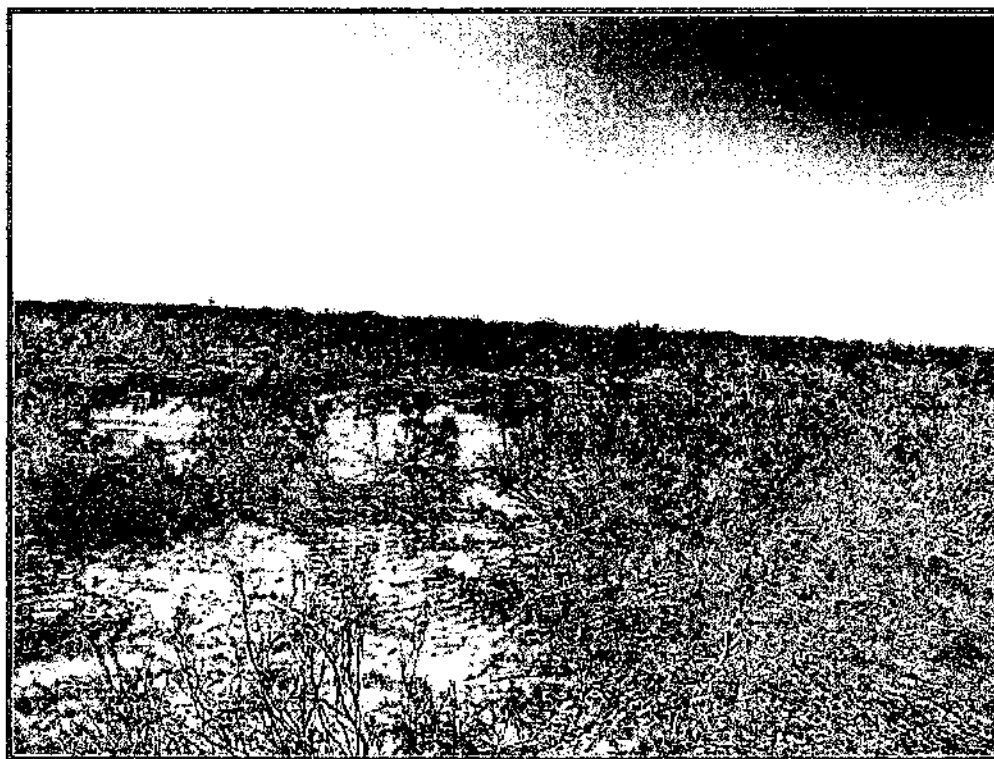
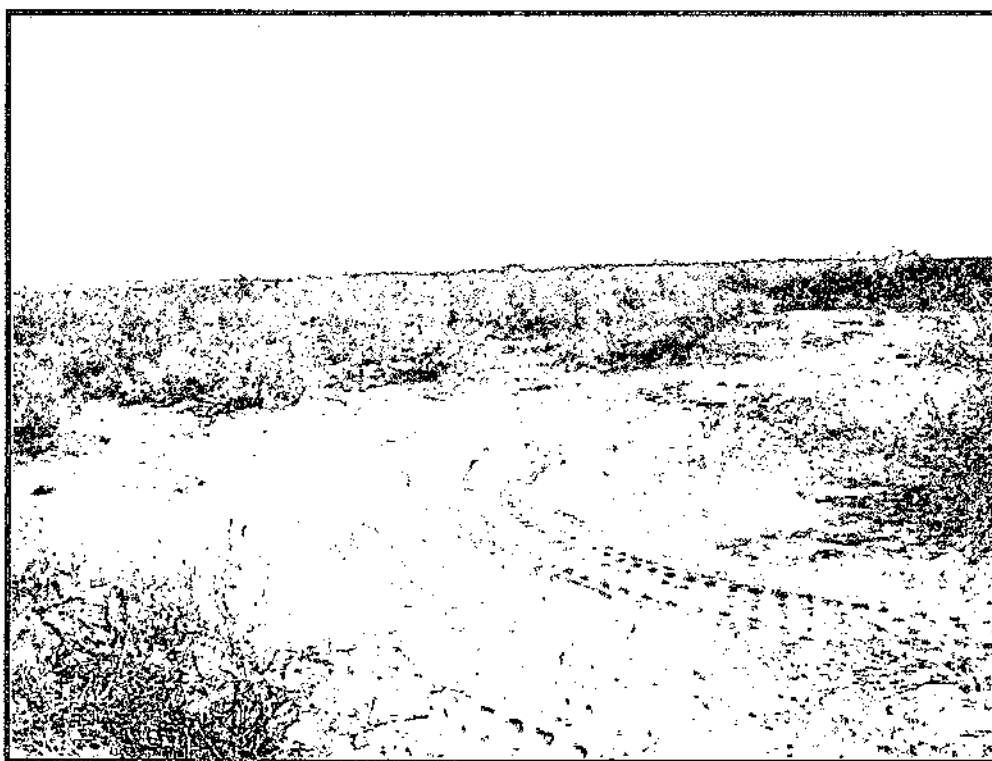
Excavated area facing south

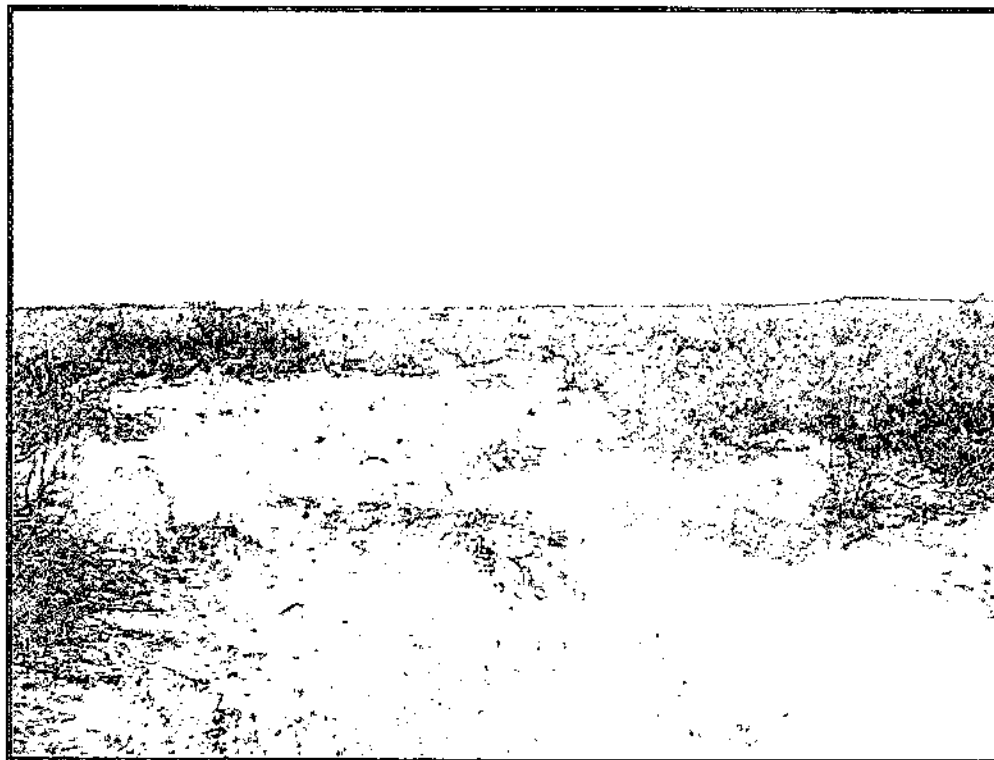
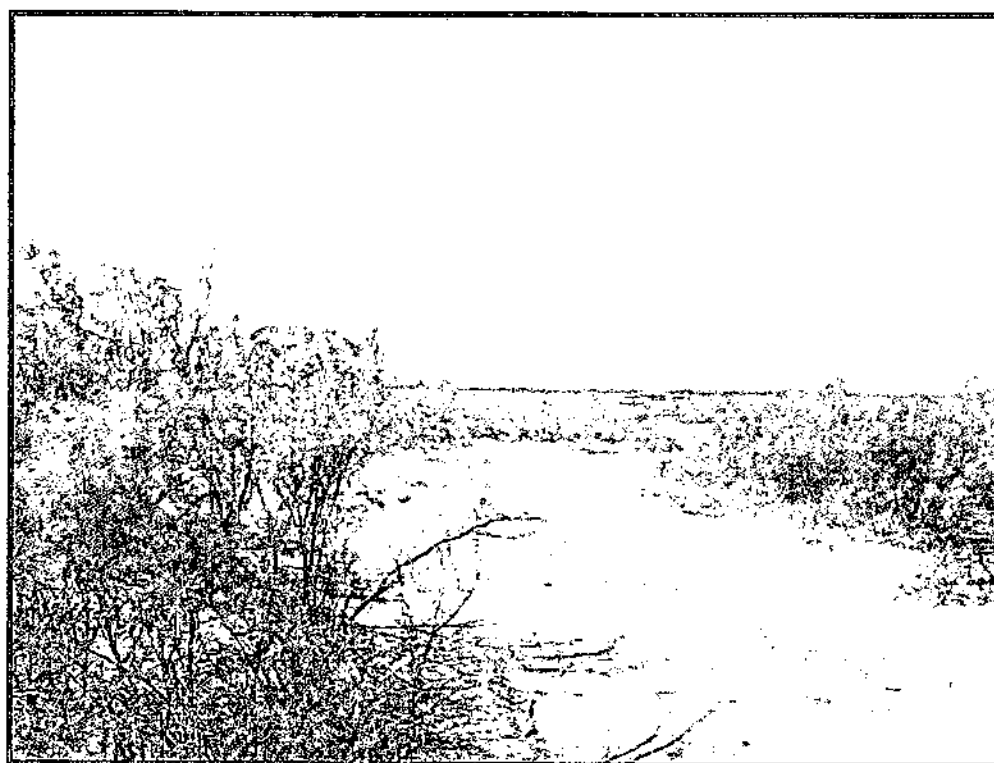
Excavated area facing southwest

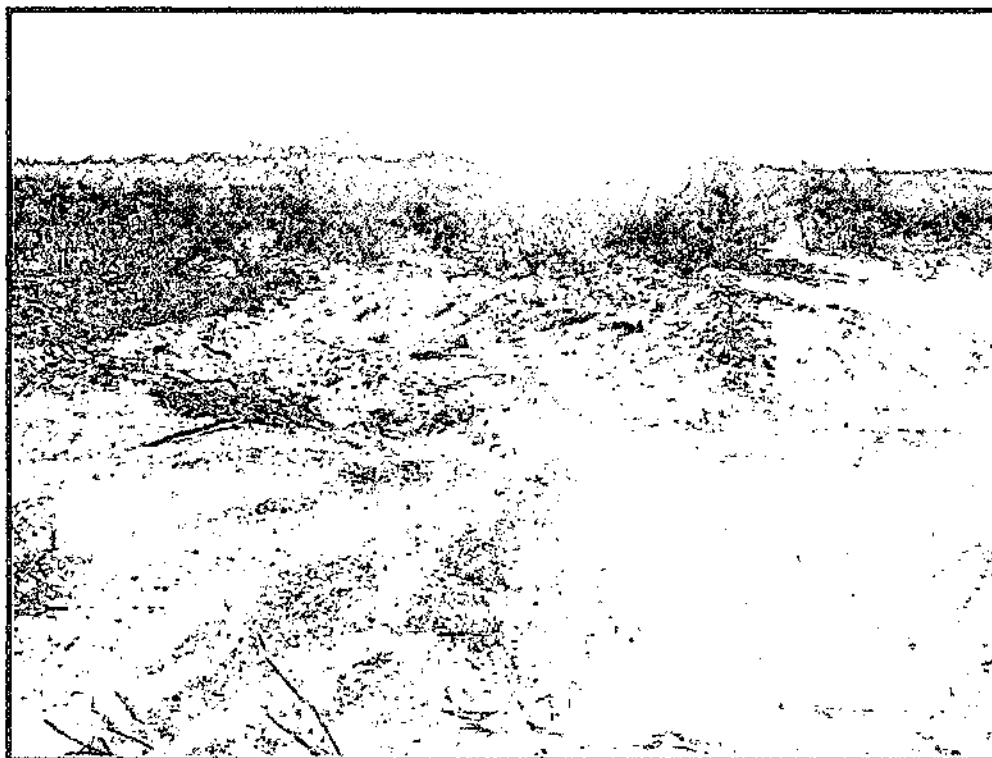
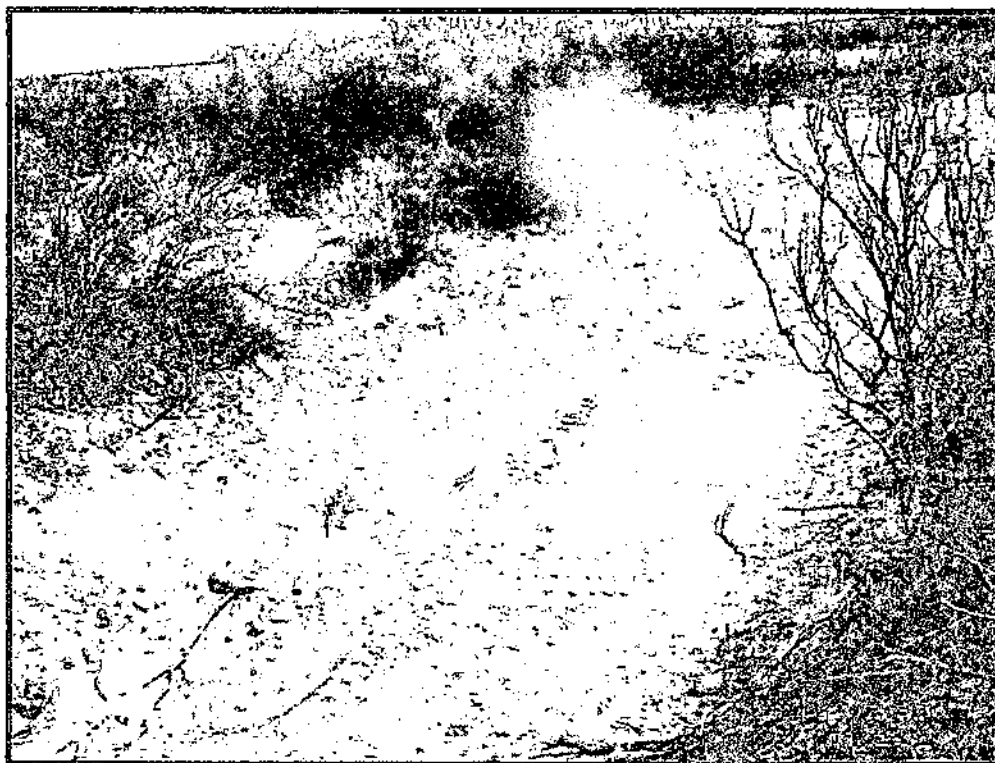
Excavated area facing west

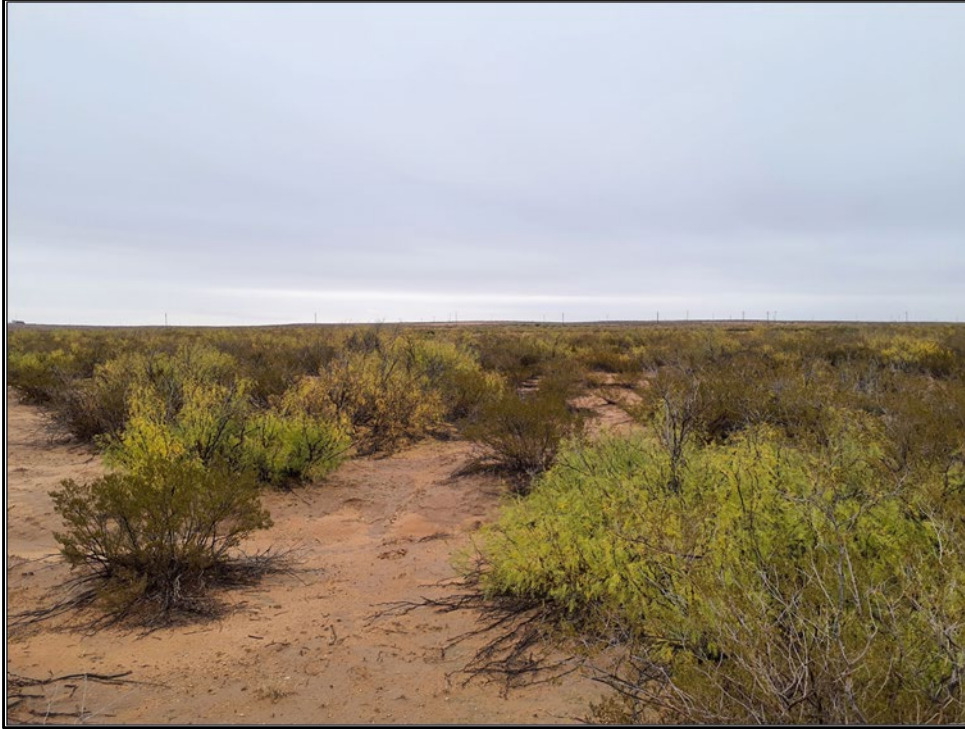
Figure 3. Overview from southern survey boundary showing undisturbed landscape, facing northeast (Frame -6434).

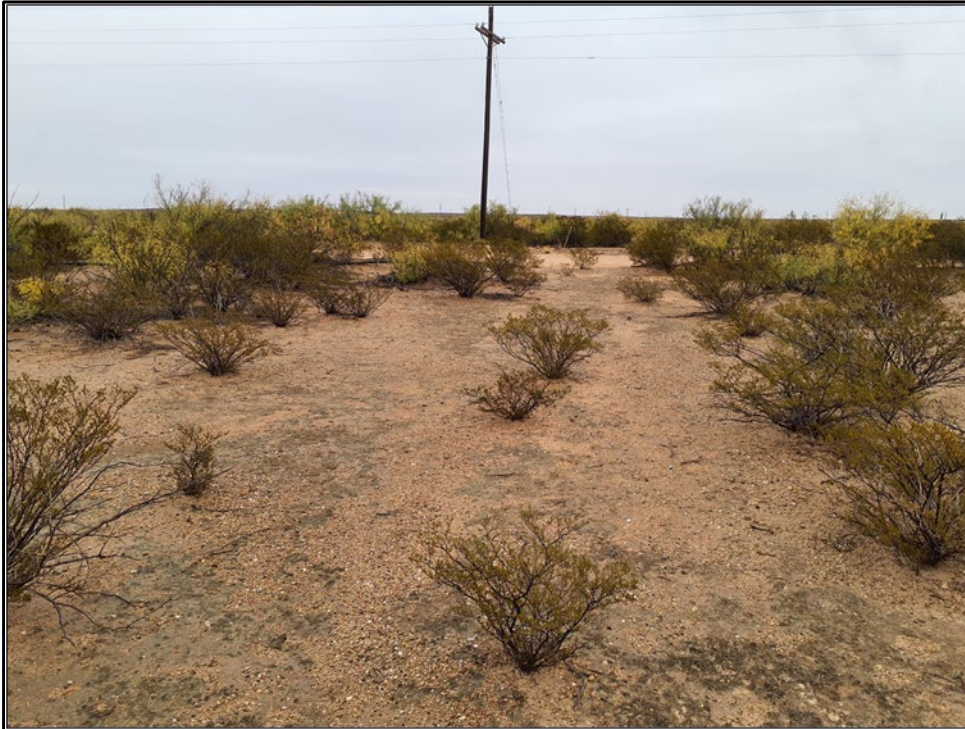
Figure 4. Overview of the eastern-most extent of release disturbance in the direction showing access road with transmission line, facing northeast (Frame -7802).

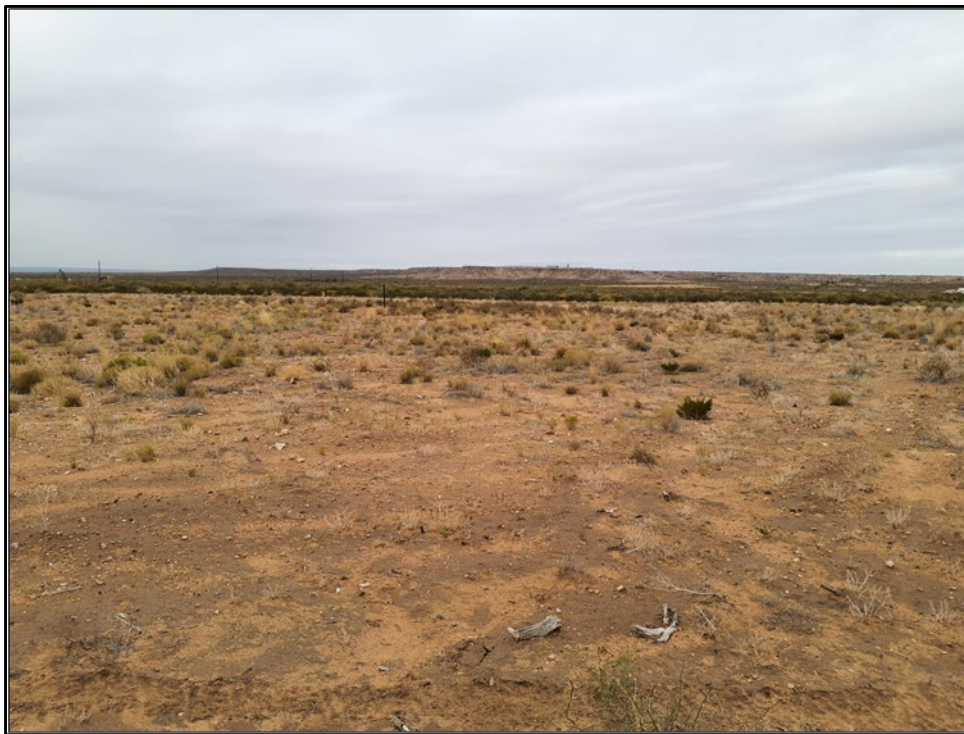
Figure 5. Overview of reclaimed well pad from eastern extent of survey area, facing west (Frame -3546).

Condition of Survey Area: The survey area has been previously disturbed by oil and gas activities including a lease road along the western portion of the project area, a reclaimed well pad in the northeast portion of the project area where the inadvertent release is located, a transmission line,
