**Re: Updated Site Summary Report and Closure Request**

Hare 16  
San Juan County, New Mexico  
Hilcorp Energy Company  
NMOCD Incident No: nAPP2335018887

Updated Site Summary Report and Closure Request  
Hare 16  
Hilcorp Energy Company

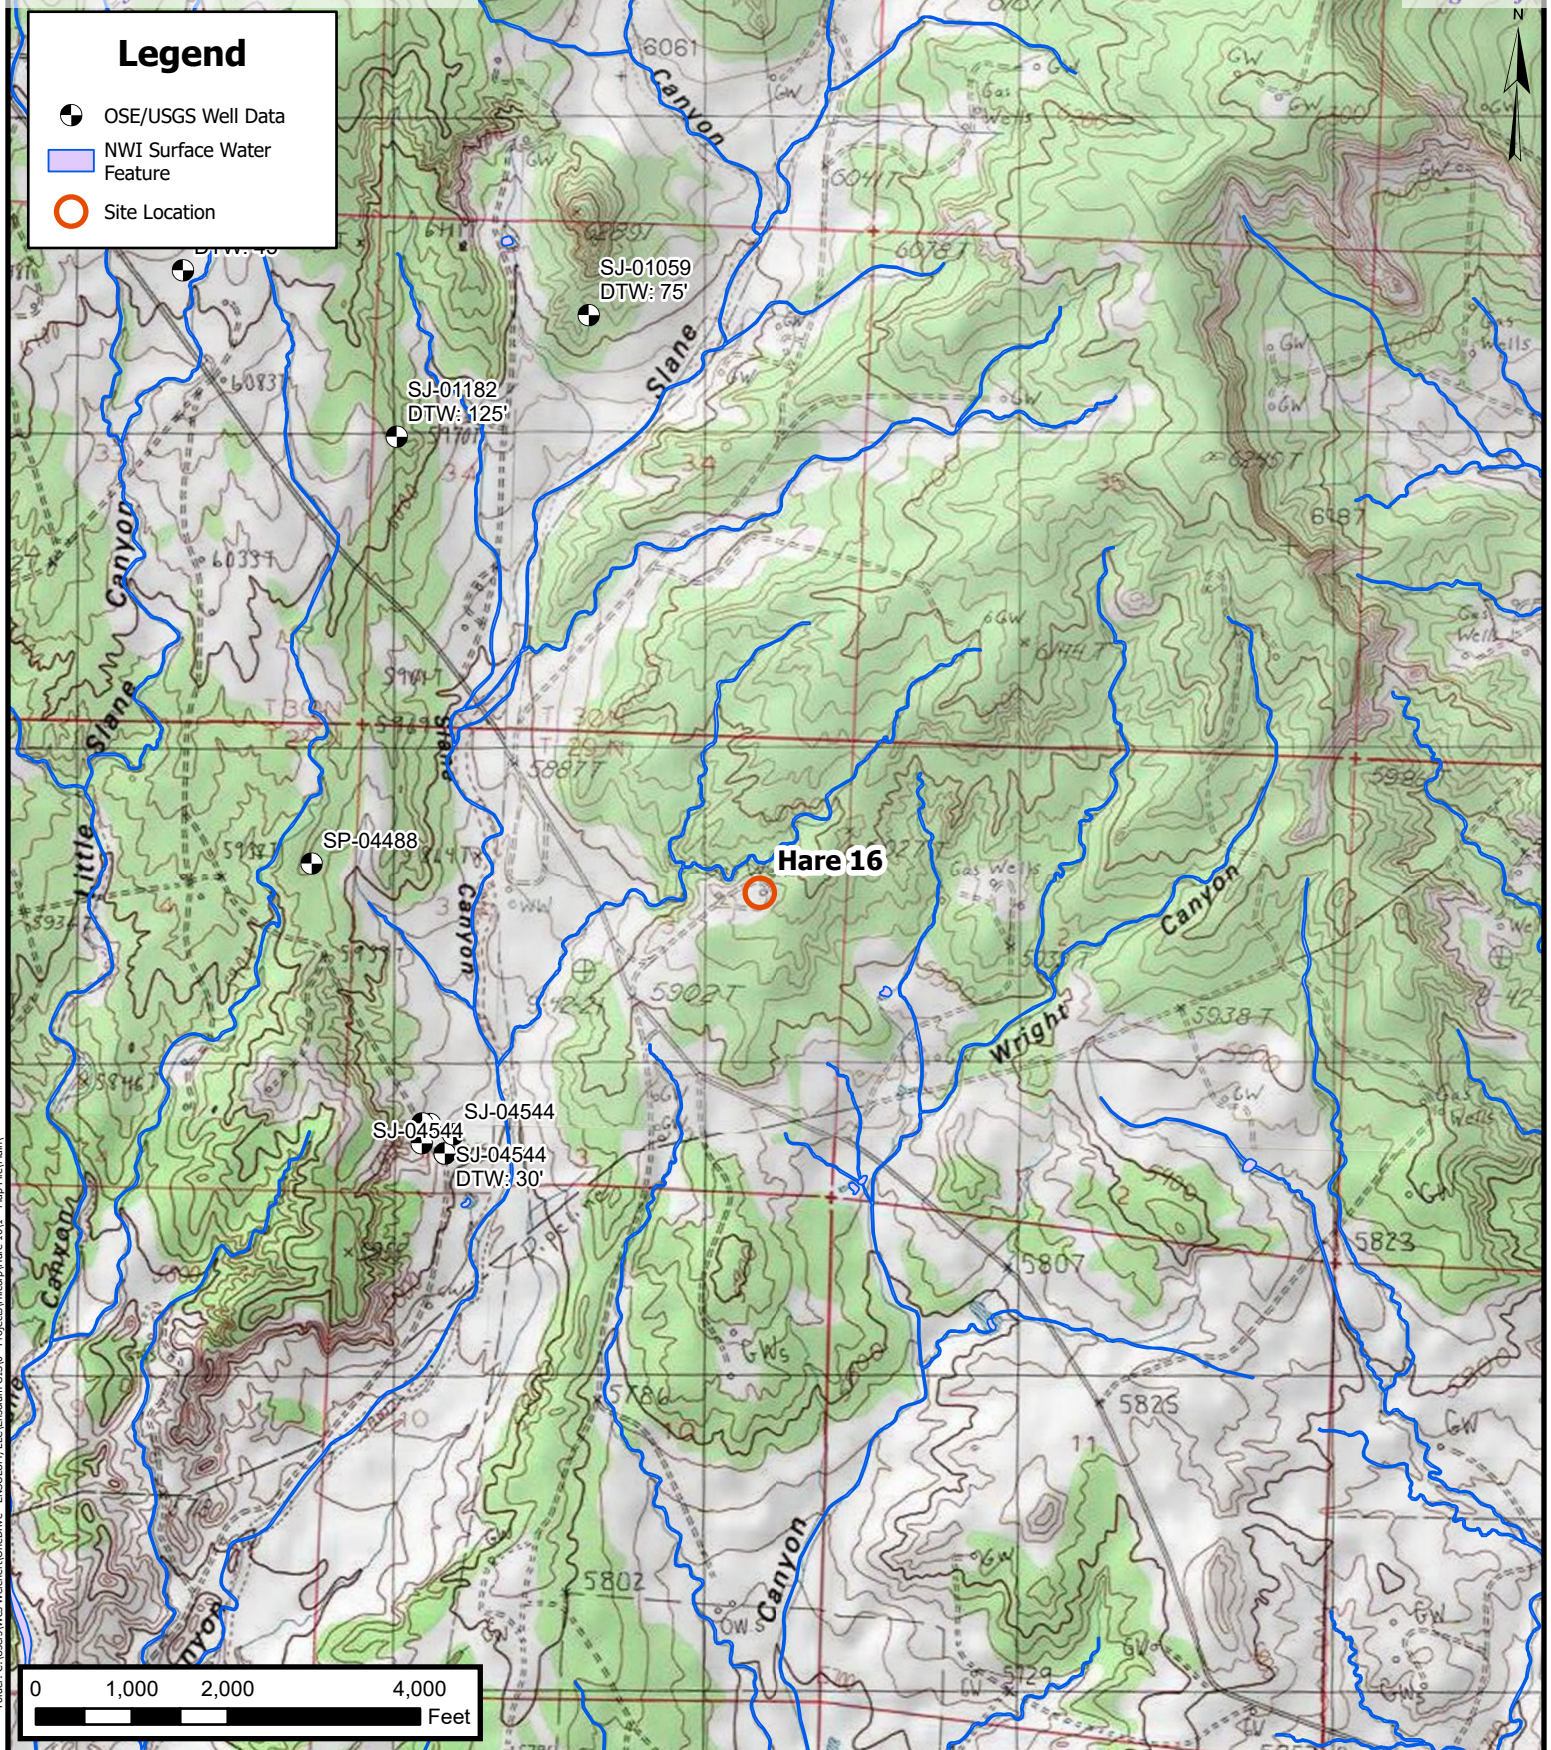
**1**

The closest significant watercourse is an intermittent stream located 370 feet north of the Site. The Site is greater than 200 feet from any lakebed, sinkhole, or playa lake, and is greater than 300 feet from a wetland (Figure 1). The nearest fresh-water well is New Mexico Office of the State Engineer (NMOSE) permitted well SJ-04544 (Appendix A), located approximately 4,130 feet southwest of the Site. The recorded depth to water on the NMOSE database is 30 feet bgs. Well SJ-04544 is located at an elevation of approximately 5,832 feet above mean sea level (AMSL), which is approximately 125 feet lower in elevation than the Site. As such, depth to groundwater beneath the Site is likely greater than 100 feet bgs. No wellhead protection areas, springs, or domestic/stock wells are located within a ½-mile radius from the Site. The Site is not within a 100-year floodplain, overlying a subsurface mine, or located within an area underlain by unstable geology (area designated as low potential karst by the BLM). Schools, hospitals, institutions, churches, and/or other occupied permanent residence or structures are not located within 300 feet of the Site.

## Soil Sample Location Map

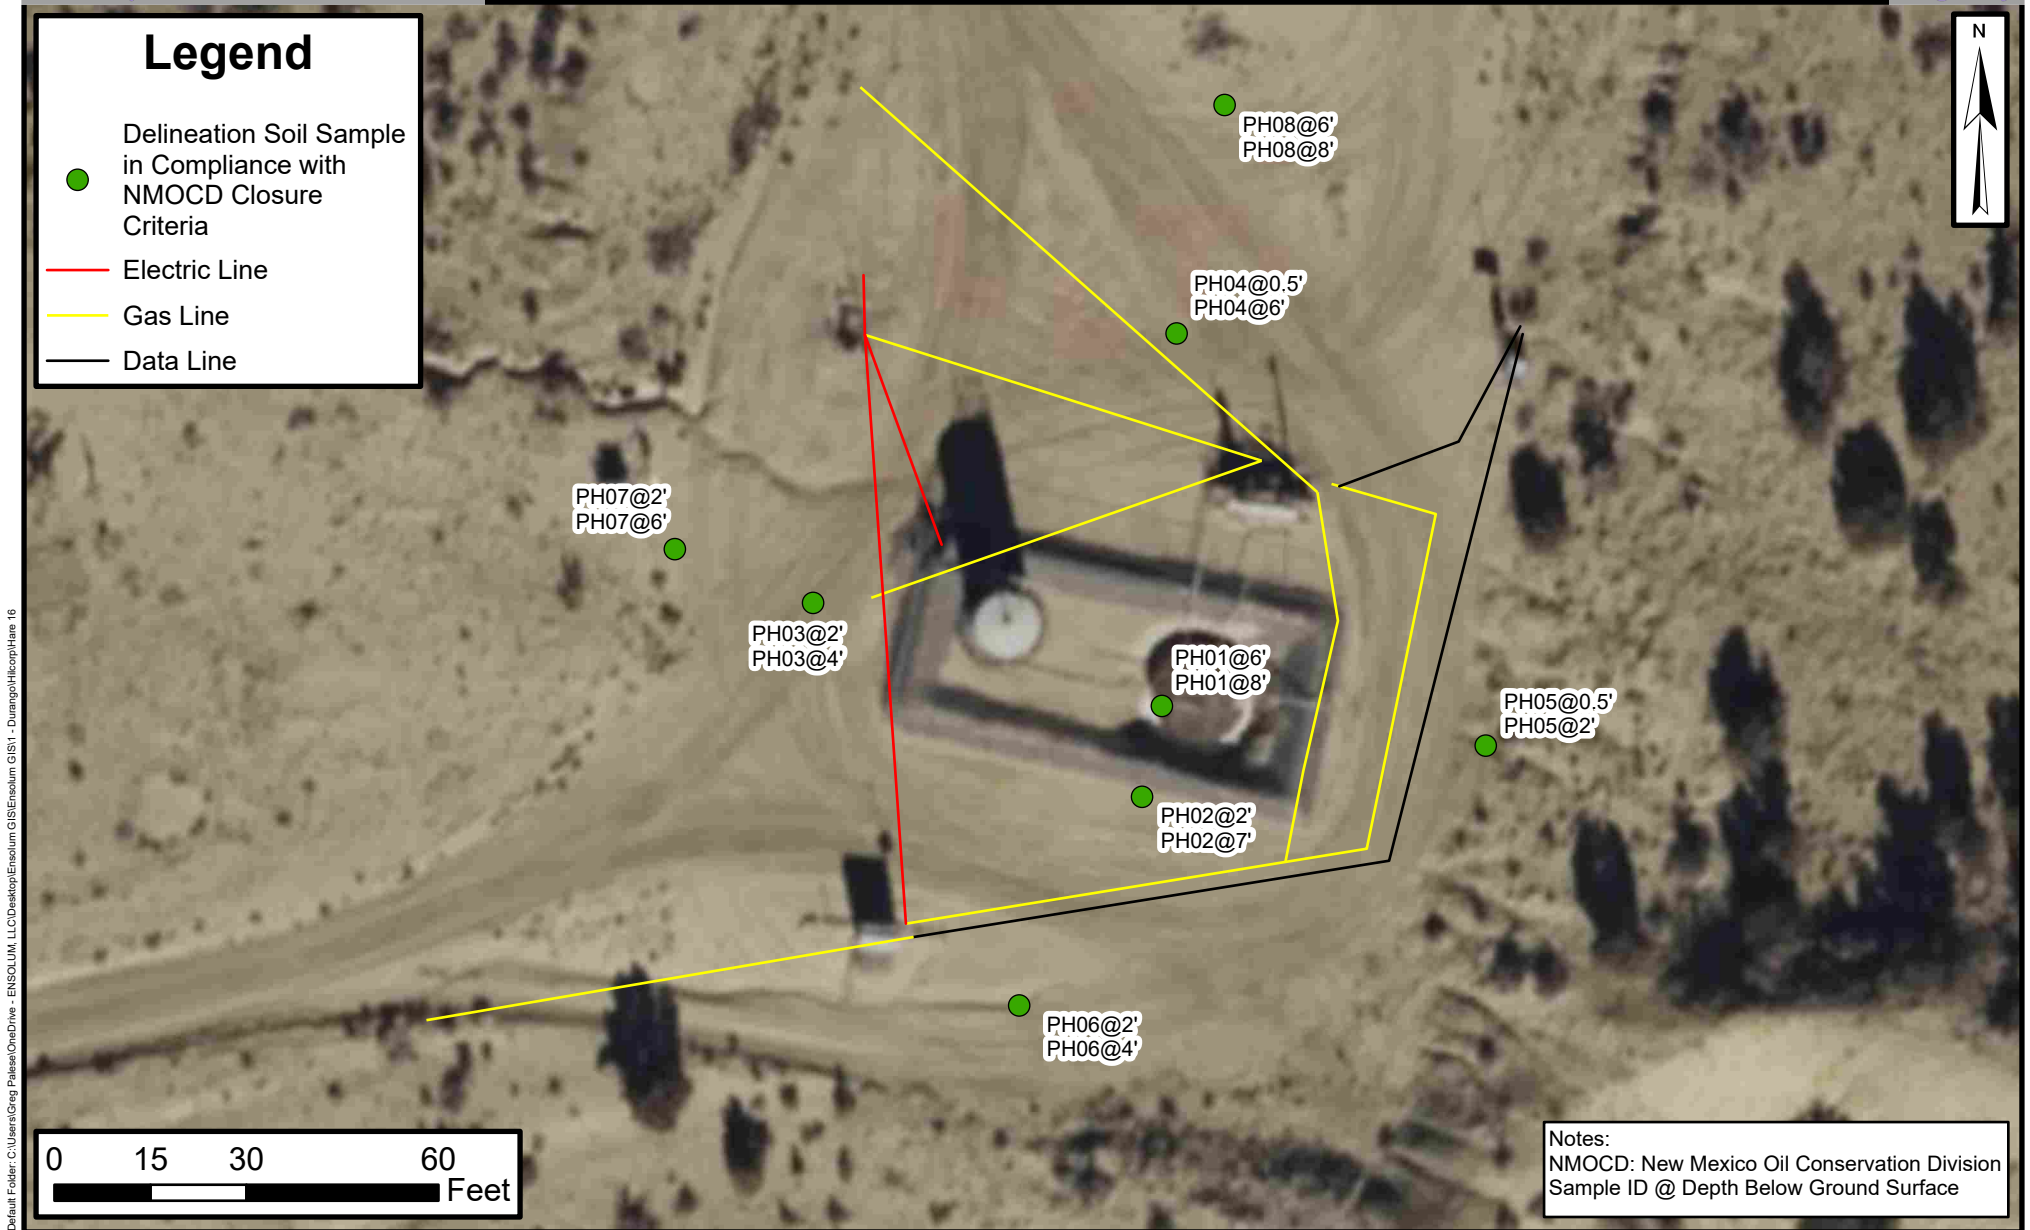
FIGURE  
2

Hilcorp and Ensolum advanced eight potholes (PH01 through PH08) using a backhoe on February 8, 2024 to assess potential soil impacts resulting from the release. The NMOCDC was notified at least two business days prior to commencing on-Site activities (Appendix B). Potholes were advanced to depths between 2 feet and 8 feet bgs and were all advanced until the backhoe met refusal on formation sandstone. Pothole PH01 was advanced immediately adjacent to the BGT (source of the release) in order to assess soils with the greatest potential impacts resulting from the release. Potholes PH02 through PH08 were advanced to delineate the lateral and vertical extents of potential impacts based on the observations encountered in PH01. Soil samples were collected from each pothole and field screened at the ground surface and at 2-foot intervals for the presence of organic vapors using a calibrated photoionization detector (PID) and chloride using Hach® QuanTab® test strips. PID and chloride field screening results are included in Table 1.

Based on the laboratory analytical results collected during the February 2024 delineation, all COC concentrations were in compliance with the NMOCD Closure Criteria. Soil sample analytical results are summarized in Table 1 and depicted on Figure 2, with complete laboratory analytical reports attached as Appendix D.

## Delineation Soil Sample Locations

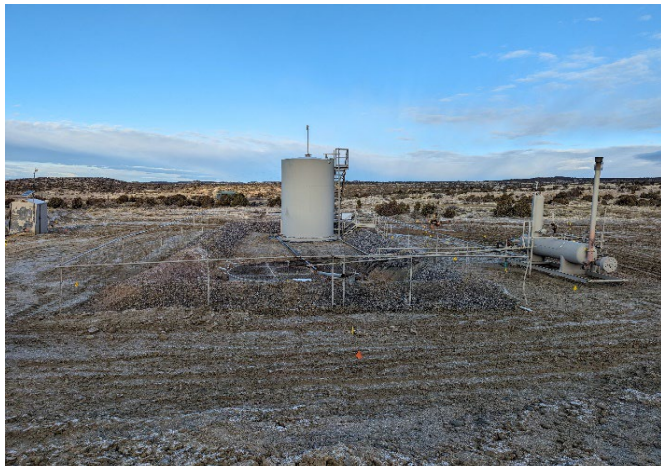
Photograph: 1                      Date: 2/8/2024  
Description: Hare 16 Well Pad  
View: West

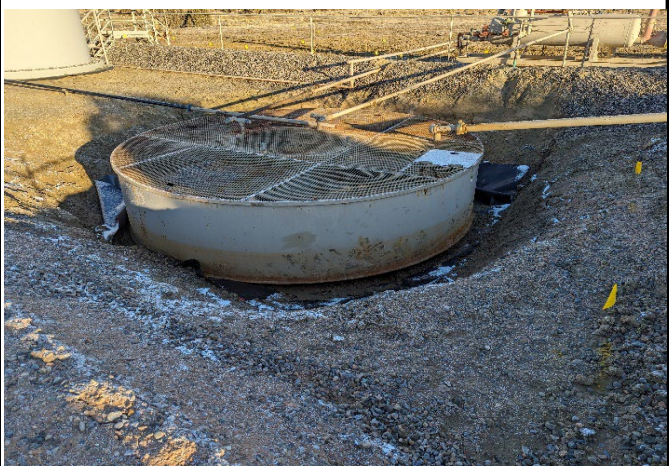
In general, Site lithology consisted of unconsolidated sand with clay and clay from the ground surface to depths up to 4 feet bgs. The sand was underlain in all potholes by sandstone and potholes were advanced until refusal was met at depths of 2 feet to 8 feet bgs. As indicated in the photographs taken during field activities (attached as Appendix C), blue/gray-stained soil and bedrock were observed in potholes PH01, PH02, PH03, PH04, PH06, and PH07 at varying depths. Soil can turn blue-gray in color due to anaerobic or reducing subsurface conditions in the soil. These anaerobic or reducing environments can often occur through microbial degradation of organic matter and the depletion of available oxygen. Additionally, elevated PID readings were measured in these potholes and correlated with the blue-stained soil.

Photograph: 2                      Date: 2/8/2024  
Description: Soil staining under BGT  
View: West

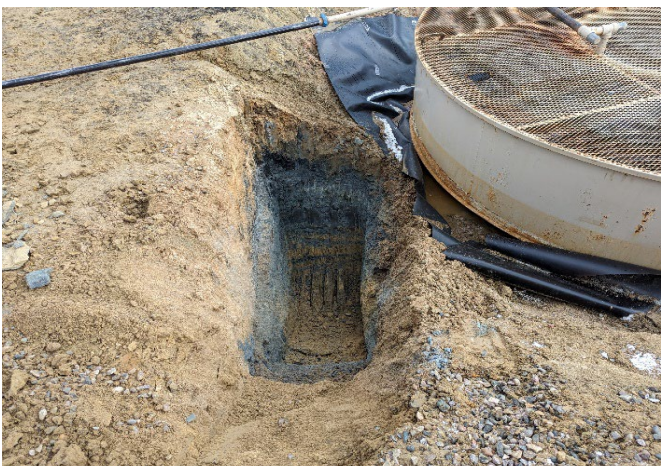
Photograph: 3                      Date: 2/8/2024  
Description: Pothole PH01 next to BGT  
View: North

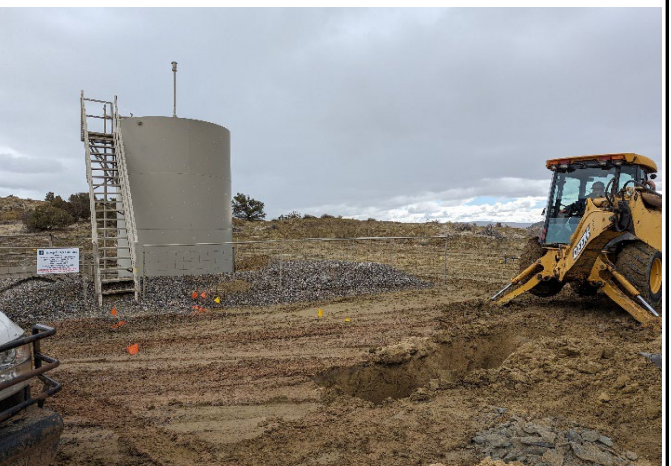
Photograph: 4                      Date: 2/8/2024  
Description: Backfilling activities  
View: West
