Devon Energy Production Company, LP  
6488 Seven Rivers Hwy  
Artesia, NM 88210  
575-748-0167

June 5, 2024

**Re: Remediation Closure Report**  
**Cotton Draw Unit 153 CTB Facility ID fAPP2128034967**  
**GPS: Latitude 32.166344 Longitude -103.763914**  
**ULSTR – B – 3 – 25S – 31E 149 FNL 564 FWL Eddy County, NM**  
**NMOCD Incident ID nAPP2316355602**

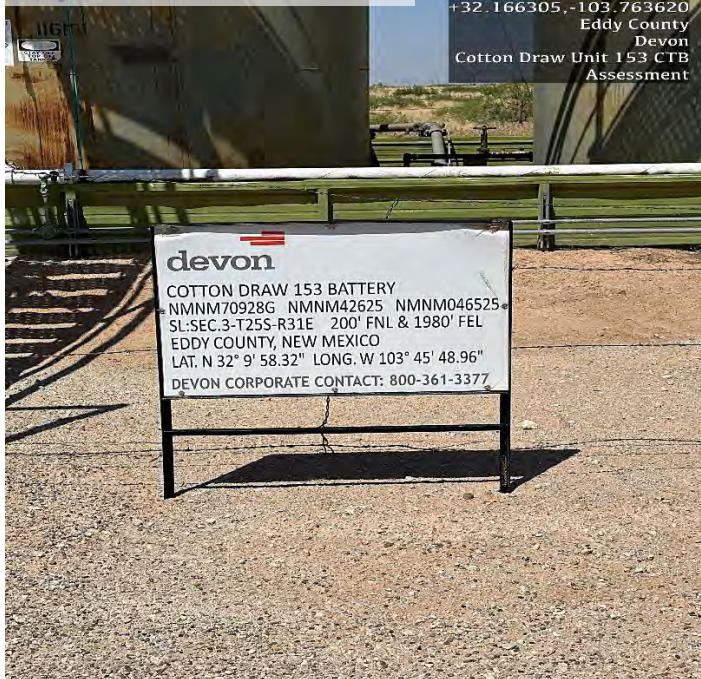
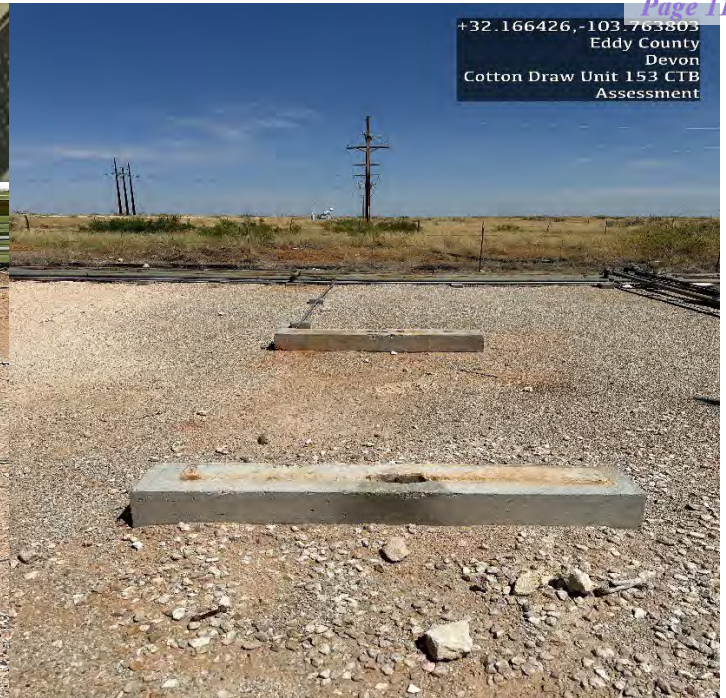
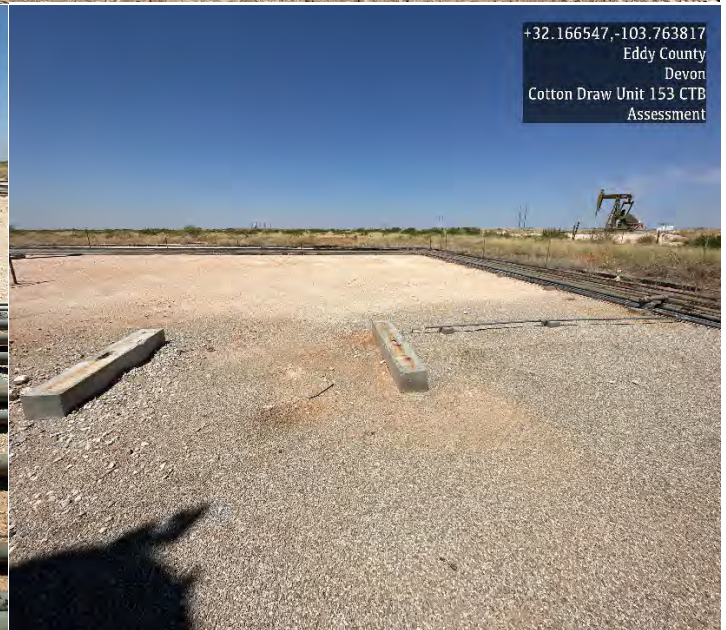
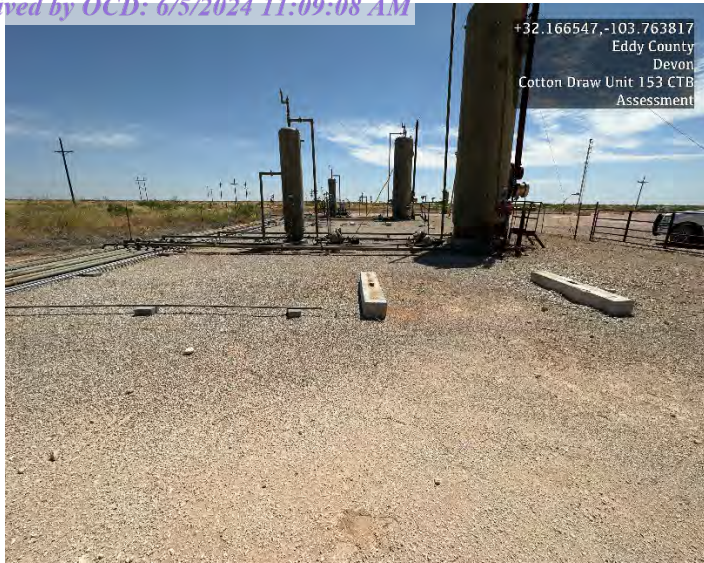
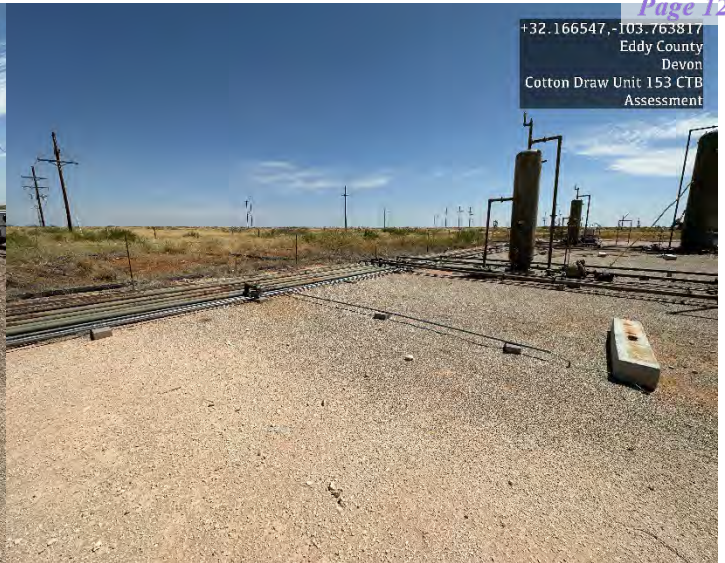
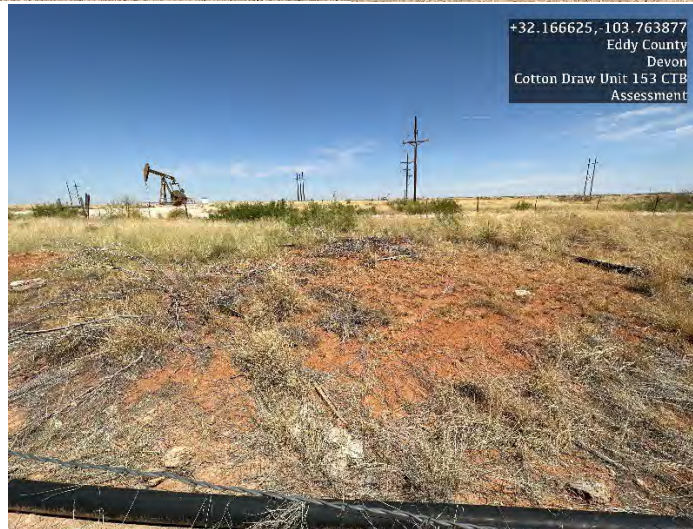
### Photographic Documentation

On May 21, 2024, Pima personnel mobilized personnel to the site to assess the area and collect surface samples as directed by the denial comments. These were discreet samples collected from S1 and S2, each from the surface and from 1' below grade surface (bgs). Samples were also collected from what were believed to be the horizontal edges of the release in question. These were composite samples consisting of 0-1' samples from each location (SW1 – SW5). A total of 9 samples were put on ice, jarred, and delivered to the lab for official testing. All samples were tested for all constituents. The Lab Sample Results Data Table can be found in Figure 1. A corresponding Site Map can be found in Figure 2.

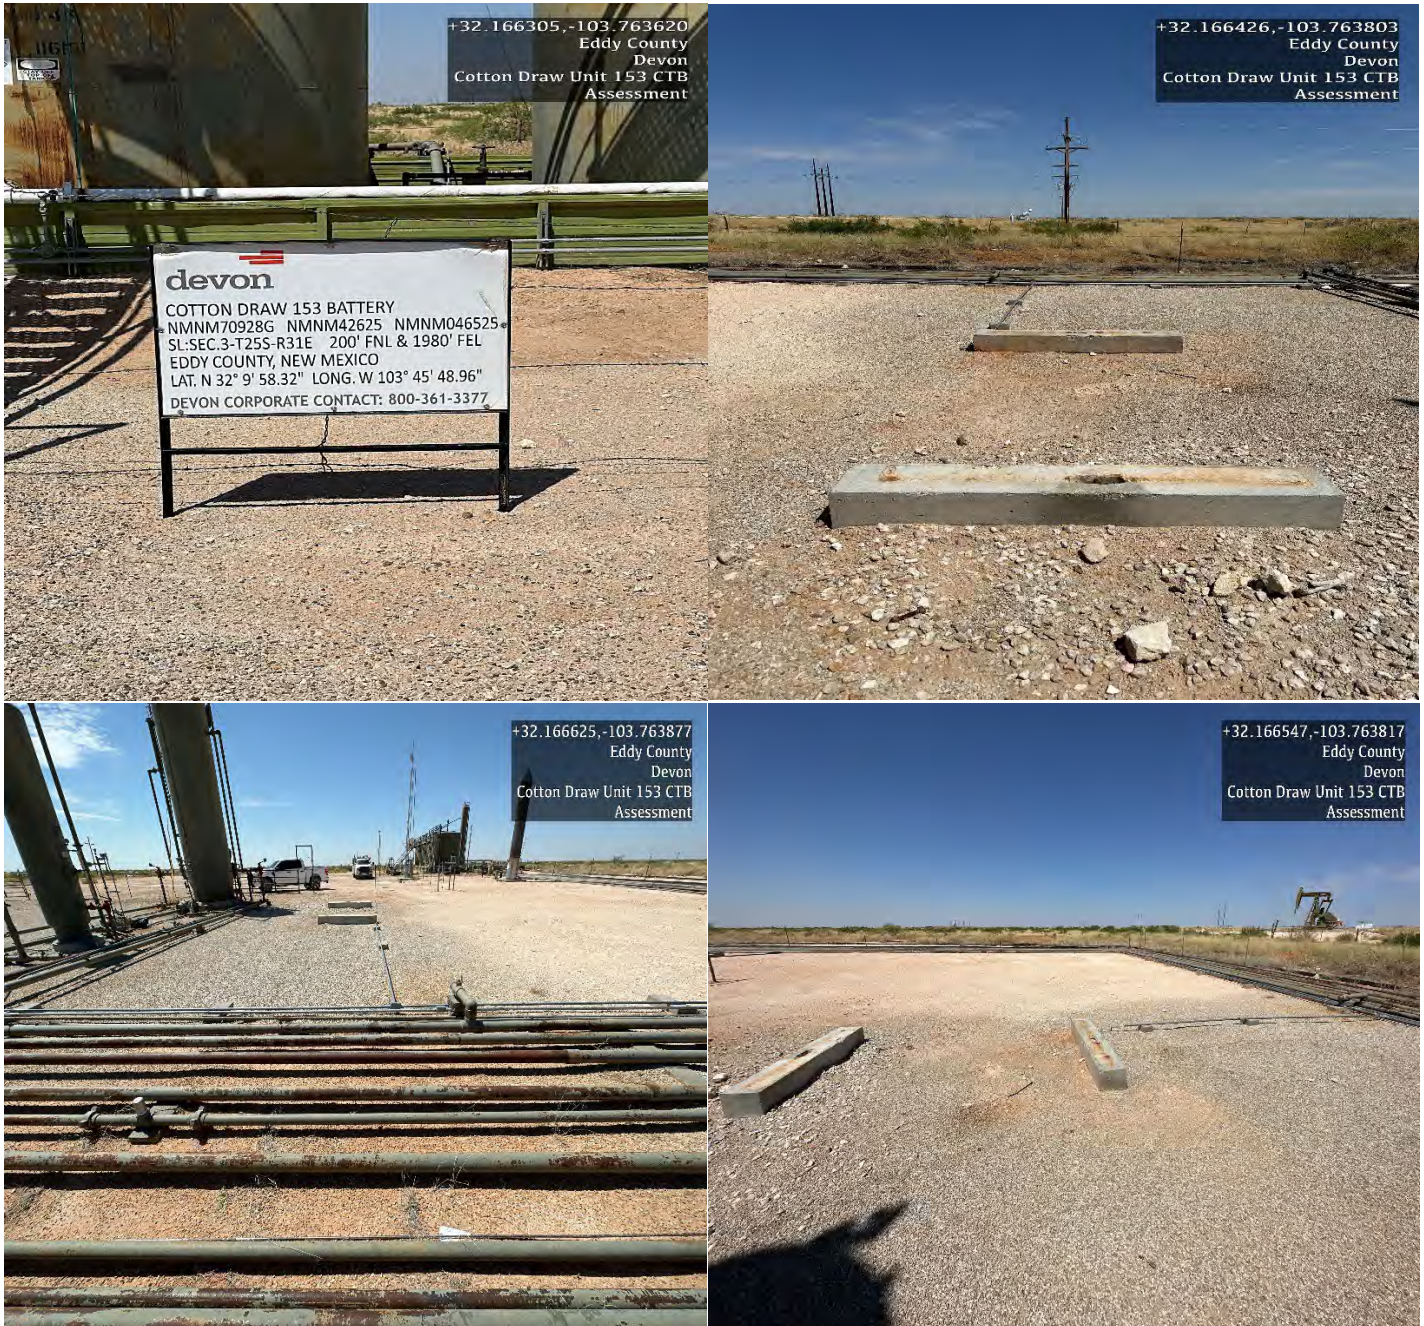
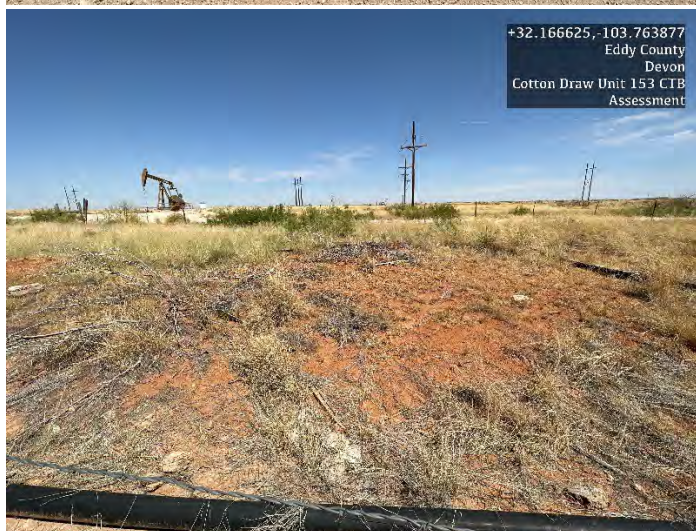
**Site Assessment**

On August 13, 2023, Pima mobilized personnel to the site to begin collecting soil samples from the spill area. The laboratory results of this sampling event can be found in the following data table. A Site Map can be found in Figure 4.
