**RE: Liner Inspection and Closure Report**  
**Skelly Unit #973**  
**API No. 30-015-36283**  
**GPS: Latitude 32.8261375 Longitude -103.8740616**  
**UL- F, Section 21, Township 17S, Range 31E**  
**Eddy County, NM**  
**NMOCD Reference No. NAPP2217442660**

Spur Energy Partners (Spur) has contracted Pima Environmental Services, LLC (Pima) to perform a liner inspection and prepare this closure report for the release of produced water that happened at the Skelly Unit #973 Battery (Skelly). On May 28, 2024, the initial C-141 was formally submitted. The corresponding release received the designation Incident ID NAPP2217442660 from the New Mexico Oil Conservation Division (NMOCD).

#### Liner Inspection-

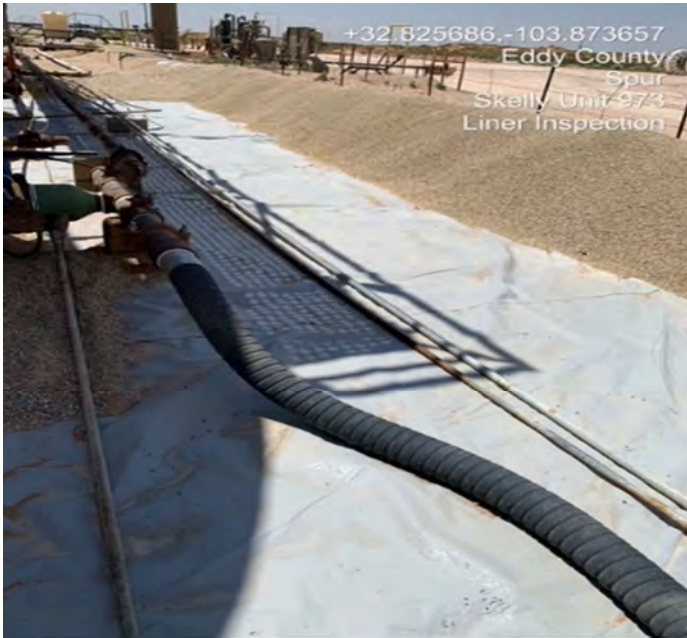
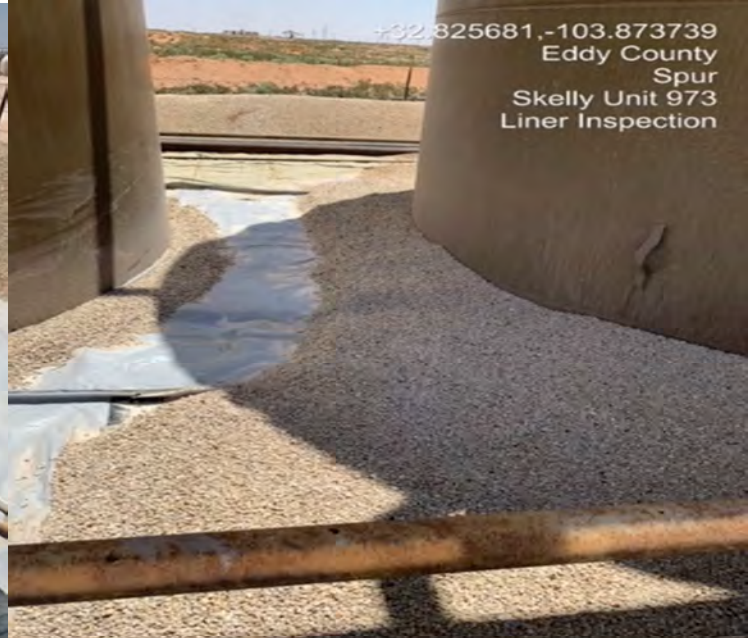
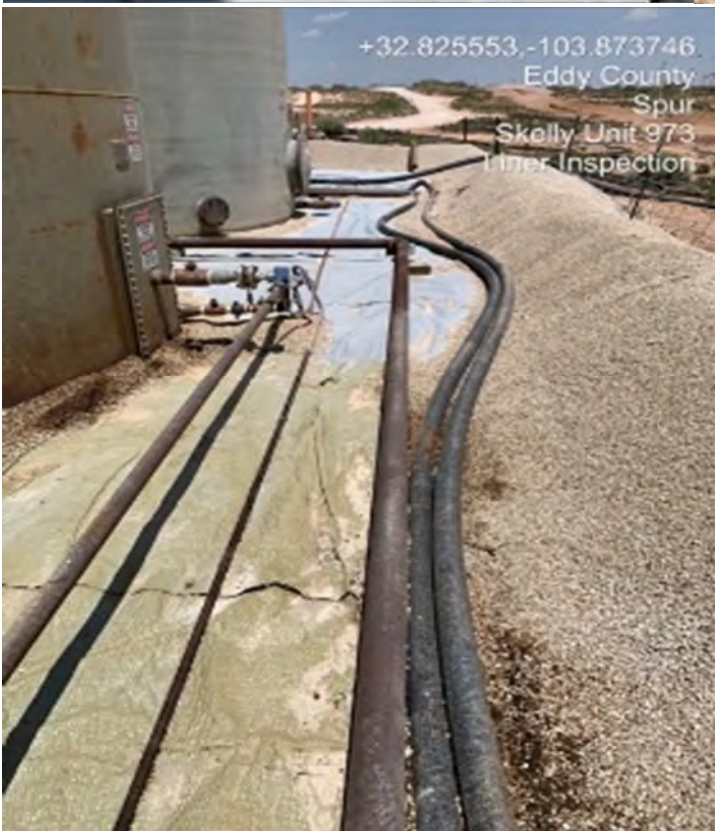
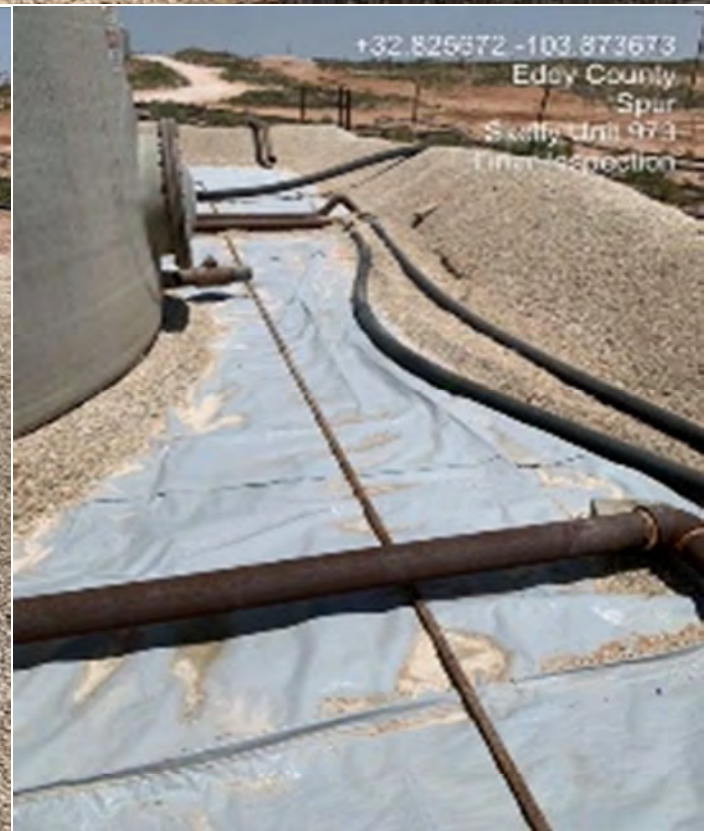
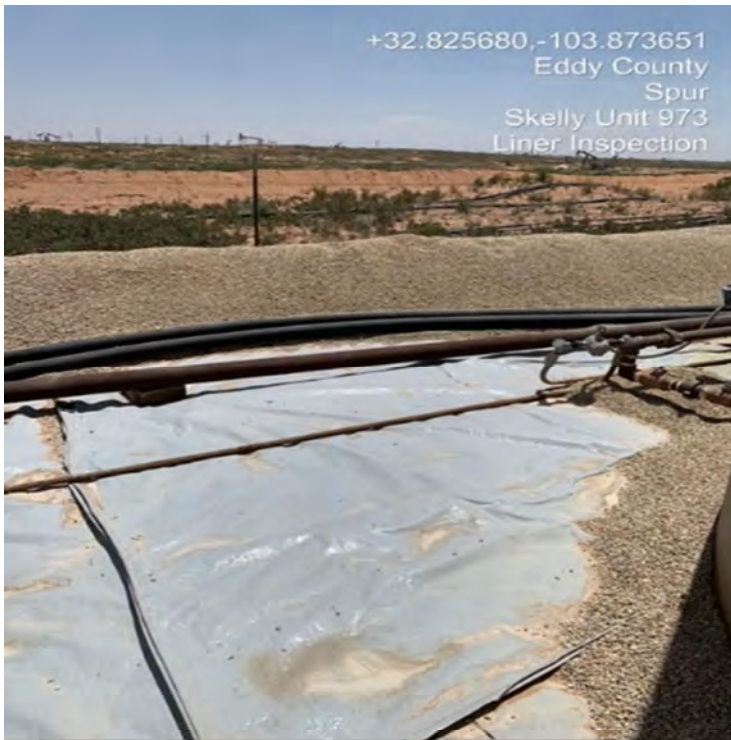
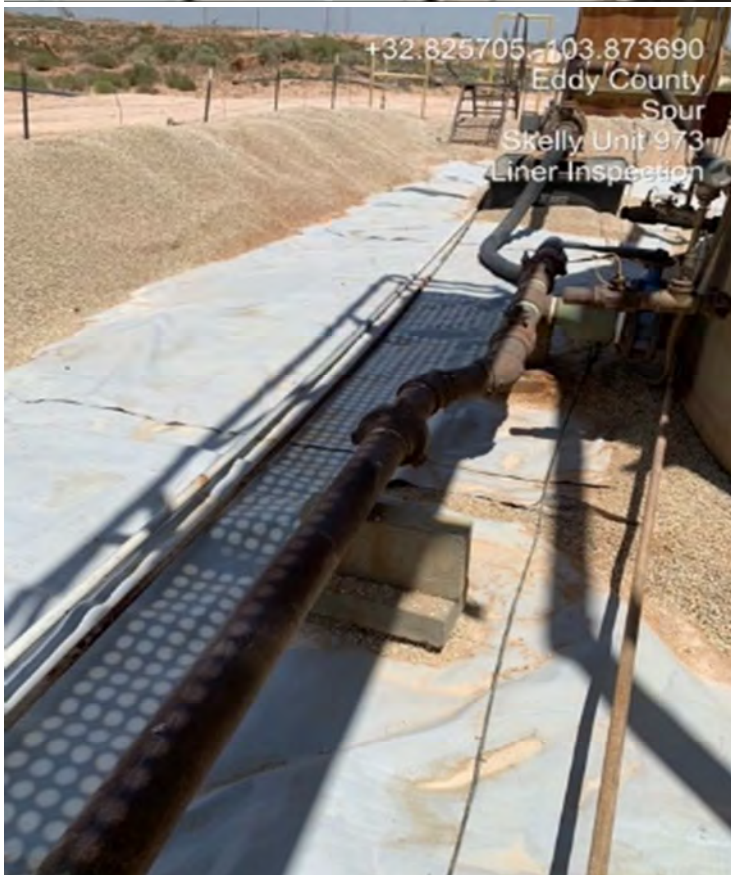
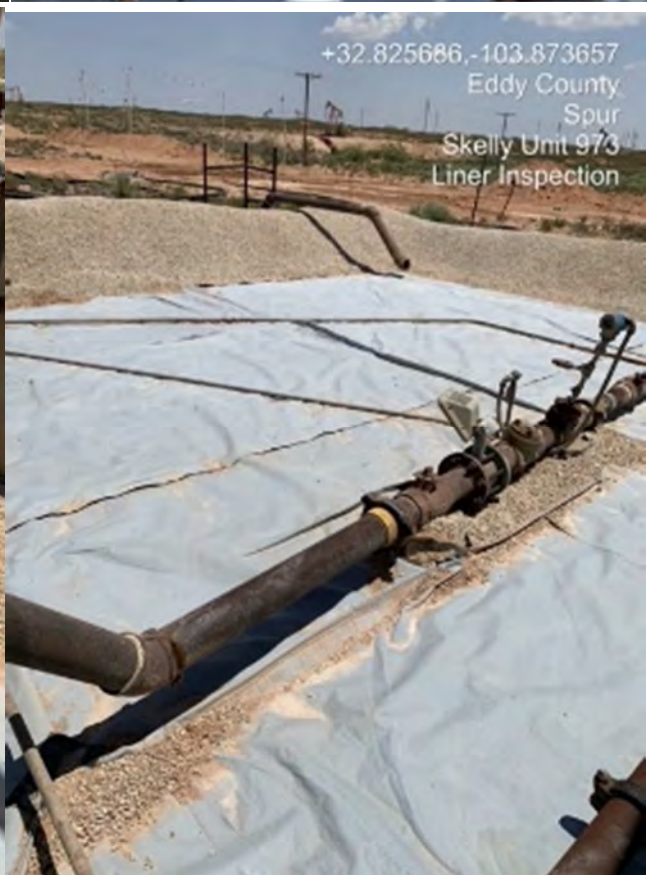
On June 6, 2024, Pima Environmental conducted a liner inspection at the Skelly, covering approximately 1,756 square feet. We concluded that the liner and containment maintained their integrity and successfully retained the fluids. The liner inspection form and photographic documentation are available in Appendix C.

Visualization	Yes	No	Comments
Is there a tear in the liner?		X	
Are there holes in the liner?		X	
Is the liner retaining any fluids?		X	
Does the liner have integrity to contain a leak?	X
