Incident ID	nAPP2317326766
District RP	
Facility ID	
Application ID

Based on laboratory analytical results and field activities conducted to date, Etech recommends Mewbourne Oil Company provide copies of this *Remediation Summary & Soil Closure Request* to the appropriate agencies and request closure be granted to the Black Sheep 4 Battery release site.

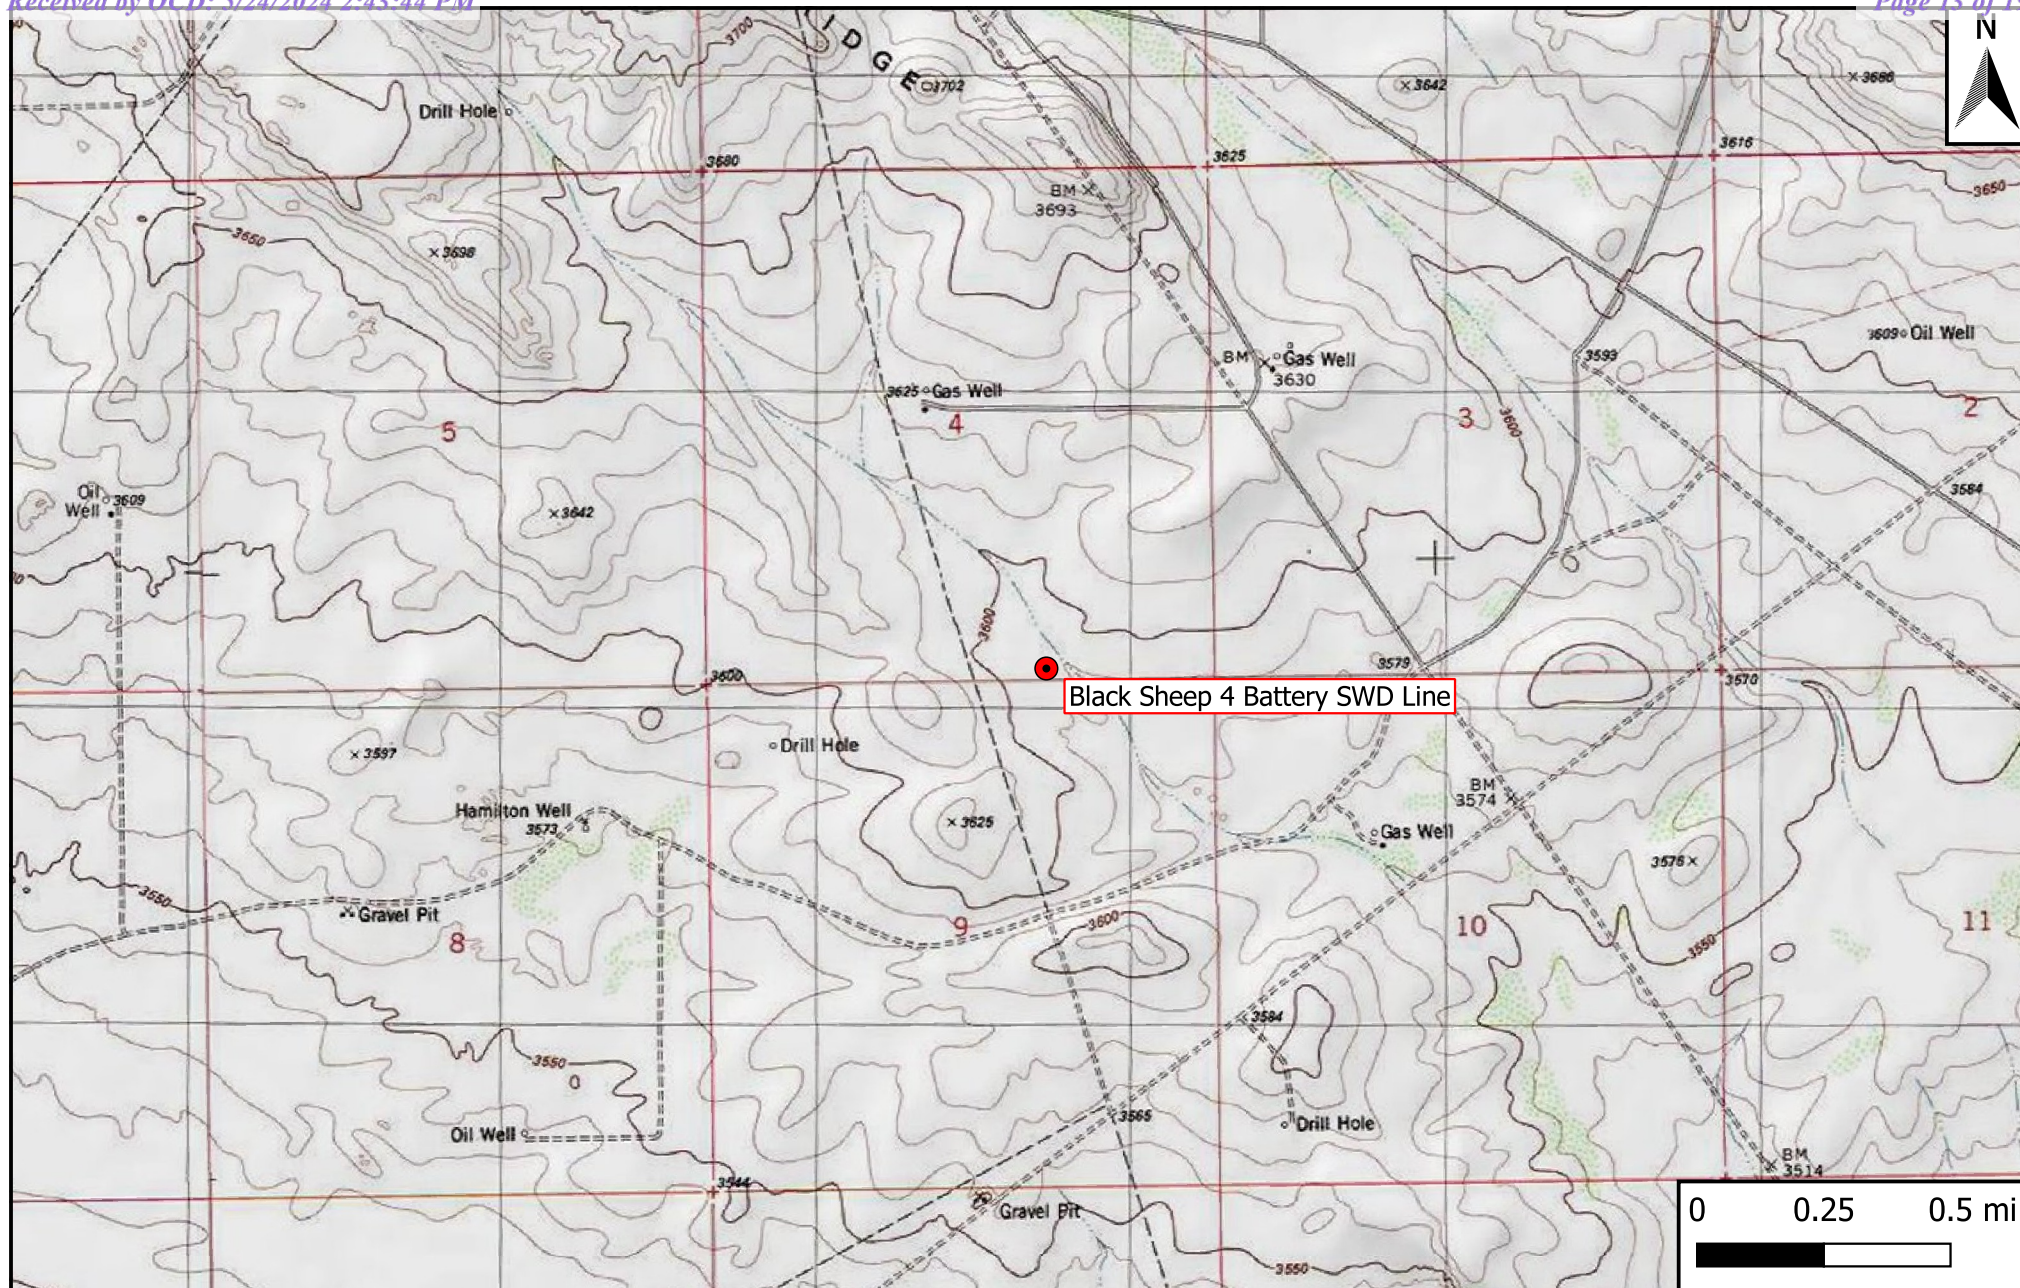
# **Figure 1**

## **Topographic Map**

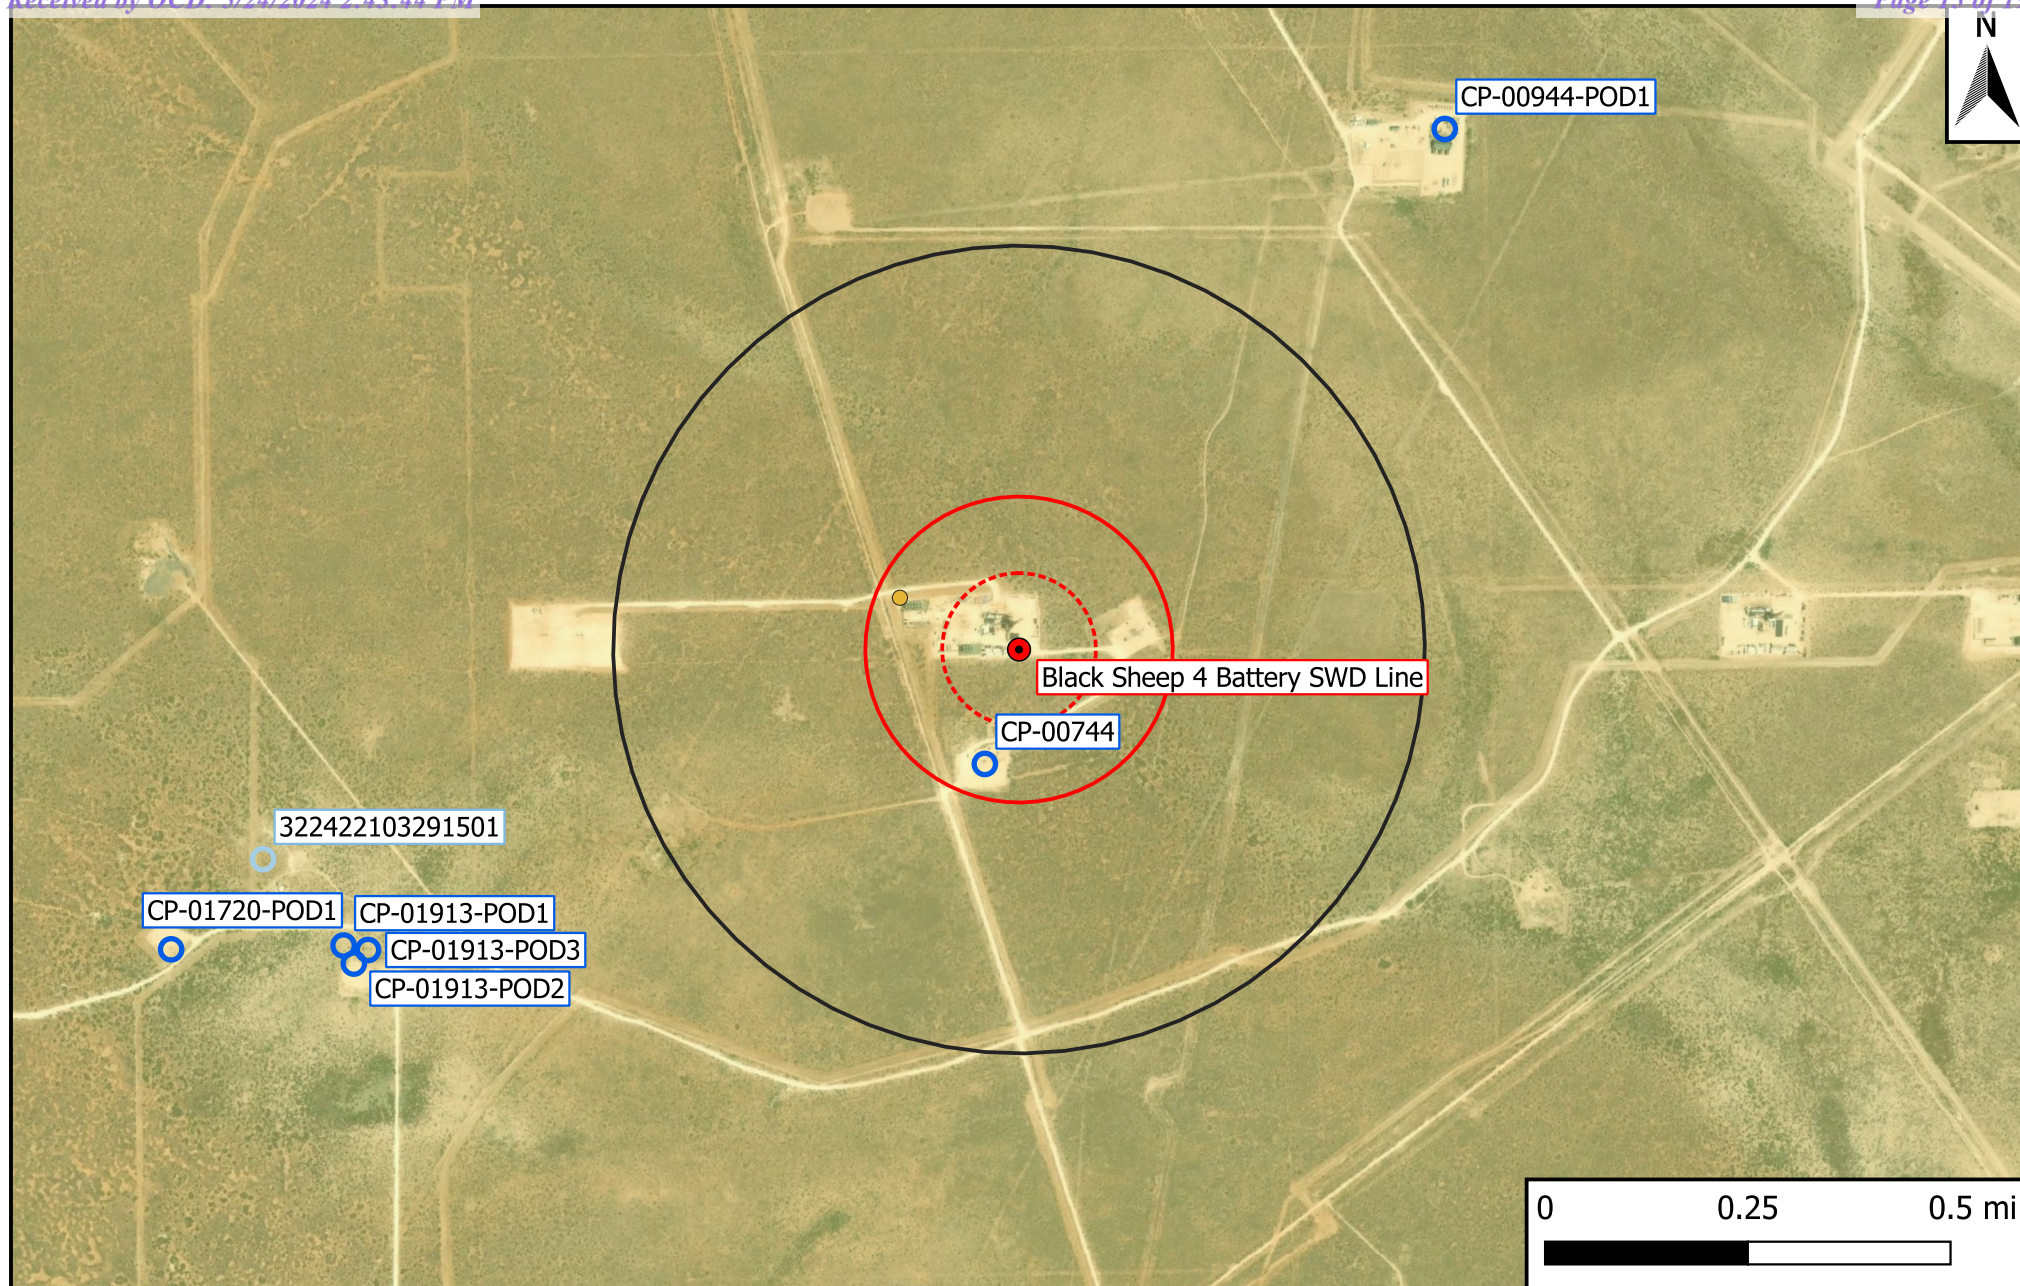
## **Figure 2**

### **Site Characterization Map**

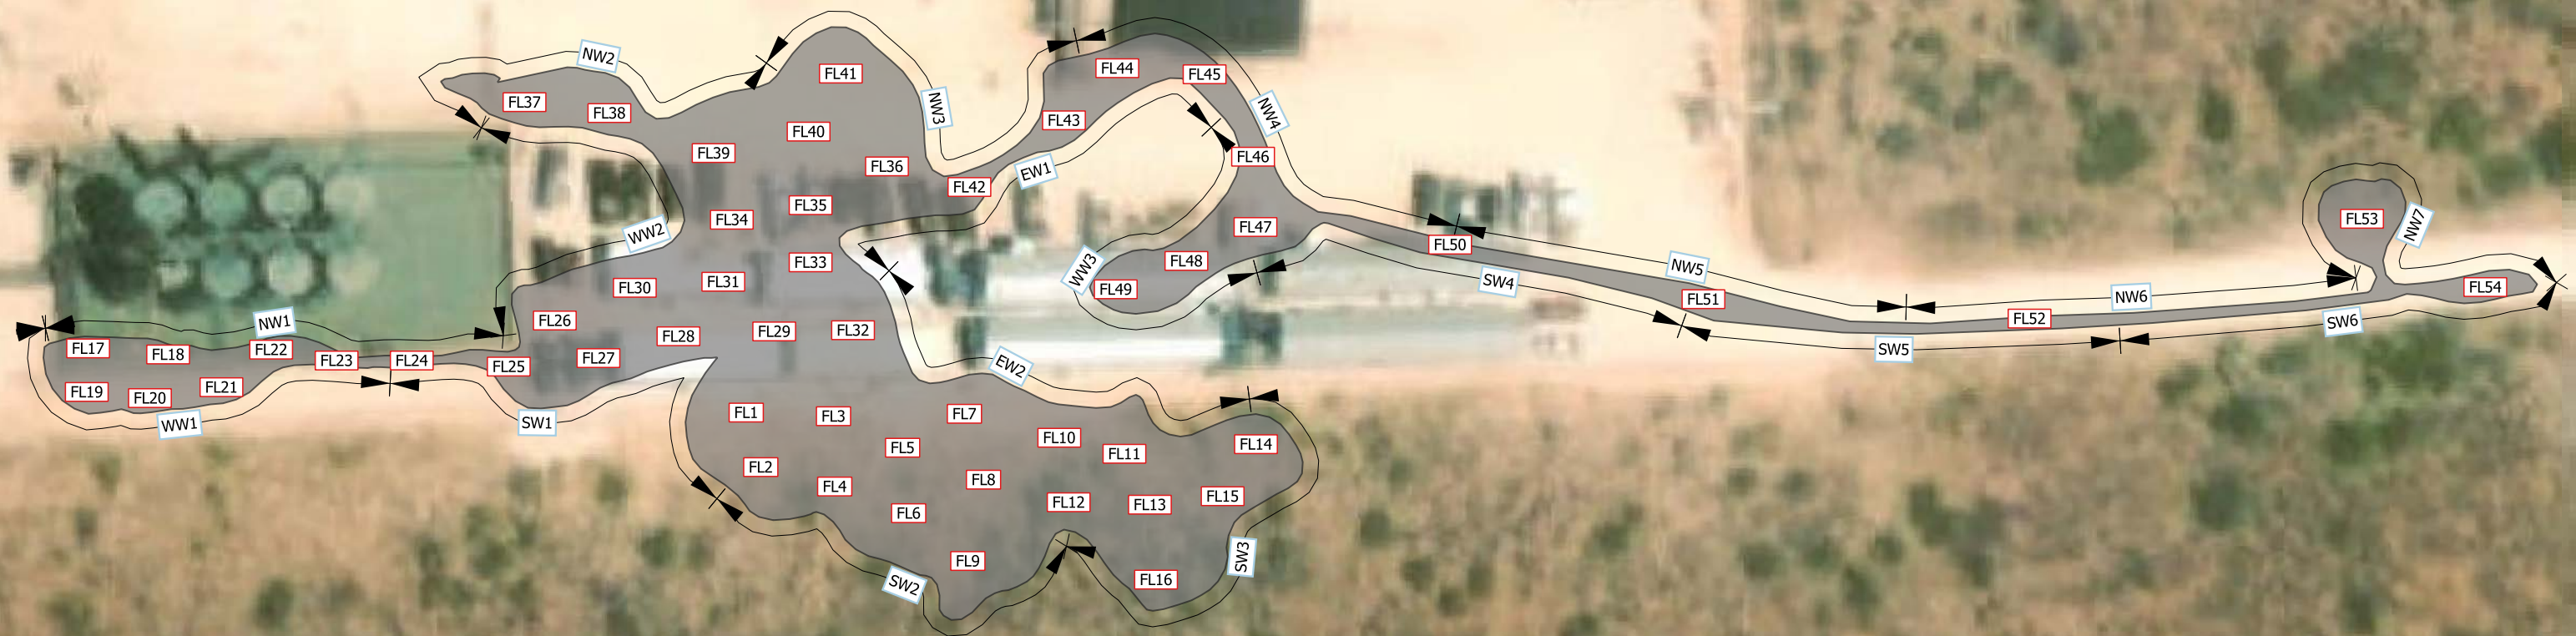
## **Figure 3**

### **Site & Sample Location Map**

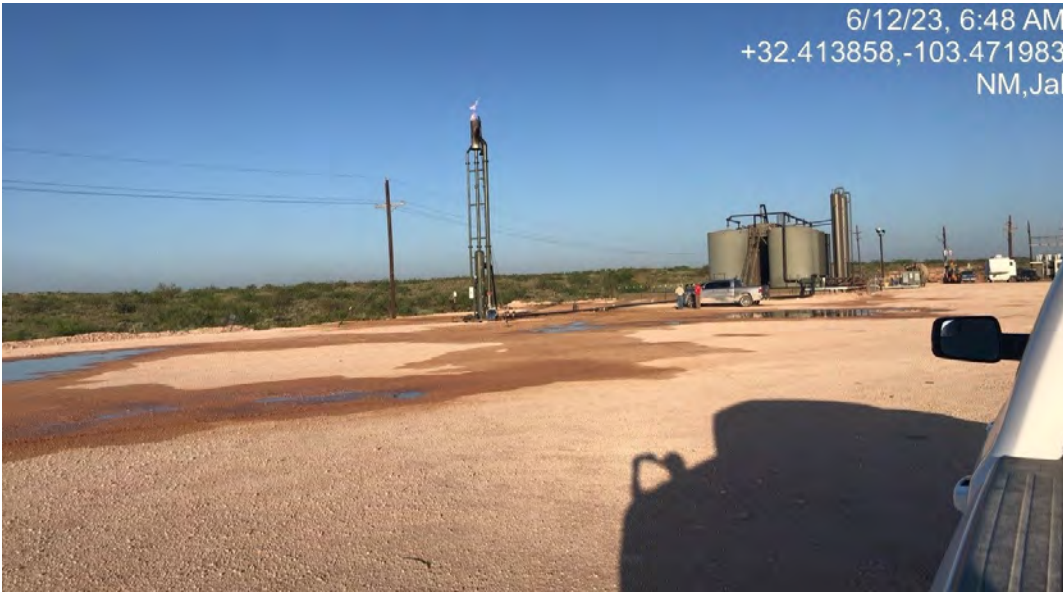
<b>Photo Number:</b> 1

<p>6/12/23, 6:48 AM +32.413858,-103.471983 NM, Jal</p>
<b>Photo Direction:</b> Southwest	
<b>Photo Description:</b>  View of the affected area.

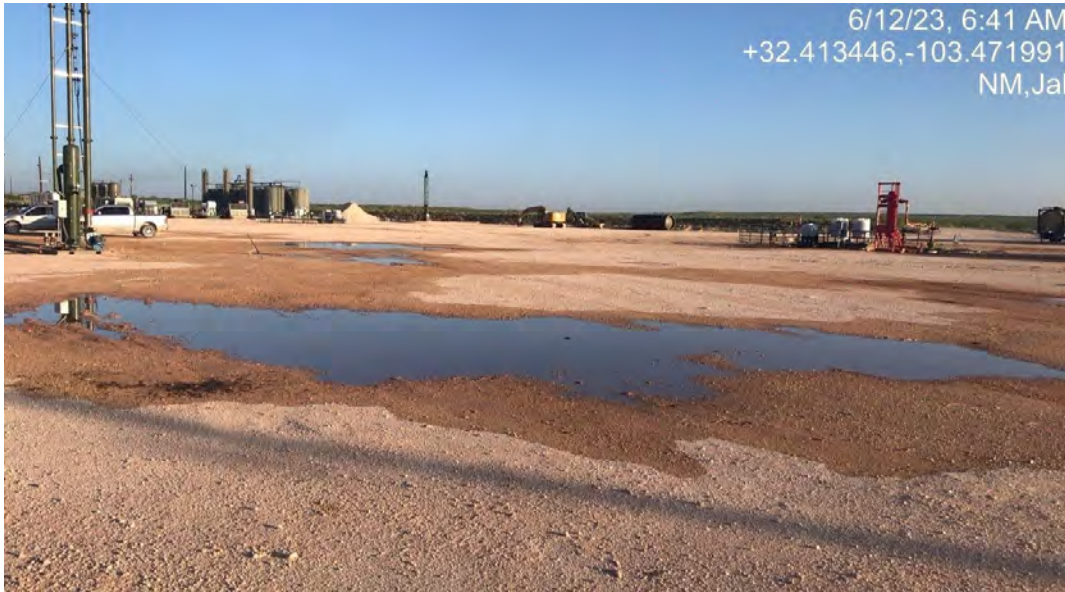
<b>Photo Number:</b> 5

<p>6/12/23, 6:41 AM +32.413446,-103.471991 NM, Jal</p>
<b>Photo Direction:</b> Northwest	
<b>Photo Description:</b>  View of the affected area.

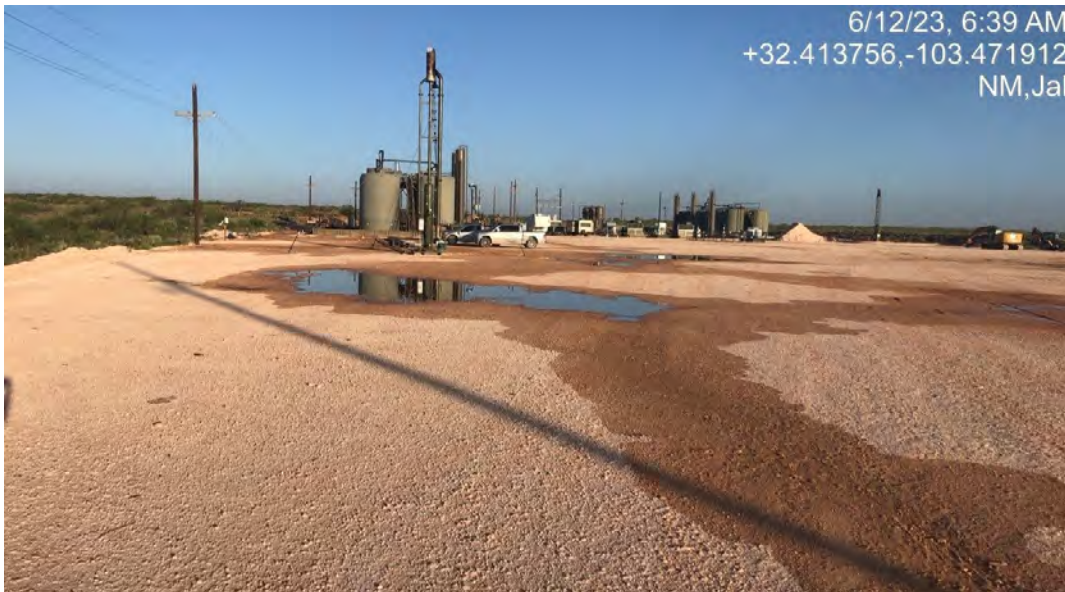
<b>Photo Number:</b> 6

<p>6/12/23, 6:39 AM +32.413756,-103.471912 NM, Jal</p>
<b>Photo Direction:</b> West	
<b>Photo Description:</b>  View of the affected area.

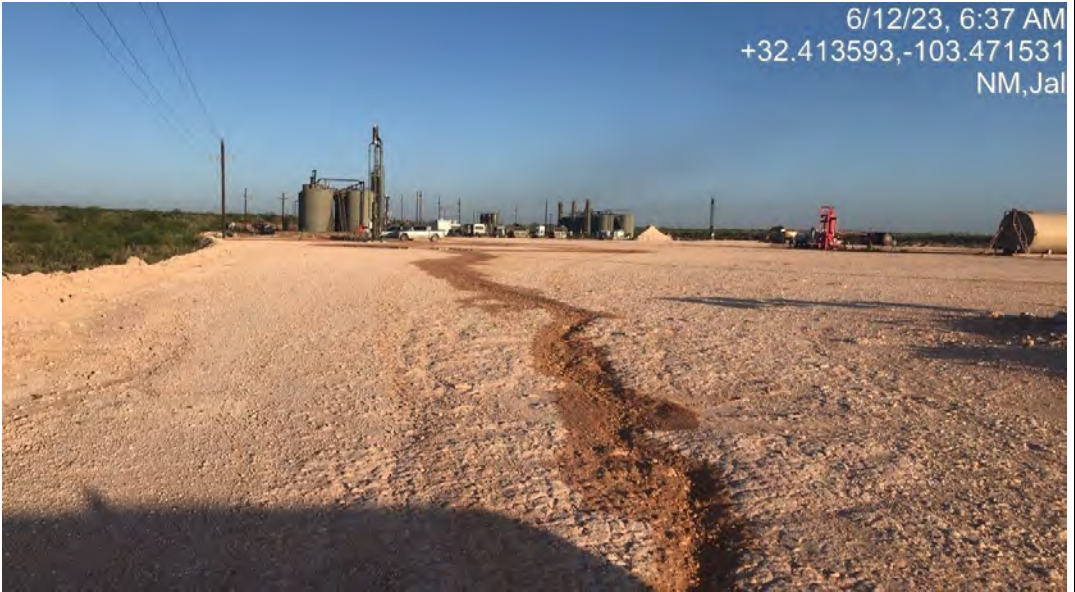
<b>Photo Number:</b> 7

<p>6/12/23, 6:37 AM +32.413593,-103.471531 NM, Jal</p>
<b>Photo Direction:</b> West	
<b>Photo Description:</b>  View of the affected area.

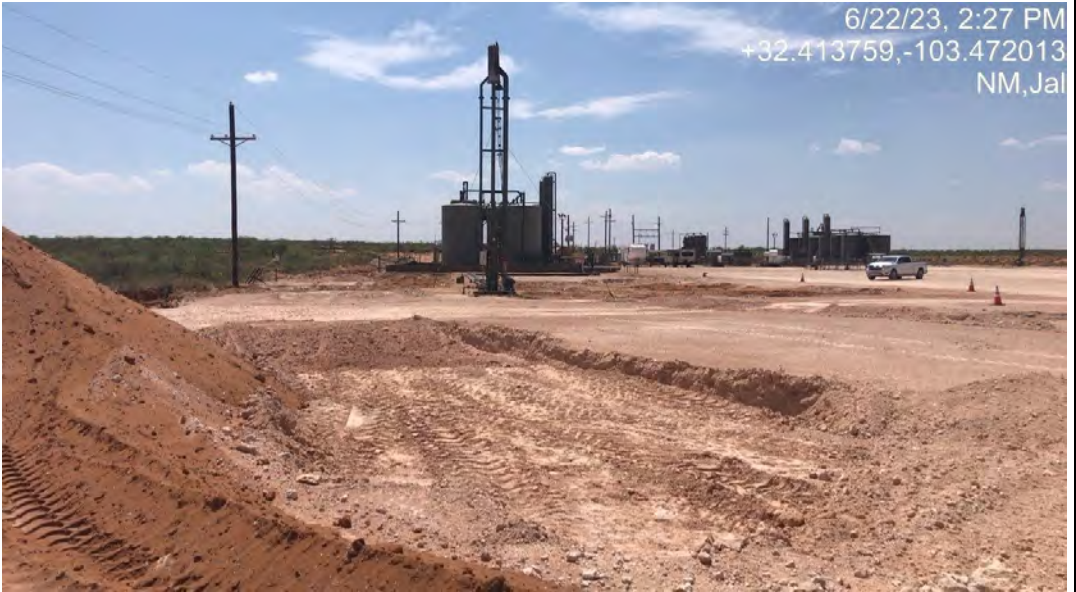
<b>Photo Number:</b> 9

<p>6/22/23, 2:27 PM +32.413759,-103.472013 NM, Jal</p>
<b>Photo Direction:</b> West	
<b>Photo Description:</b>  View of the excavated area.

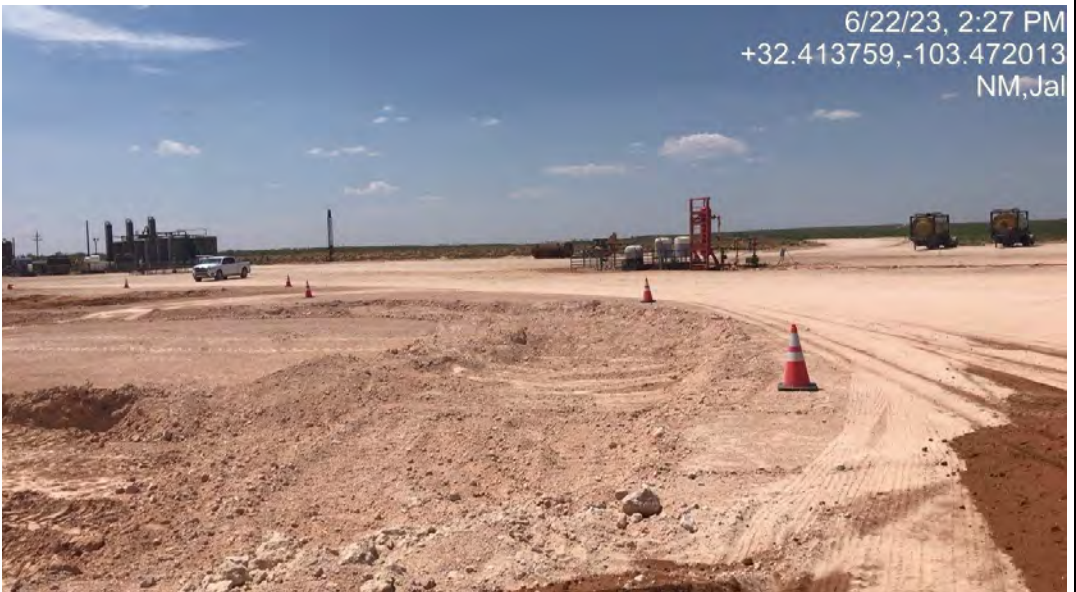
<b>Photo Number:</b> 10

<p>6/22/23, 2:27 PM +32.413759,-103.472013 NM, Jal</p>
<b>Photo Direction:</b> Northwest	
<b>Photo Description:</b>  View of the excavated area.

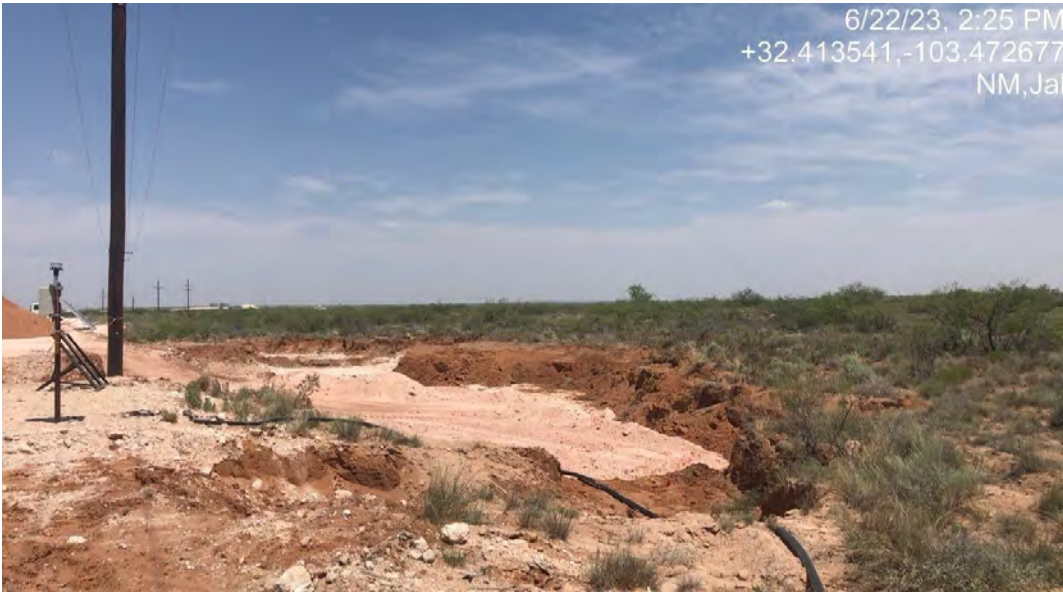
<b>Photo Number:</b> 13

<p>6/22/23, 2:25 PM +32.413541,-103.472677 NM, Jal</p>
<b>Photo Direction:</b> East	
<b>Photo Description:</b>  View of the excavated area.

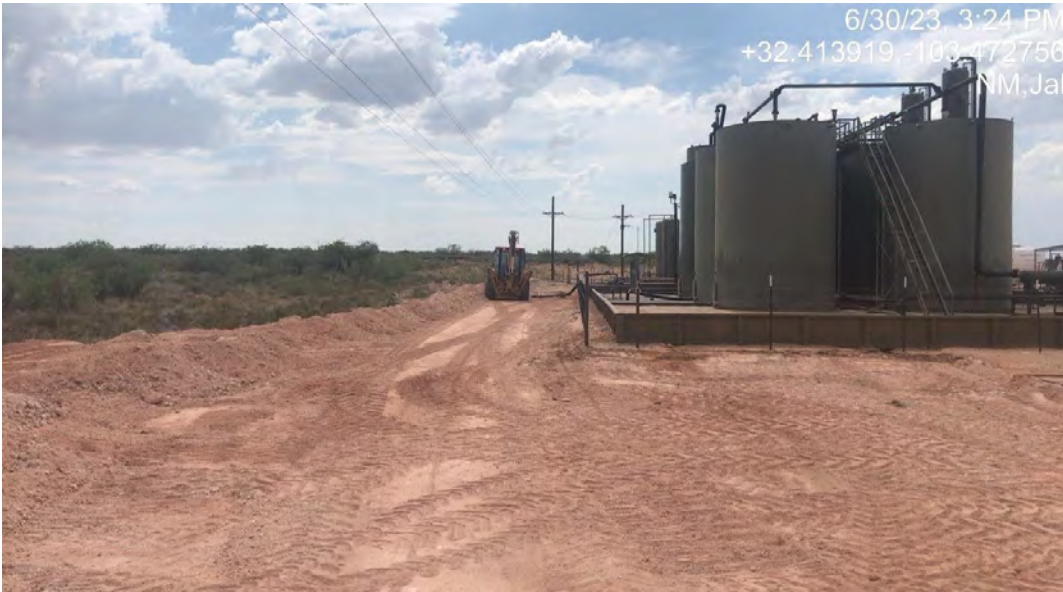
<b>Photo Number:</b> 19

<b>Photo Direction:</b> West	
<b>Photo Description:</b>  View of the remediated area after backfill and regrading.

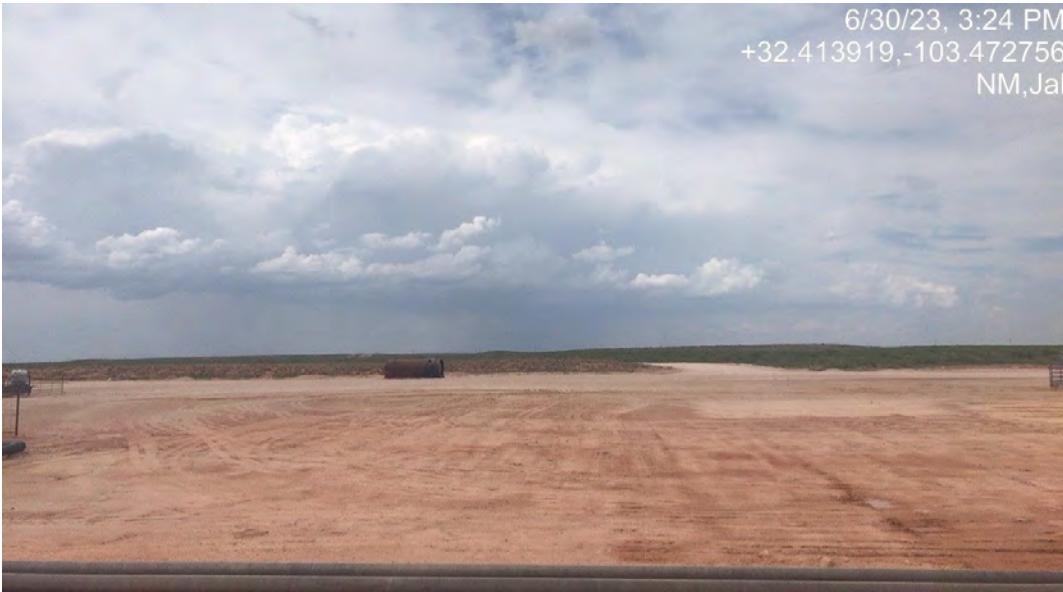
<b>Photo Number:</b> 20

<b>Photo Direction:</b> North	
<b>Photo Description:</b>  View of the remediated area after backfill and regrading.

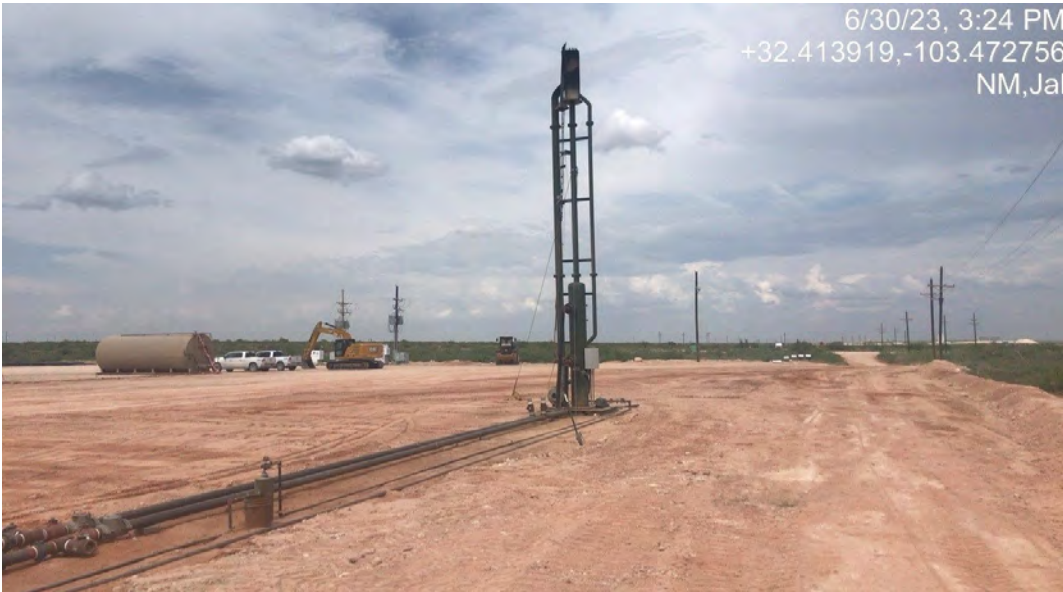
<b>Photo Number:</b> 21

<b>Photo Direction:</b> East	
<b>Photo Description:</b>  View of the remediated area after backfill and regrading.

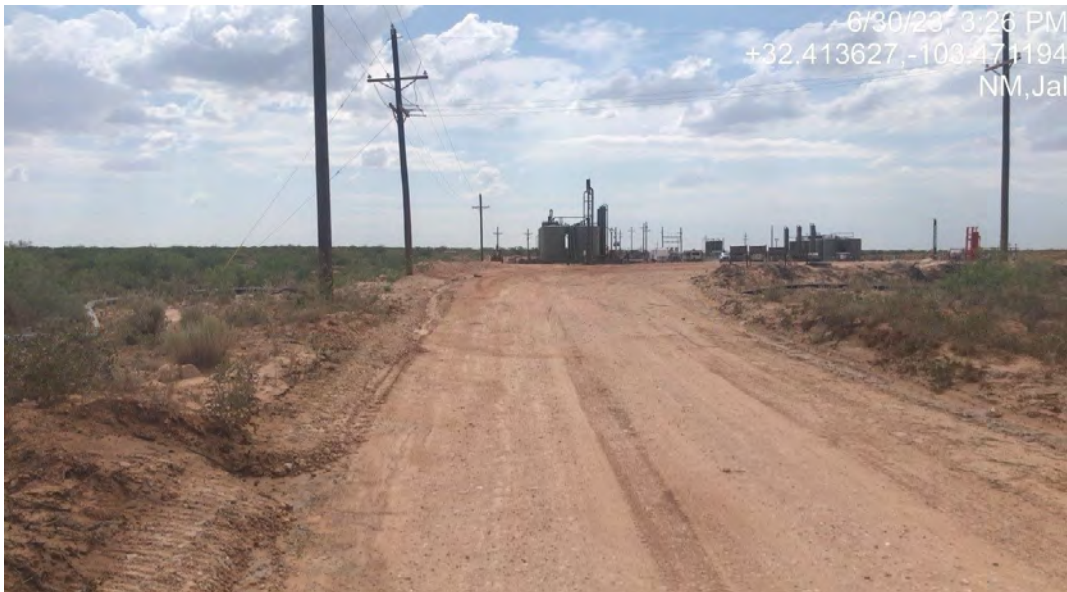
<b>Photo Number:</b> 26

<p>6/30/23, 3:26 PM +32.413627,-103.471194 NM, Jal</p>
<b>Photo Direction:</b> West	
<b>Photo Description:</b>  View of the remediated area after backfill and regrading.
