# Remediation Summary & Soil Closure Request

## Mewbourne Oil Company Thundercloud 30/29 Battery #1

Lea County, New Mexico  
Unit Letter "D", Section 30, Township 18 South, Range 32 East  
Latitude 32.722926 North, Longitude 103.812344 West  
NMOCD Reference No. nAPP2408651560

**Etech Environmental & Safety Solutions, Inc.**  
6309 Indiana Ave, Ste. D  
Lubbock, Texas 79413

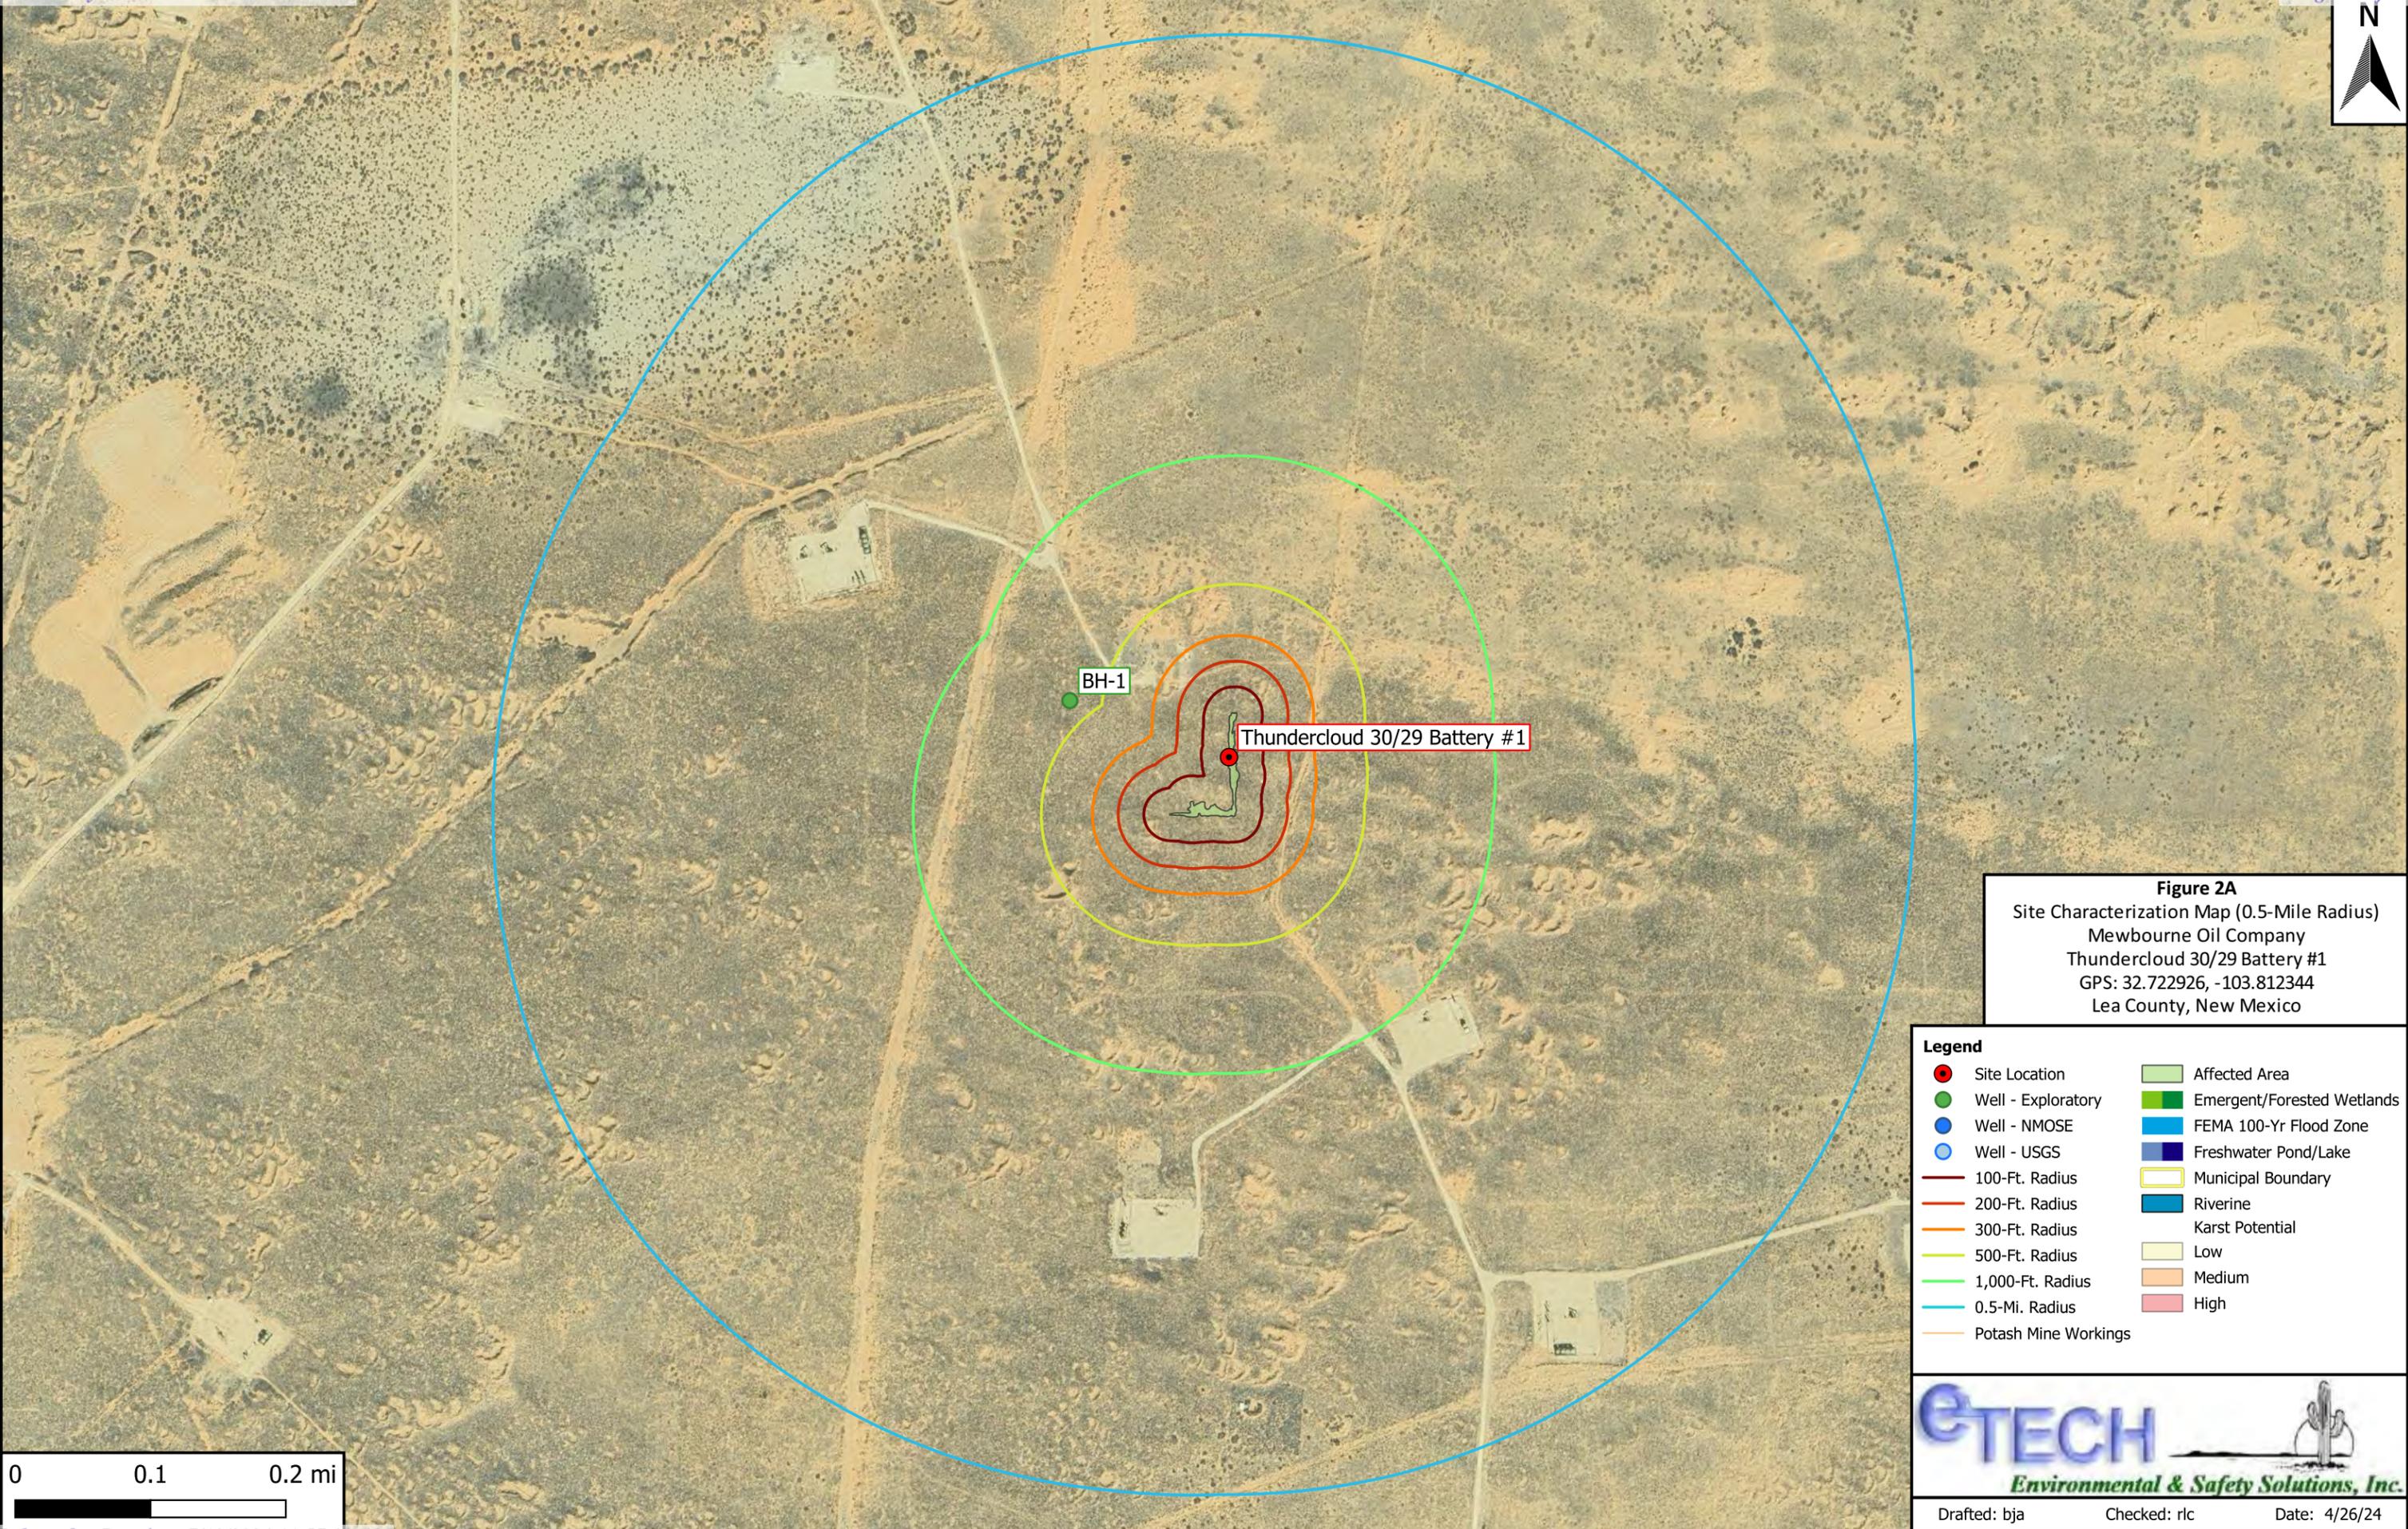
**Figure 2A**  
 Site Characterization Map (0.5-Mile Radius)  
 Mewbourne Oil Company  
 Thundercloud 30/29 Battery #1  
 GPS: 32.722926, -103.812344  
 Lea County, New Mexico

Probable groundwater depth was determined using data generated by numeric models based on available water well data and published information. In addition, on March 25, 2024, an investigative soil boring was drilled nearby in an effort to determine if shallow groundwater is present in the area. The soil boring was advanced to a total depth of approximately 105 feet bgs and left open for over 72 hours. No indications of inflow and/or accumulation of water were noted during the advancement of the soil boring or prior to plugging and abandonment. In addition, a groundwater gauging event conducted on April 4, 2024, confirmed that the borehole was dry. The location of the investigative soil bore is depicted in Figures 2A, 2B, and 4. A drilling log is provided in Appendix A.

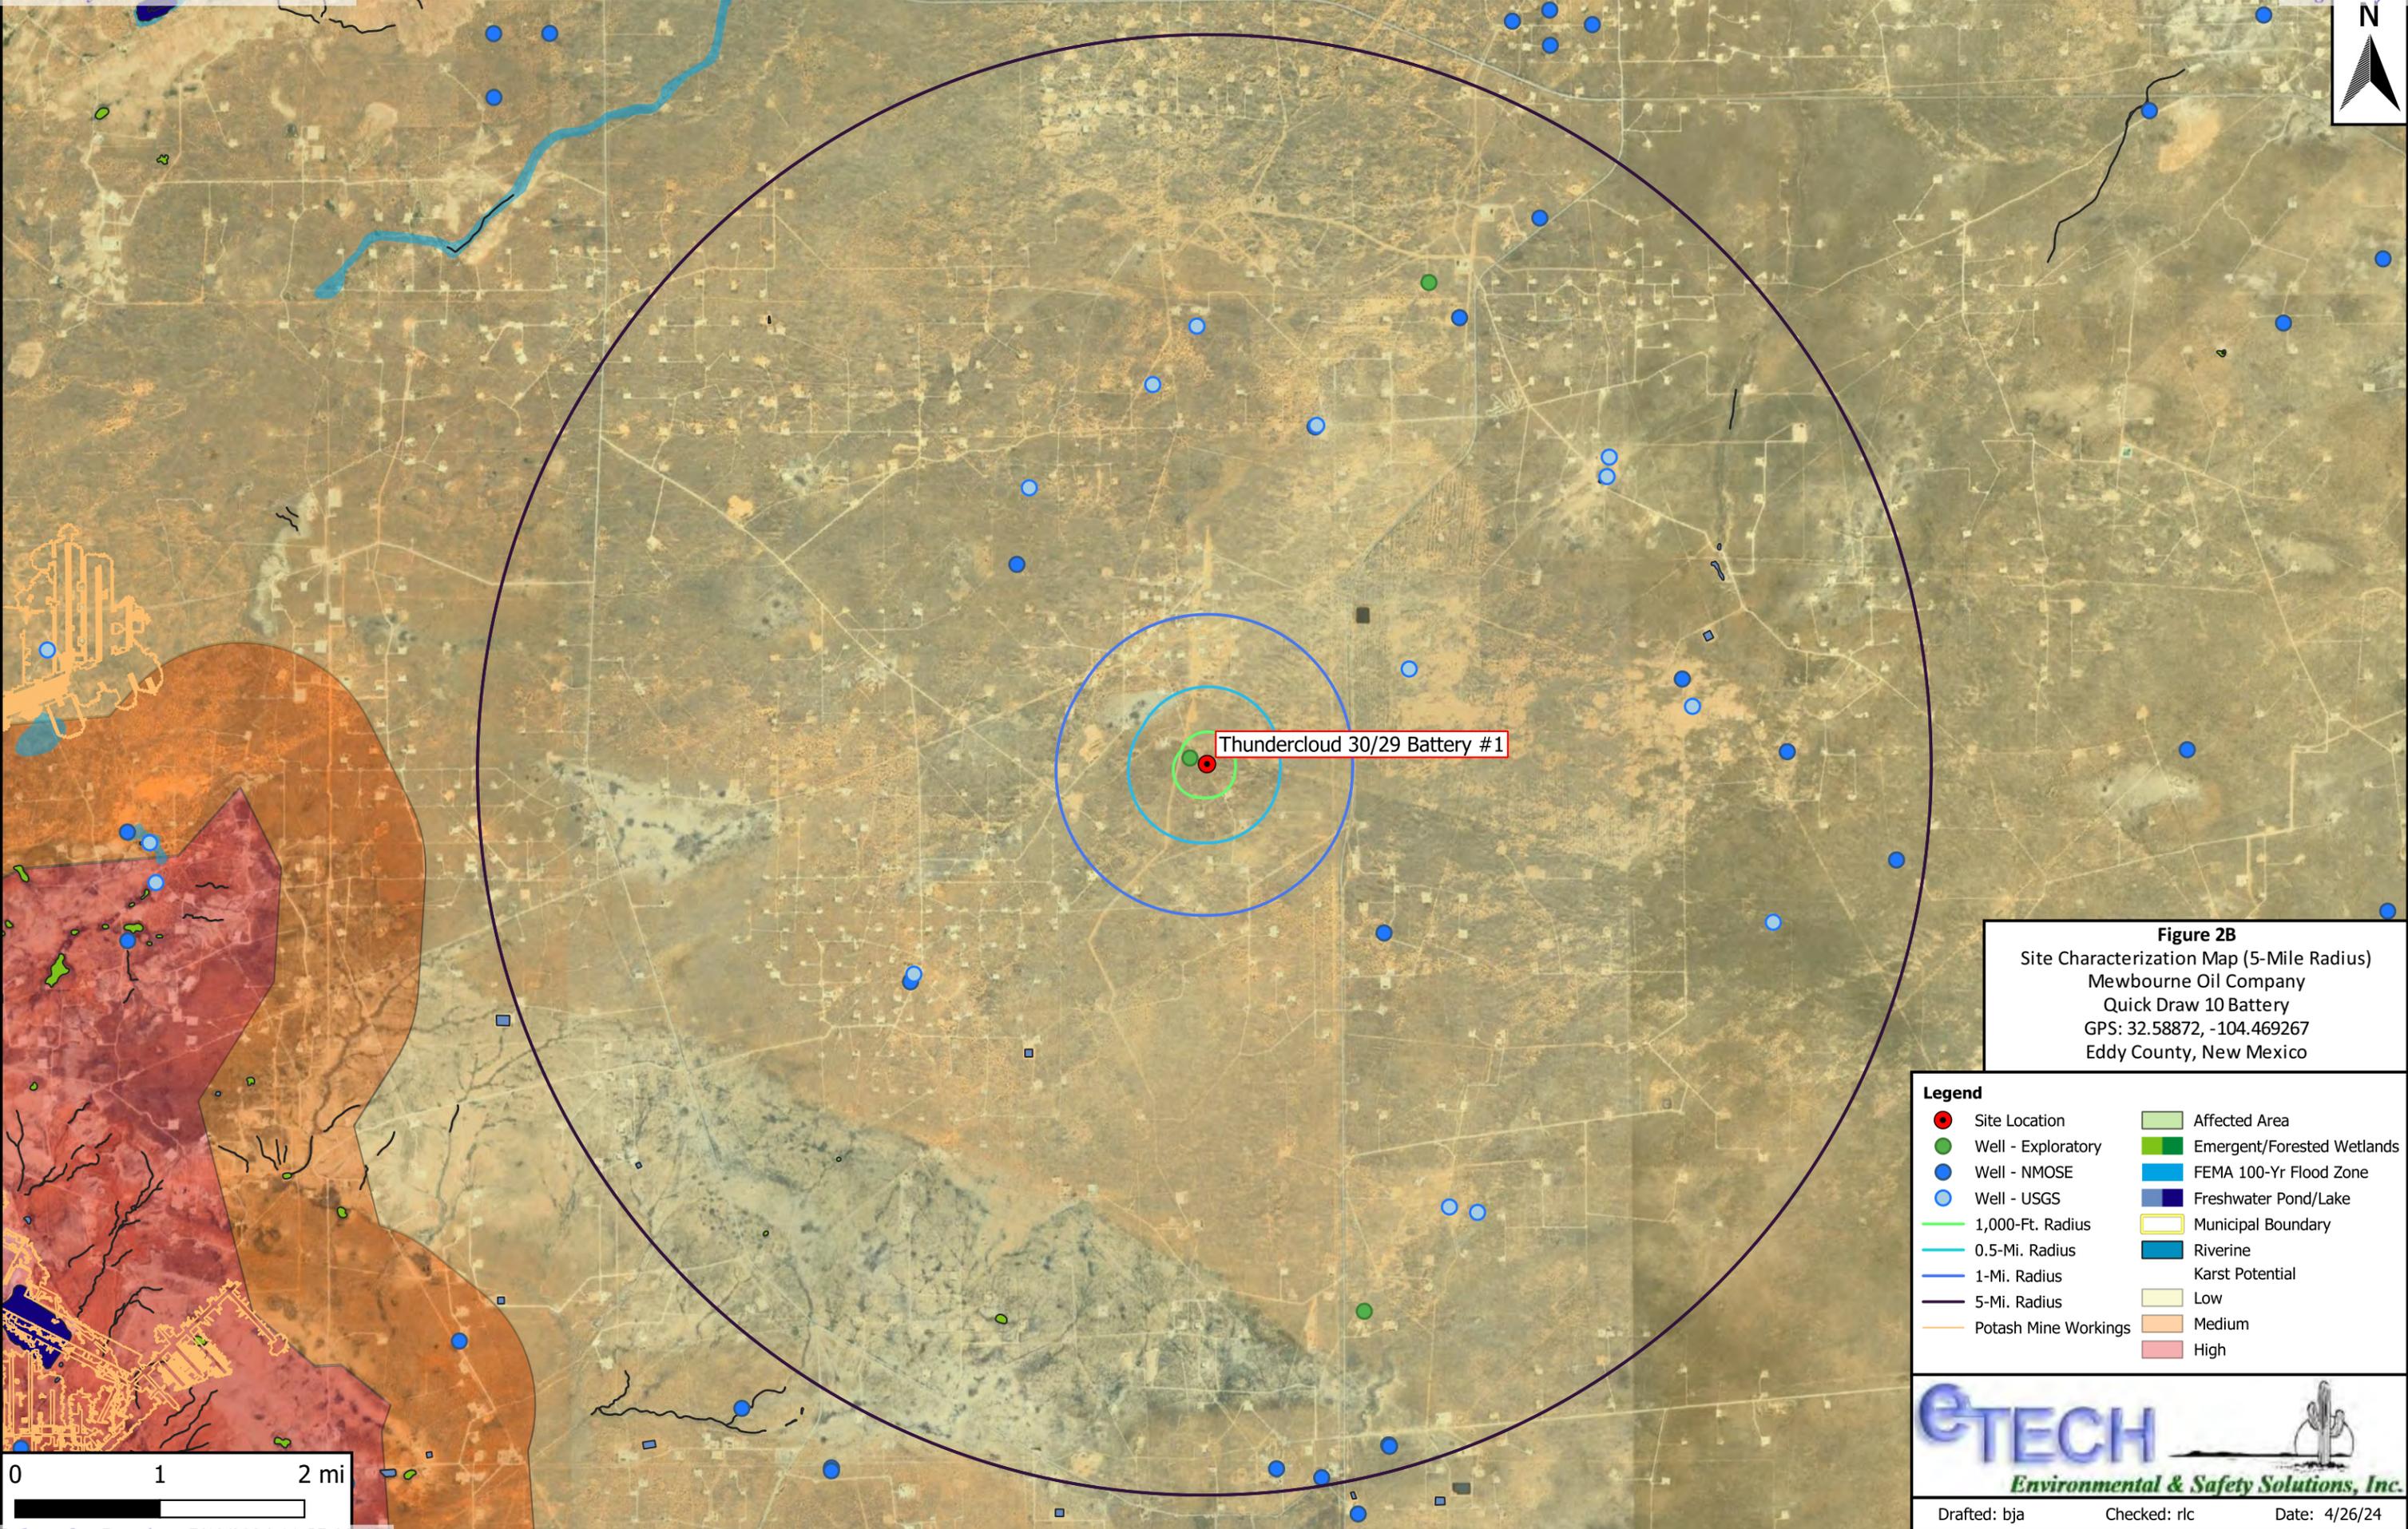
**Figure 2B**  
 Site Characterization Map (5-Mile Radius)  
 Mewbourne Oil Company  
 Quick Draw 10 Battery  
 GPS: 32.58872, -104.469267  
 Eddy County, New Mexico

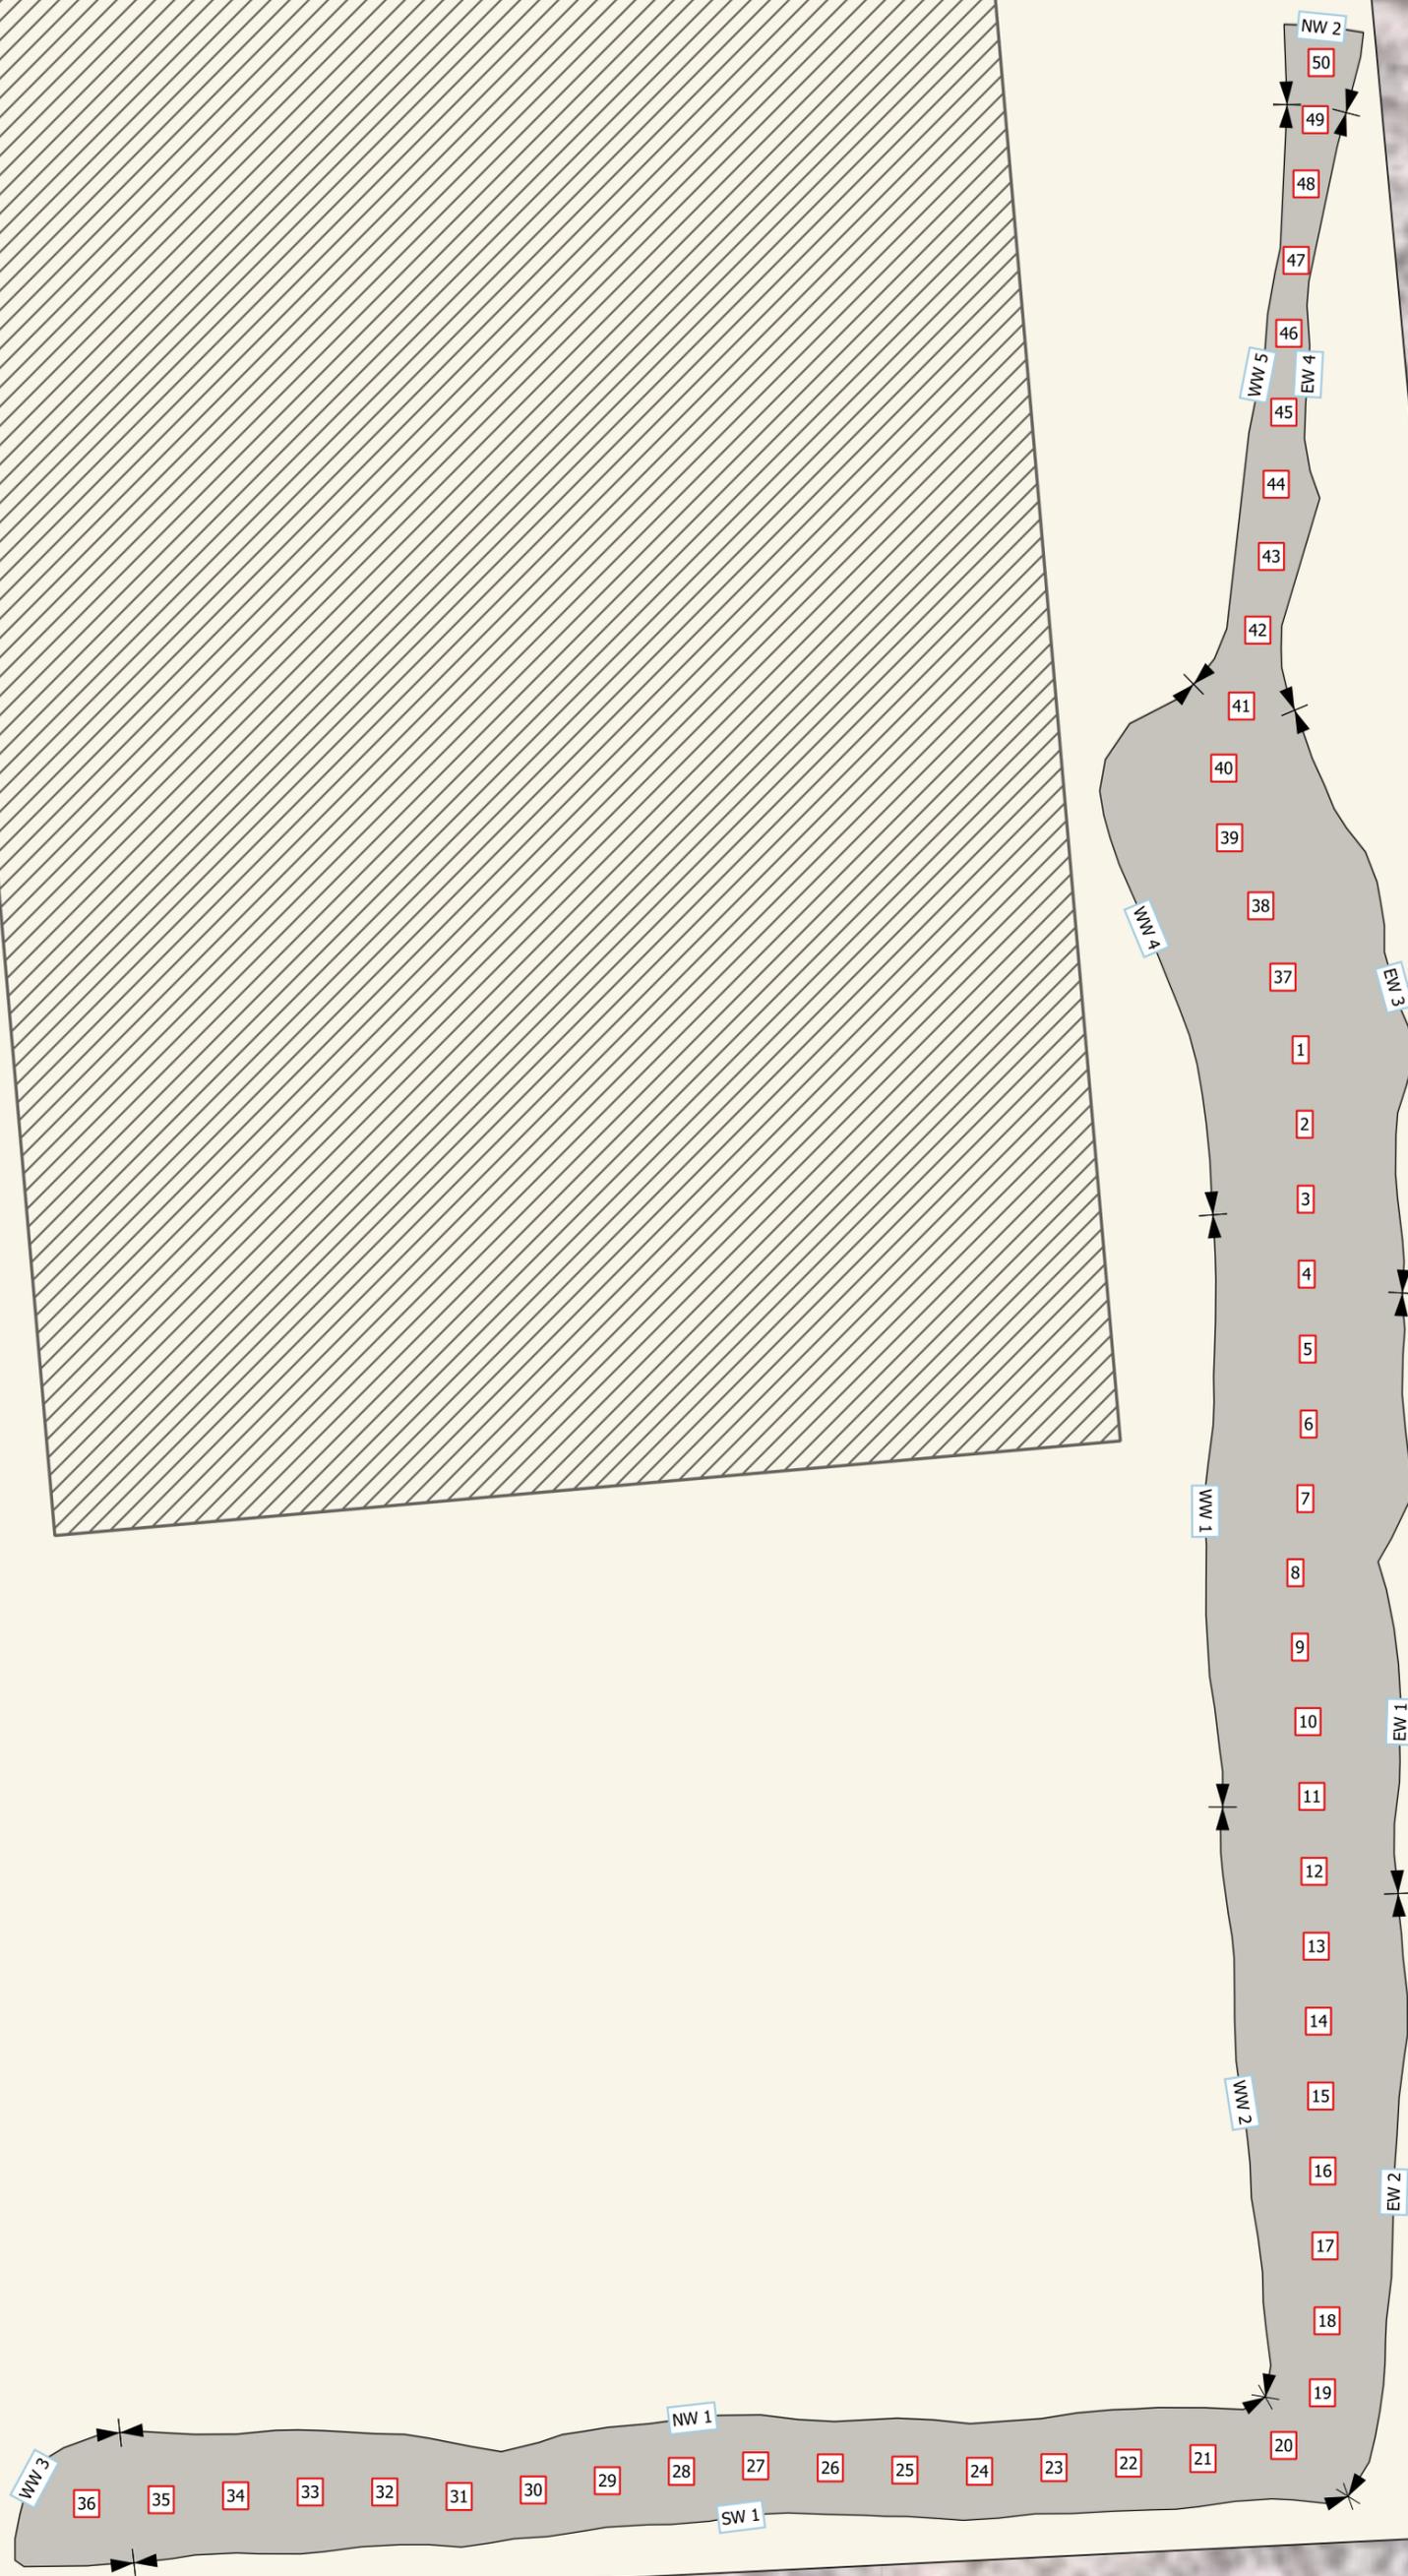
Legend	
	Caliche Pad
	Composite Floor Sample
	Excavation Extent
	Composite Wall Sample
	Tank Battery Containment

**Figure 3**  
 Sample Location Map  
 Mewbourne Oil Company  
 Thundercloud 30/29 Battery #1  
 GPS: 32.722926, -103.812344  
 Lea County, New Mexico

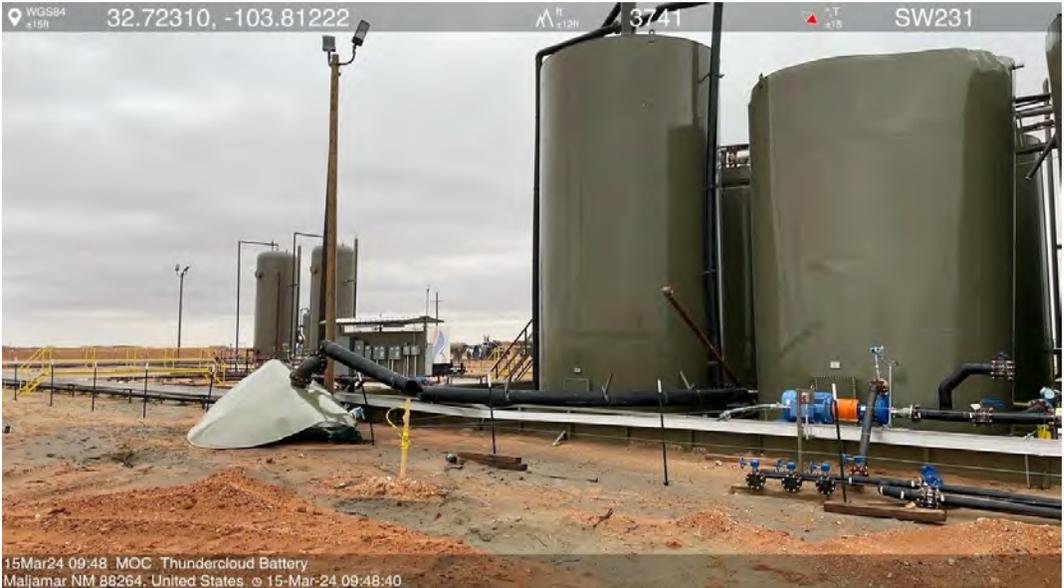
<b>Photo Number:</b> 1

<p>WGS84 32.72310, -103.81222 3741 SW231</p> <p>15Mar24 09:48 MOC Thundercloud Battery Maljamar NM 88264, United States © 15-Mar-24 09:48:40</p>
<b>Photo Direction:</b> Southwest	
<b>Photo Description:</b>  View of the affected area.

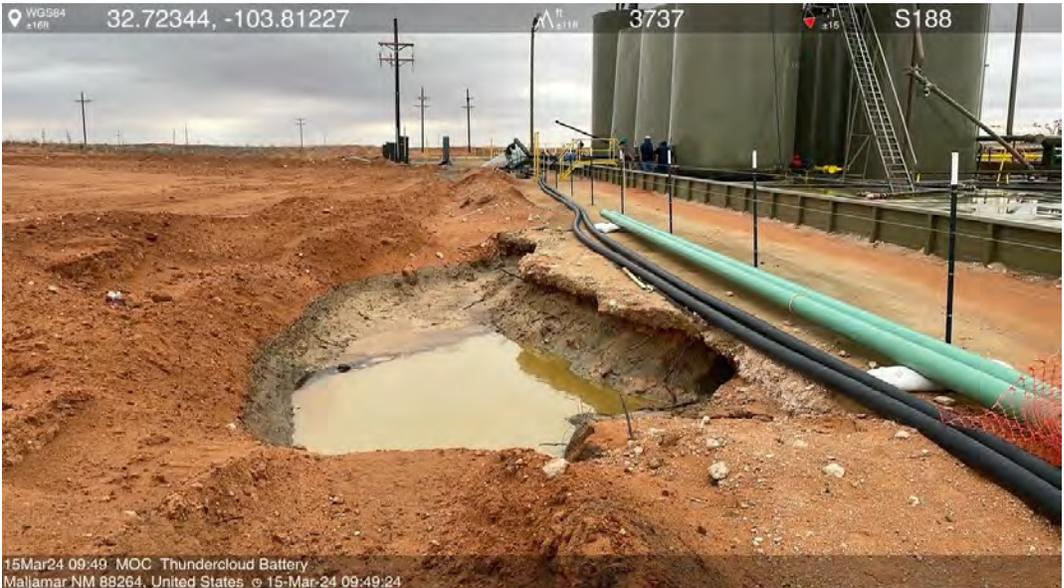
<b>Photo Number:</b> 2

<p>WGS84 32.72344, -103.81227 3737 S188</p> <p>15Mar24 09:49 MOC Thundercloud Battery Maljamar NM 88264, United States © 15-Mar-24 09:49:24</p>
<b>Photo Direction:</b> South	
<b>Photo Description:</b>  View of the affected area.

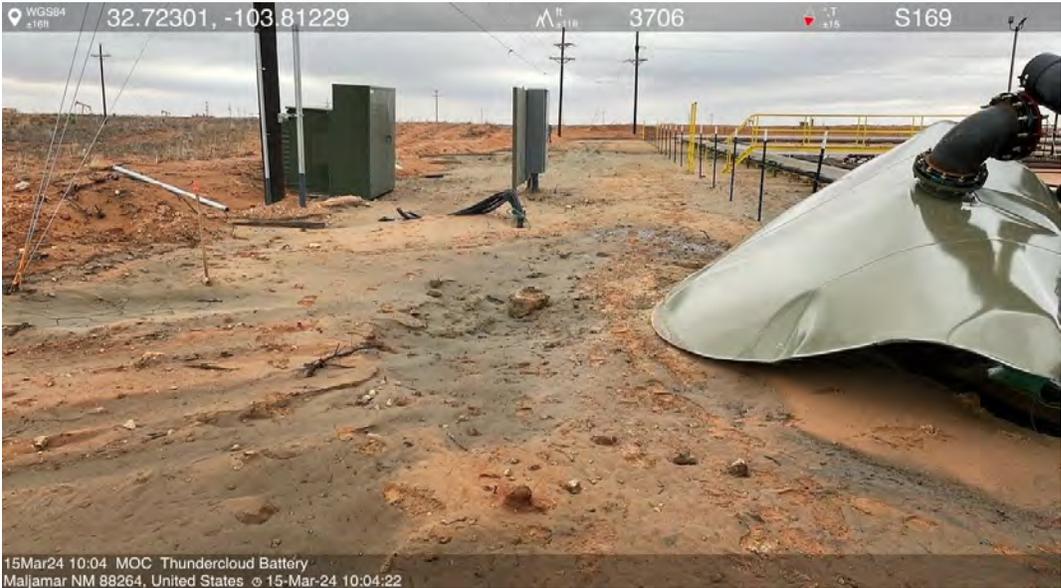
<b>Photo Number:</b> 3

<p>WGS84 32.72301, -103.81229 3706 S169</p> <p>15Mar24 10:04 MOC Thundercloud Battery Maljamar NM 88264, United States © 15-Mar-24 10:04:22</p>
<b>Photo Direction:</b> South	
<b>Photo Description:</b>  View of the affected area.

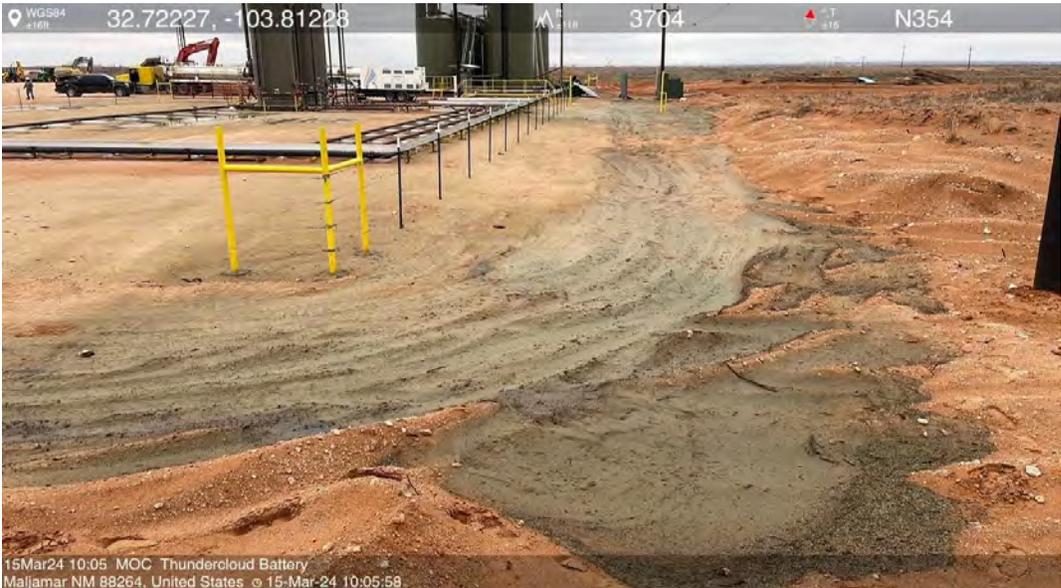
<b>Photo Number:</b> 4

<p>WGS84 32.72227, -103.81228 3704 N354</p> <p>15Mar24 10:05 MOC Thundercloud Battery Maljamar NM 88264, United States © 15-Mar-24 10:05:59</p>
<b>Photo Direction:</b> North	
<b>Photo Description:</b>  View of the affected area.

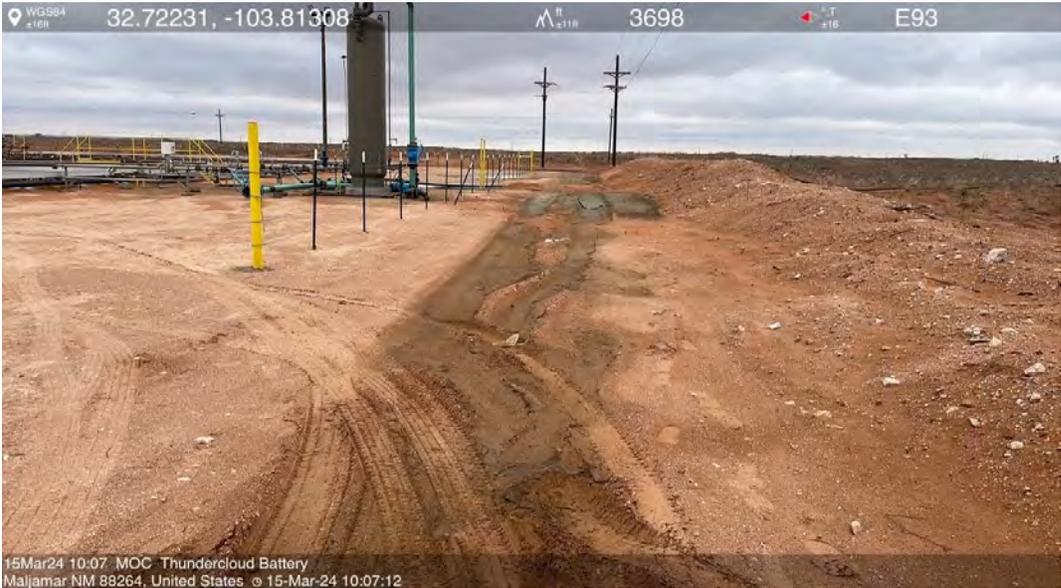
<b>Photo Number:</b> 5

<p>15Mar24 10:07 MOC Thundercloud Battery Maljamar NM 88264, United States © 15-Mar-24 10:07:12</p>
<b>Photo Direction:</b> East	
<b>Photo Description:</b>  View of the affected area.

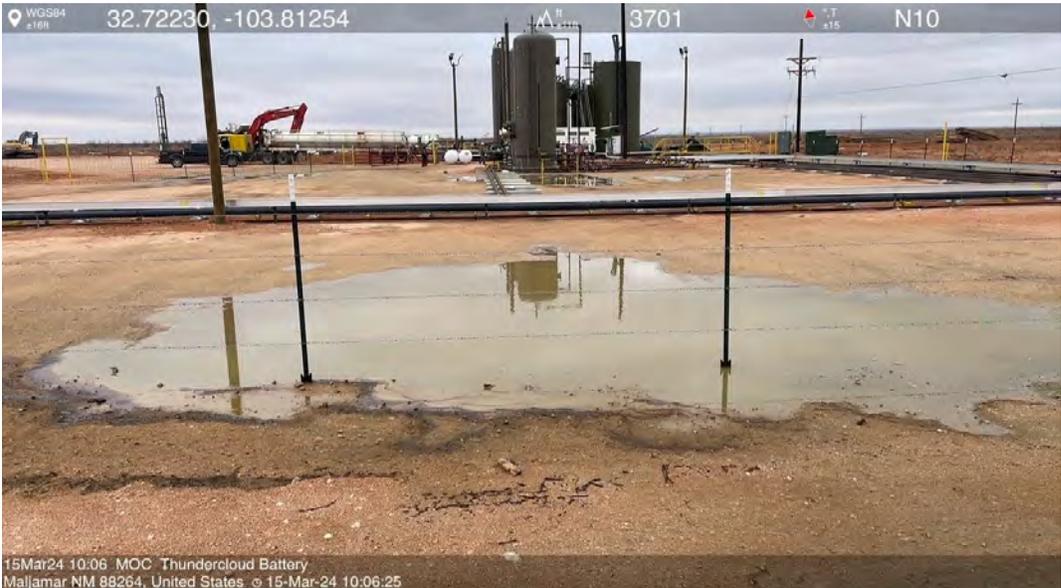
<b>Photo Number:</b> 6

<p>15Mar24 10:06 MOC Thundercloud Battery Maljamar NM 88264, United States © 15-Mar-24 10:06:25</p>
<b>Photo Direction:</b> North	
<b>Photo Description:</b>  View of the affected area.

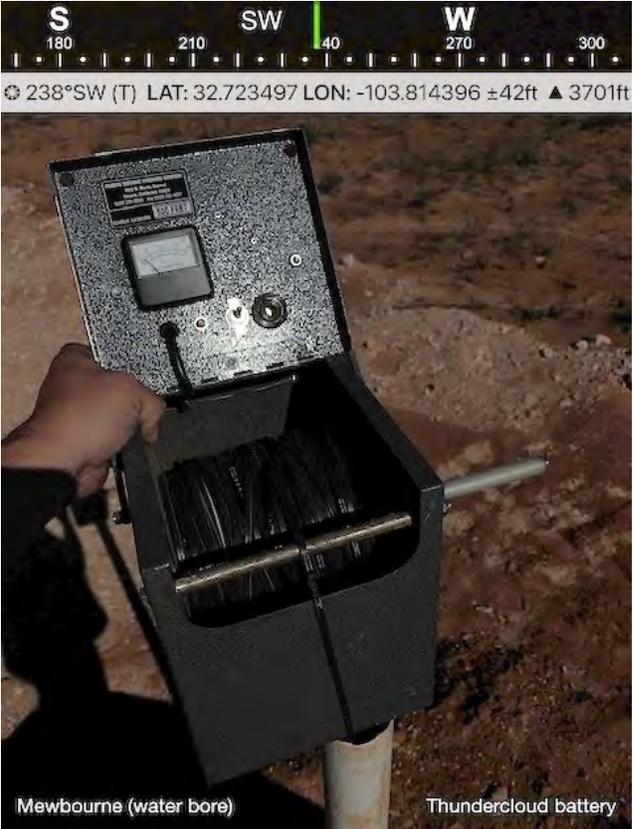
<b>Photo Number:</b> 7

<p>Mewbourne (water bore) Thundercloud battery</p>
<b>Photo Direction:</b> West-Southwest	
<b>Date Taken:</b> 4/4/2024	
<b>Photo Description:</b>  View of exploratory soil boring BH-1.

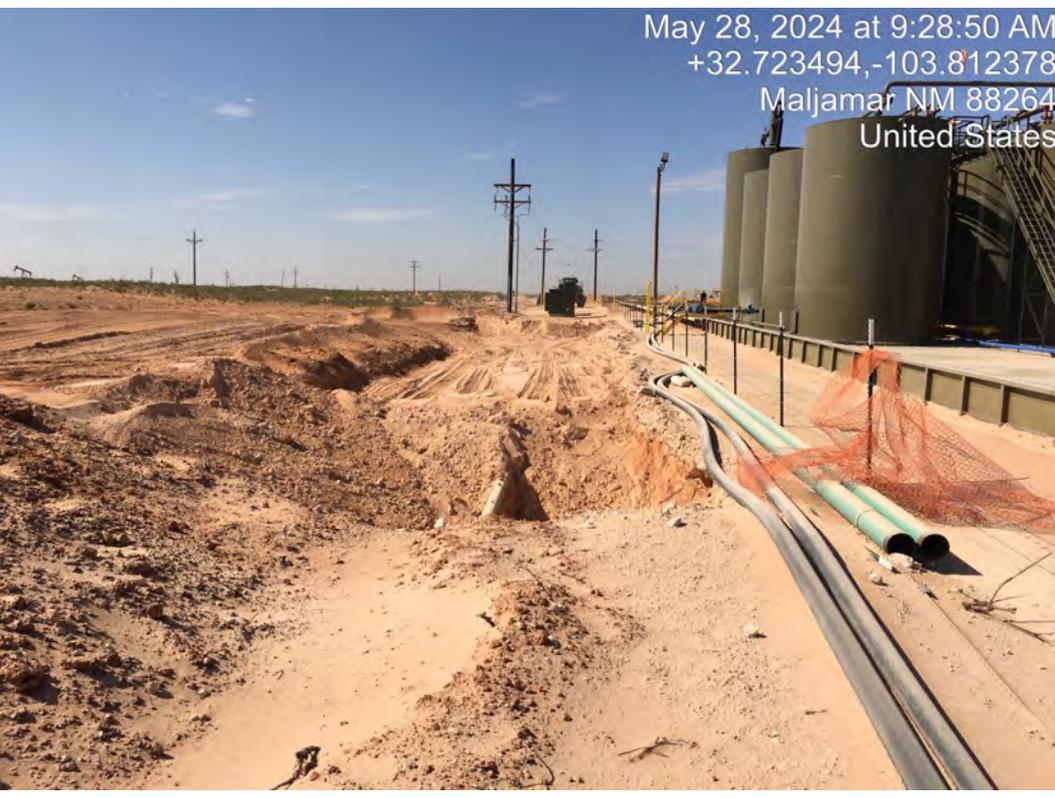
<b>Photo Number:</b> 8

<p>May 28, 2024 at 9:28:50 AM +32.723494,-103.812378 Maljamar NM 88264 United States</p>
<b>Photo Direction:</b> South	
<b>Photo Description:</b>  View of the excavated area prior to backfilling.

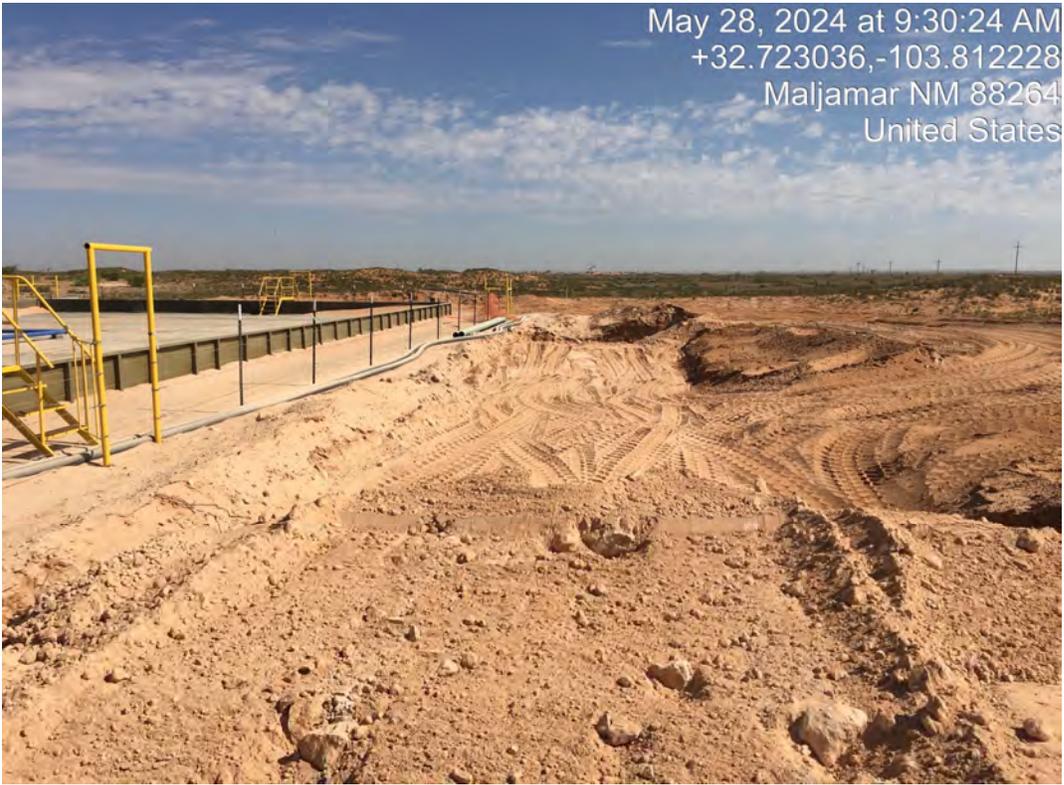
<b>Photo Number:</b> 9

<p>May 28, 2024 at 9:30:24 AM +32.723036,-103.812228 Maljamar NM 88264 United States</p>
<b>Photo Direction:</b> North	
<b>Photo Description:</b>  View of the excavated area prior to backfilling.

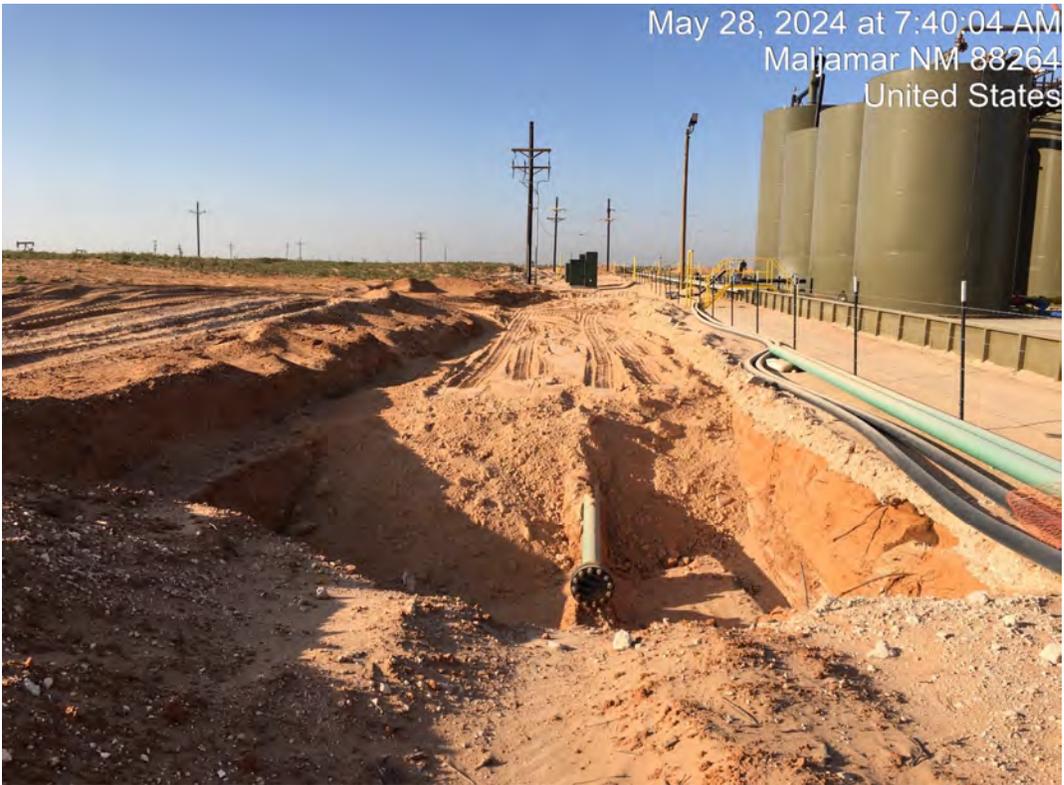
<b>Photo Number:</b> 10

<p>May 28, 2024 at 7:40:04 AM Maljamar NM 88264 United States</p>
<b>Photo Direction:</b> South	
<b>Coordinates:</b> 32.723360,-103.812261	
<b>Photo Description:</b>  View of the excavated area with top layers of native soil and caliche well pad visible.

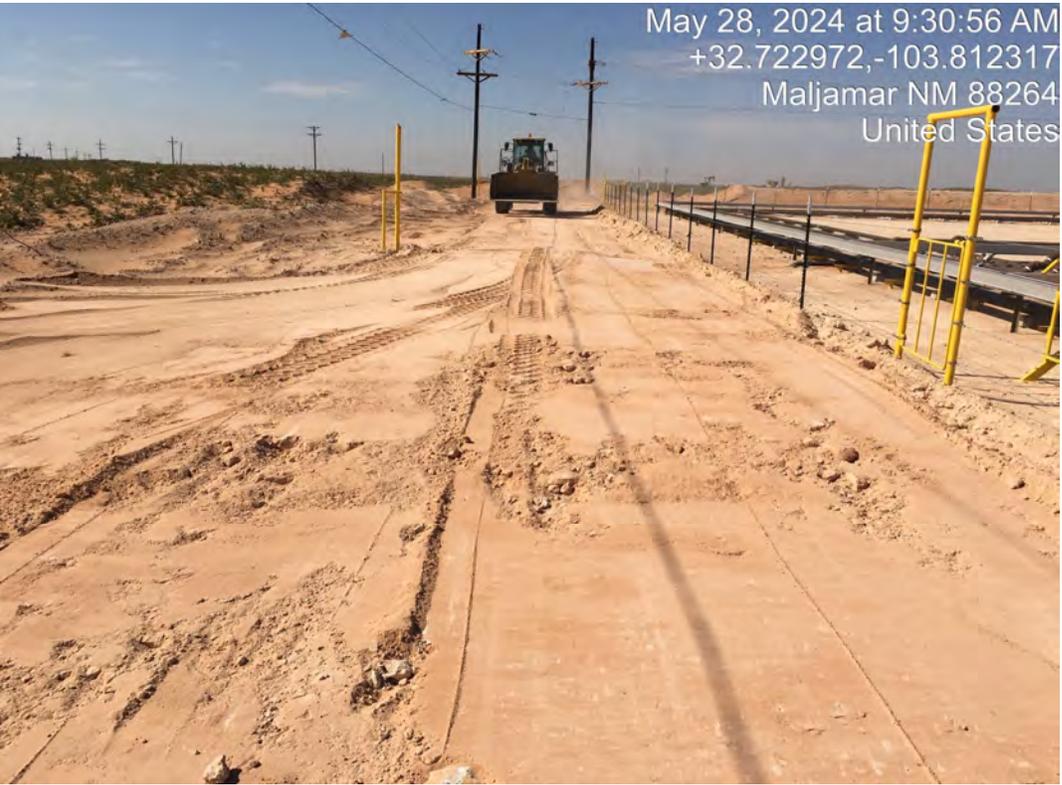
<b>Photo Number:</b> 11

<p>May 28, 2024 at 9:30:56 AM +32.722972,-103.812317 Maljamar NM 88264 United States</p>
<b>Photo Direction:</b> South	
<b>Photo Description:</b>  View of the excavated area during backfilling.

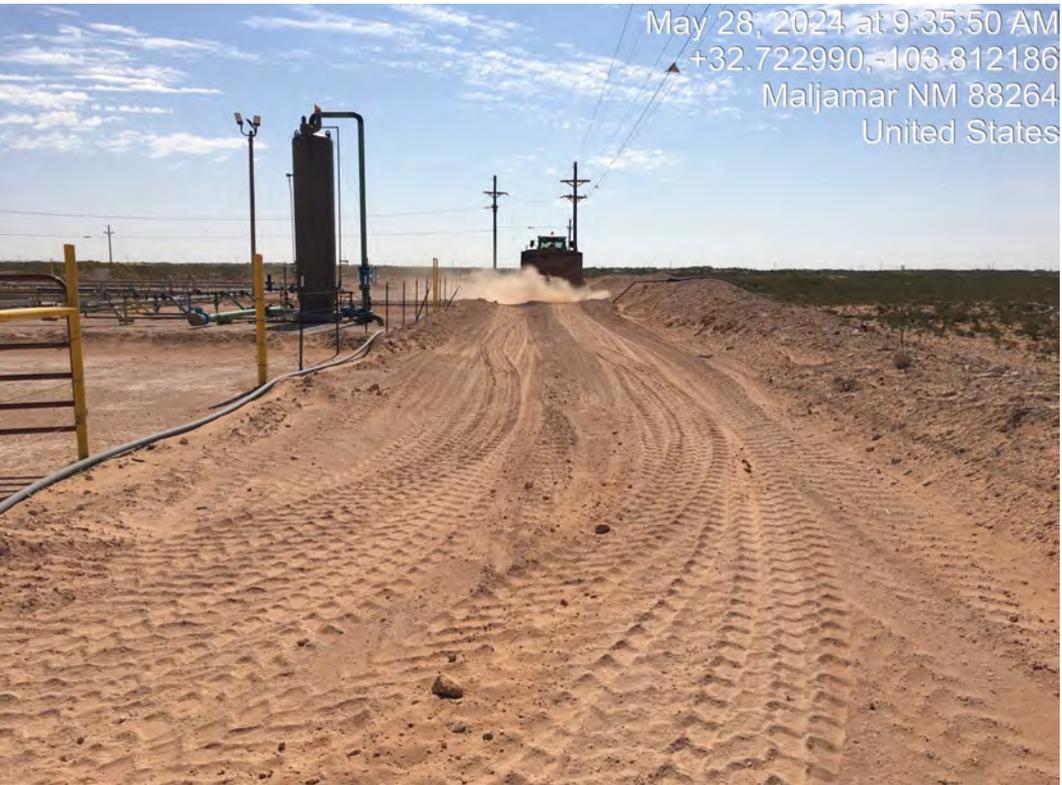
<b>Photo Number:</b> 12

<p>May 28, 2024 at 9:35:50 AM +32.722990,-103.812186 Maljamar NM 88264 United States</p>
<b>Photo Direction:</b> East	
<b>Photo Description:</b>  View of the excavated area during backfilling.

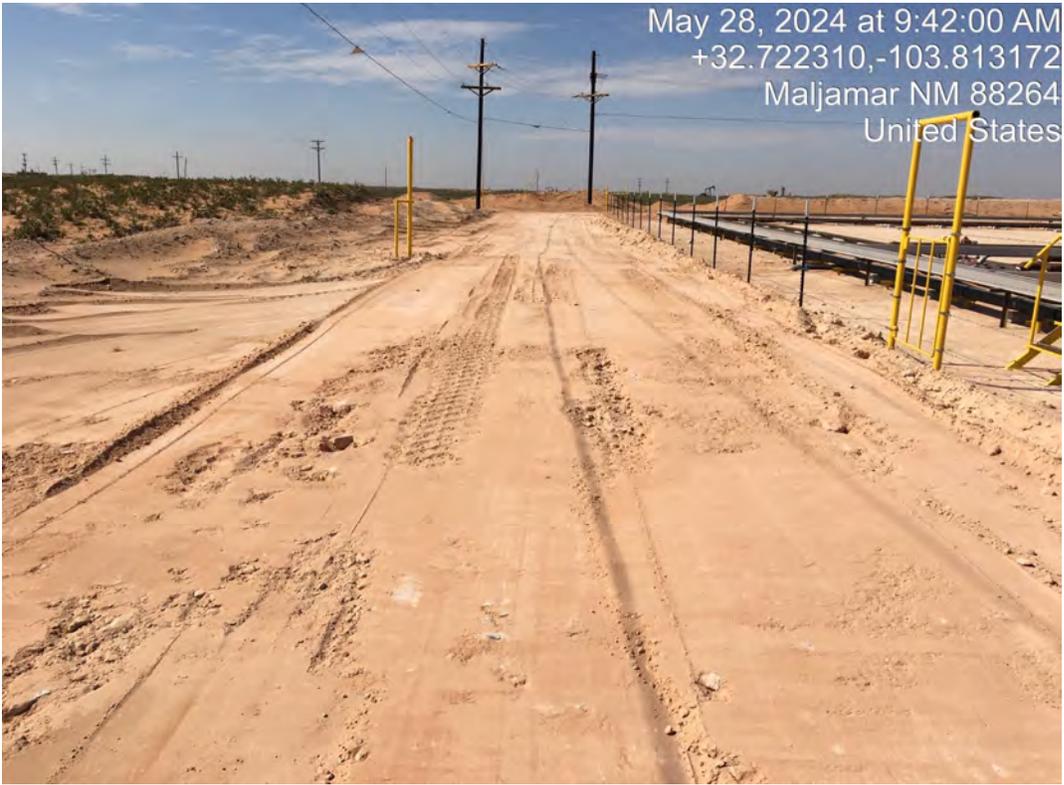
<b>Photo Number:</b> 13

<p>May 28, 2024 at 9:42:00 AM +32.722310,-103.813172 Maljamar NM 88264 United States</p>
<b>Photo Direction:</b> South	
<b>Photo Description:</b>  View of the remediated area following backfilling and regrading.

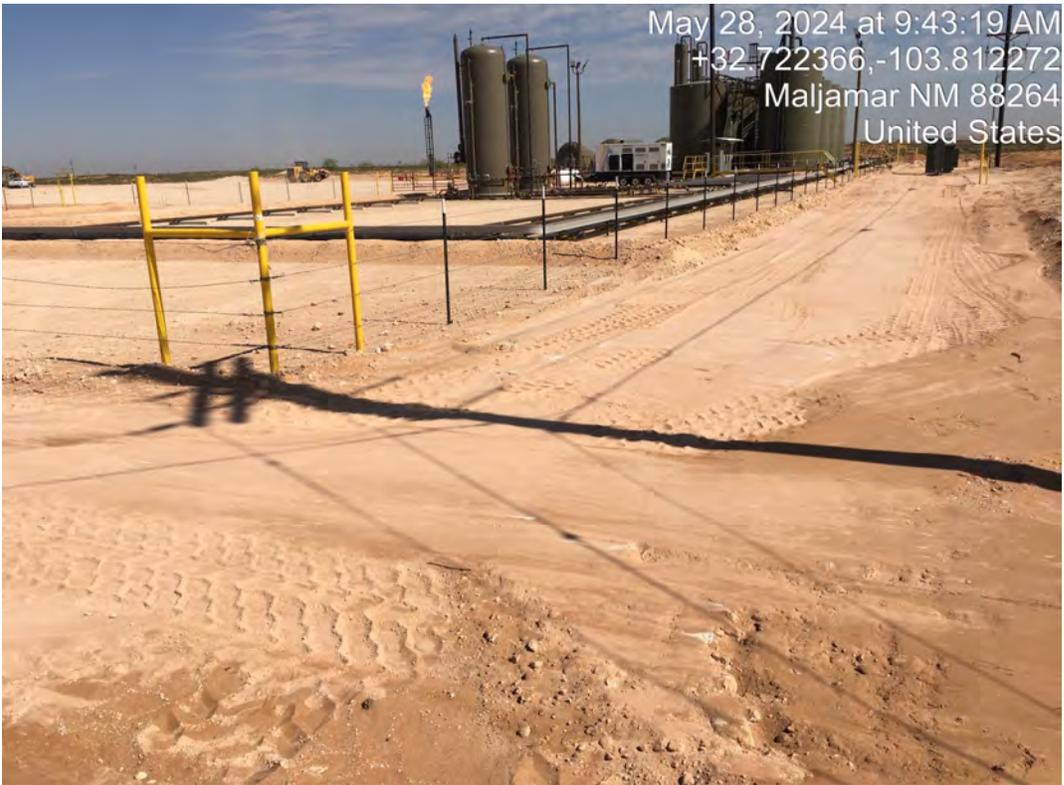
<b>Photo Number:</b> 14

<p>May 28, 2024 at 9:43:19 AM +32.722366,-103.812272 Maljamar NM 88264 United States</p>
<b>Photo Direction:</b> North-Northwest	
<b>Photo Description:</b>  View of the remediated area following backfilling and regrading.
