# Remediation Summary & Soil Closure Request

## Mewbourne Oil Company Thundercloud 30/29 Battery #1

Lea County, New Mexico  
Unit Letter "D", Section 30, Township 18 South, Range 32 East  
Latitude 32.722926 North, Longitude 103.812344 West  
NMOCD Reference No. nAPP2408651560

**Etech Environmental & Safety Solutions, Inc.**  
6309 Indiana Ave, Ste. D  
Lubbock, Texas 79413

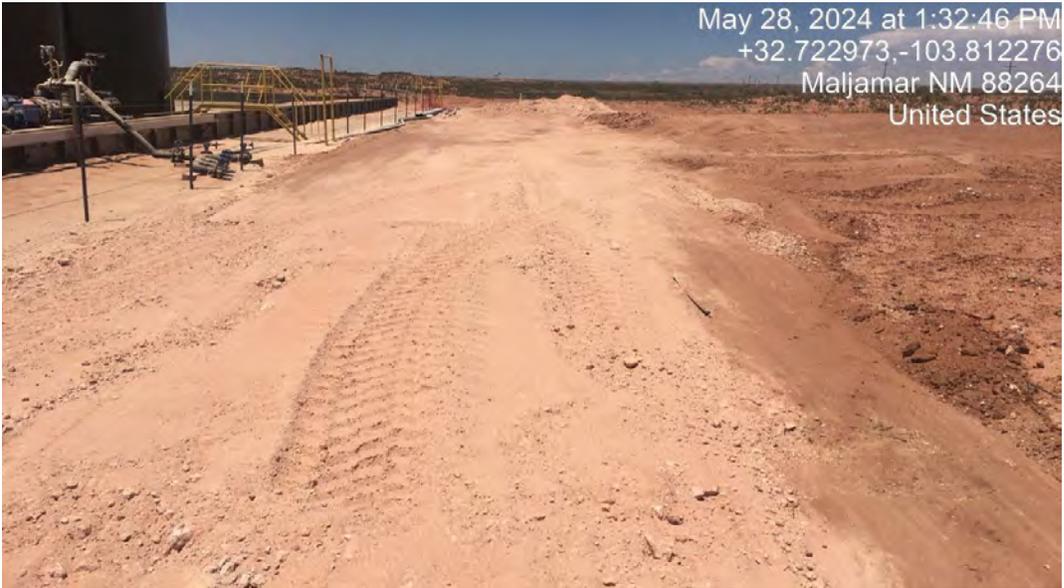
<b>Photo Number:</b> 15

<p>May 28, 2024 at 1:32:46 PM +32.722973,-103.812276 Maljamar NM 88264 United States</p>
<b>Photo Direction:</b> North	
<b>Photo Description:</b>  View of the remediated area following backfilling and regrading.

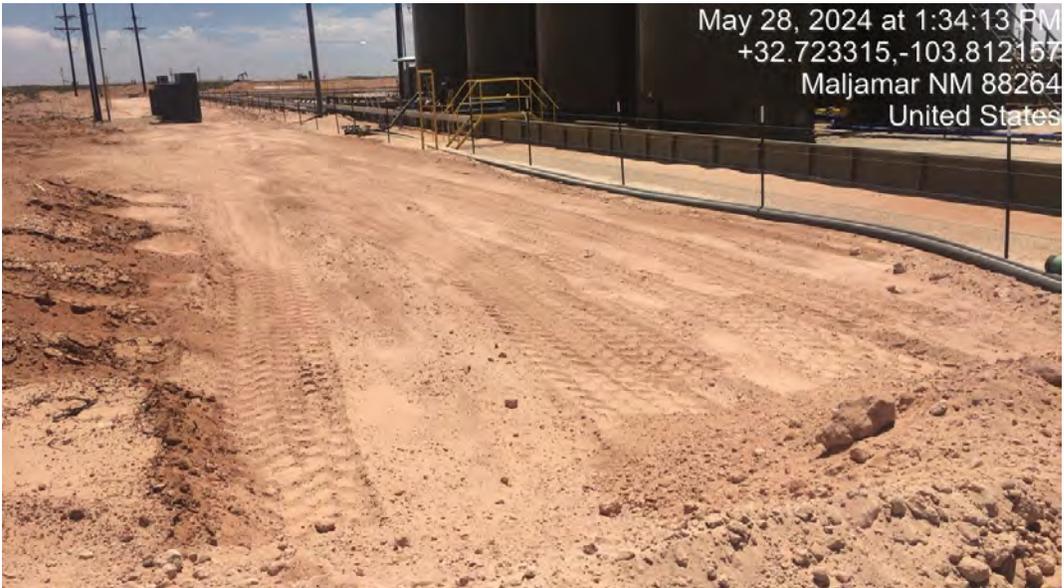
<b>Photo Number:</b> 16

<p>May 28, 2024 at 1:34:13 PM +32.723315,-103.812157 Maljamar NM 88264 United States</p>
<b>Photo Direction:</b> South-Southwest	
<b>Photo Description:</b>  View of the remediated area following backfilling and regrading.
