## Remediation Summary & Soil Closure Request

**XTO Energy, Inc.**

**ADU 226**

**NMOCD Reference No. nAPP2409551506**

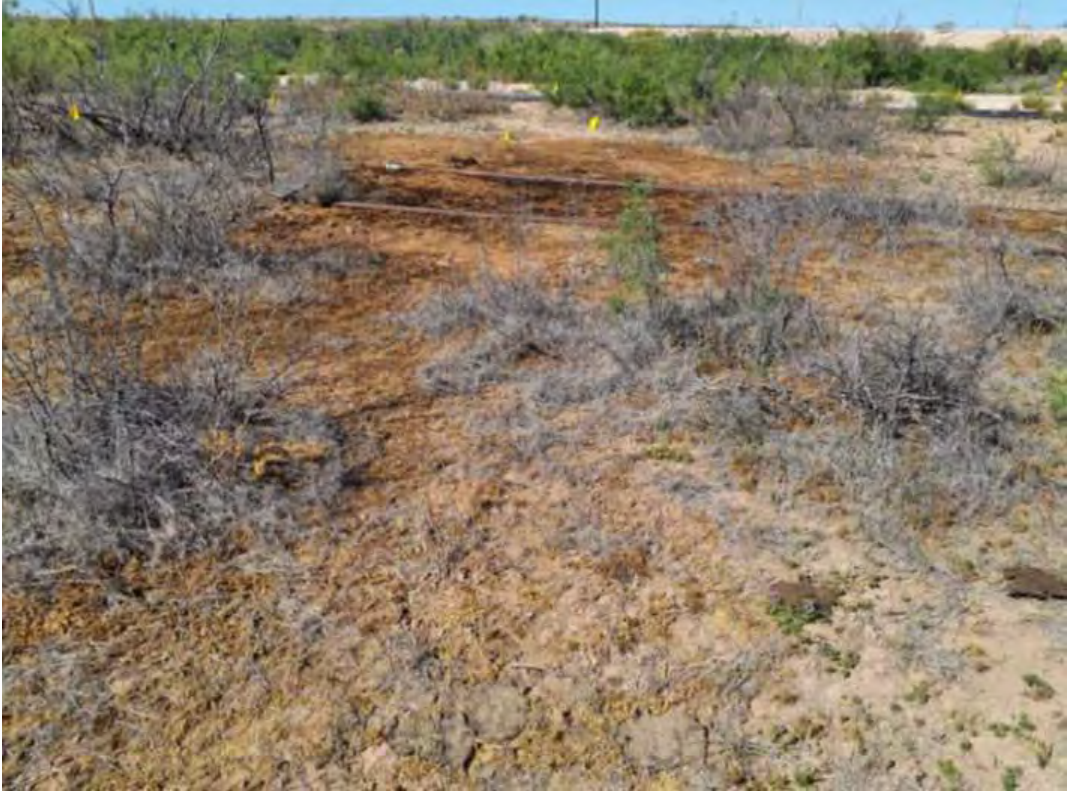
<b>Photo Number:</b> 1

<b>Photo Direction:</b> Southwest	
<b>Coordinates:</b> 32.539132,-104.216376	
<b>Photo Description:</b>  View of the affected area.

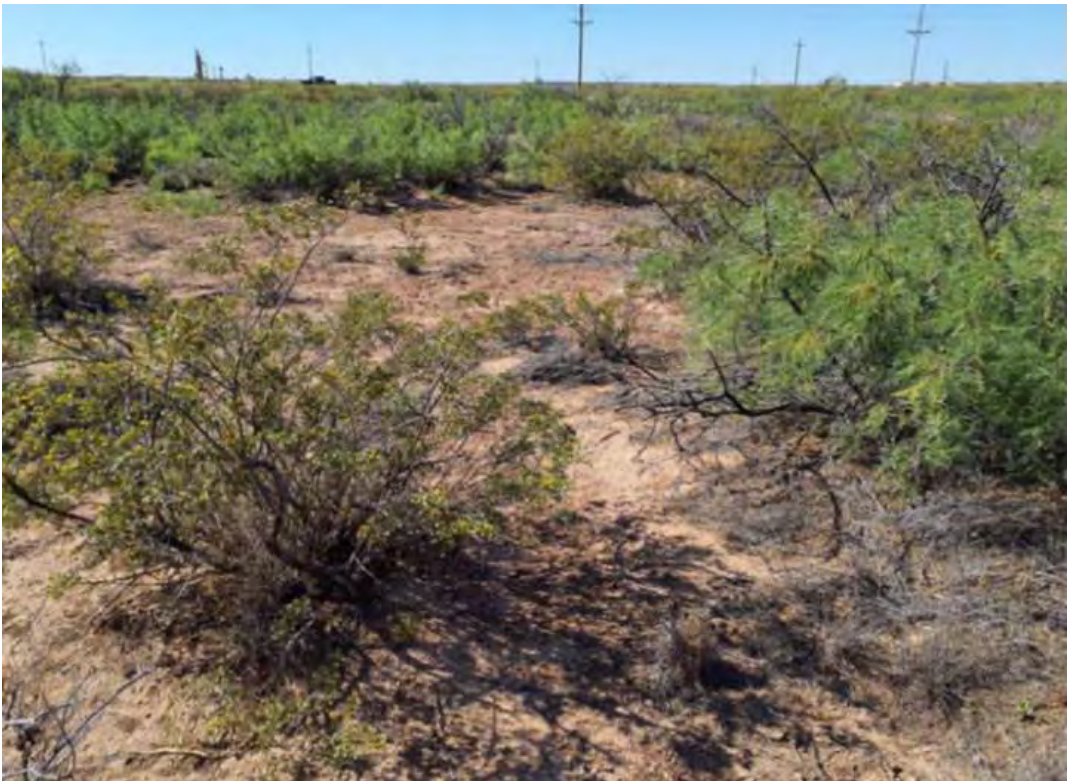
<b>Photo Number:</b> 2

<b>Photo Direction:</b> South	
<b>Coordinates:</b> 32.539135,-104.216303	
<b>Photo Description:</b>  View of the affected area.

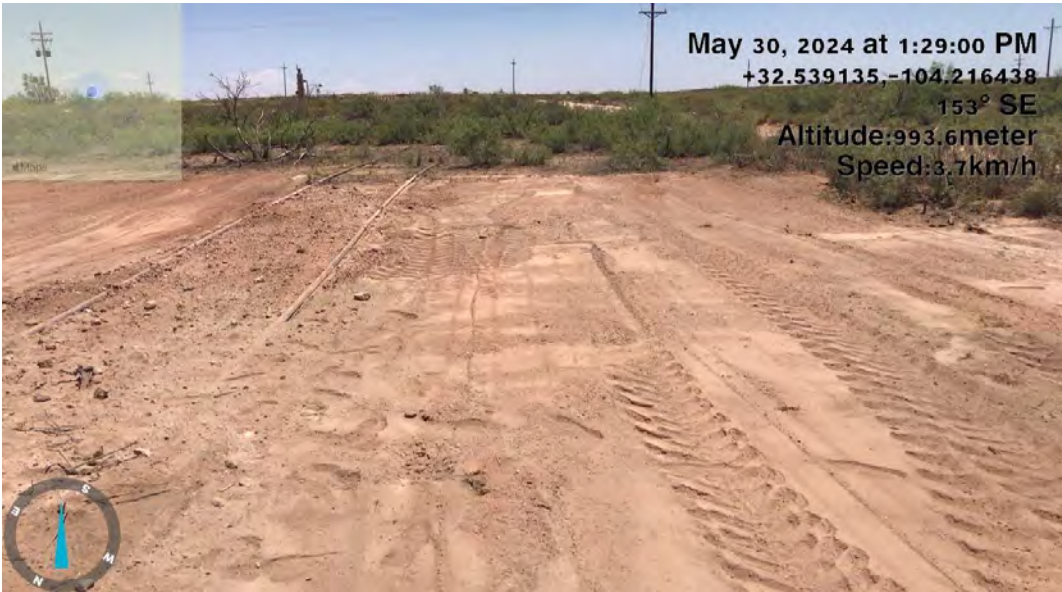
<b>Photo Number:</b> 7

<b>Photo Direction:</b> South-Southeast	
<b>Photo Description:</b>  View of the remediated area following backfilling and regrading.

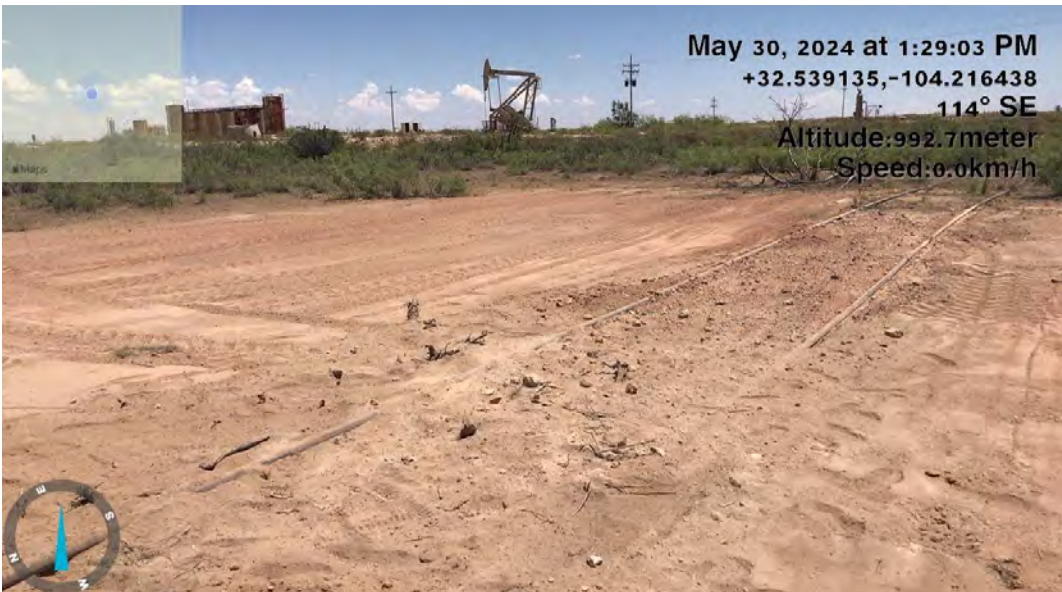
<b>Photo Number:</b> 8

<b>Photo Direction:</b> East-Southeast	
<b>Photo Description:</b>  View of the remediated area following backfilling and regrading.

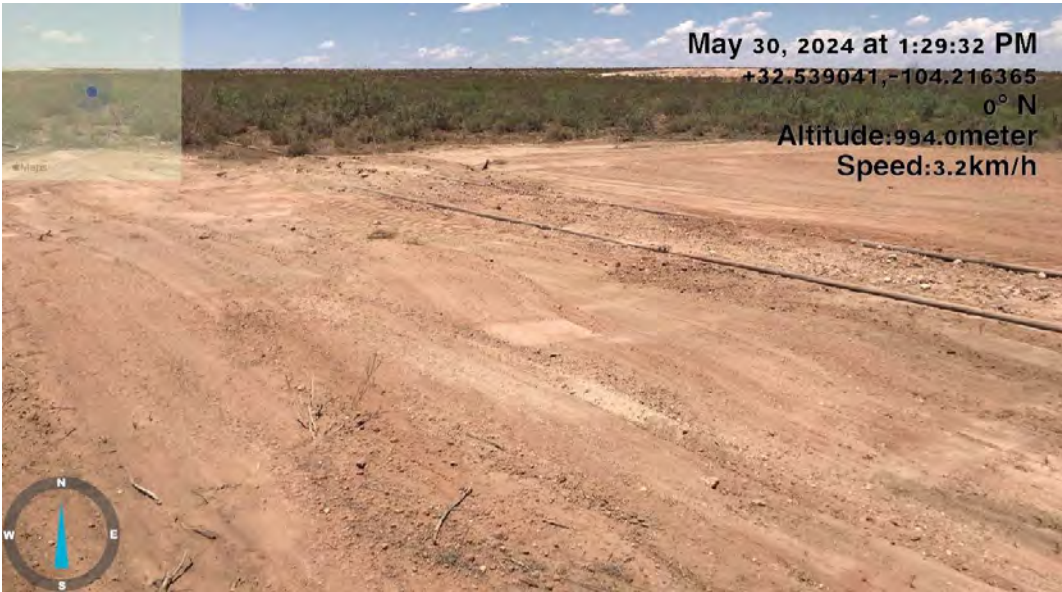
<b>Photo Number:</b> 9

<b>Photo Direction:</b> North	
<b>Photo Description:</b>  View of the remediated area following backfilling and regrading.

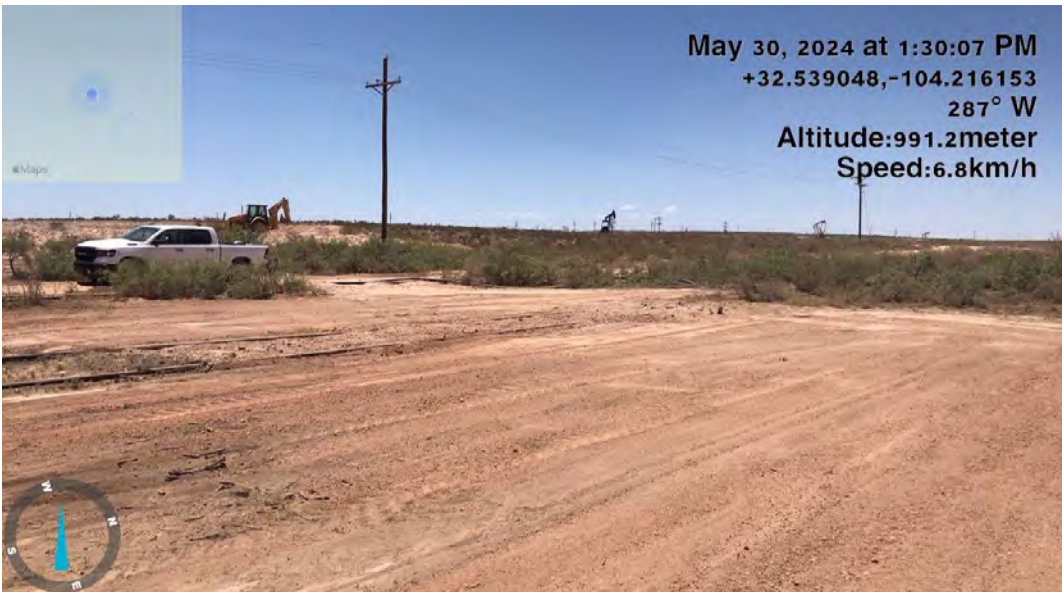
<b>Photo Number:</b> 10

<b>Photo Direction:</b> West-Northwest	
<b>Photo Description:</b>  View of the remediated area following backfilling and regrading.

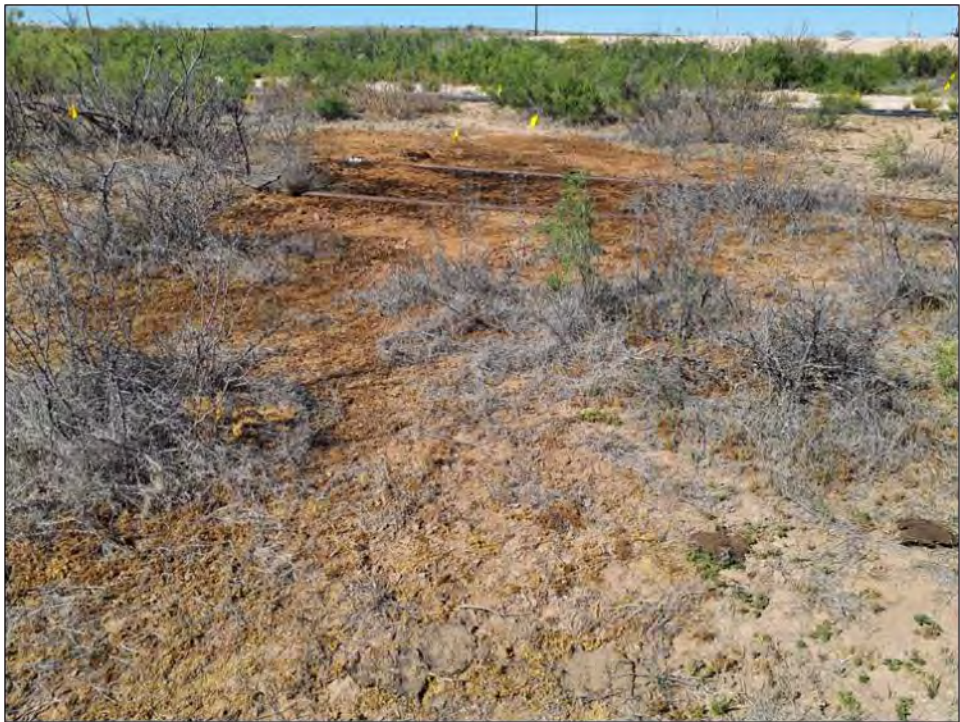
Figure 6. Project overview showing release area, facing southwest (Frame 8306).
