Closure Report

M- 10 17 Loop St HH #1 - 10" - PL - 06172024

Incident ID: NAPP2417032594

Lea County, New Mexico

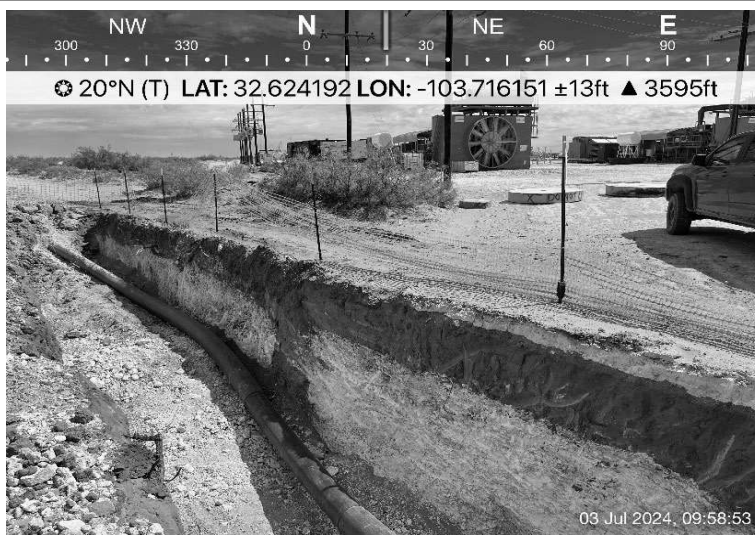
Photograph No. 1

View North, area of CS-1 through CS-4.

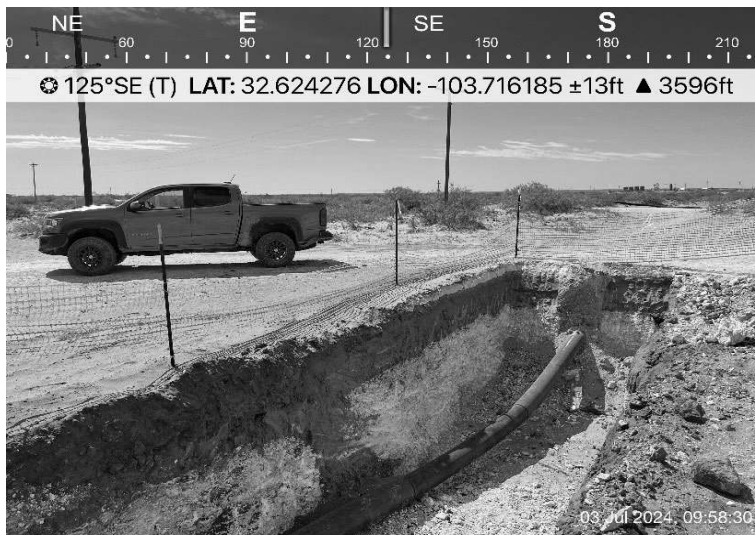
Photograph No. 2

View Southeast, area of CS-1 and CS-2.
