# Trinity Oilfield Services & Rentals, LLC

Re: **Remediation Plan Request**  
**Southeast Maljamar GB/SA Unit #410**  
**Tracking #: NAPP2401758024**

Trinity Oilfield Services (Trinity), on behalf of Cross Timbers Energy, LLC, hereby submits the following Remediation Plan Request in response to a release that occurred at the above-referenced location, and further described below.

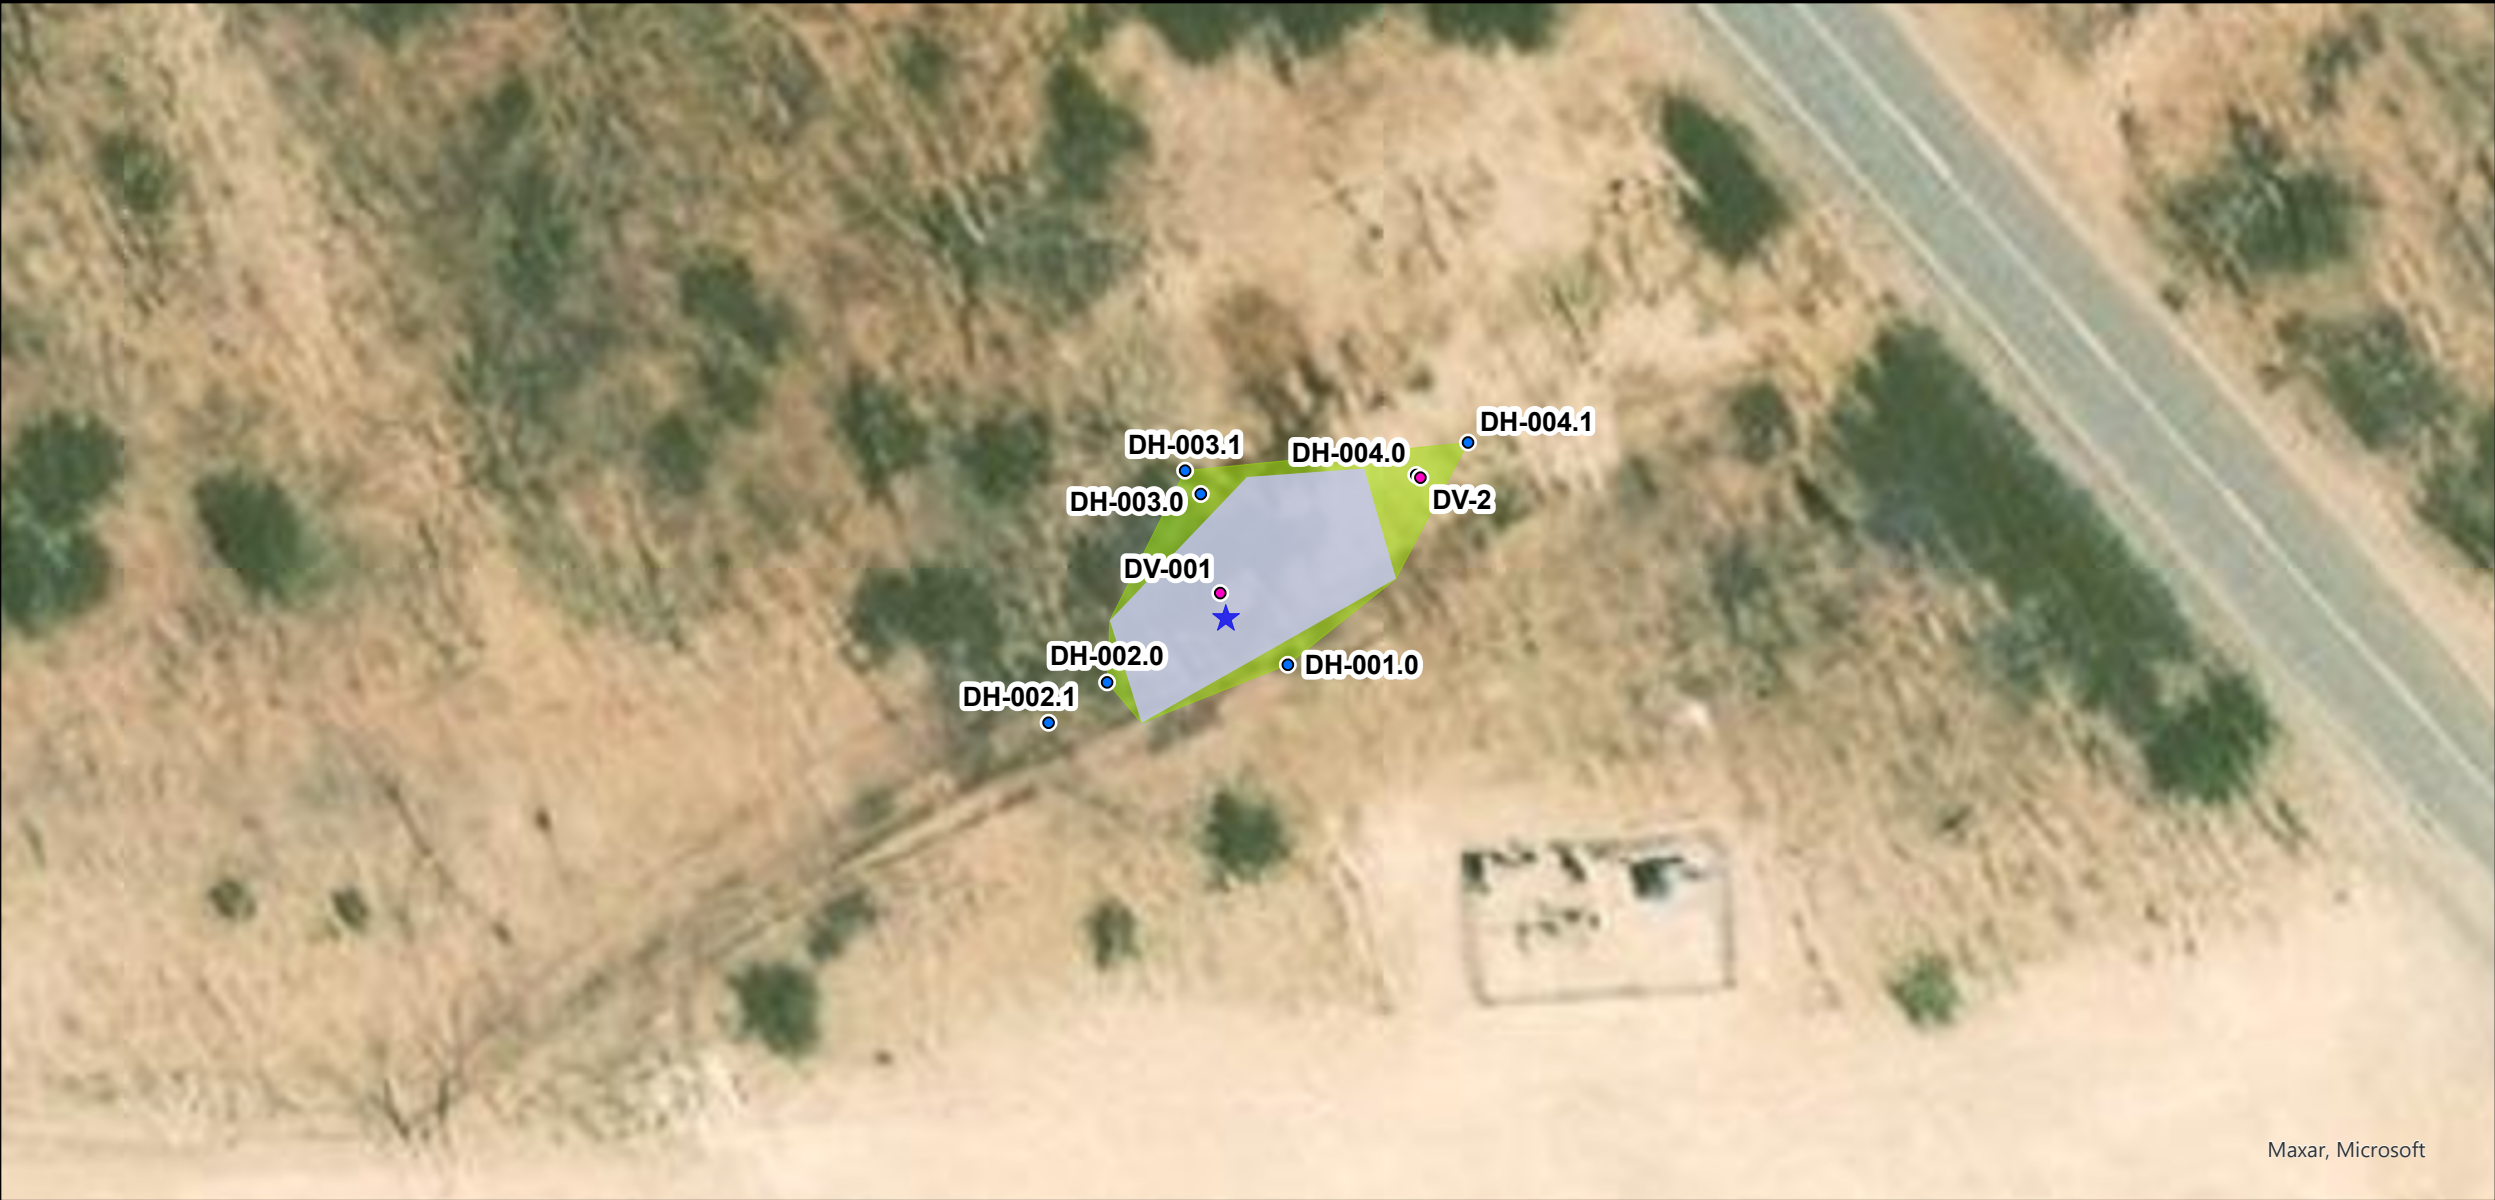
**Delineation Map**  
**Cross Timbers Energy, LLC**  
**Southeast Maljamar GB/SA Unit #410**  
**Lea County, New Mexico**  
**32.803999, -103.690407**  
**NMOCD Reference # NAPP2401758024**

Delineation Summary	
Delineation Dates	01/23/2024 - 03/15/2024
Depths Sampled	0' - 4'
Delineation Map	Attached
Laboratory Results	Table 1

<b>Remediation Summary</b>	
Remediation Dates	Within 90 Days of NMOCD Approval
Liner Variance Request	None
Deferral Request	None
Proposed Depths Excavated	4'
Proposed Area of 5-point Confirmation Samples – Floors and Walls	200 sqft.
Estimated Total Volume of Excavated Soil	240 yards

Impacted soil within the release margins will be excavated and temporarily stockpiled on-site on a 6-mil plastic sheeting, pending final disposition. Unless a Variance Request has been approved, all floors and walls of the excavated area will be advanced until laboratory analytical results from confirmation soil samples indicate Chloride, Benzene, BTEX, and TPH concentrations meet reclamation standards and are below the RRAL NMOCD Closure Criteria listed in the Table above at 4'. Confirmation soil samples (five-point composites representing no more than 200 sqft. of the excavated area) will be collected from the floor and sidewalls.

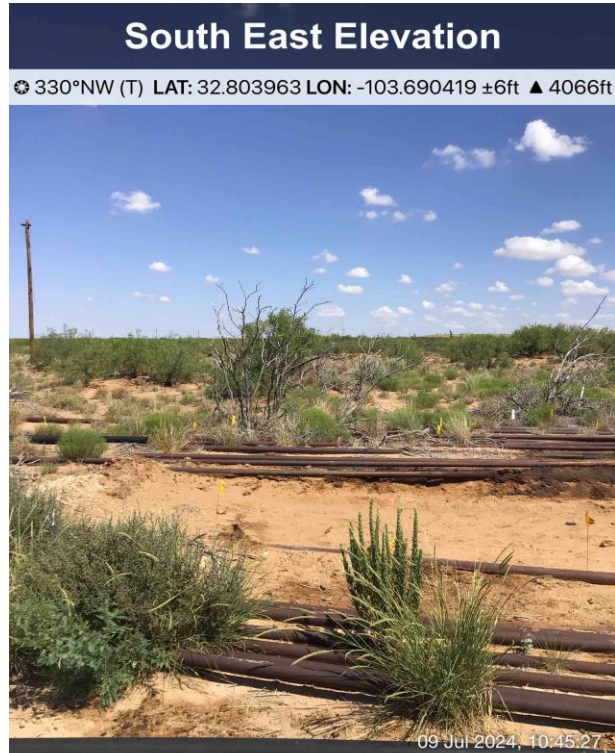
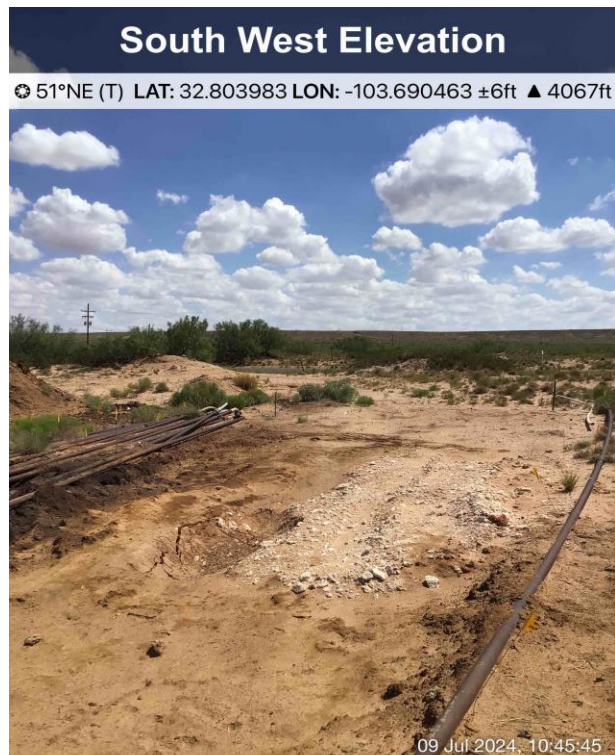
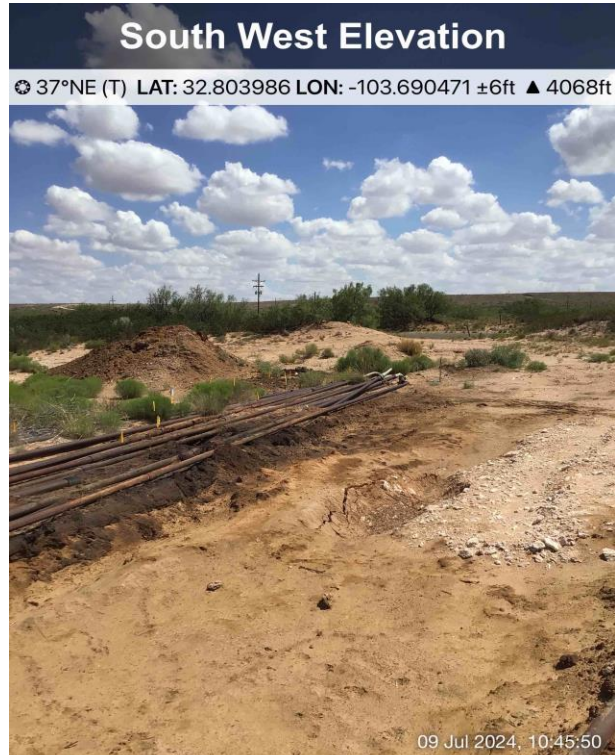
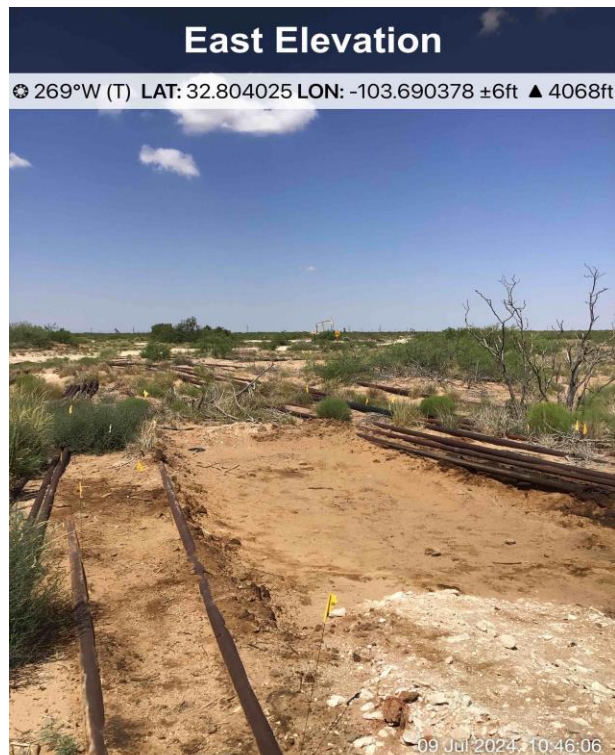
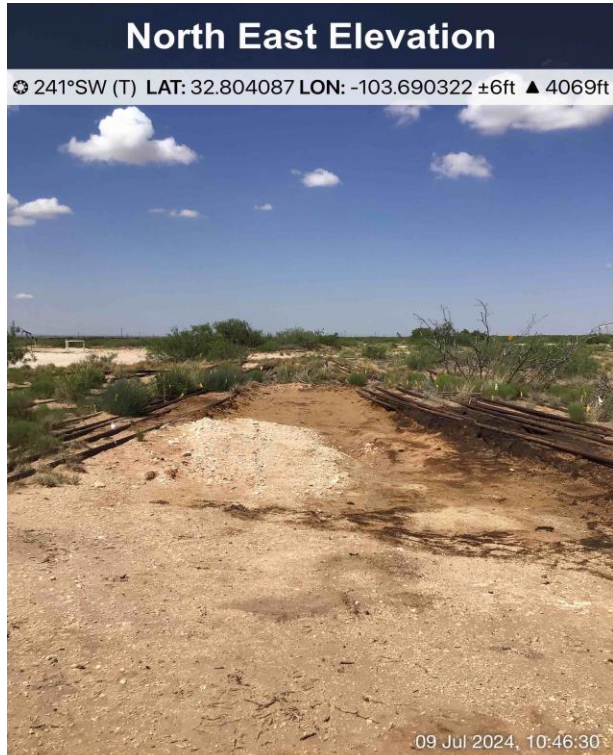
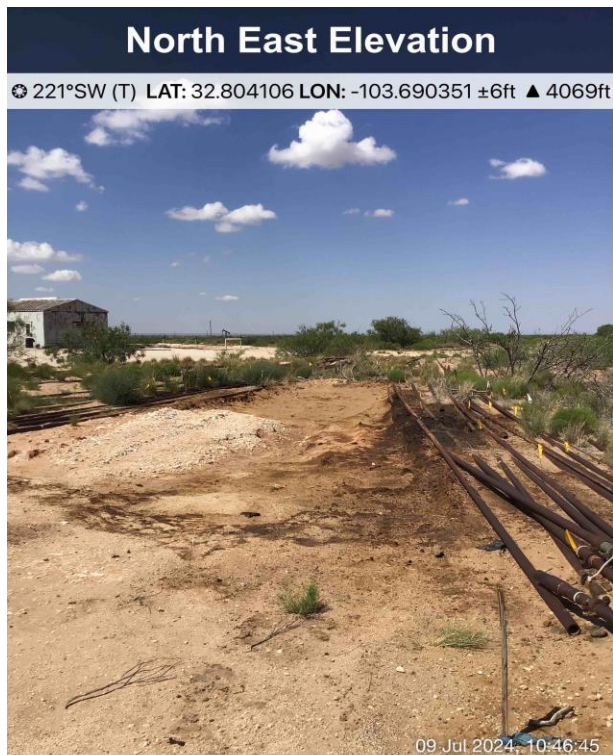
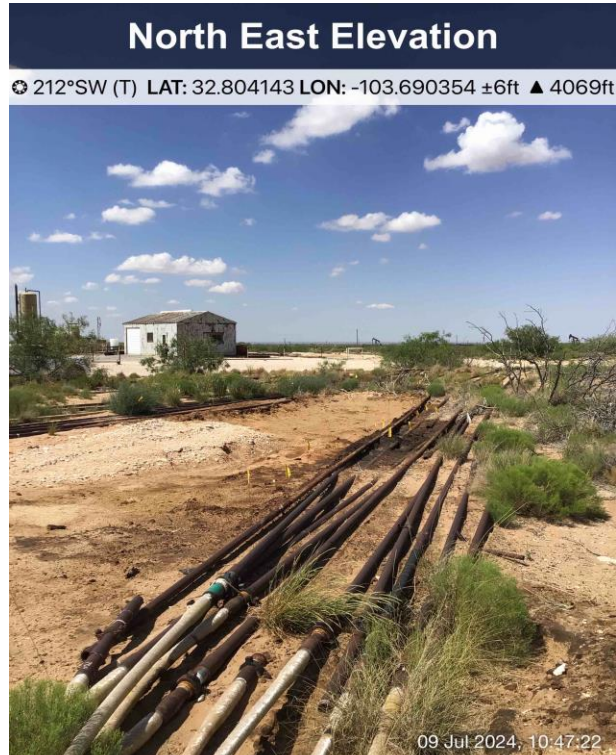
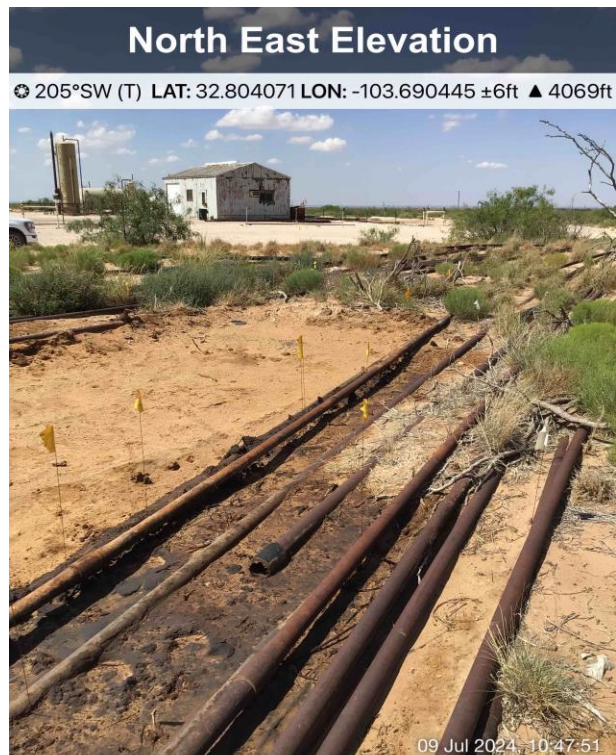
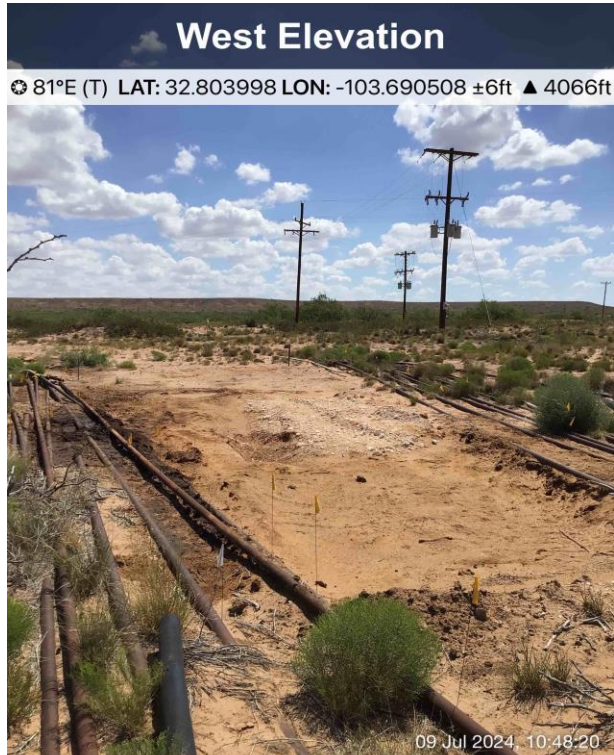
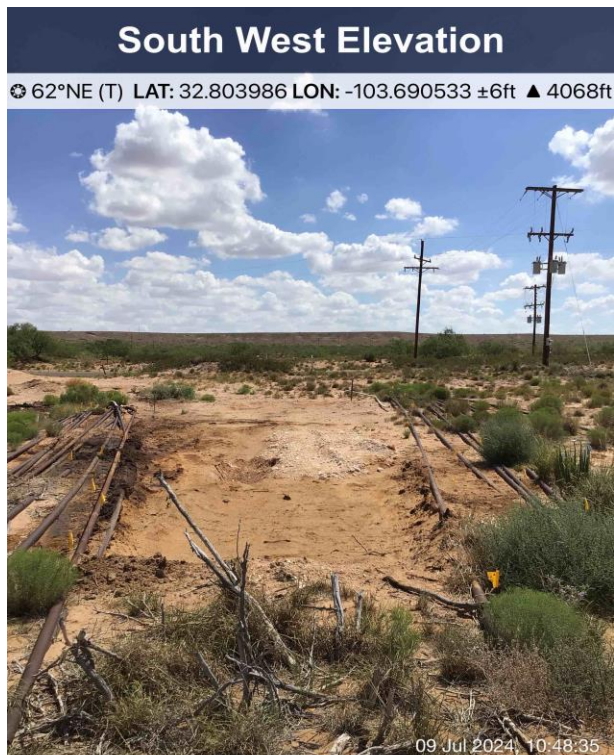
## Initial Release

On 01/17/2024, Cross Timbers Energy, LLC reported a release at the Southeast Maljamar GB/SA Unit #410. The release was caused by a freeze. Approximately 1,109 sqft. of the Pasture was found to be damp upon initial inspection.
