Remediation Summary and Closure Request

Murchison Oil & Gas, LLC

Hightower State Unit #2

NMOCD Incident # nAPP2410253099

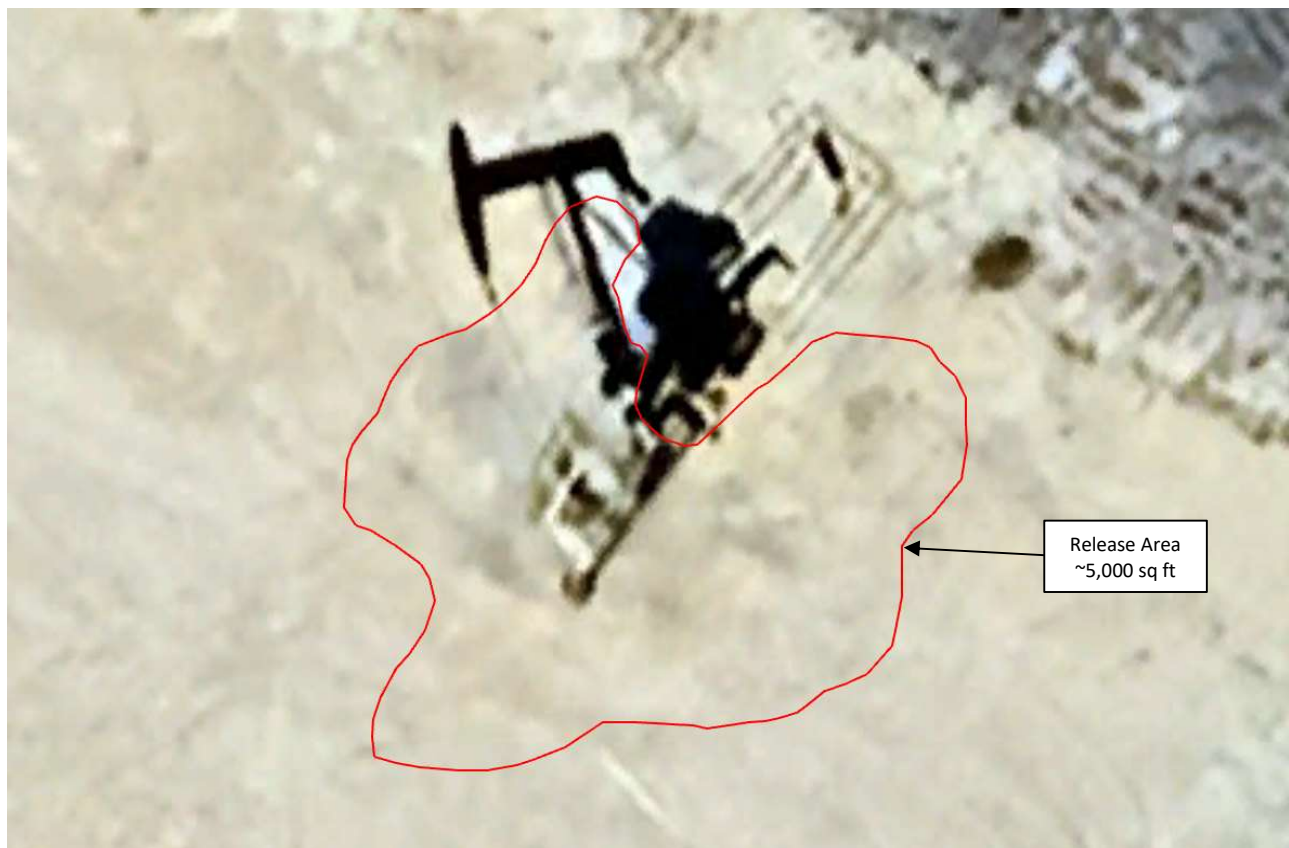
Volume Calculation

Location: Hightower State Unit #2

Fluid: Oil

Area: 5,000 (ft²)

Depth: 6.75 (in)

Porosity/Saturation: 0.03 %

Volume of oil released: 15.0 bbls

Volume of oil recovered: 10 bbls

Volume of liquid remaining in soil: 5.0 bbls

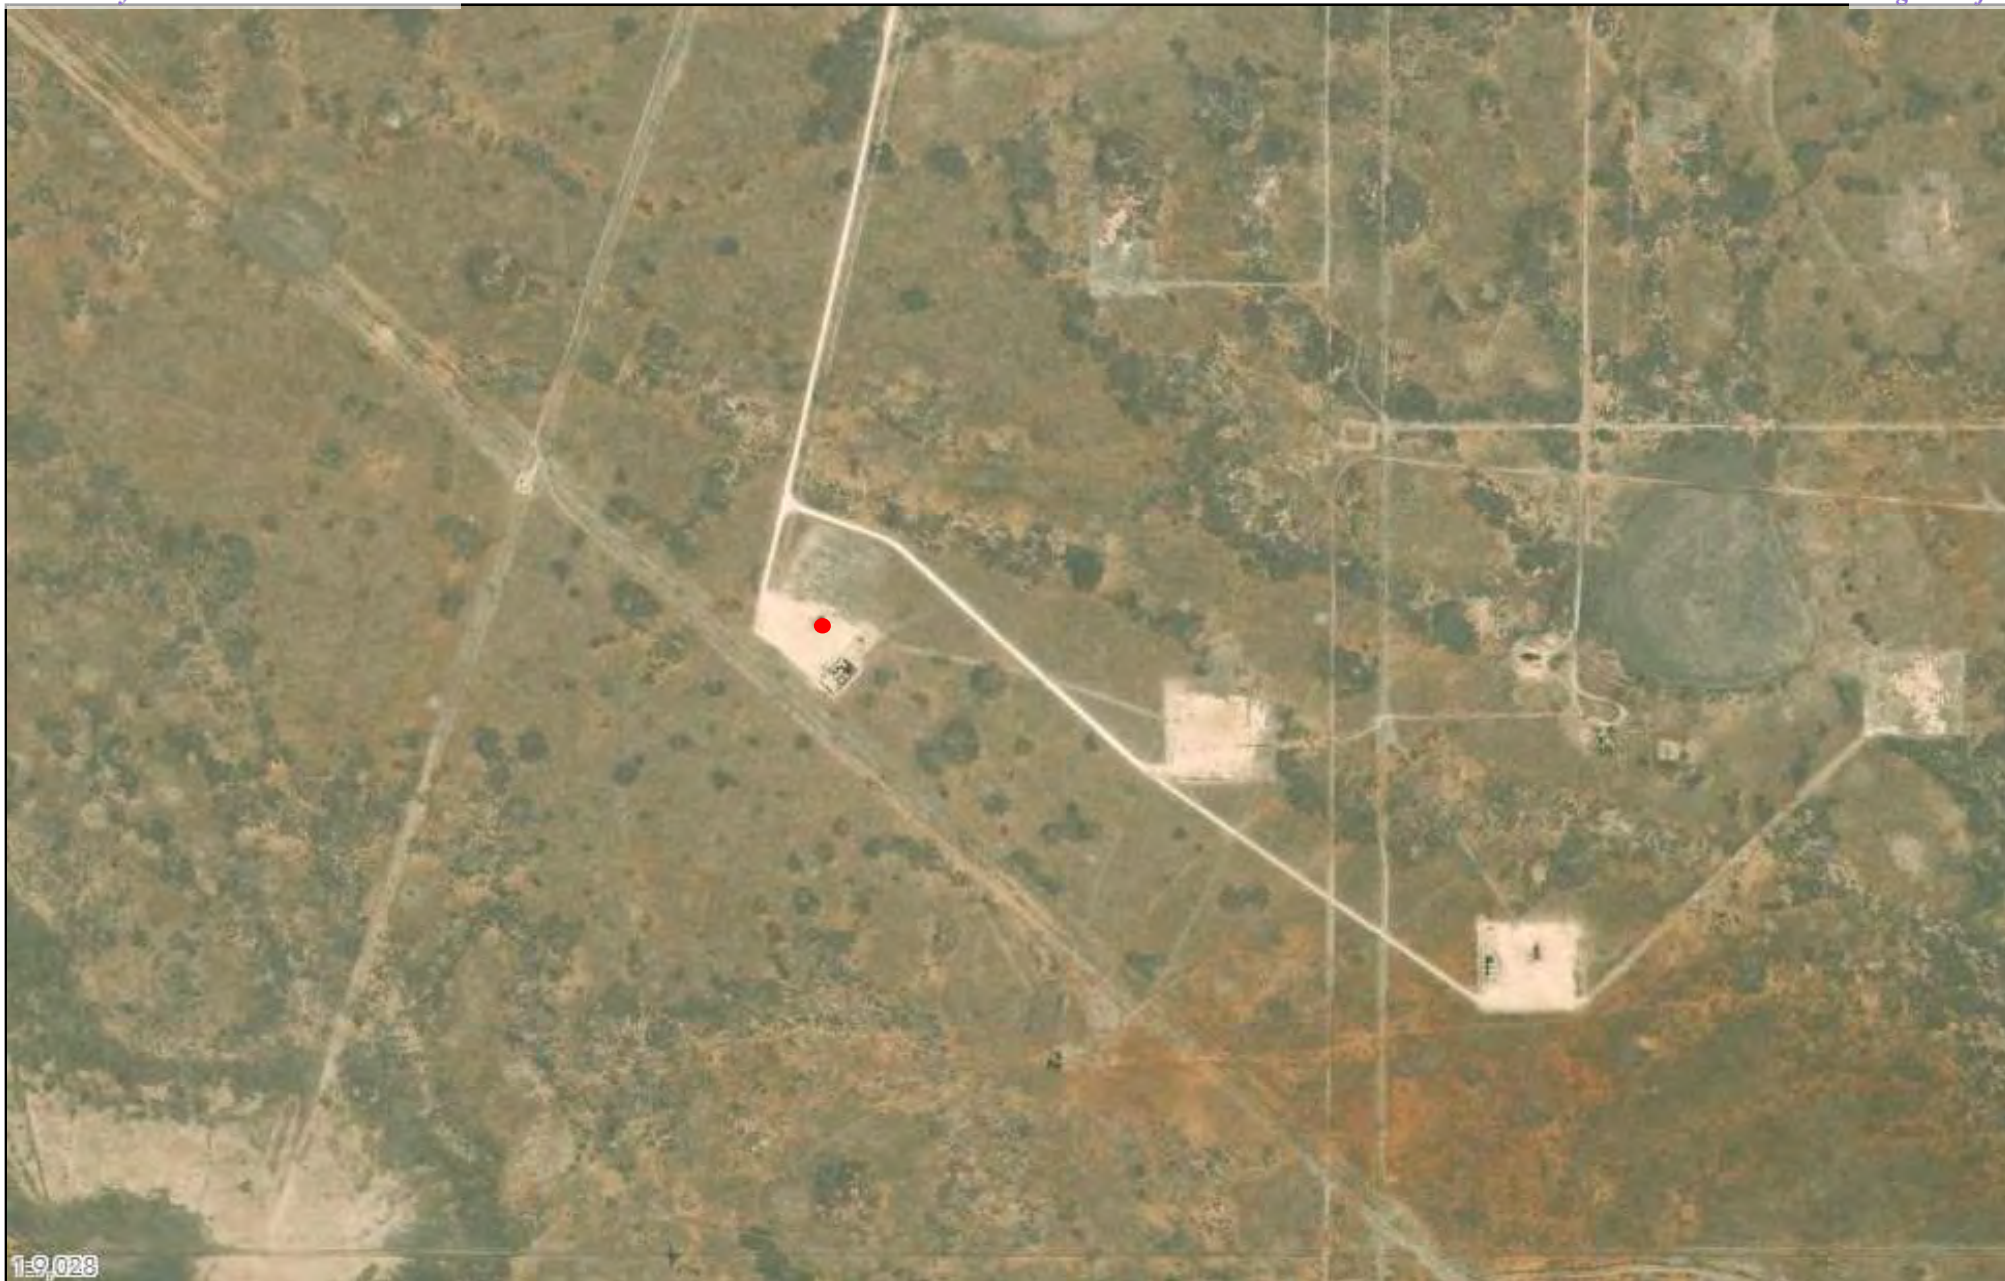
**Figure 2**

A search of the New Mexico Office of the State Engineer (NMOSE) and United States Geological Survey (USGS) groundwater databases was completed in an effort to determine the horizontal distance to known water sources within a half mile radius of the Release Site. Approximate depth to groundwater was determined using maintained and published water well data. Karst mapping indicates the site is located in an Erosional Karst designated area. Depth to groundwater information is provided as Attachment IV and the results are depicted on Figures 2 and 3.

OSE POD Locations Map
Murchison Oil & Gas
Hightower State Unit #2
GPS: 33.248184, -103.59864
Lea County

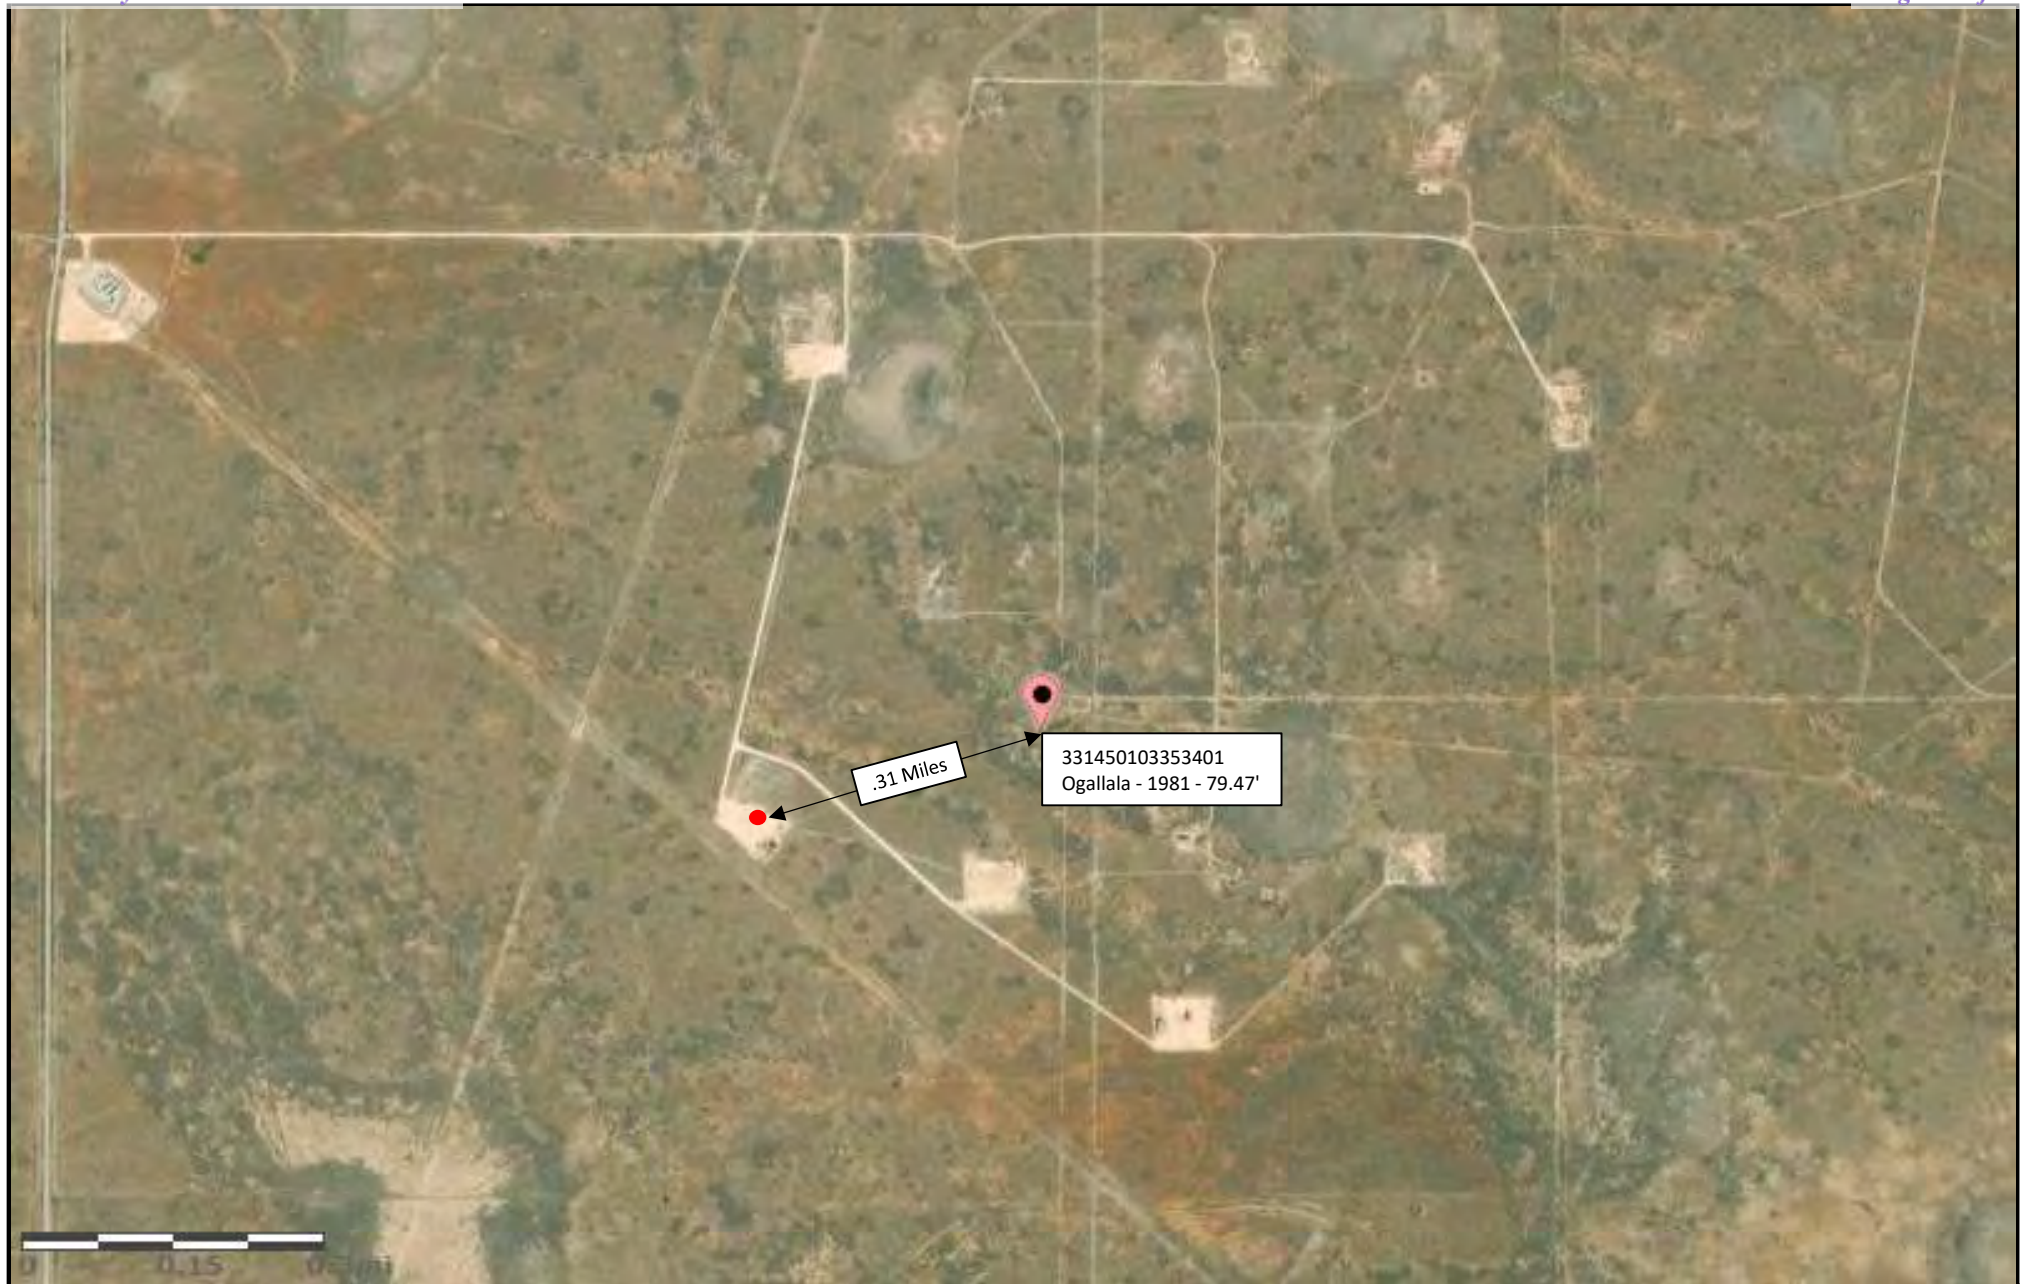
**Figure 3**

USGS Well Locations Map
Murchison Oil & Gas
Hightower State Unit #2
GPS: 33.248184, -103.59864
Lea County

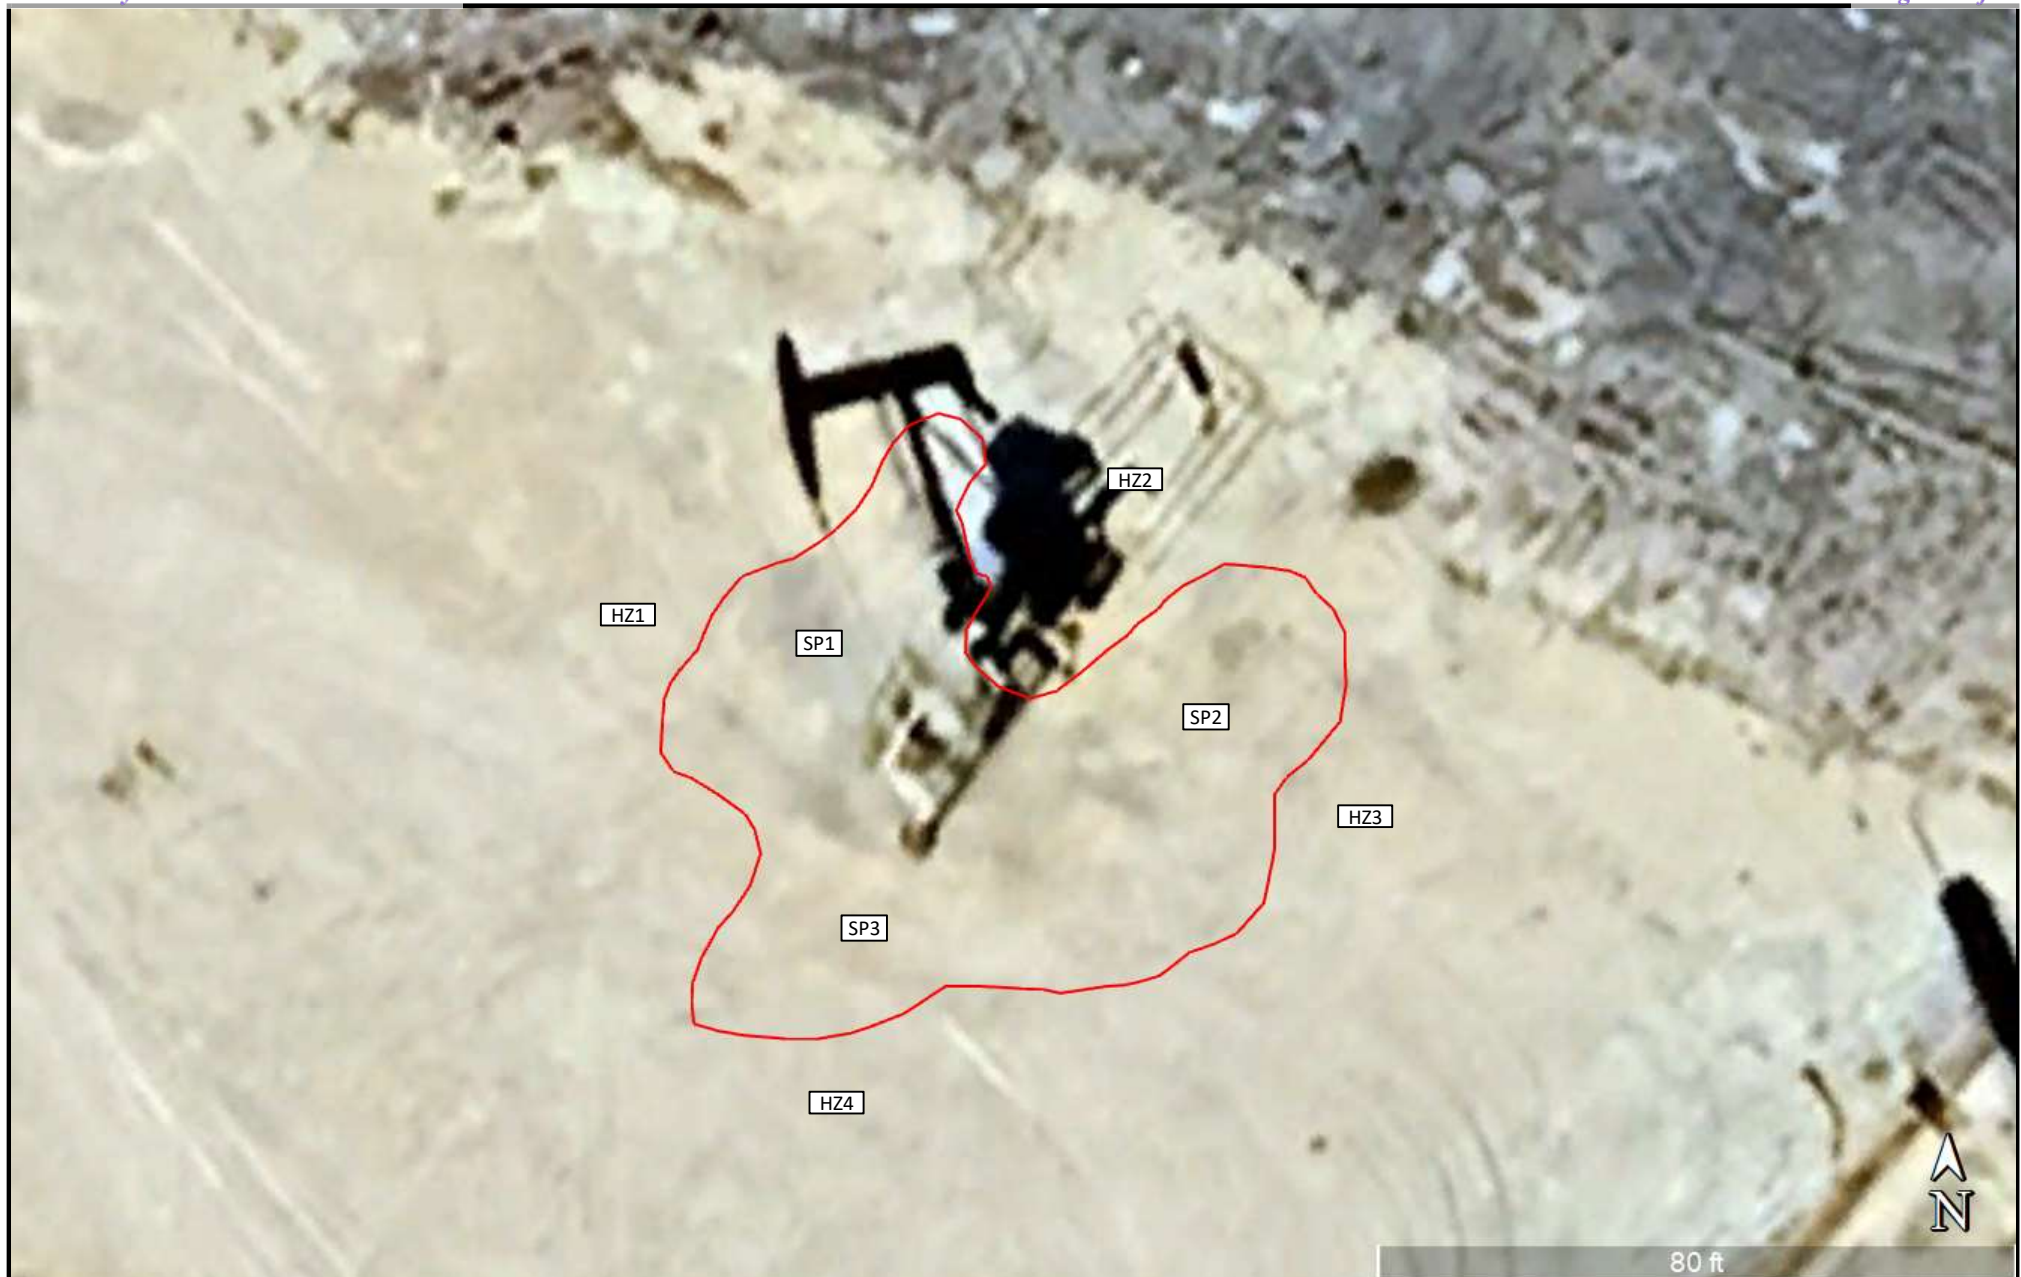
**Figure 4**

Based on field observations and field test data noted above and provided in Attachment V, eleven representative soil samples were selected for laboratory analysis. Delineation soil samples SP1 through SP3, and HZ1 through HZ4, were submitted to the laboratory for analysis of BTEX, TPH, and chloride. Laboratory analytical results indicated contaminant concentrations were below the NMOCD Closure Criteria in each of the submitted samples, with the exception of SP1, SP2, and SP3, each at Surface, which exhibited TPH and/or chloride concentrations in excess of NMOCD Closure Criteria.

Delineation Sample Map
Murchison Oil & Gas
Hightower State Unit #2
GPS: 33.248184, -103.59864
Lea County

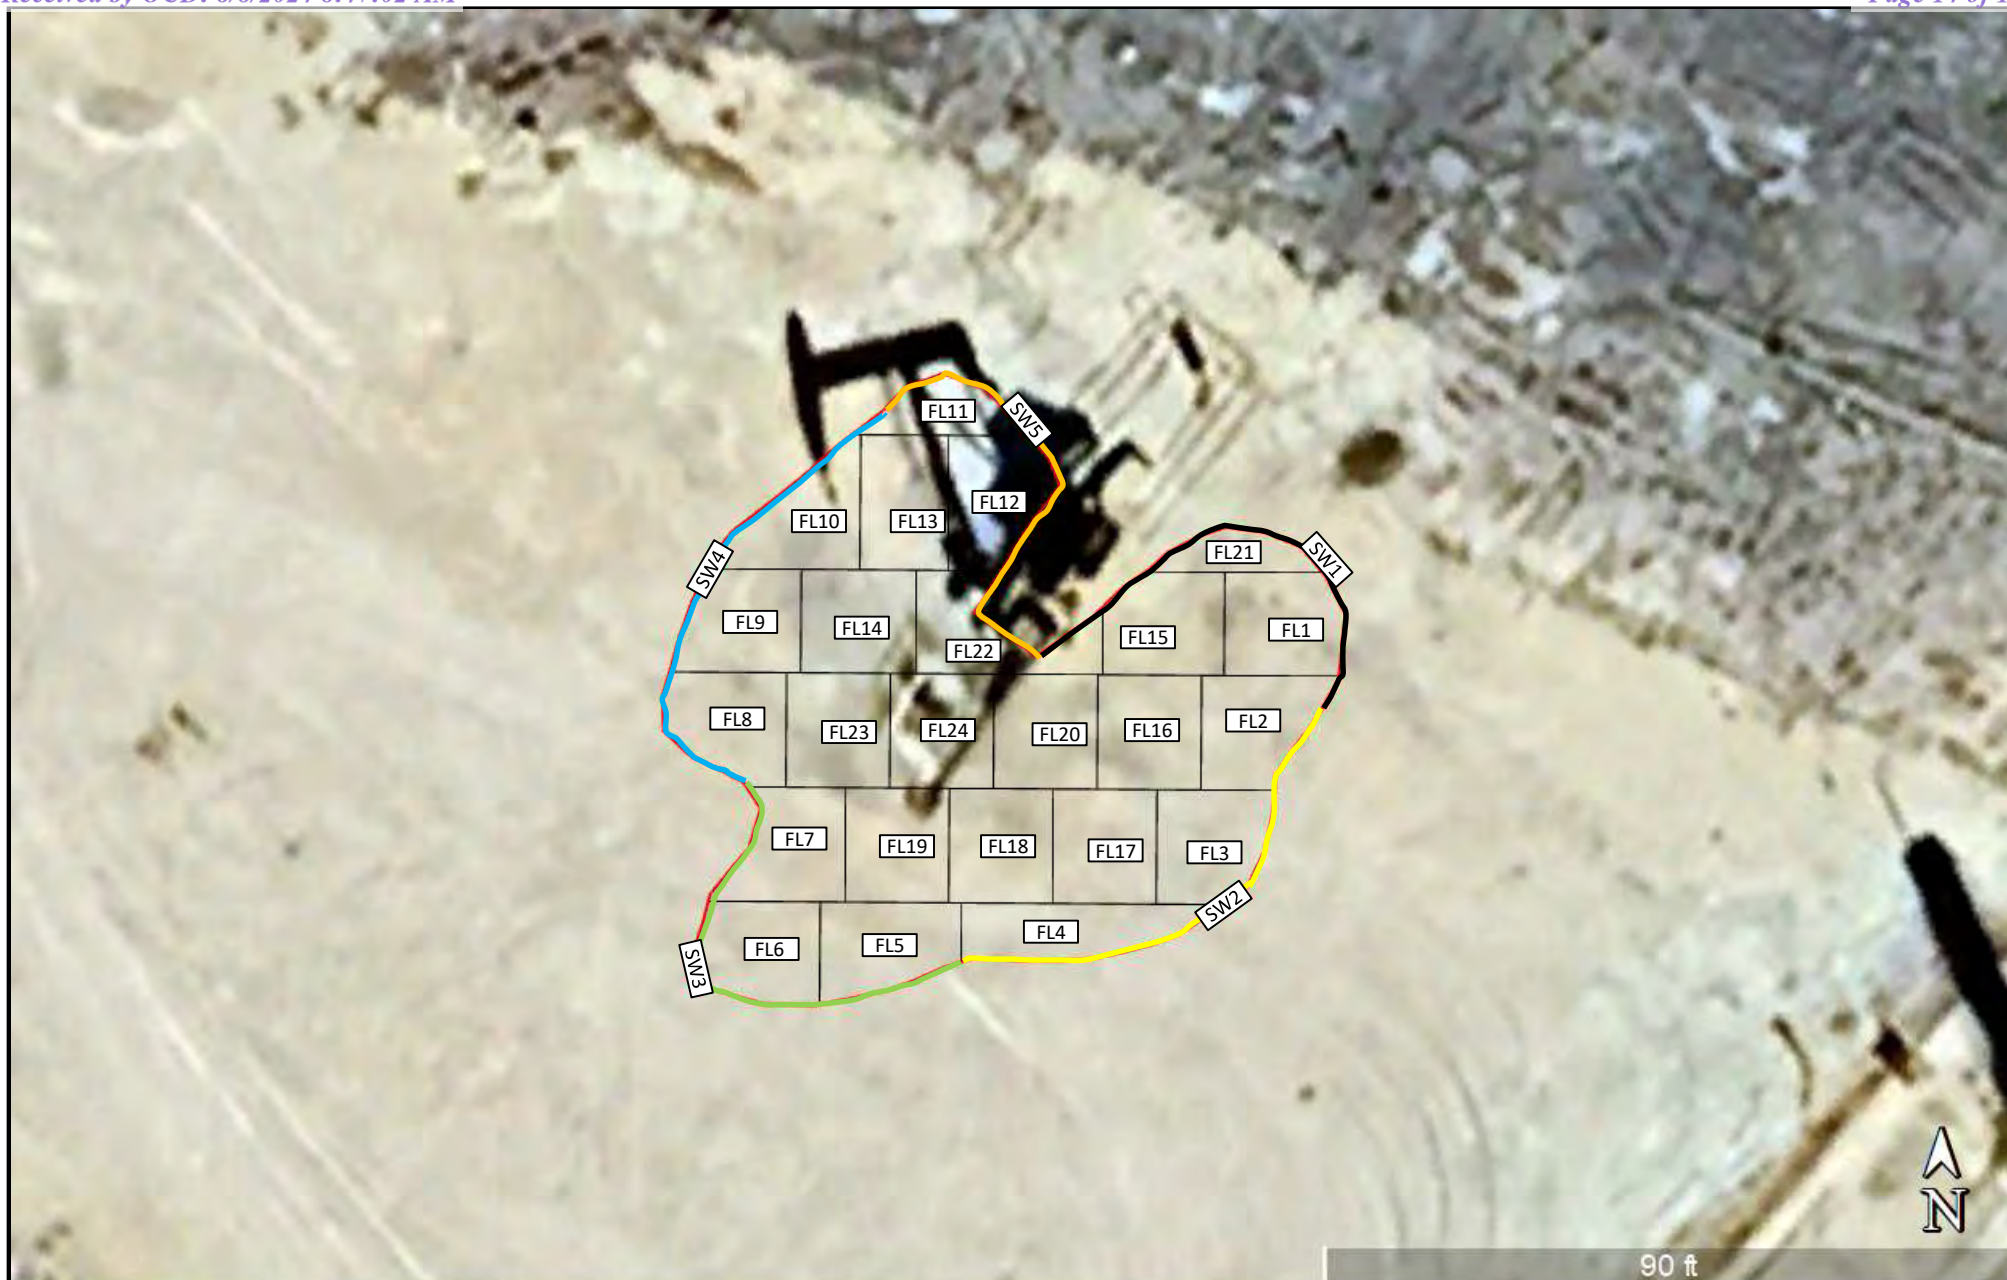
**Figure 5**

Excavation Sample Map
 Murchison Oil & Gas
 Hightower State Unit #2
 GPS: 33.248184, -103.59864
 Lea County
