LEAK #150

Remediation Action Plan

NMOCD Incident No. nAPP2335641154
UL "I", Sec. 19, T19S, R37E
32.283345°, -104.283345°
Lea County, New Mexico

August 13, 2024

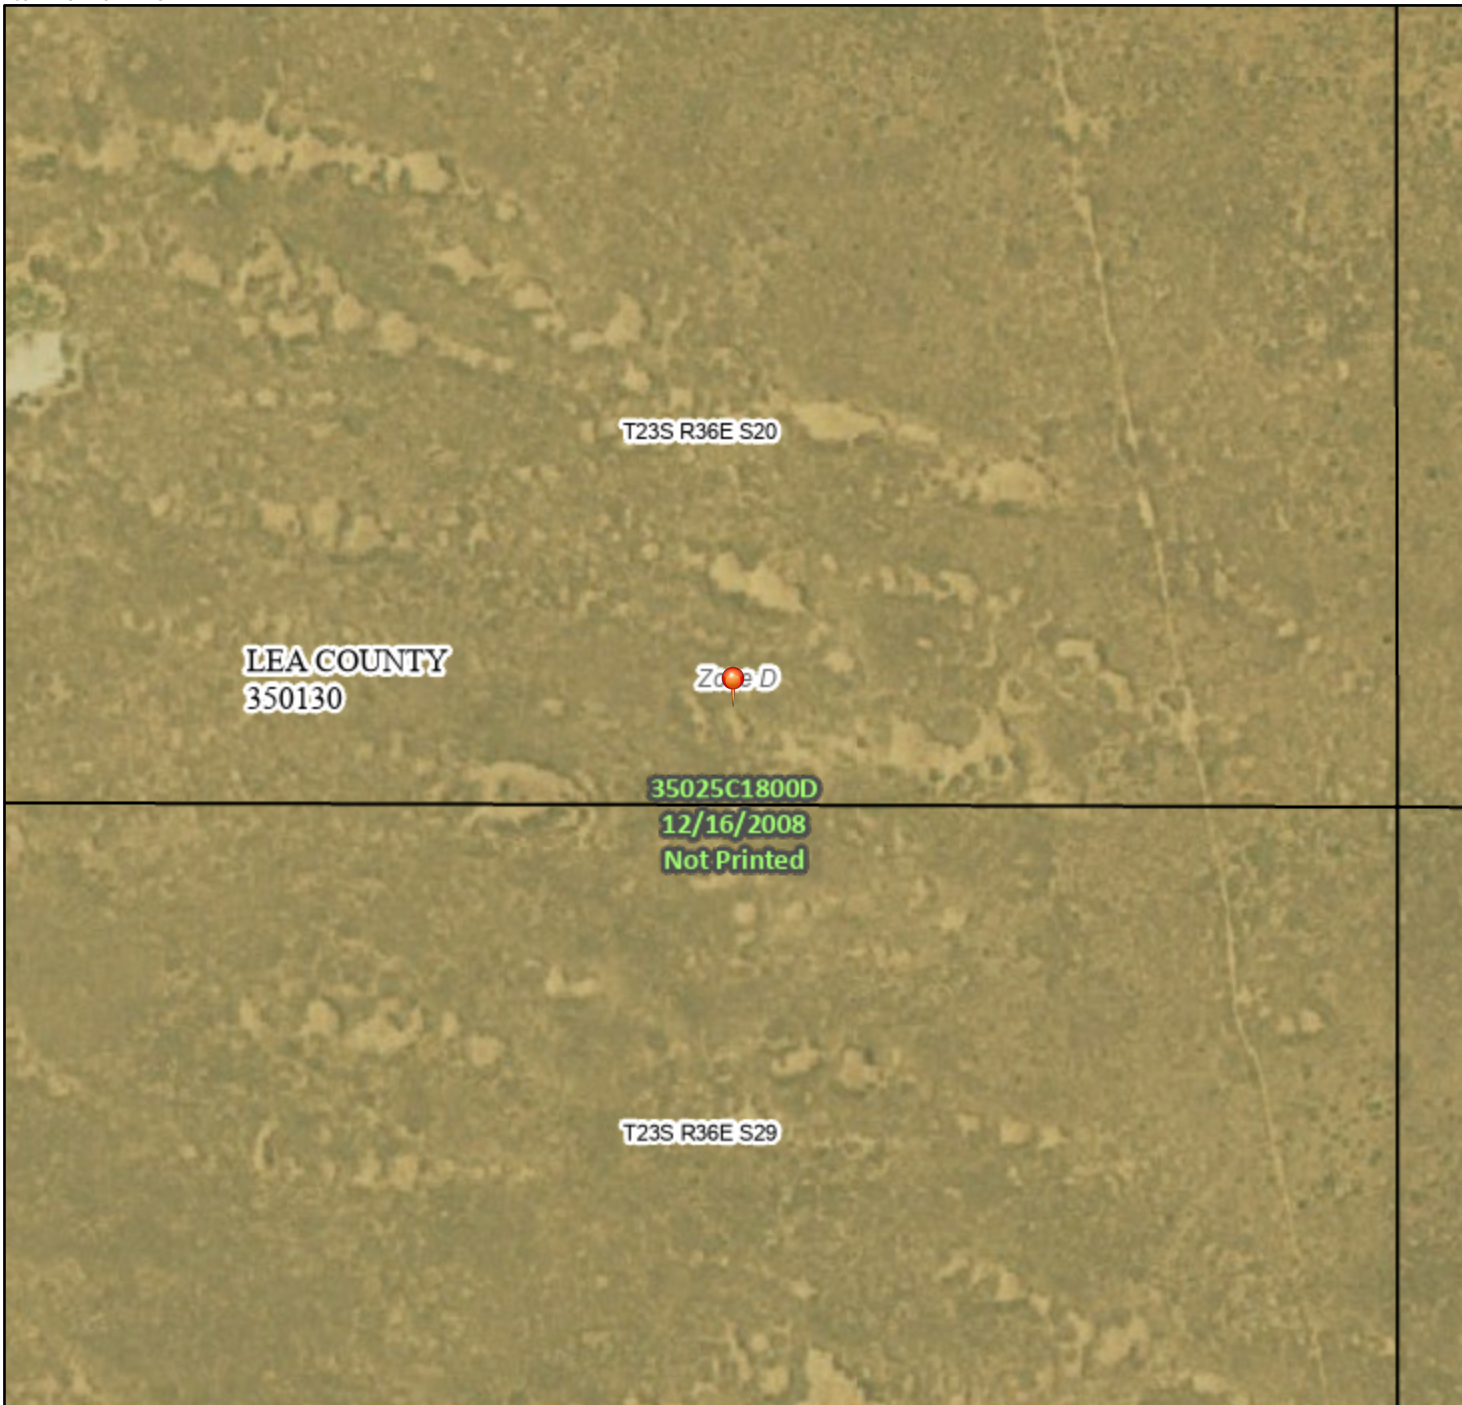
Review of flood map data published by the Federal Emergency Management Agency (FEMA) indicates the site is not located within a 100-year floodplain. A copy of the FEMA FIRMe Map

can be found attached as Figure 4.

National Flood Hazard Layer FIRMMette

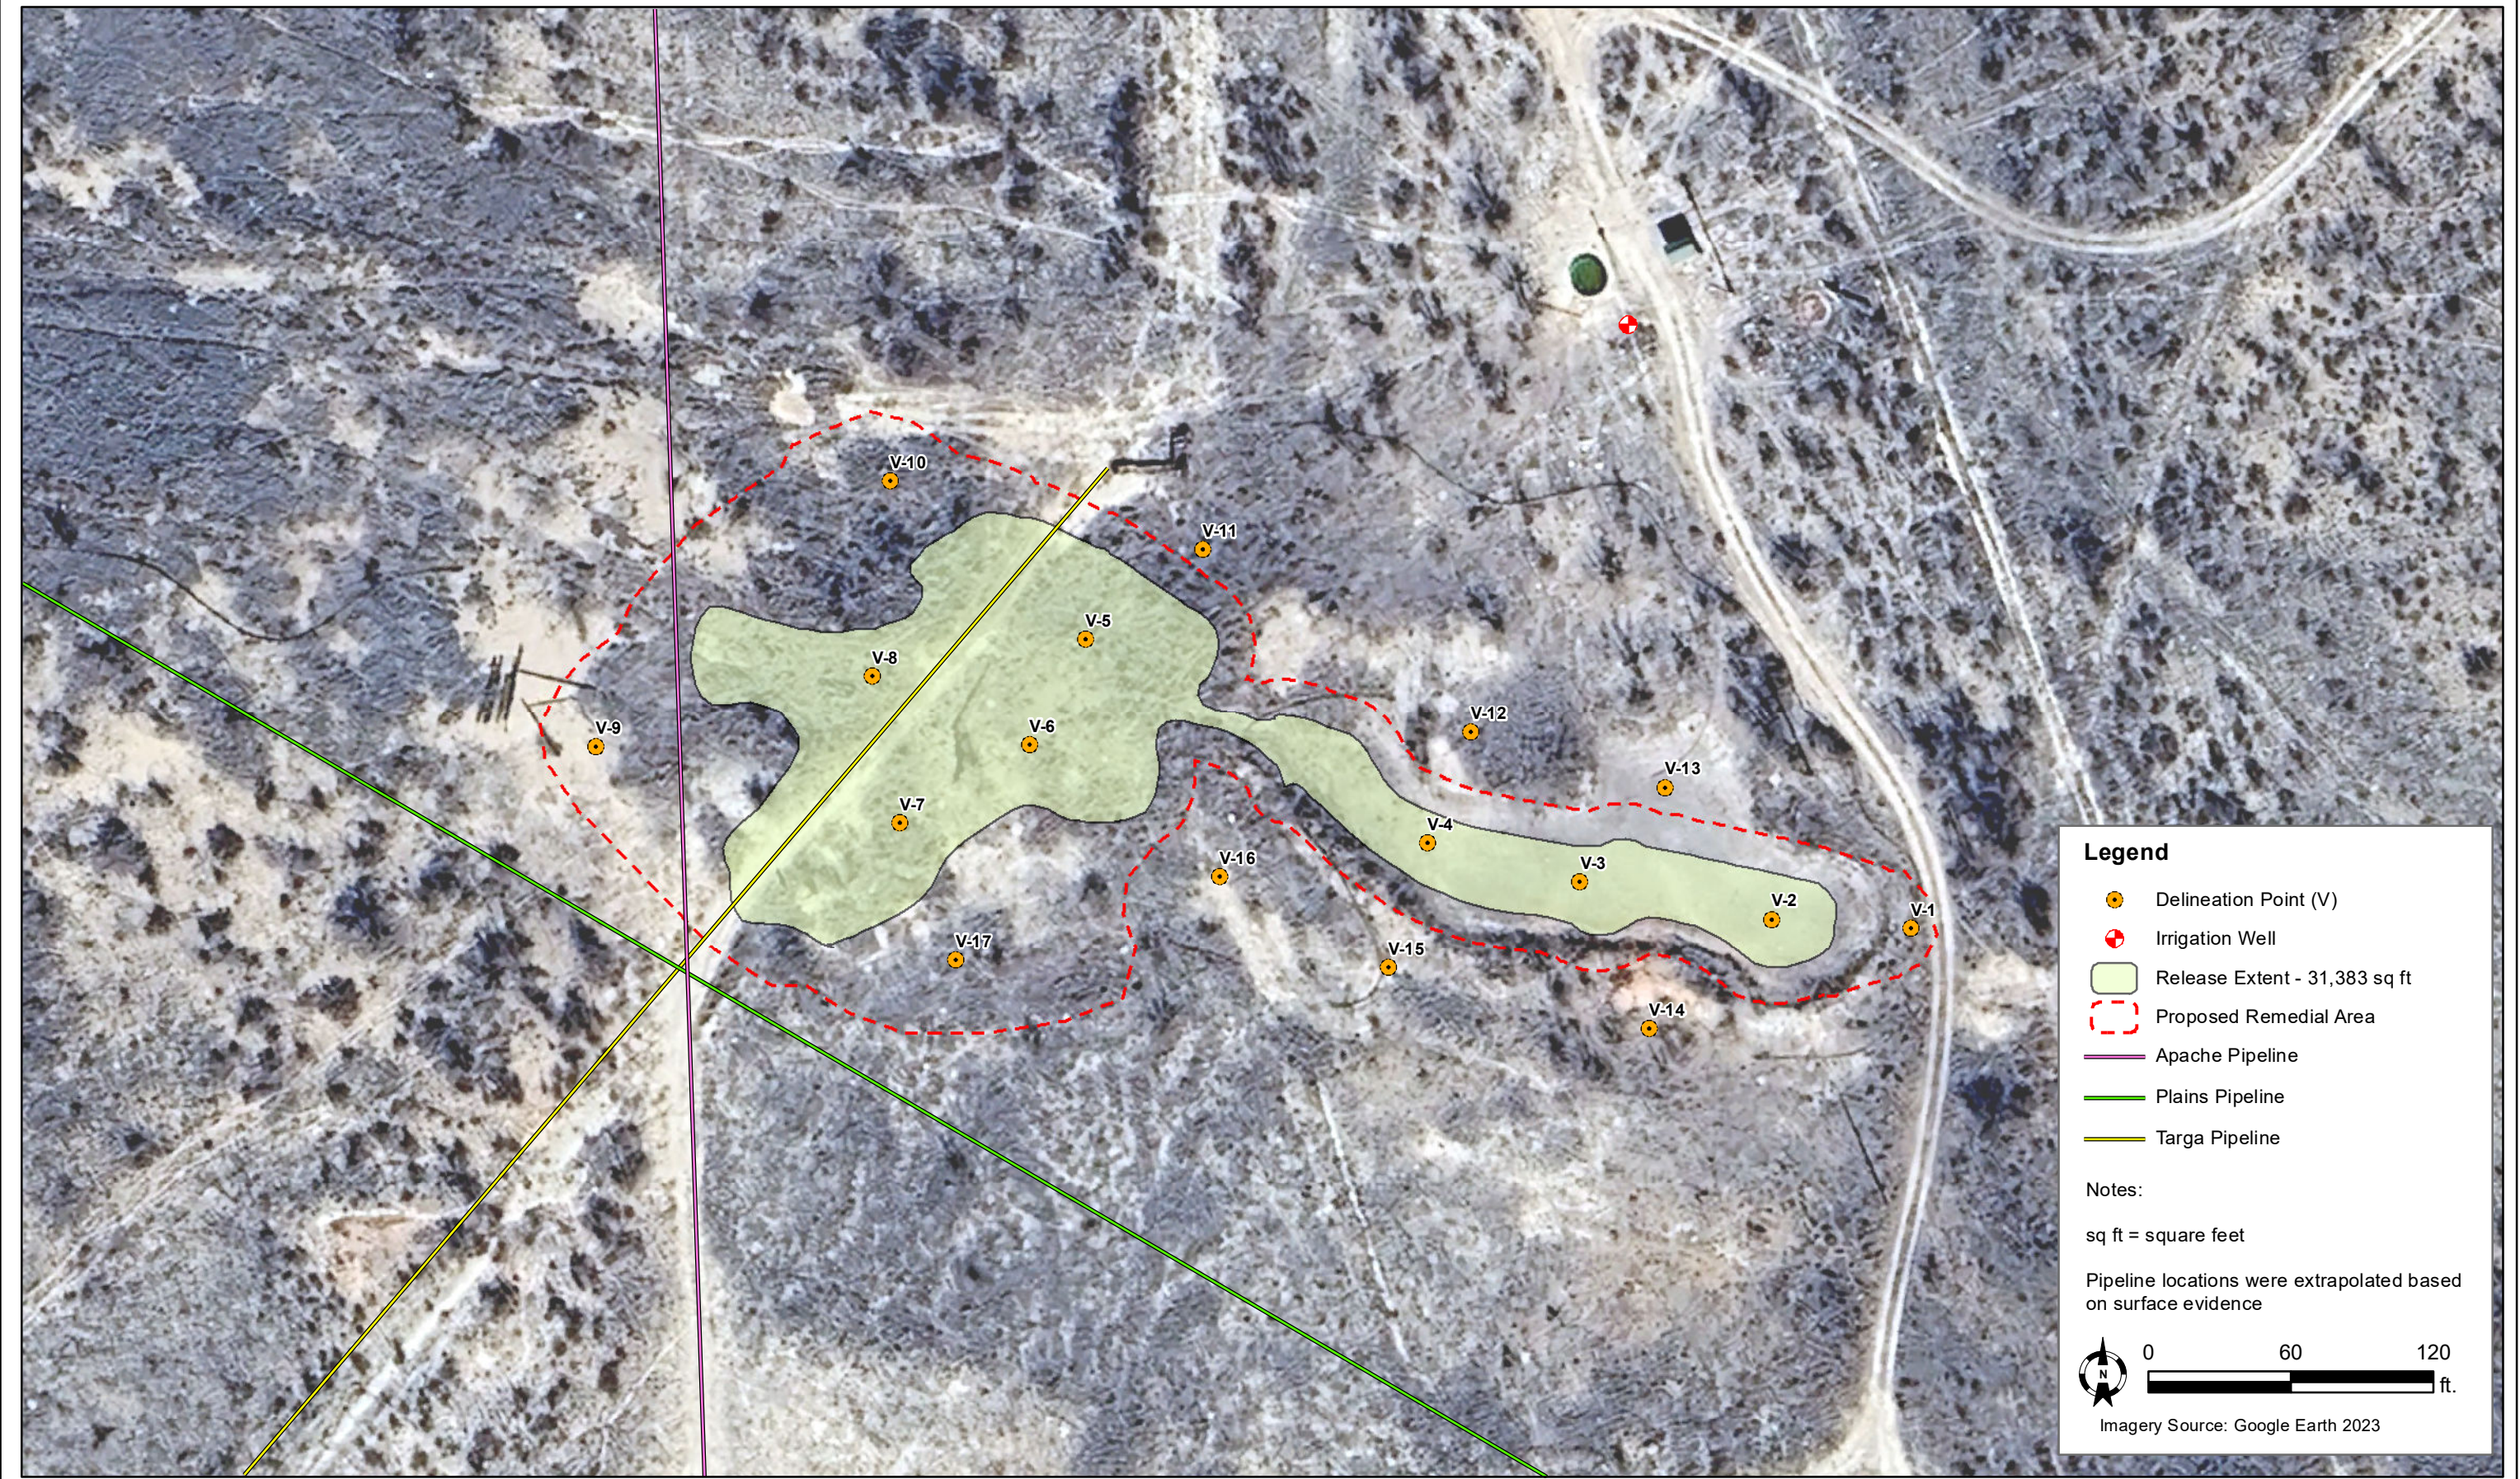
The nearest potable water well is an irrigation well was identified approximately 240 feet from the nearest point of the release area. The well is assumed to be NMOSE POD L-10277 and used to fill the pond discussed in the following section. The location of this well is shown on the attached Figure 1 and Figure 5.

The attached Figure 5 illustrates the observed release area and location of vertical delineation trenches.

Analytical results are summarized on Table 1 and laboratory analytical results are included as Appendix D. Vertical delineation trench locations are illustrated on Figure 5.

Vertical delineation of TPH impacts were not achieved at verticals V-1, V-2, V-5, V-7 through V-10, and V-17 and chloride impacts at verticals V-8 through V-10. Horizontal delineation of TPH impacts were not achieved at verticals V-1, V-9, V-10, and V-17 and chloride impacts at verticals V-9 and V-10.
