## D-6-7-14 EXT LINE Remediation Summary & Closure Report

NMOCD Incident No. nAPP2308664488  
UL "G", Sec. 10, T21S, R27E  
32.495455°, -104.176842°  
Eddy County, New Mexico

Re: Remediation Summary & Closure Report  
D-6-7-14 Ext Line  
UL "G", Section 10, Township 21 South, Range 27 East  
Eddy County, New Mexico  
NMOCD Incident No. nAPP2308664488  
Tasman Project No. 5473

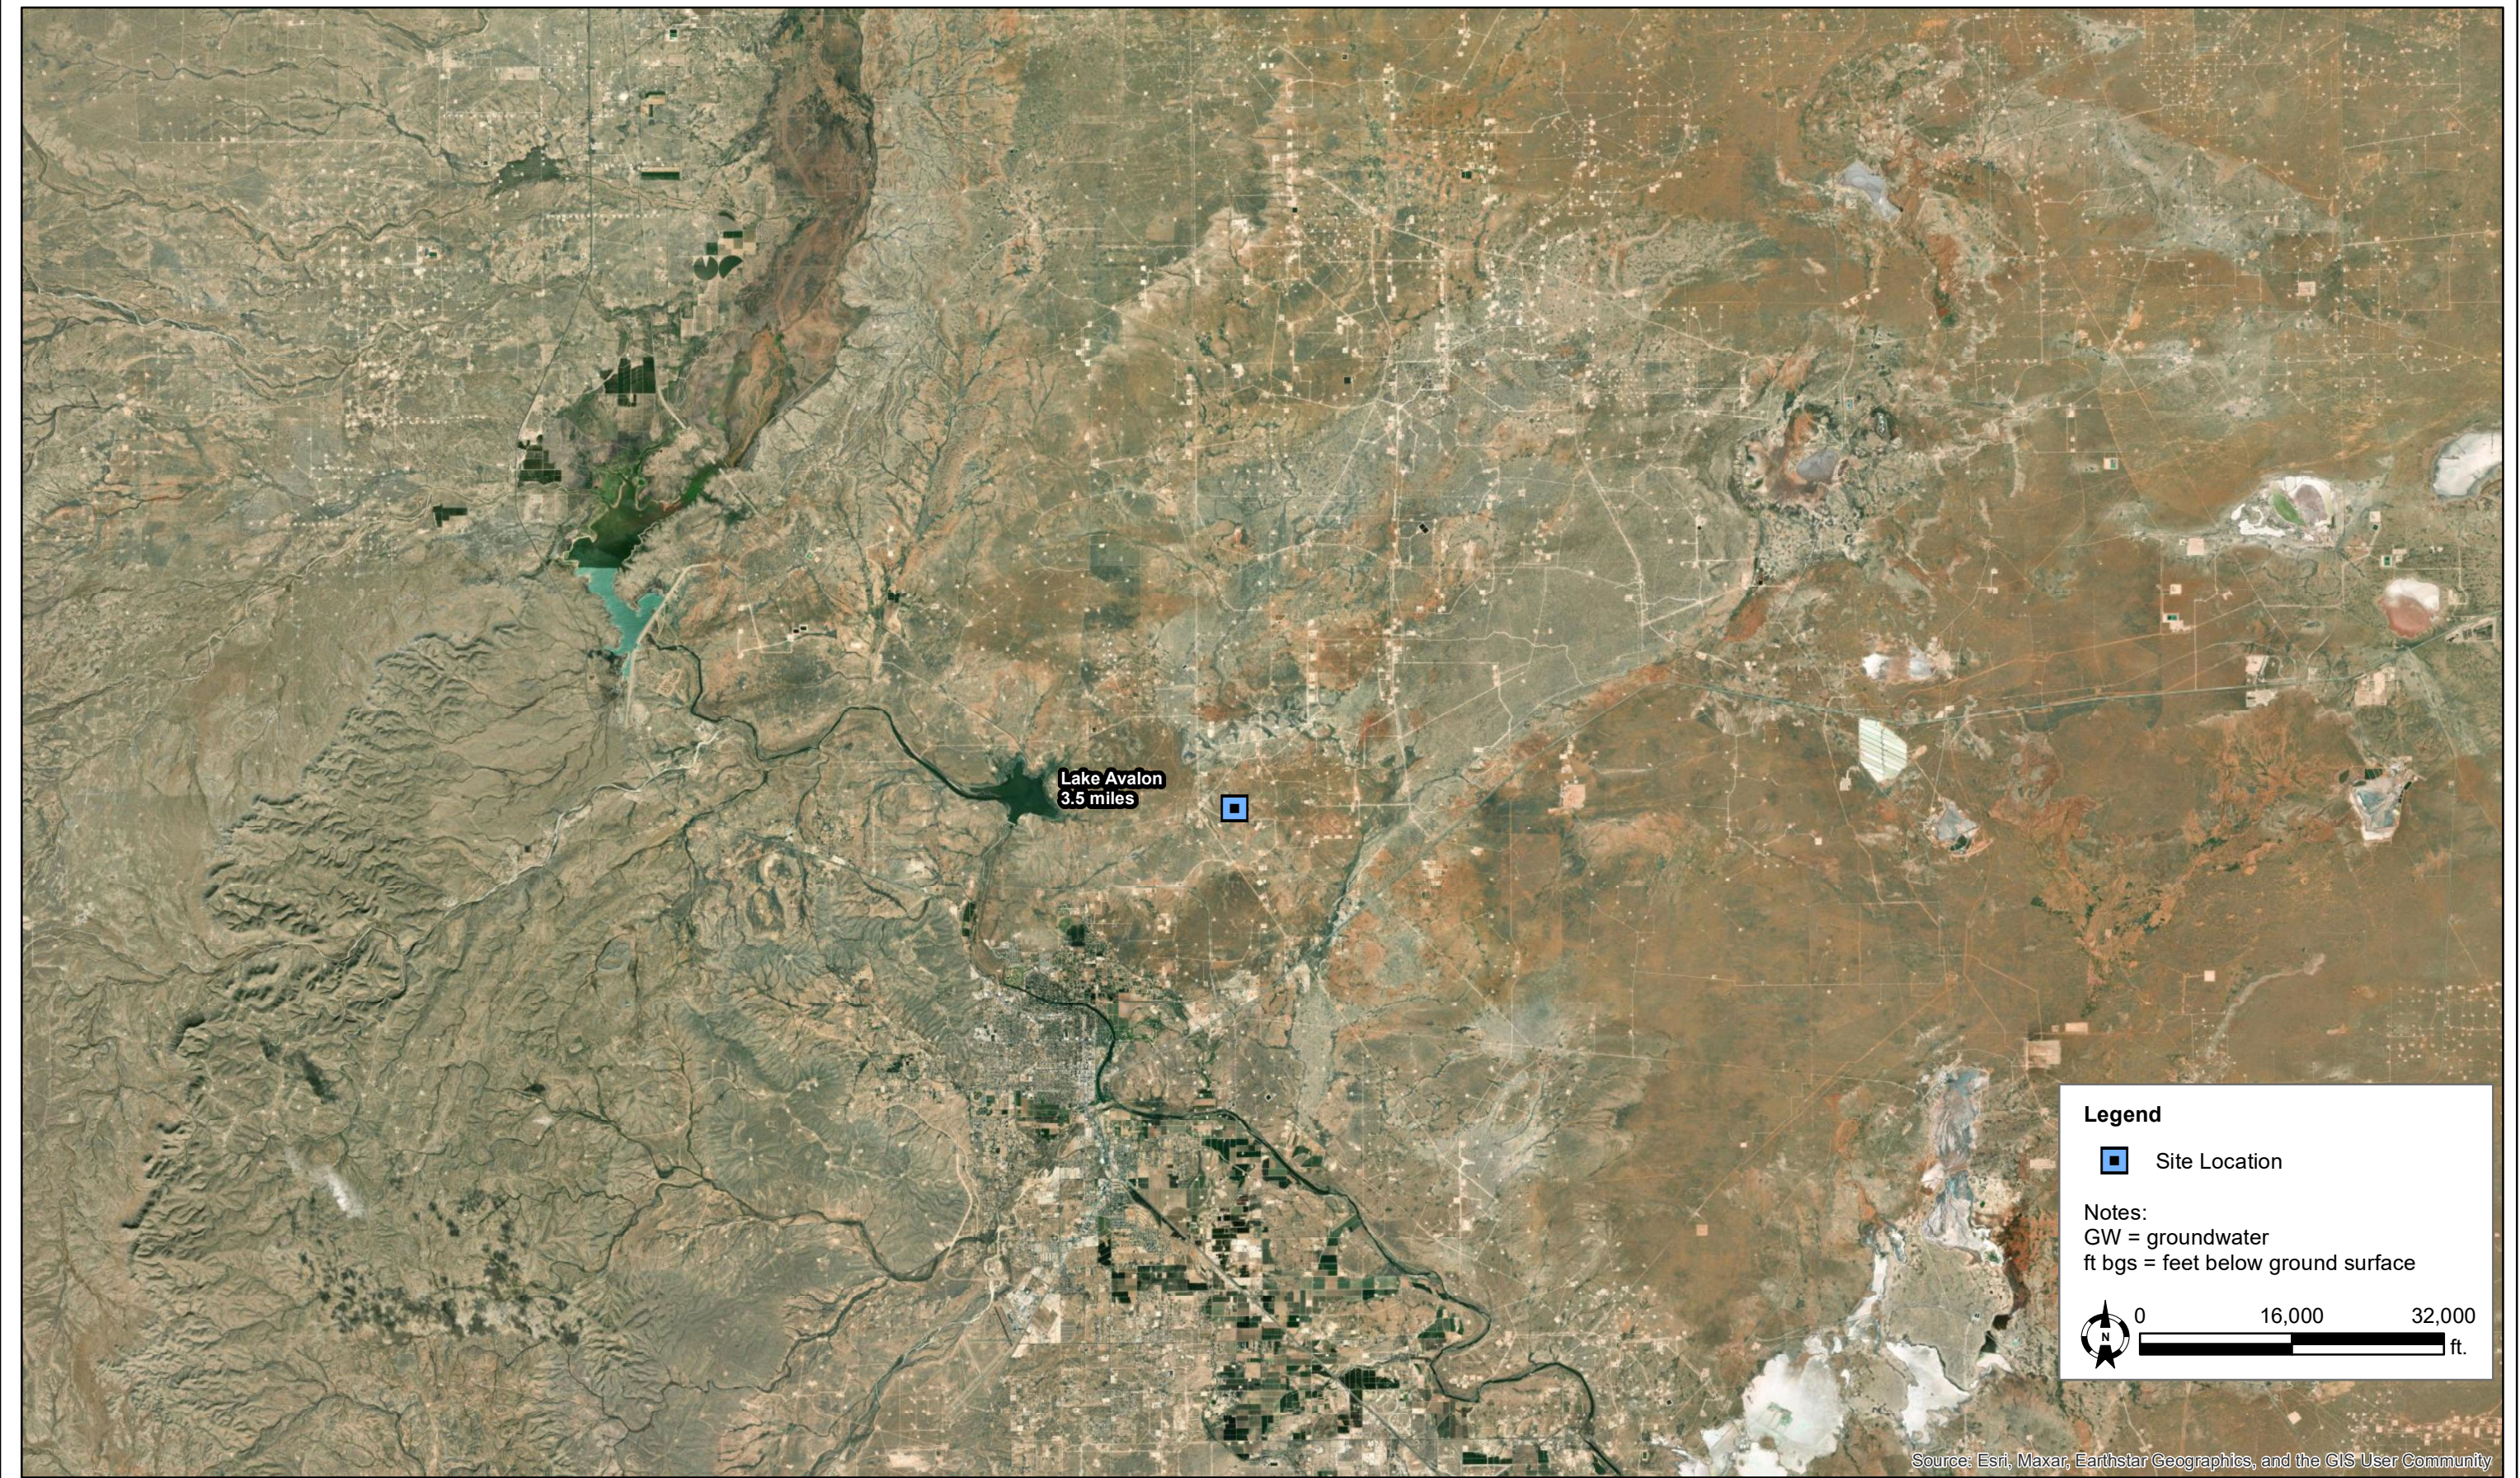
Tasman reviewed aerial imagery and the National Wetland Inventory Map, published by the U.S. Fish and Wildlife Service, for wetlands and surface water in the vicinity of the site. The nearest riverine is located 1.22 miles east of the site. The nearest significant surface water was identified as Lake Avalon, located 3.5 miles from the site. The location of the nearest wetland and surface water body can be seen on Figures 1 and 3.

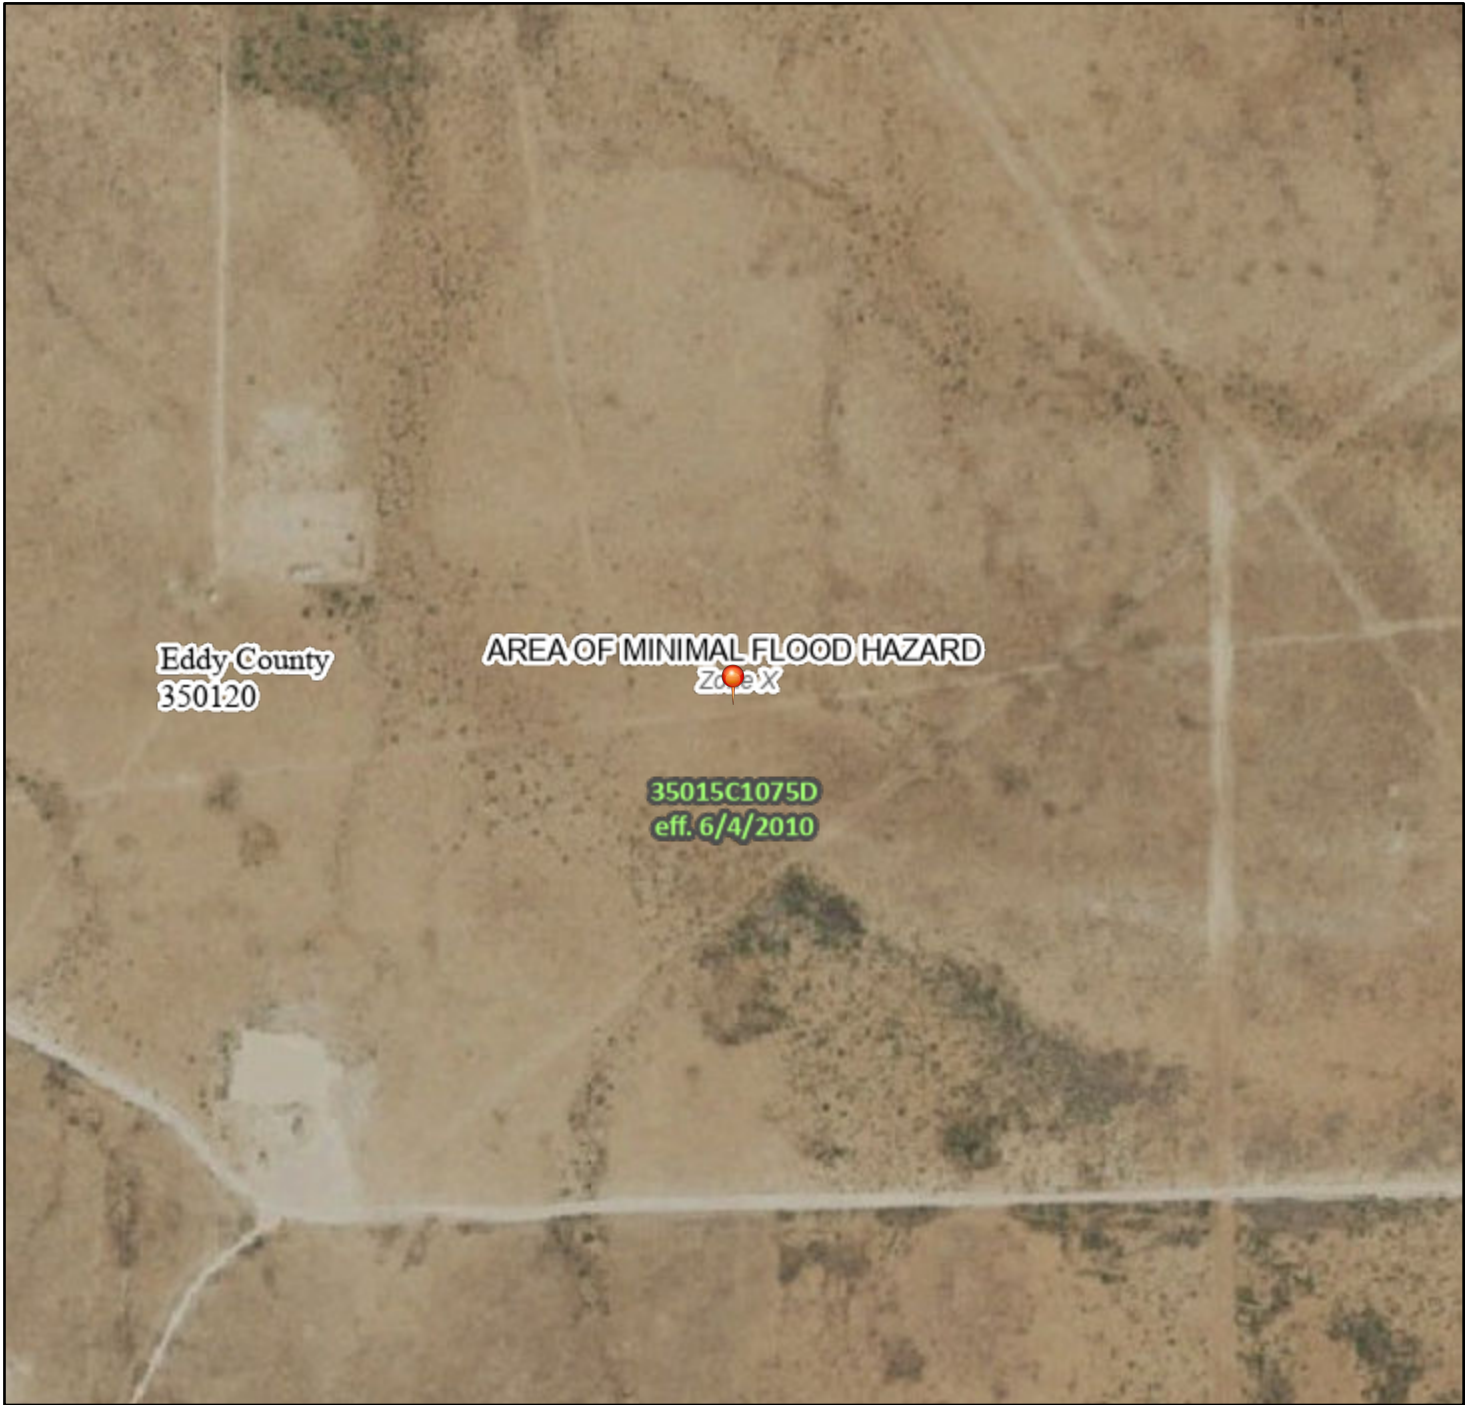
# National Flood Hazard Layer FIRMette

Review of flood map data published by the Federal Emergency Management Agency (FEMA) indicates the site is not located within a 100-year floodplain. A copy of the FEMA FIRMet Map can be found attached as Figure 4.
