**Re: Liner Inspection Report and Closure Request  
BTA Oil Producers, LLC  
Hades Tank Battery Release  
Unit Letter A, Section 2, Township 23 South, Range 28 East  
Eddy County, New Mexico  
Incident ID# nAPP2328520901**

Liner Inspection Report and Closure Request  
August 20, 2024

**HADES BATTERY RELEASE LINER INSPECTION  
APPROXIMATE RELEASE EXTENT AND LINER INSPECTION**

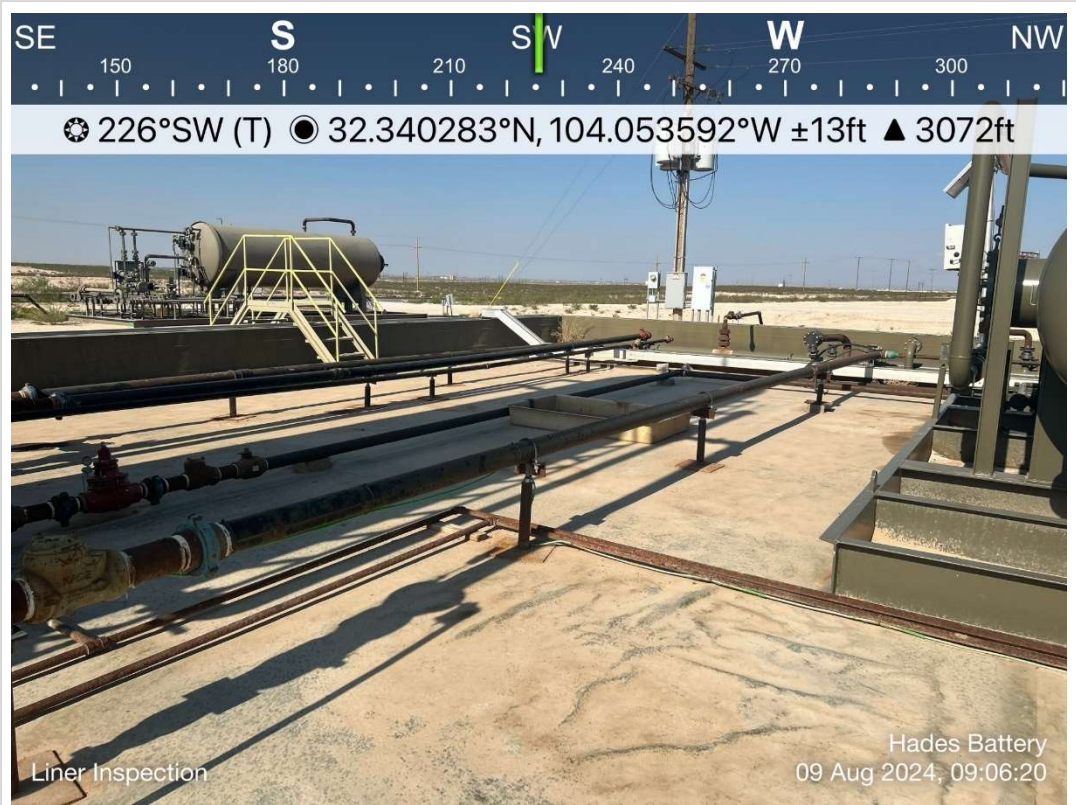
TETRA TECH, INC. PROJECT NO. 212C-MD-03557	DESCRIPTION	View southwest. Current lined containment area conditions; no rips, holes or tears observed.	6
	SITE NAME	HADES TANK BATTERY	8/9/2024
