**Re: Remediation/Reclamation Report and Closure Request
Maverick Permian, LLC
MCA Unit #265 Test Line Release
Unit Letter L, Section 20, Township 17 South, Range 32 East
Lea County, New Mexico
Incident ID# nGRL1131428247**

Remediation/Reclamation Report and Closure Request
 Maverick Permian, LLC
 MCA Unit #265 Test Line Release
 Incident ID: nGRL1131428247

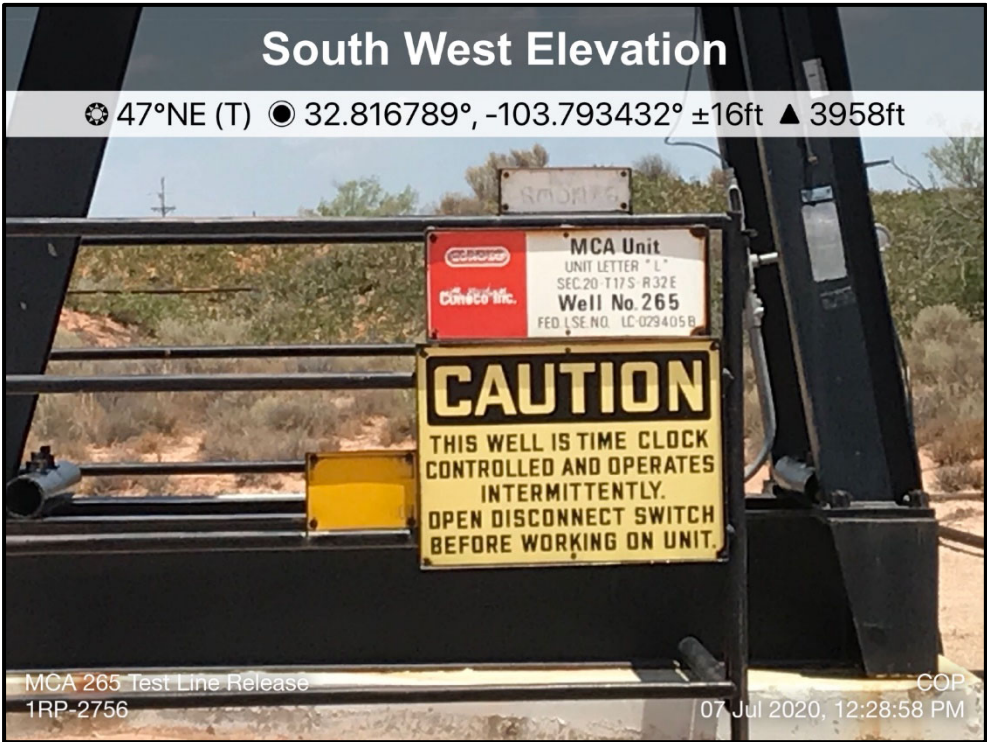
TETRA TECH, INC. PROJECT NO. 212C-MD-02152	DESCRIPTION	View facing northeast of lease signage.	1
	SITE NAME	MCA 265 Test Line Release	7/7/2020

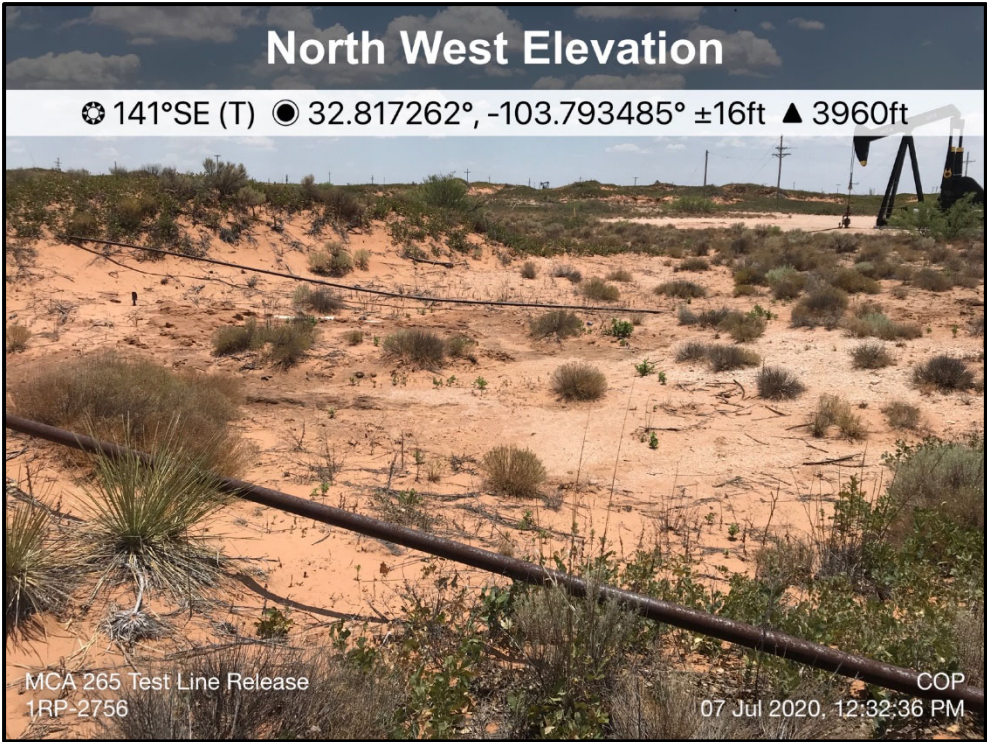
TETRA TECH, INC. PROJECT NO. 212C-MD-02152	DESCRIPTION	View facing southeast of release area.	3
	SITE NAME	MCA 265 Test Line Release	7/7/2020

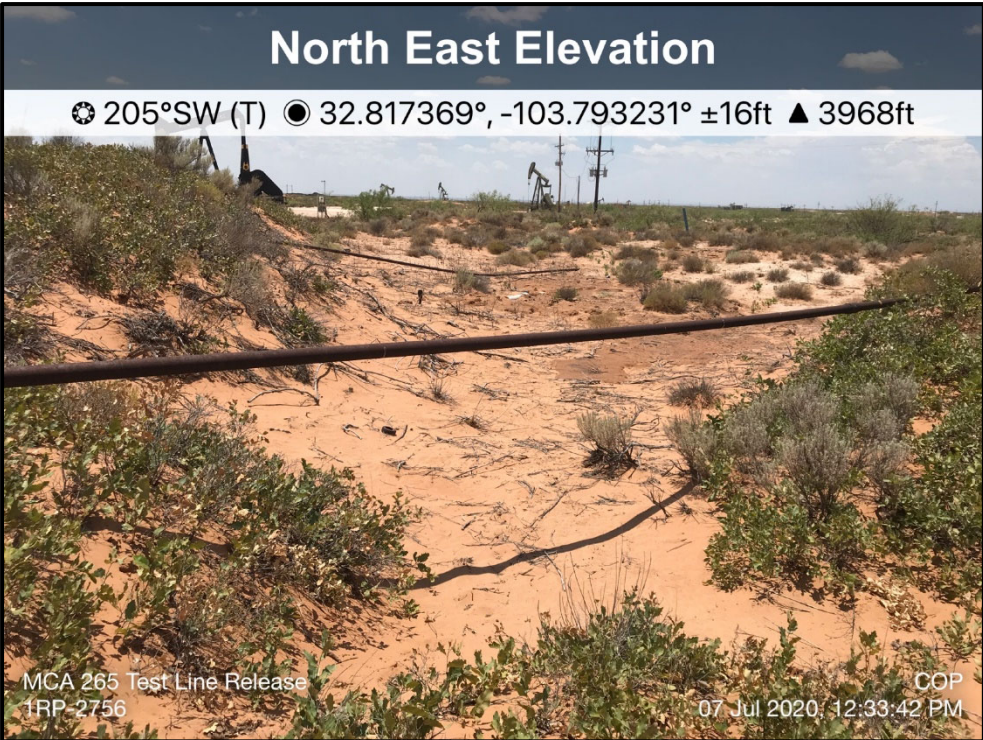
TETRA TECH, INC. PROJECT NO. 212C-MD-02152	DESCRIPTION	View facing southwest of release area.	5
	SITE NAME	MCA 265 Test Line Release	7/7/2020

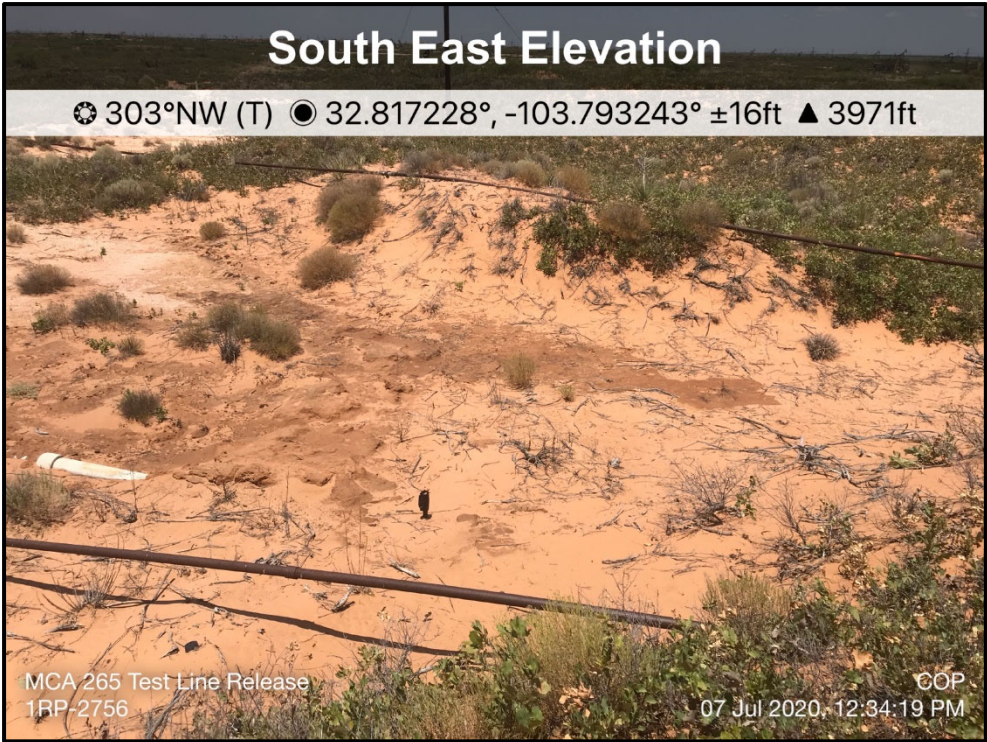
TETRA TECH, INC. PROJECT NO. 212C-MD-02152	DESCRIPTION	View facing northwest of release area.	7
	SITE NAME	MCA 265 Test Line Release	7/7/2020
