**Re: Closure Request
PLU 19 DTD 322H
Incident Number NAPP2414341172
Eddy County, New Mexico**

Ensolum, LLC (Ensolum), on behalf of XTO Energy, Inc (XTO), has prepared this *Closure Request* to document a fire at the PLU 19 DTD 322H (Site). Based on the Site investigation activities, XTO is submitting this *Closure Request*, and requesting no further action and closure for Incident Number NAPP2414341172.

**Photographic Log**

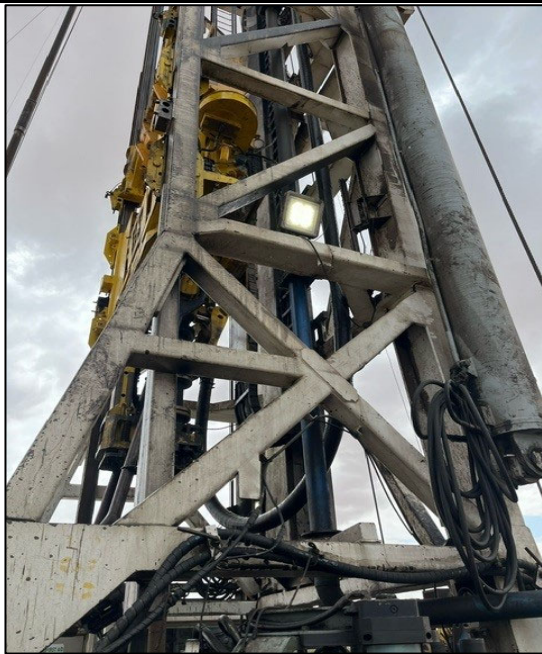
Photograph: 1 Date: 7/18/2024
Description: View of top drive showing the location of equipment where the fire occurred.

Following the fire, a service technician determined the cause of the fire was faulty wiring. During the inspection, XTO personnel confirmed no fluids were released as a result of the equipment failure or fire. Photographic documentation of the top drive, damaged wiring, and equipment inspection is included in Appendix B. The photos confirm there was no path for potential fluids, though none were released, to reach pad soils. The top drive was repaired and returned to service and drilling operations continued.

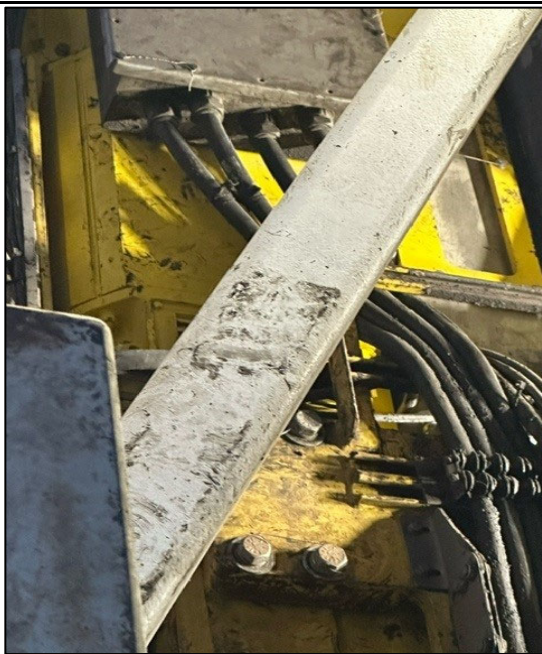
Photograph: 4 Date: 7/18/2024
Description: Damage to wiring that caused the fire. No fluids were released, but the Incident was reported because of the occurrence of a fire.
