Remediation Closure Report

COTTON DRAW 32 STATE SWD #002

nOY1803741279 -- Devon Energy

August 26, 2024

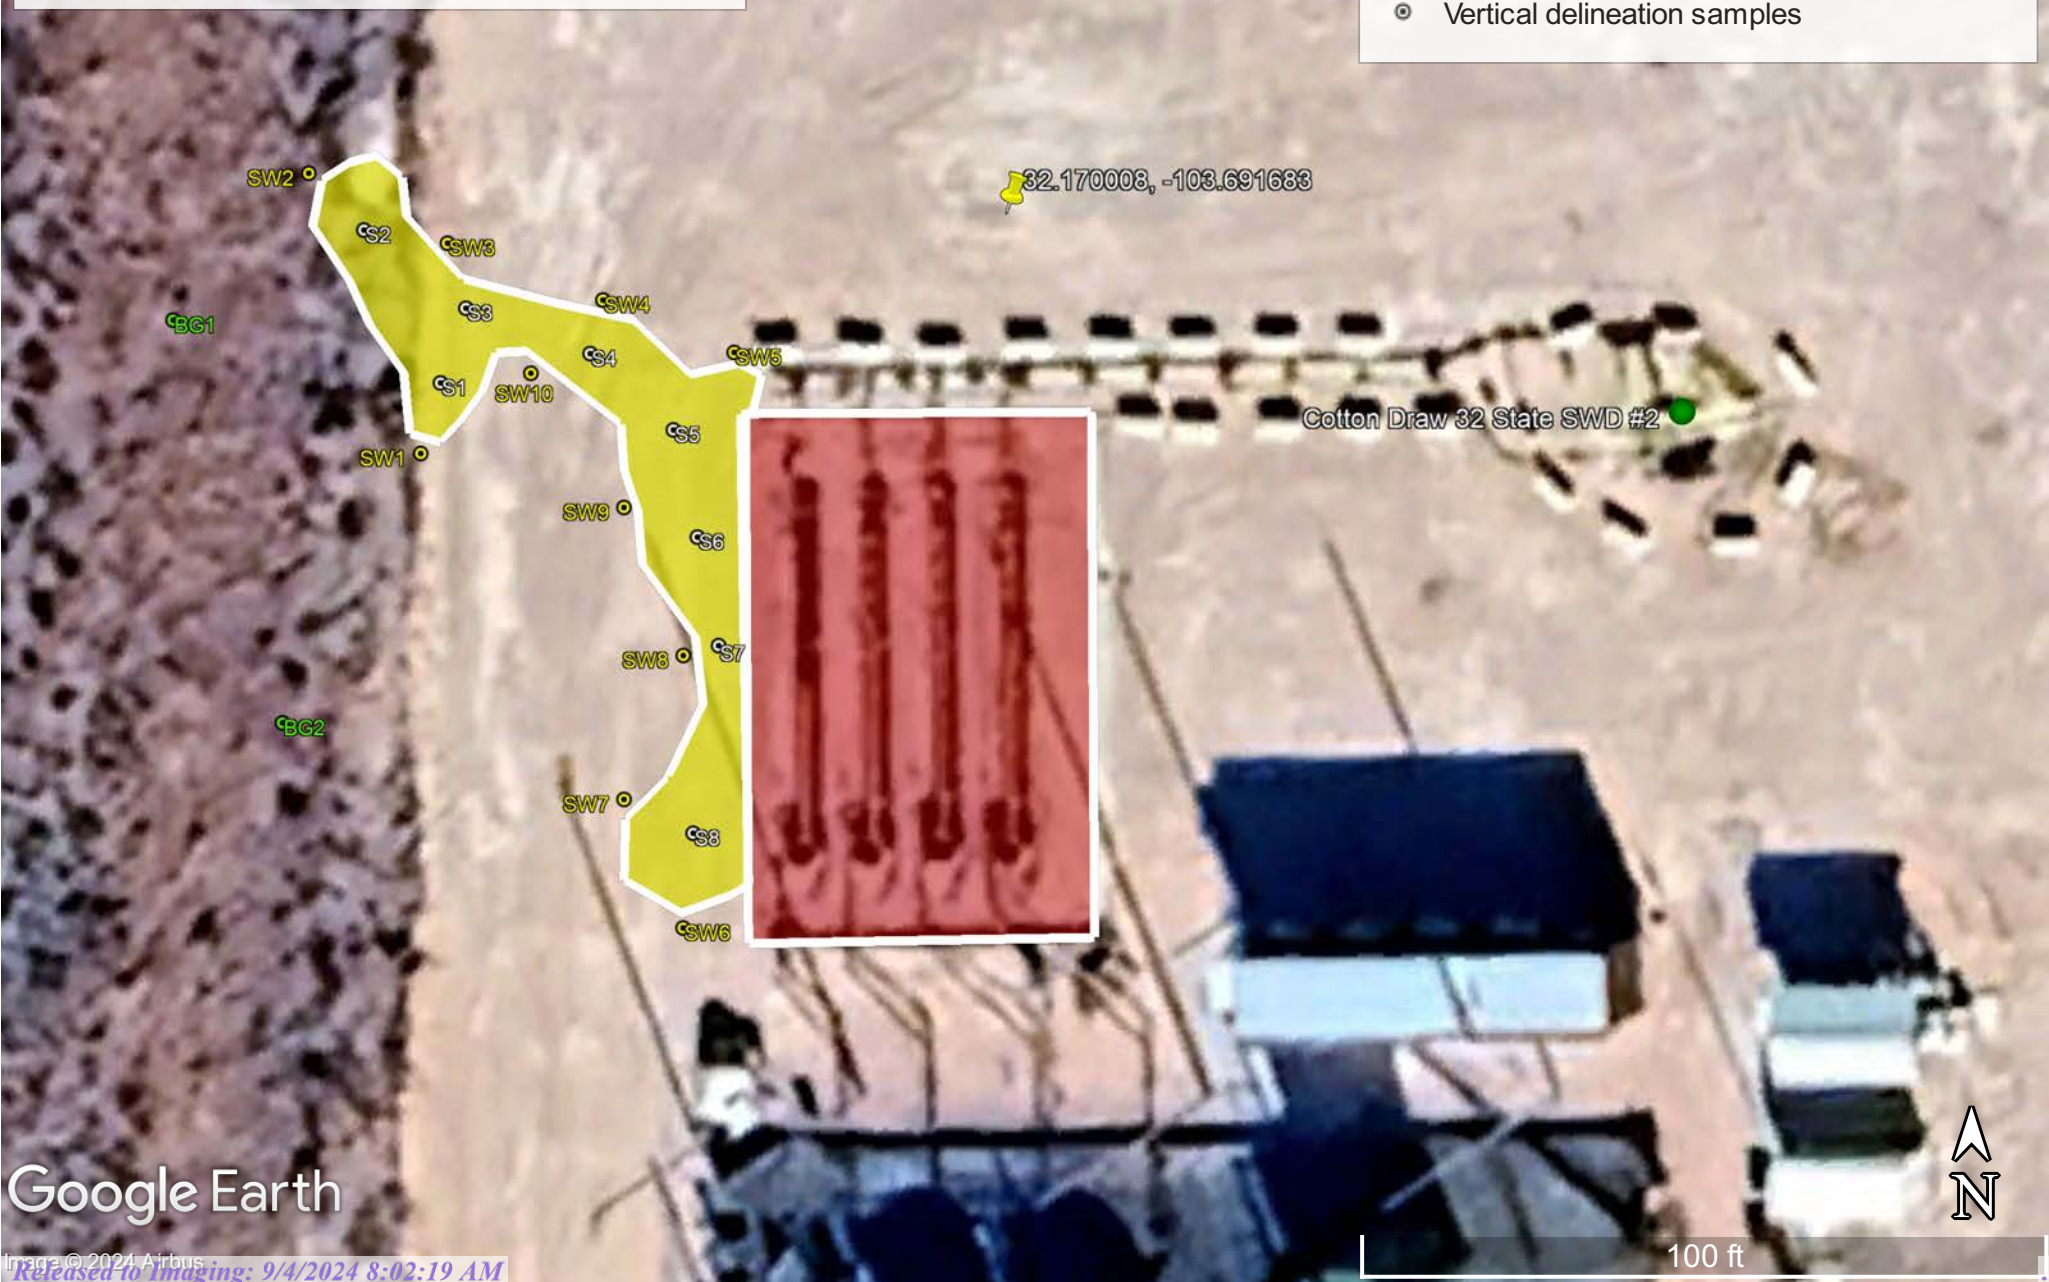
On January 25, 2023, an initial assessment was performed by Pima Environmental Services to find full vertical and horizontal delineation of the release area. An area on the west side of the concrete H-Pump containment was affected by fluid spraying out of the containment, measured to be approximately 1,826 square feet, and assessed for contamination. Twenty-four samples were collected from 8 different sample points within the release area for vertical delineation. These samples were collected from depths of 1', 3', and 5' bgs. Ten samples were collected from 10 different sample points around the edges of the release area for horizontal delineation. These samples were collected from a depth of 3' bgs. Background samples were collected from 2 different sample points in the pasture west of the pad area. These samples were collected from a depth of 1' bgs. All samples were analyzed for all constituents listed in Table 1 19.15.29.12 NMAC by Envirotech Analytical Laboratories. The official laboratory results of this sampling event can be found in the following data table. A corresponding Site Map can be found in Figure 1.

- Background samples
- Concrete H-Pump containment - 3,829 sqft
- Horizontal delineation samples
- Release area - 1,826 sqft
- Vertical delineation samples

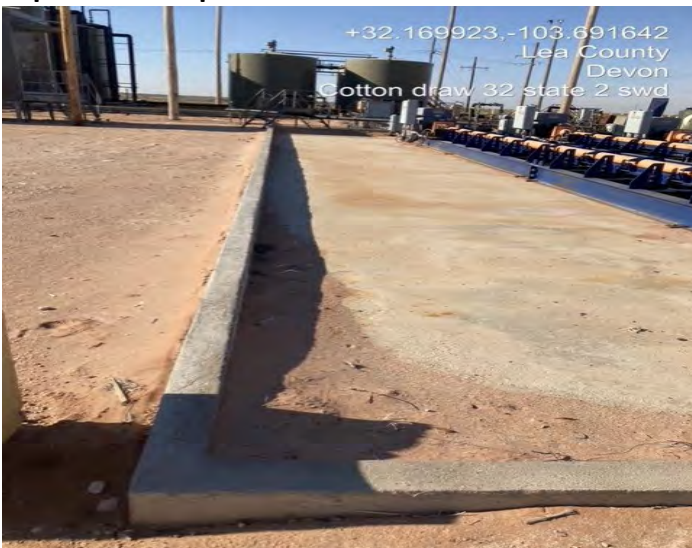
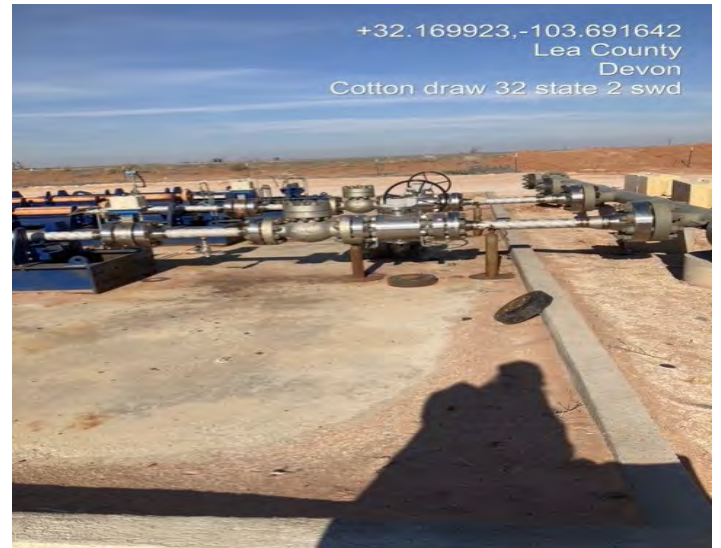
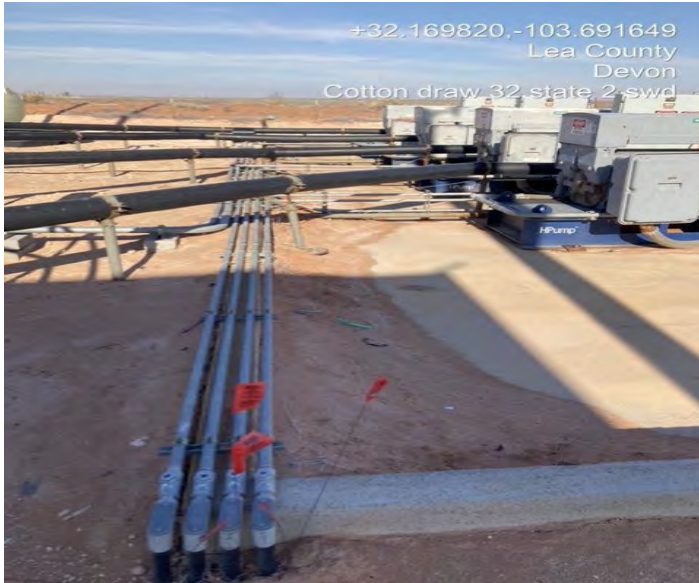
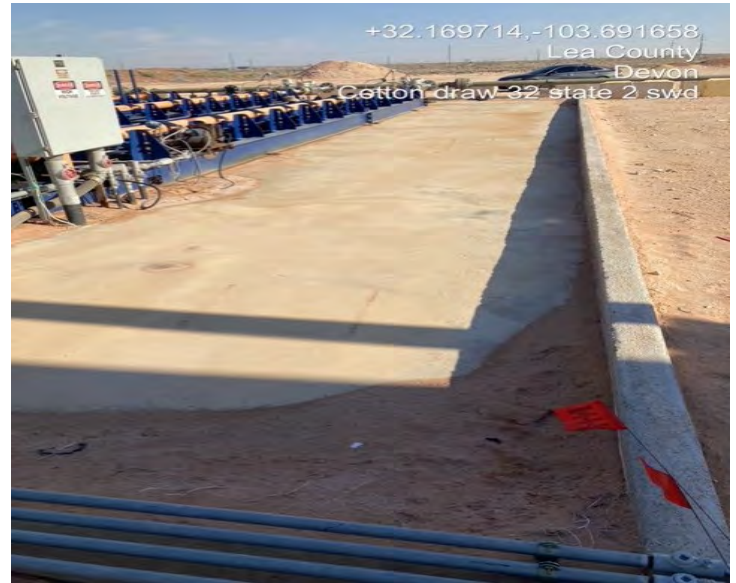
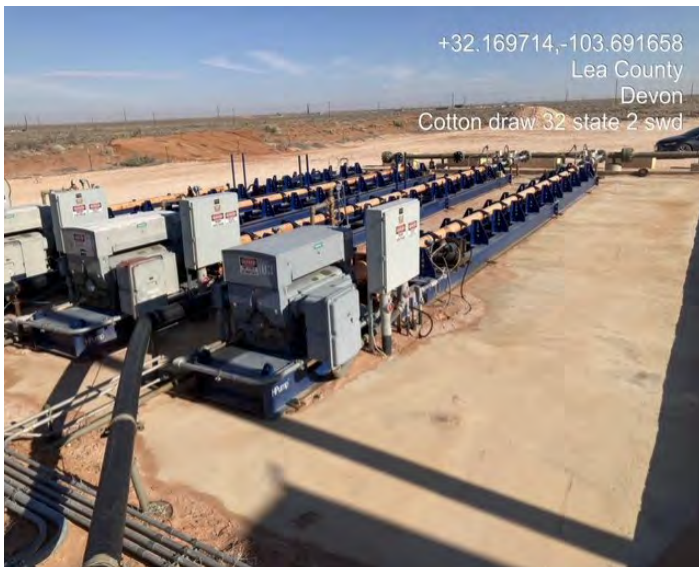
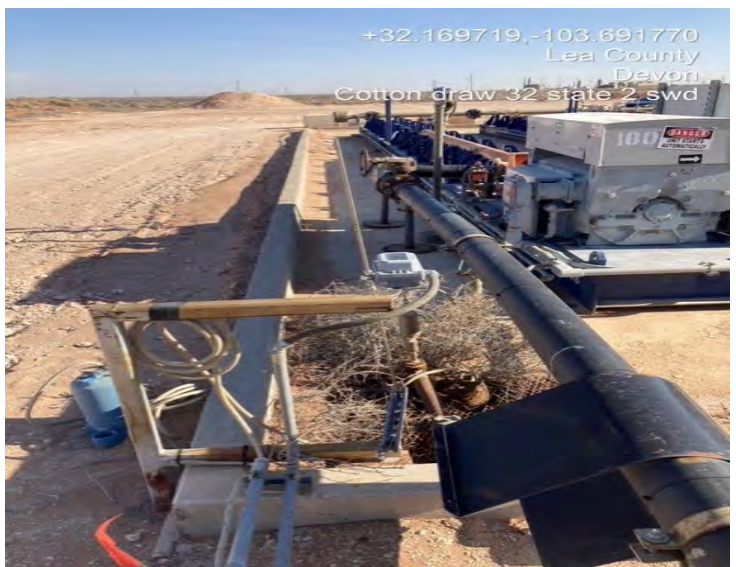
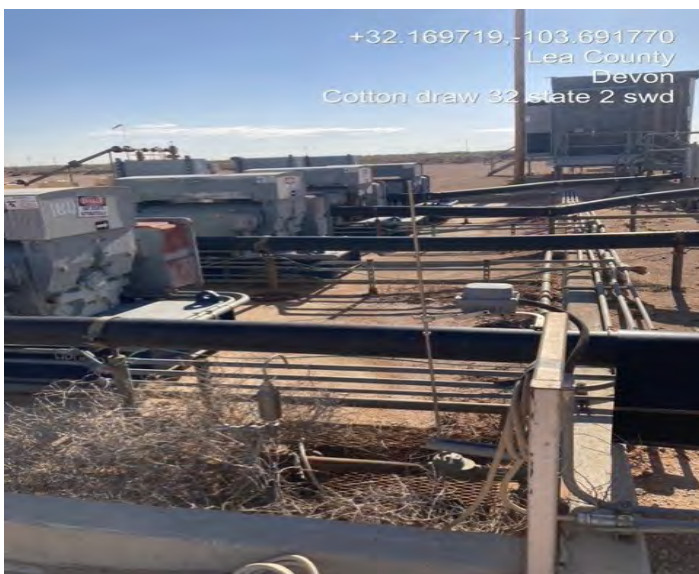
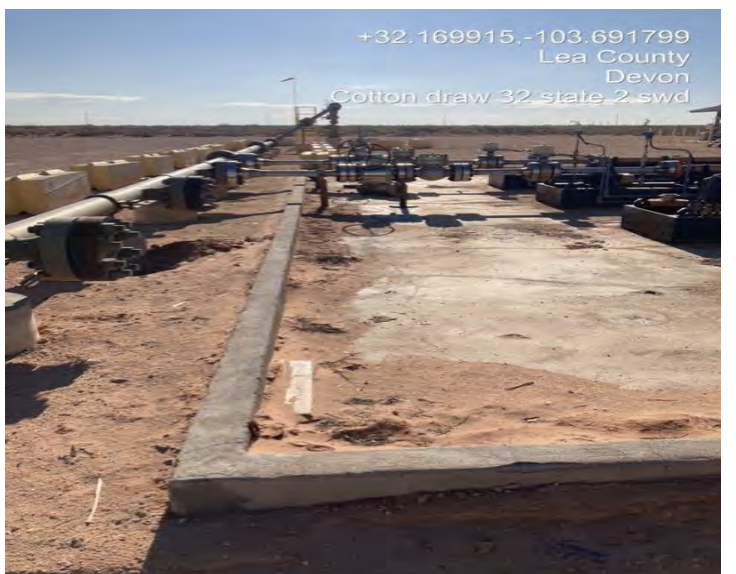
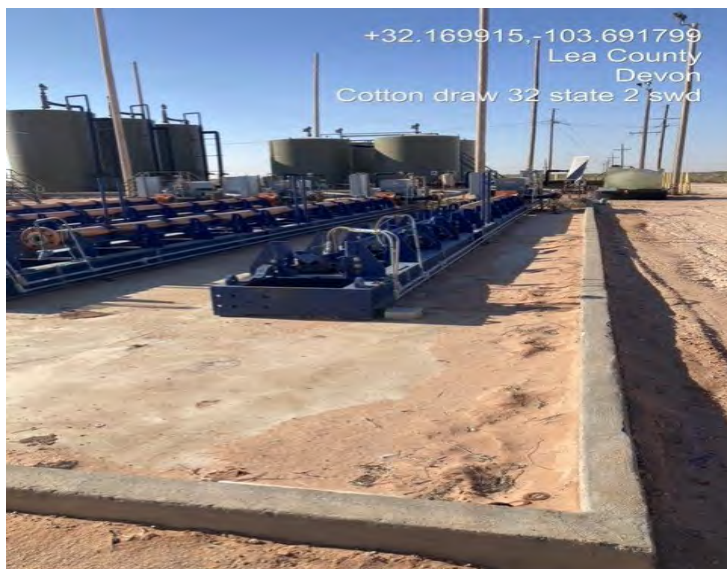
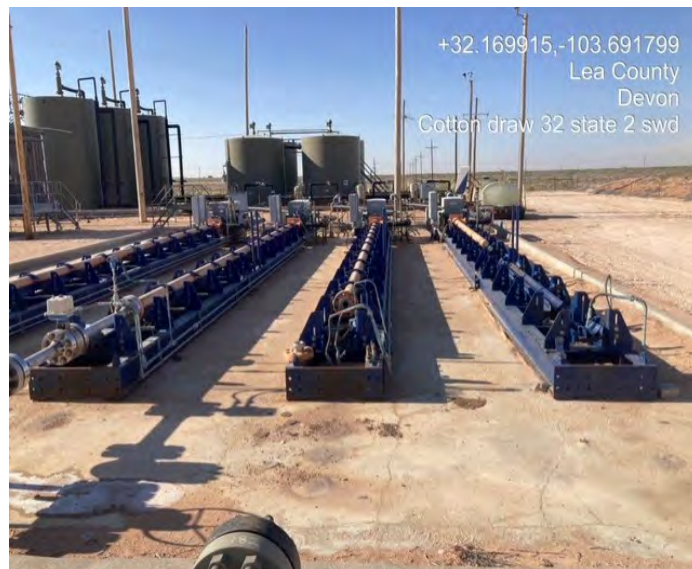
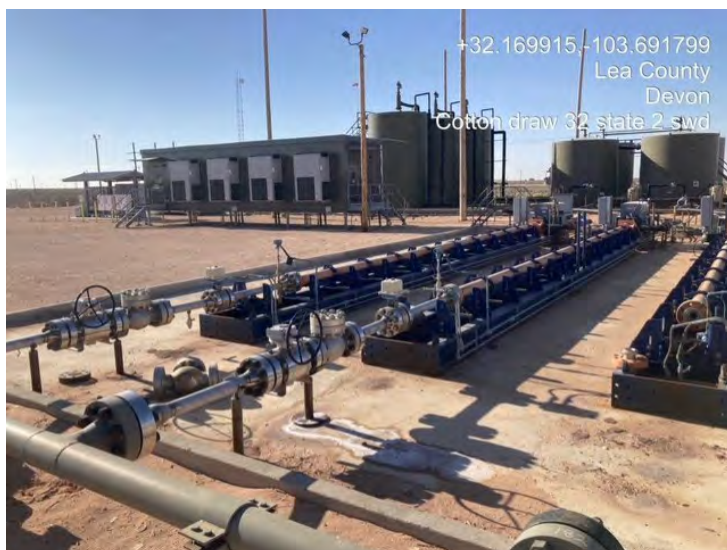
Sapec Liner Inspection 2024

On August 23, 2024, after Devon submitted a 48-hour notification for a liner inspection (Appendix A), Sapec personnel mobilized to the site to inspect the concrete-lined H-pump secondary containment. This secondary containment measures approximately 51' x 75' and has an approximate 8" curb wall surrounding the perimeter. The capacity for this containment at a perfectly level state is approximately 606 bbls. After a thorough inspection, it was found that this containment has the integrity to hold the volume of released fluids associated with this release. It was also concluded that the only effect to the surrounding areas was from the fluids that sprayed out of the containment area. Photographic Documentation and the Liner Inspection Field Report can be referenced in Appendix D.

Visualization	Yes	No	Comments
Is there a tear in the liner?		X	
Are there holes in the liner?		X	
Is the liner retaining any fluids?		X	Some sand blown in from surroundings
Does the liner have integrity to contain a leak?	X
