SITE RECLAMATION REPORT

**DAYTON RECYCLE LAYFLAT LINE
32.7100048, -104.344324
UNIT A, SECTION 35 T18S-R26E
EDDY COUNTY, NEW MEXICO
NMOCD INCIDENT ID # nAPP2326254488**

AUGUST 14, 2024

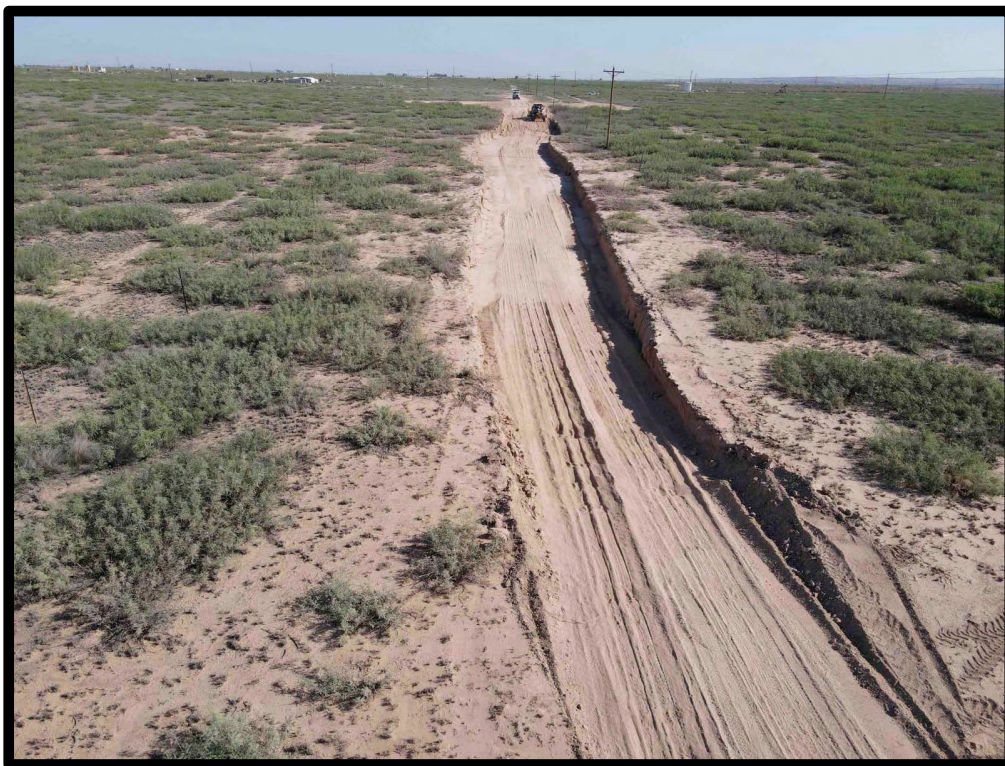
(Approximate GPS Coordinates: 32.708324, -104.344476)

PHOTOGRAPH NO. 1 – A view of the Site during the backfill activities. The view is towards the north. The view is towards the north.

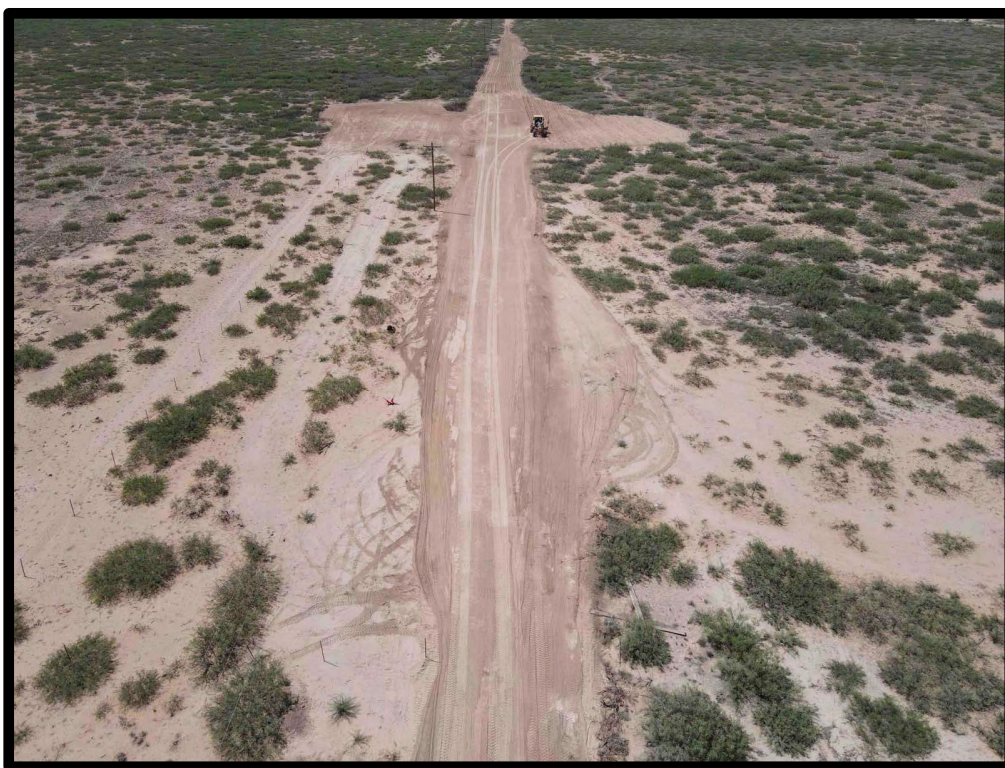
(Approximate GPS Coordinates: 32.710777, -104.344346)

PHOTOGRAPH NO. 2 – A view Site during the during the backfilling activities. The view is towards the south.

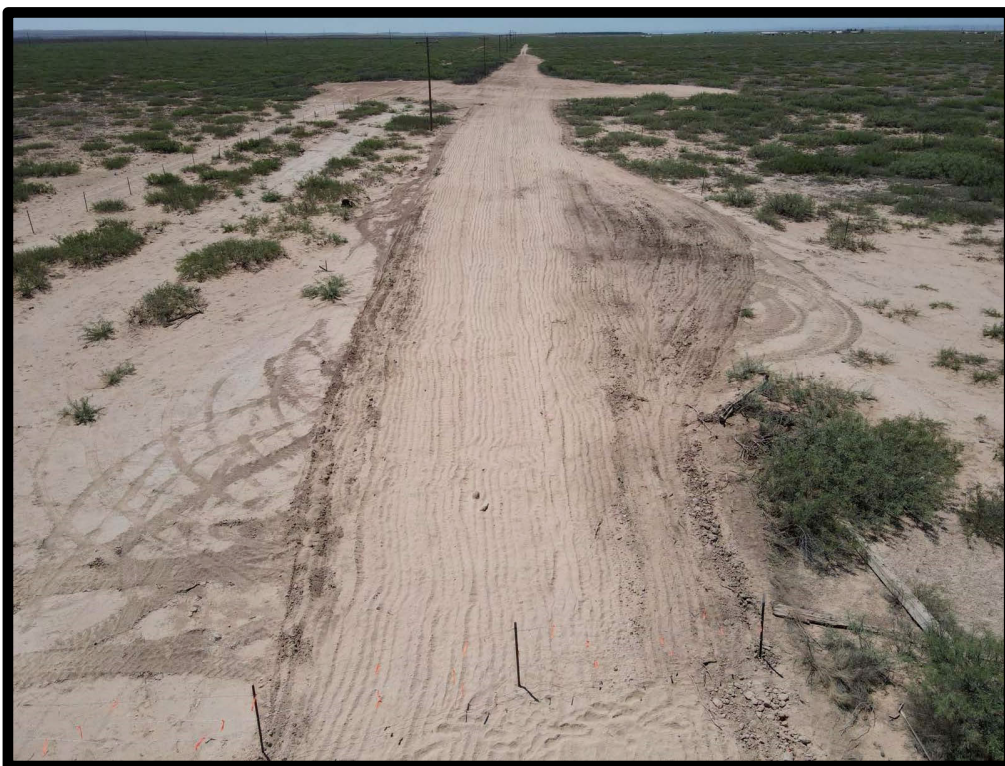
(Approximate GPS Coordinates: 32.711332, -104.344287)

PHOTOGRAPH NO. 4 – A view of the Site upon completion of the backfill and tilling operations. The view is towards the south.
