## Remediation Summary and Soil Closure Request

### Spur Energy Partners, LLC Tin Horn 79-80 Main Line

Eddy County, New Mexico  
Unit Letter O, Section 23, Township 17 South, Range 31 East  
Latitude 32.815832 North, Longitude 103.837281 West  
NMOCD Reference No. nAPP2321432080

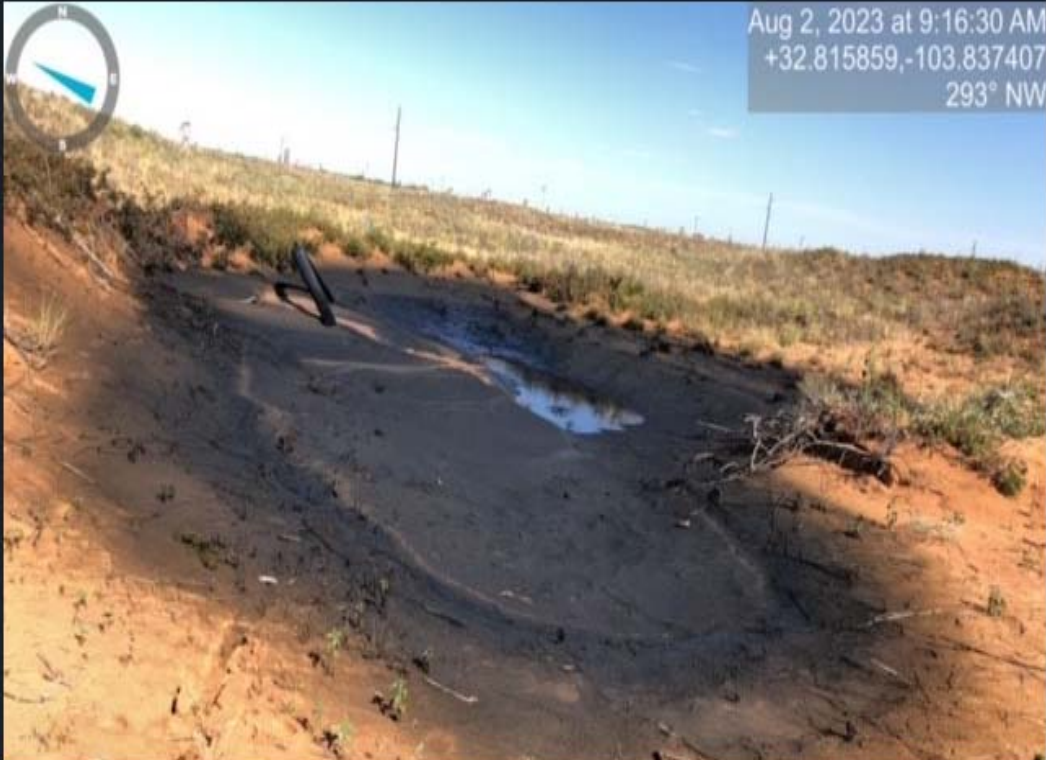
<b>Photo Number:</b> #1

<b>Photo Direction:</b> South	
<b>Photo Description:</b>	
<b>Initial Release</b>

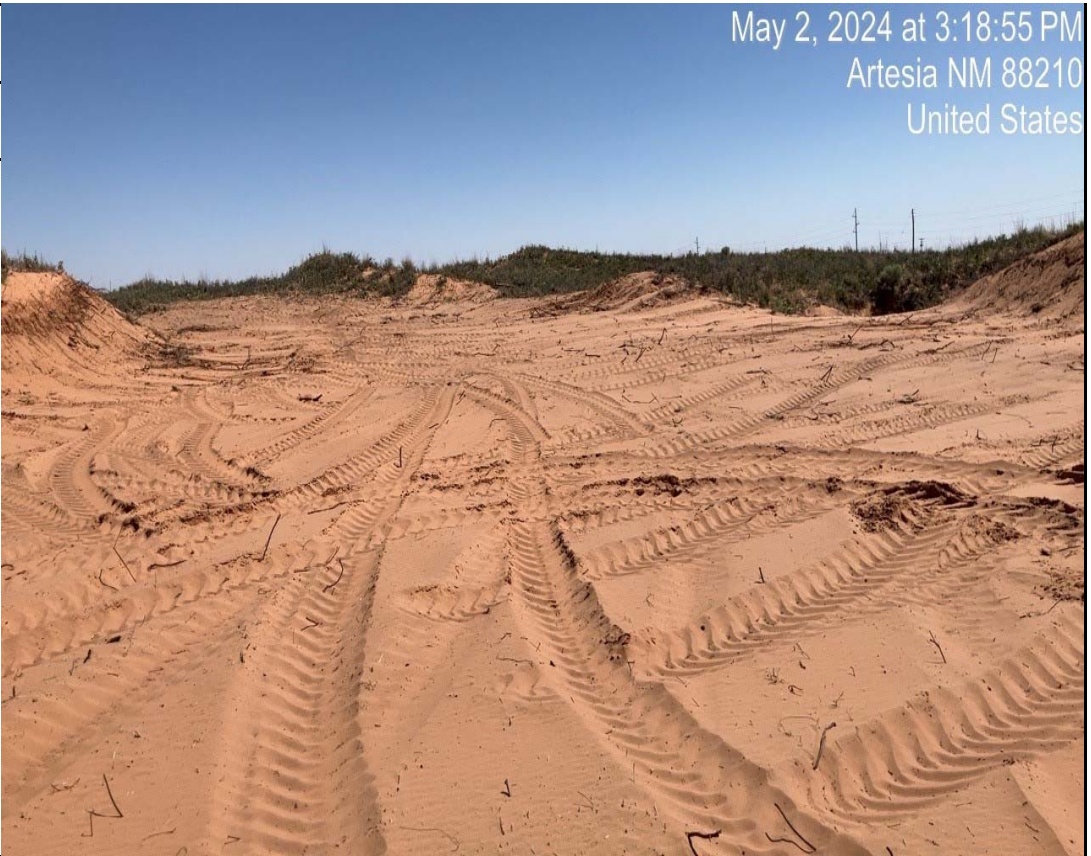
<b>Photo Number:</b> #5

May 2, 2024 at 3:18:55 PM Artesia NM 88210 United States
<b>Photo Direction:</b> South		
<b>Photo Description:</b>  Backfilled

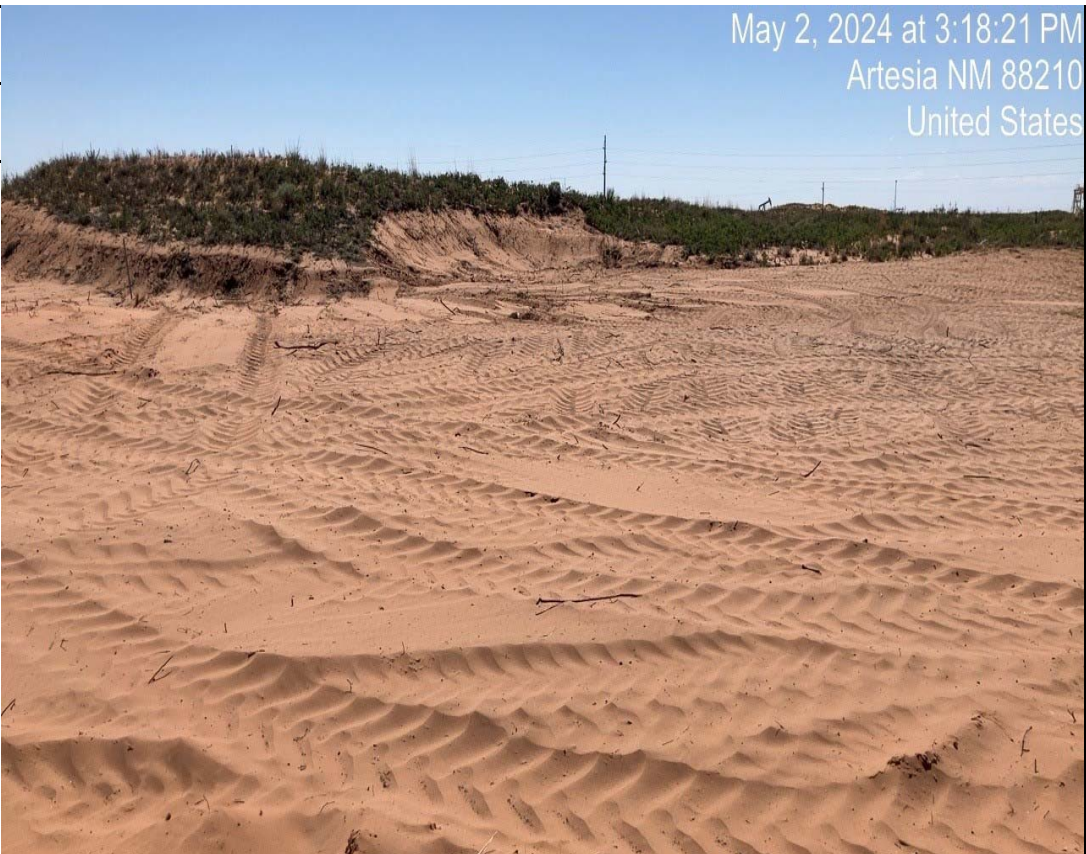
<b>Photo Number:</b>

#6	
<b>Photo Direction:</b>	
West	
<b>Photo Description:</b>	
<b>Backfilled</b>
