Remediation Summary & Soil Closure Request

XTO Energy, Inc.

PLU C2 Frac Pond

NMOCD Reference No. nAPP2419849771

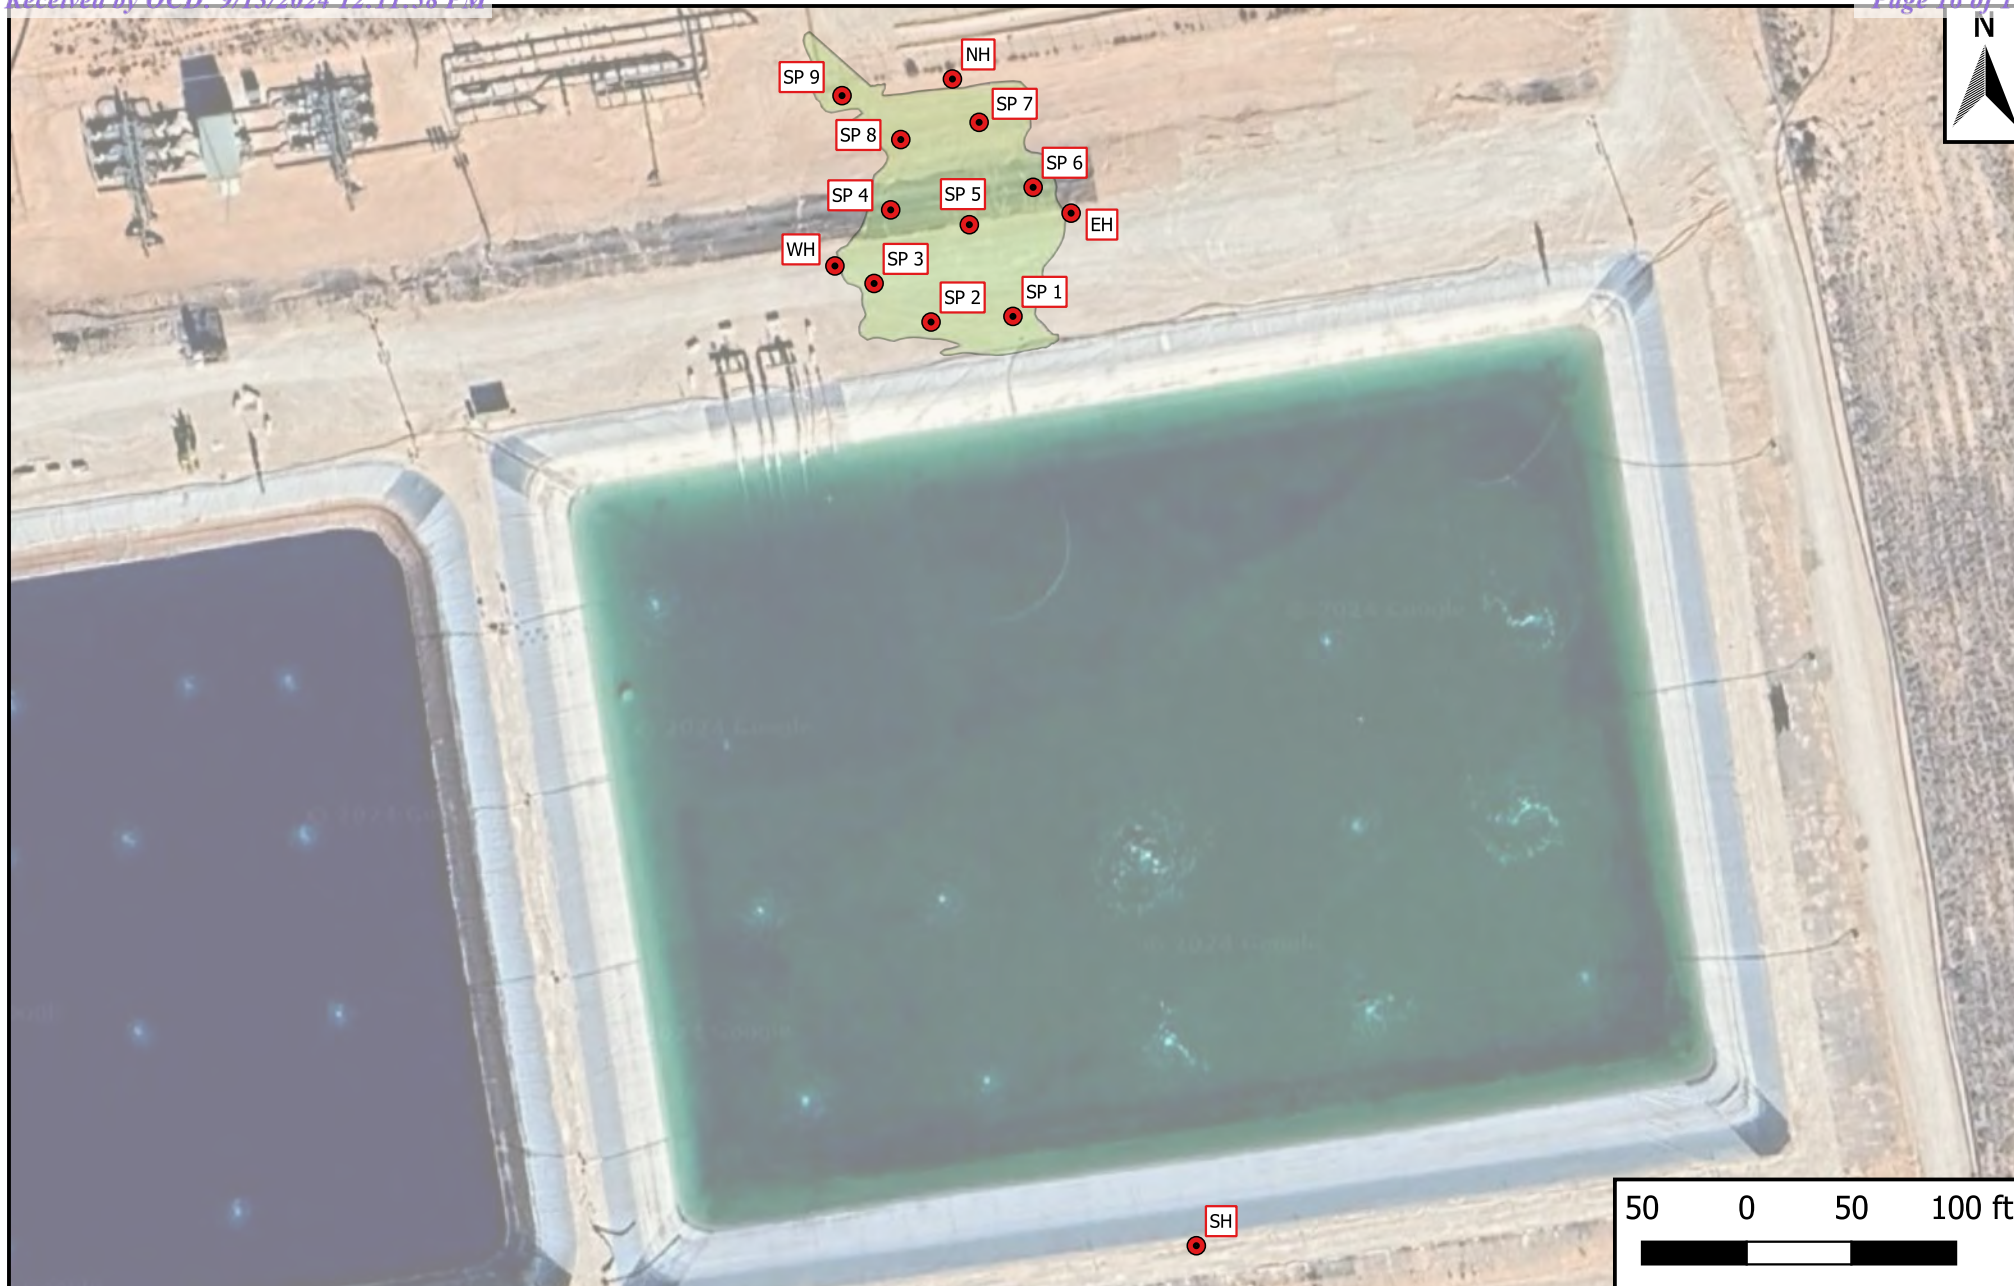
Figures 3A & 3B

Sample Location Maps

- Affected Area (11,447 ft²)
- Delineation Sample Point

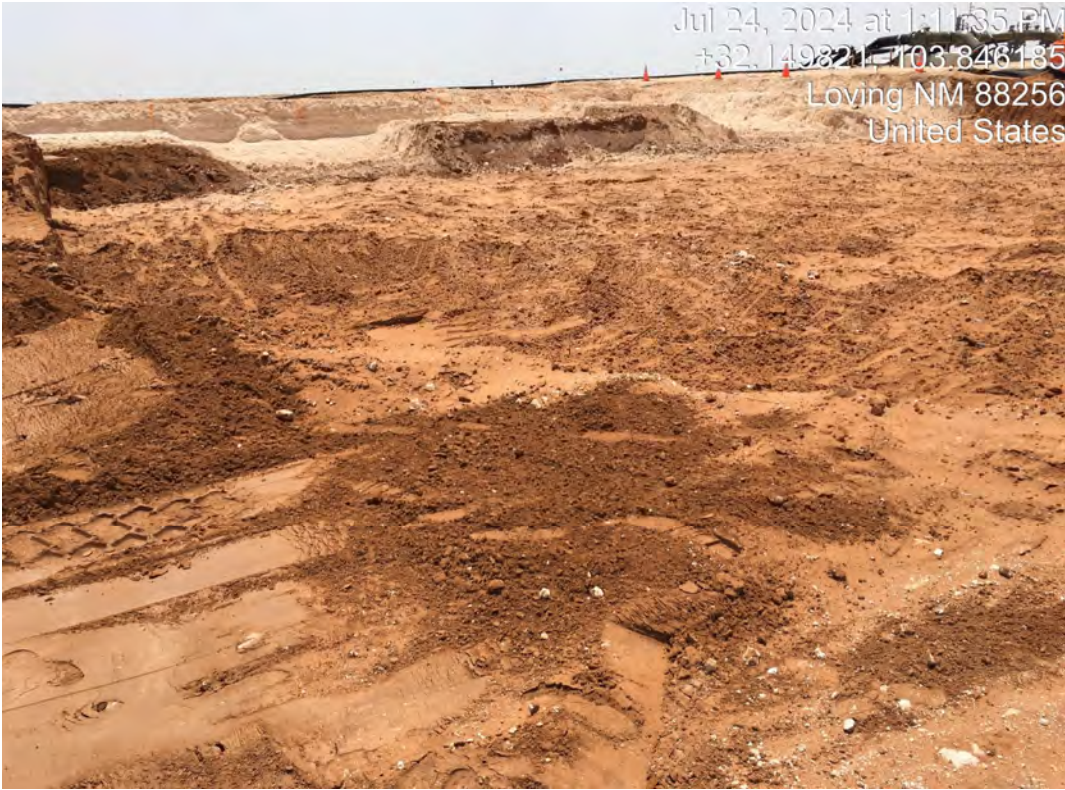
Photo Number: 8

<p>Jul 24, 2024 at 1:11:35 PM +32.149821, -103.846185 Loving NM 88256 United States</p>
Photo Direction: Southwest	
Photo Description: View of the excavated area.

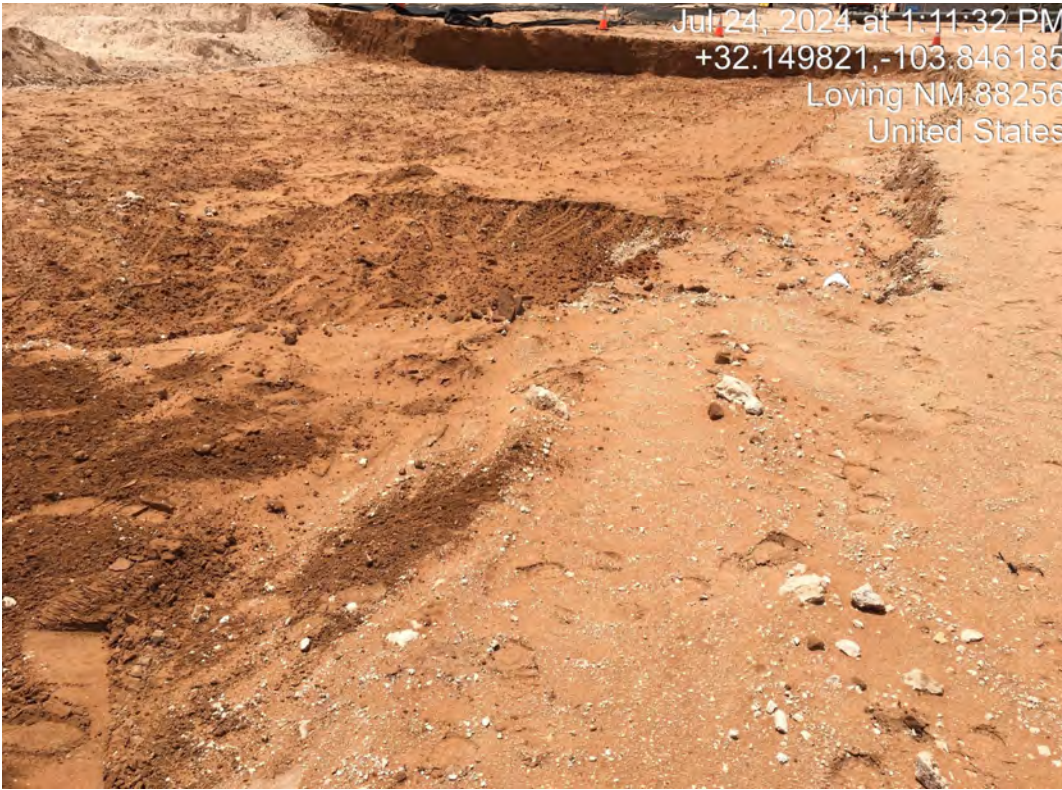
Photo Number: 9

<p>Jul 24, 2024 at 1:11:32 PM +32.149821,-103.846185 Loving NM 88256 United States</p>
Photo Direction: West	
Photo Description: View of the excavated area.

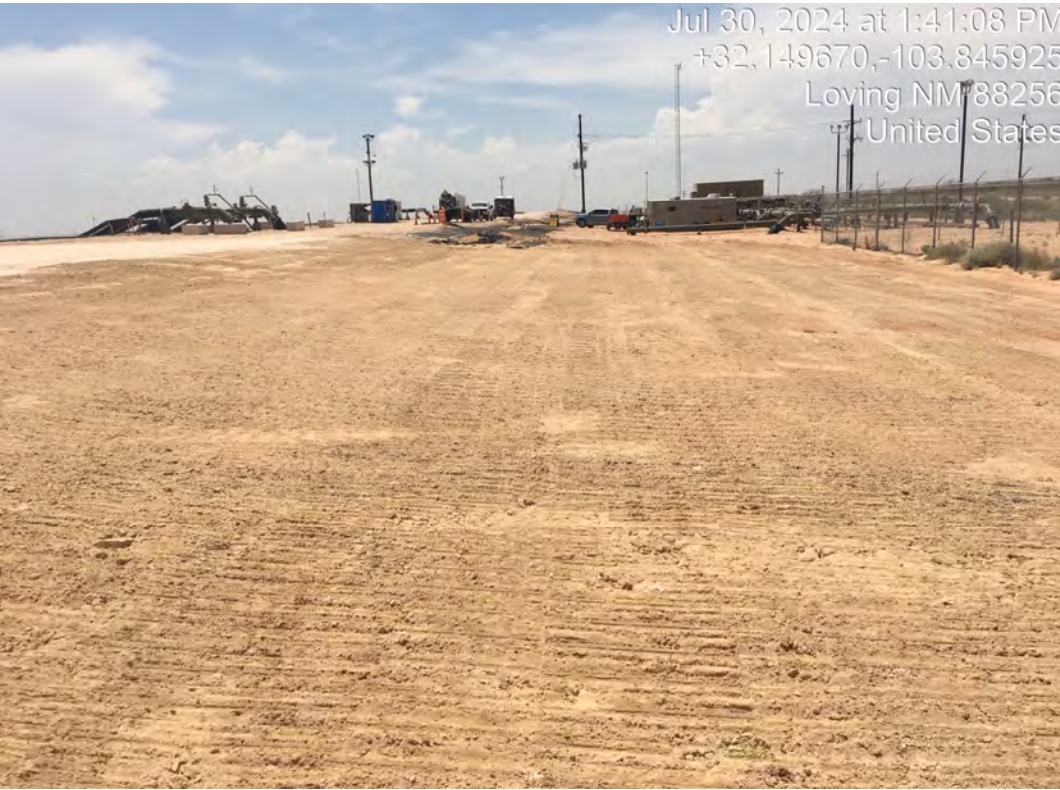
Photo Number: 11

<p>Jul 30, 2024 at 1:41:08 PM +32.149670,-103.845925 Loving NM 88256 United States</p>
Photo Direction: West	
Photo Description: View of the remediated area following backfilling and regrading.
