Diamond PWU 22 #1H  
nAB1601139679

Remediation Closure Report

**Re: Site Assessment and Remediation Closure Report**  
**Diamond PWU 22 #1H**  
**API No. 30-015-38334**  
**GPS: Latitude 32.6519089 Longitude -104.0702057**  
**ULSTR - D - 22 - 19S - 29E 575 FNL 330 FWL Eddy County, NM**  
**NMOCD Ref. No. NAB1601139679**

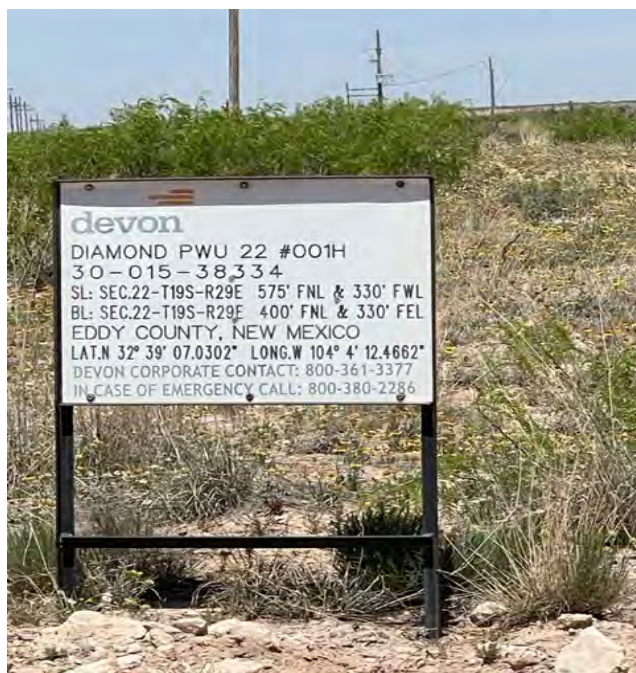
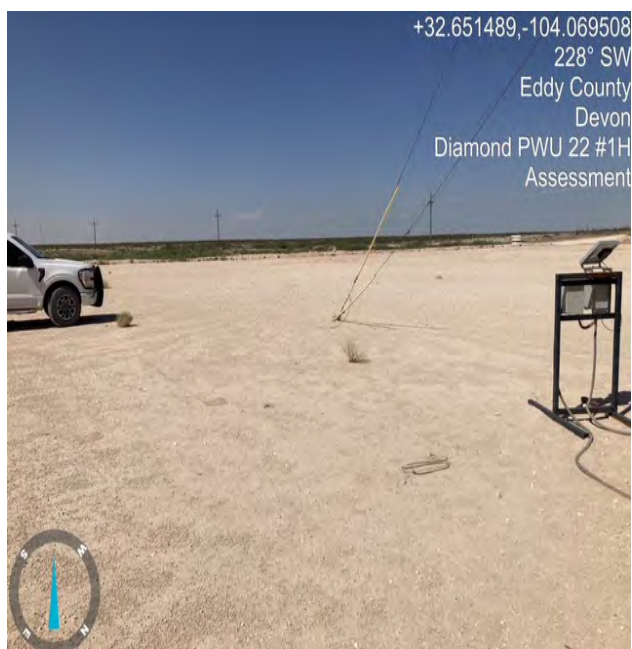
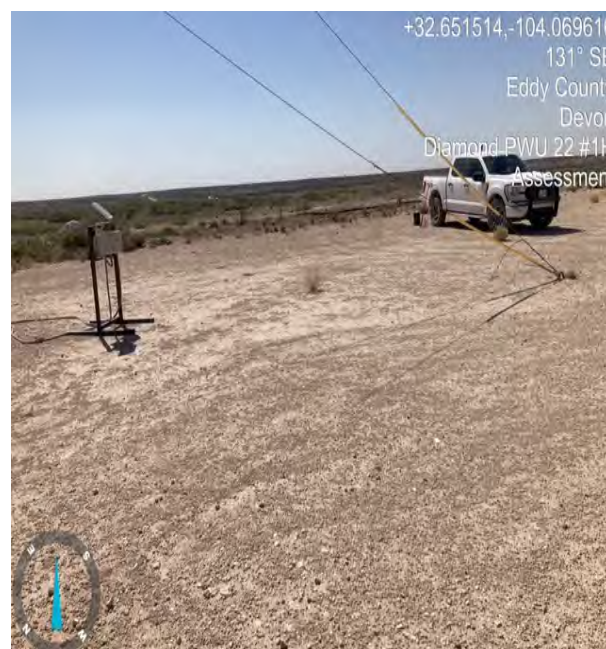
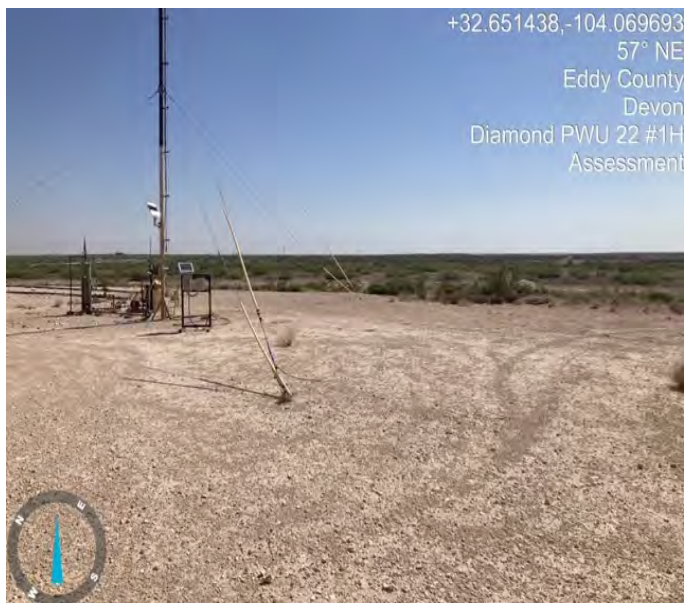
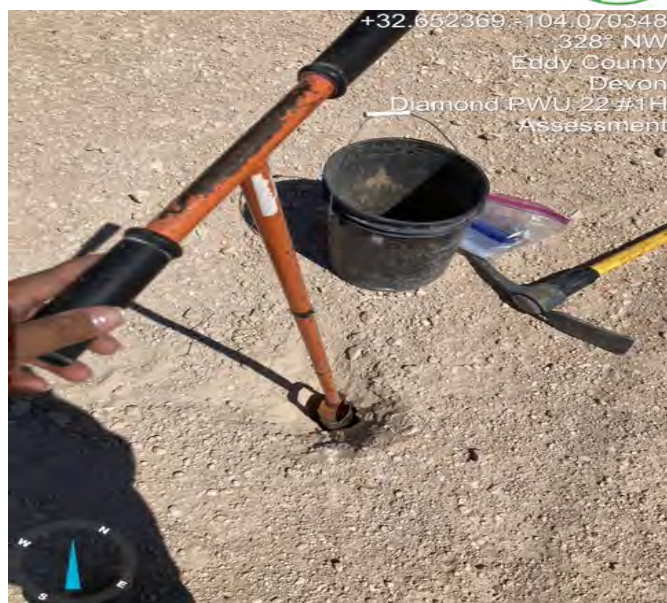
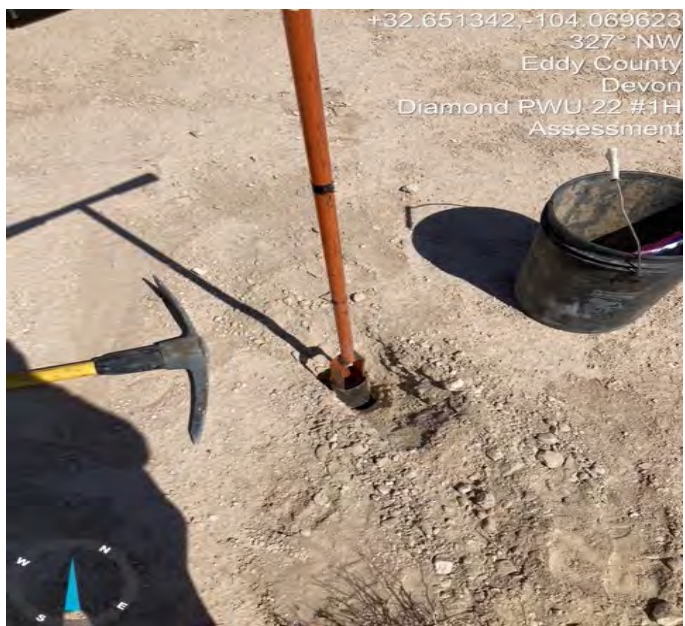
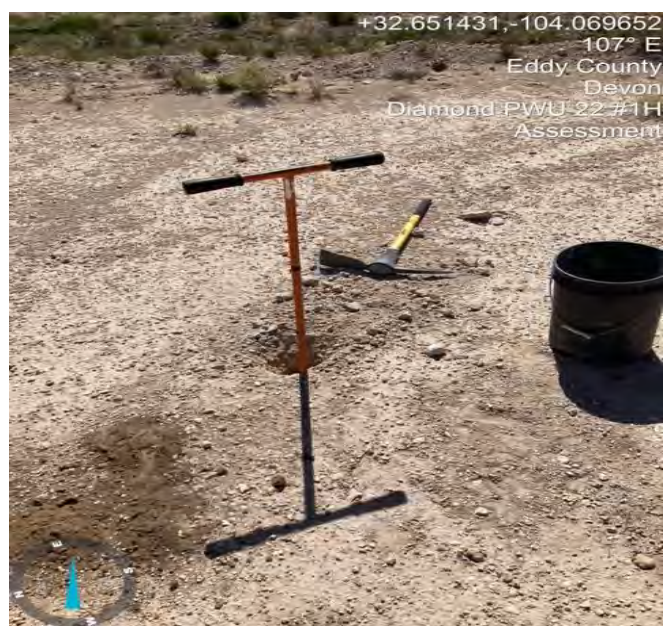
**Site Assessment**

**SITE PHOTOGRAPHS**  
**DEVON ENERGY**  
**DIAMOND PWU 22 1H**

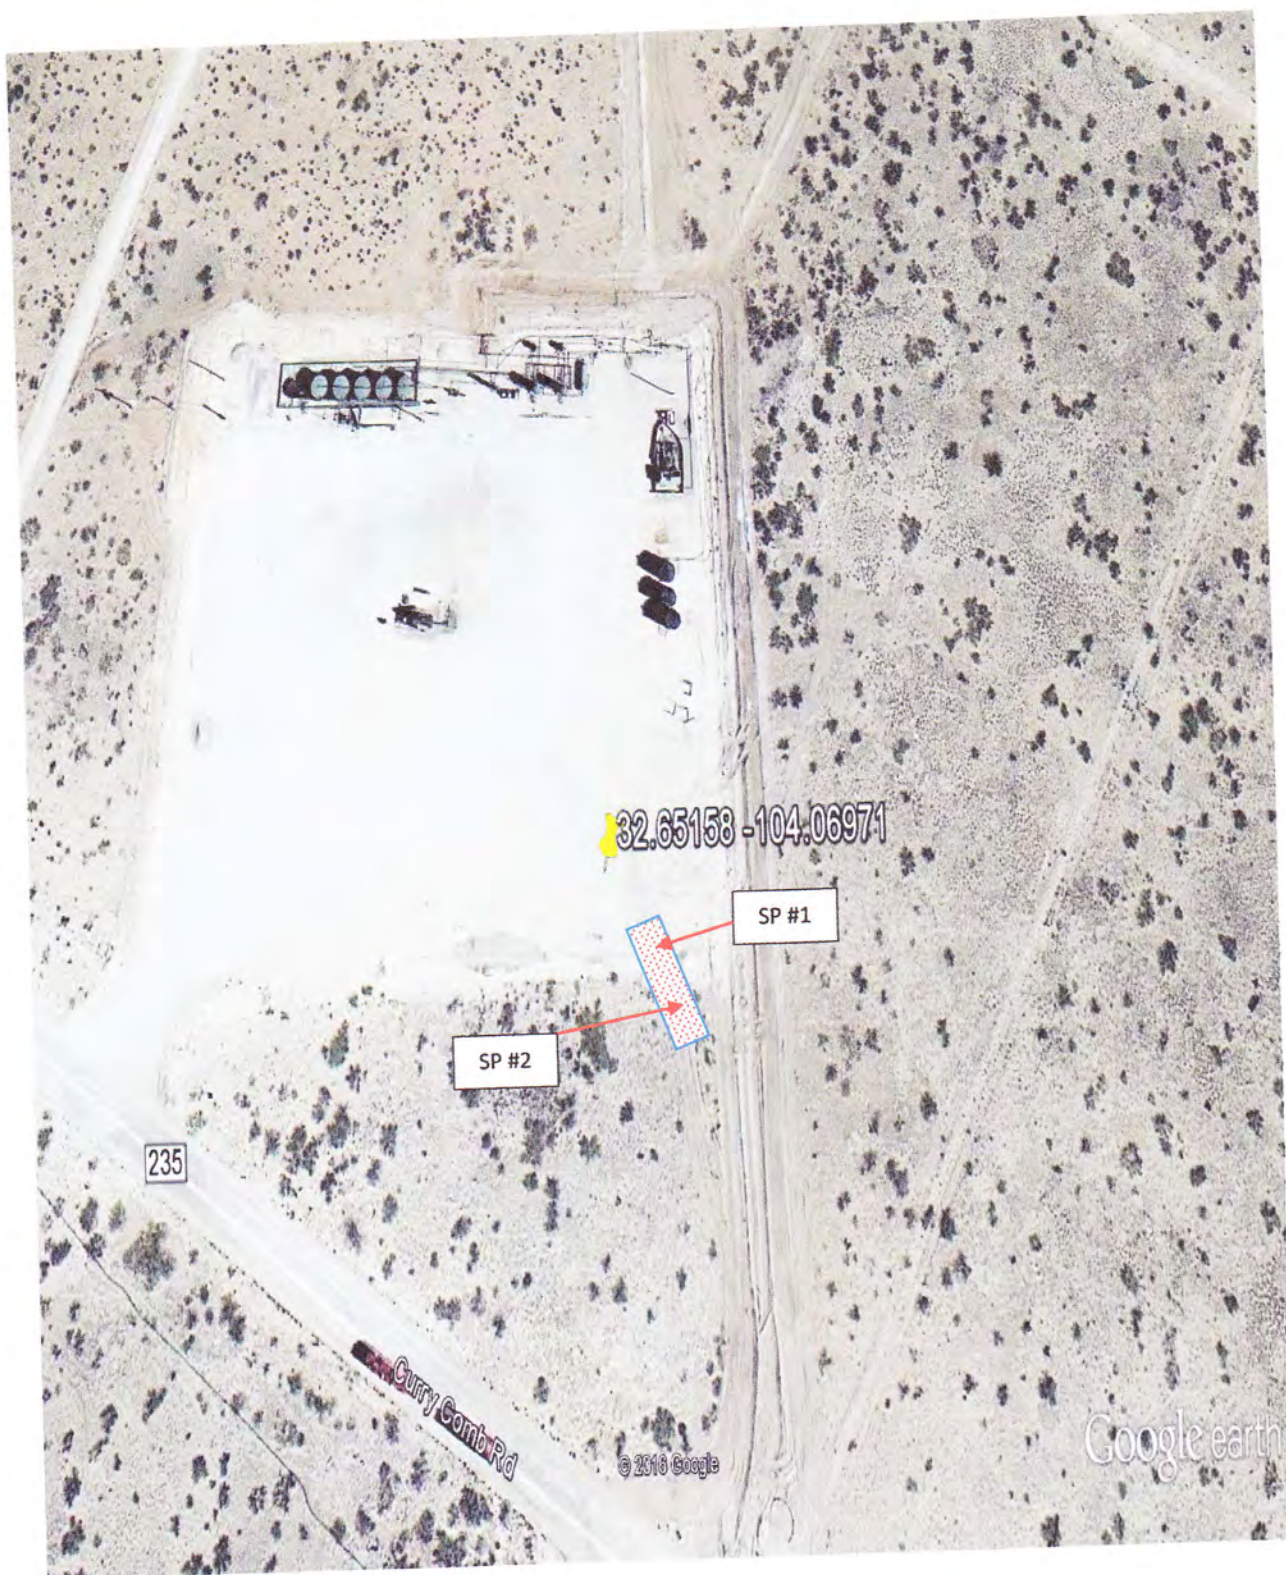
Devon Energy Production Company-Diamond PWU 22 #1H

Impacted are is approximately 20' x 40'.

I propose to treat the impacted area with a liberal application of MicroBlaze and then use large landscape rakes to rake and blend the impacted soil. This action will "break the crust" of the hydrocarbons and aid the microbes in remediation. This proposal will cause the least amount of surface disturbance, while assuring remediation of the hydrocarbons.
