Closure Report

Cabo Wabo 24 Federal 005H (05.02.23)

Incident ID: NAPP2314531100

Produced Water Release

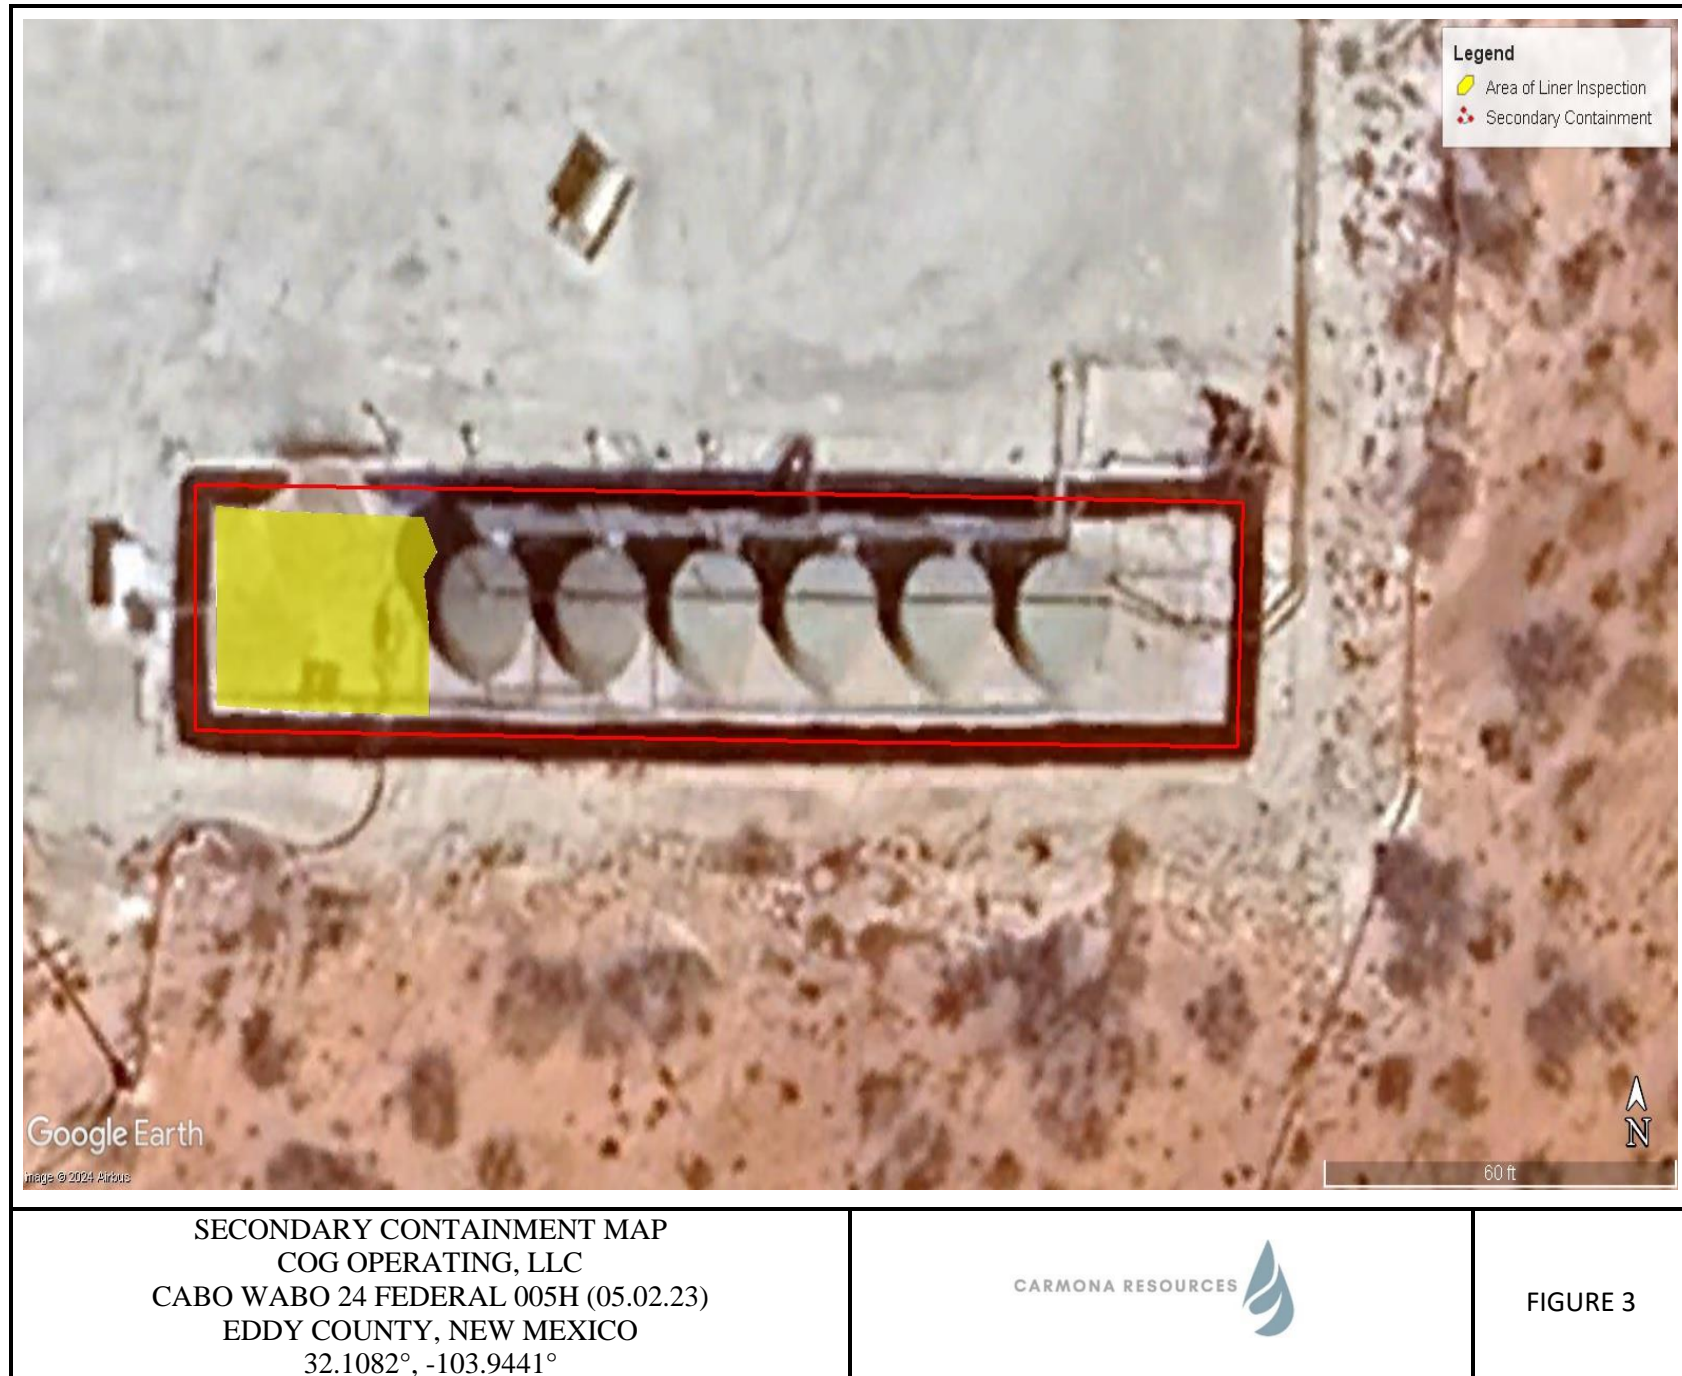
FIGURE 3 SECONDARY CONTAINMENT MAP

Based on the initial C-141 obtained from the New Mexico Oil Conservation Division (NMOCD), the release was discovered on May 2, 2023, caused by a leaking water tank due to corrosion. It resulted in approximately five (5) barrels of produced water being released and zero (0) barrels of produced water recovered within the gravel-lined facility. The five released barrels were removed when the pea gravel was removed and replaced during the facility clean-up. See Figure 3. The initial C-141 form is attached in Appendix B.

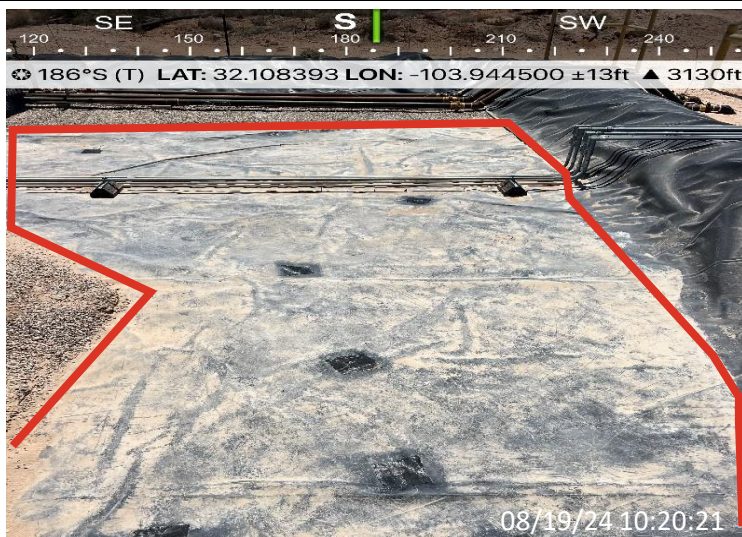
Photograph No. 1

View South of the intact liner after the pea gravel has been removed. Red outline is the area of the liner inspection.

Before performing the liner inspection, a crew was on location to remove all the impacted pea gravel so the liner would be free of any freestanding fluids. The plastic liner was then cleaned so it could be inspected thoroughly. Prior to performing the liner inspection, the NMOCD division office was notified via email on August 15, 2024, per Subsection D of 19.15.29.12 NMAC. See Appendix B. On August 19, 2024, Carmona Resources, LLC personnel inspected the liner visually and determined the liner was intact with no integrity issues. Refer to the Photolog.

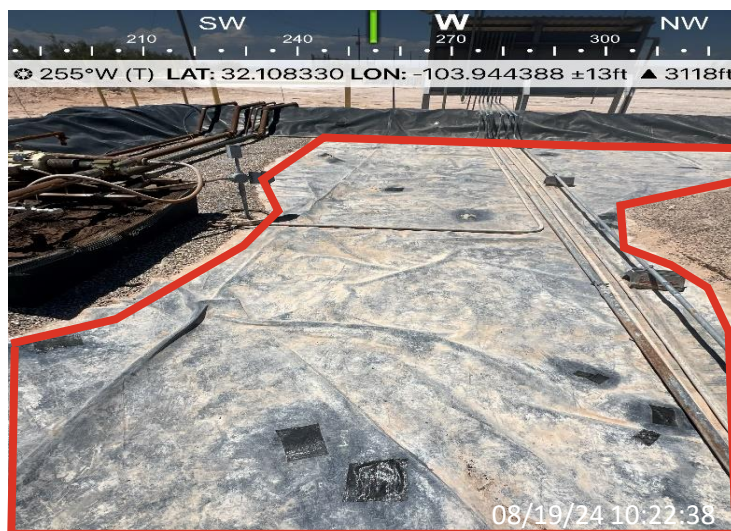
Photograph No. 2

View West of the intact liner after the pea gravel has been removed. Red outline is the area of the liner inspection.

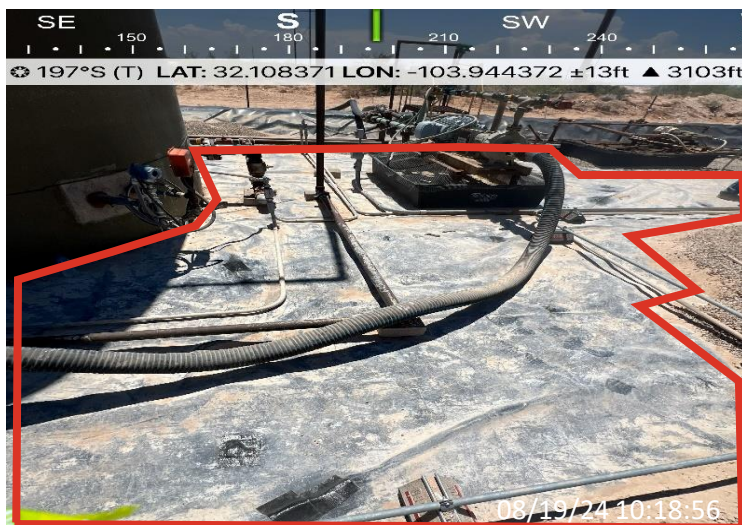
Photograph No. 3

View South of the intact liner after the pea gravel has been removed. Red outline is the area of the liner inspection.
