## **Introduction**

We are confident that data presented herein demonstrates that depth to ground water beneath the release footprint exceeds 50-feet. However, the recent sampling event shows that the volume potentially subject to remediation is small and a dig-haul-dispose remedy to the most stringent standards (depth of 50-feet) provides better protection of groundwater and is financially more responsible than drilling a boring to generate high-quality data that provides the level of certainty preferred in OCD Guidance.

### Nature of Release and Specific Justification for Volume Estimate

McElvain Energy - Fed #2 Release

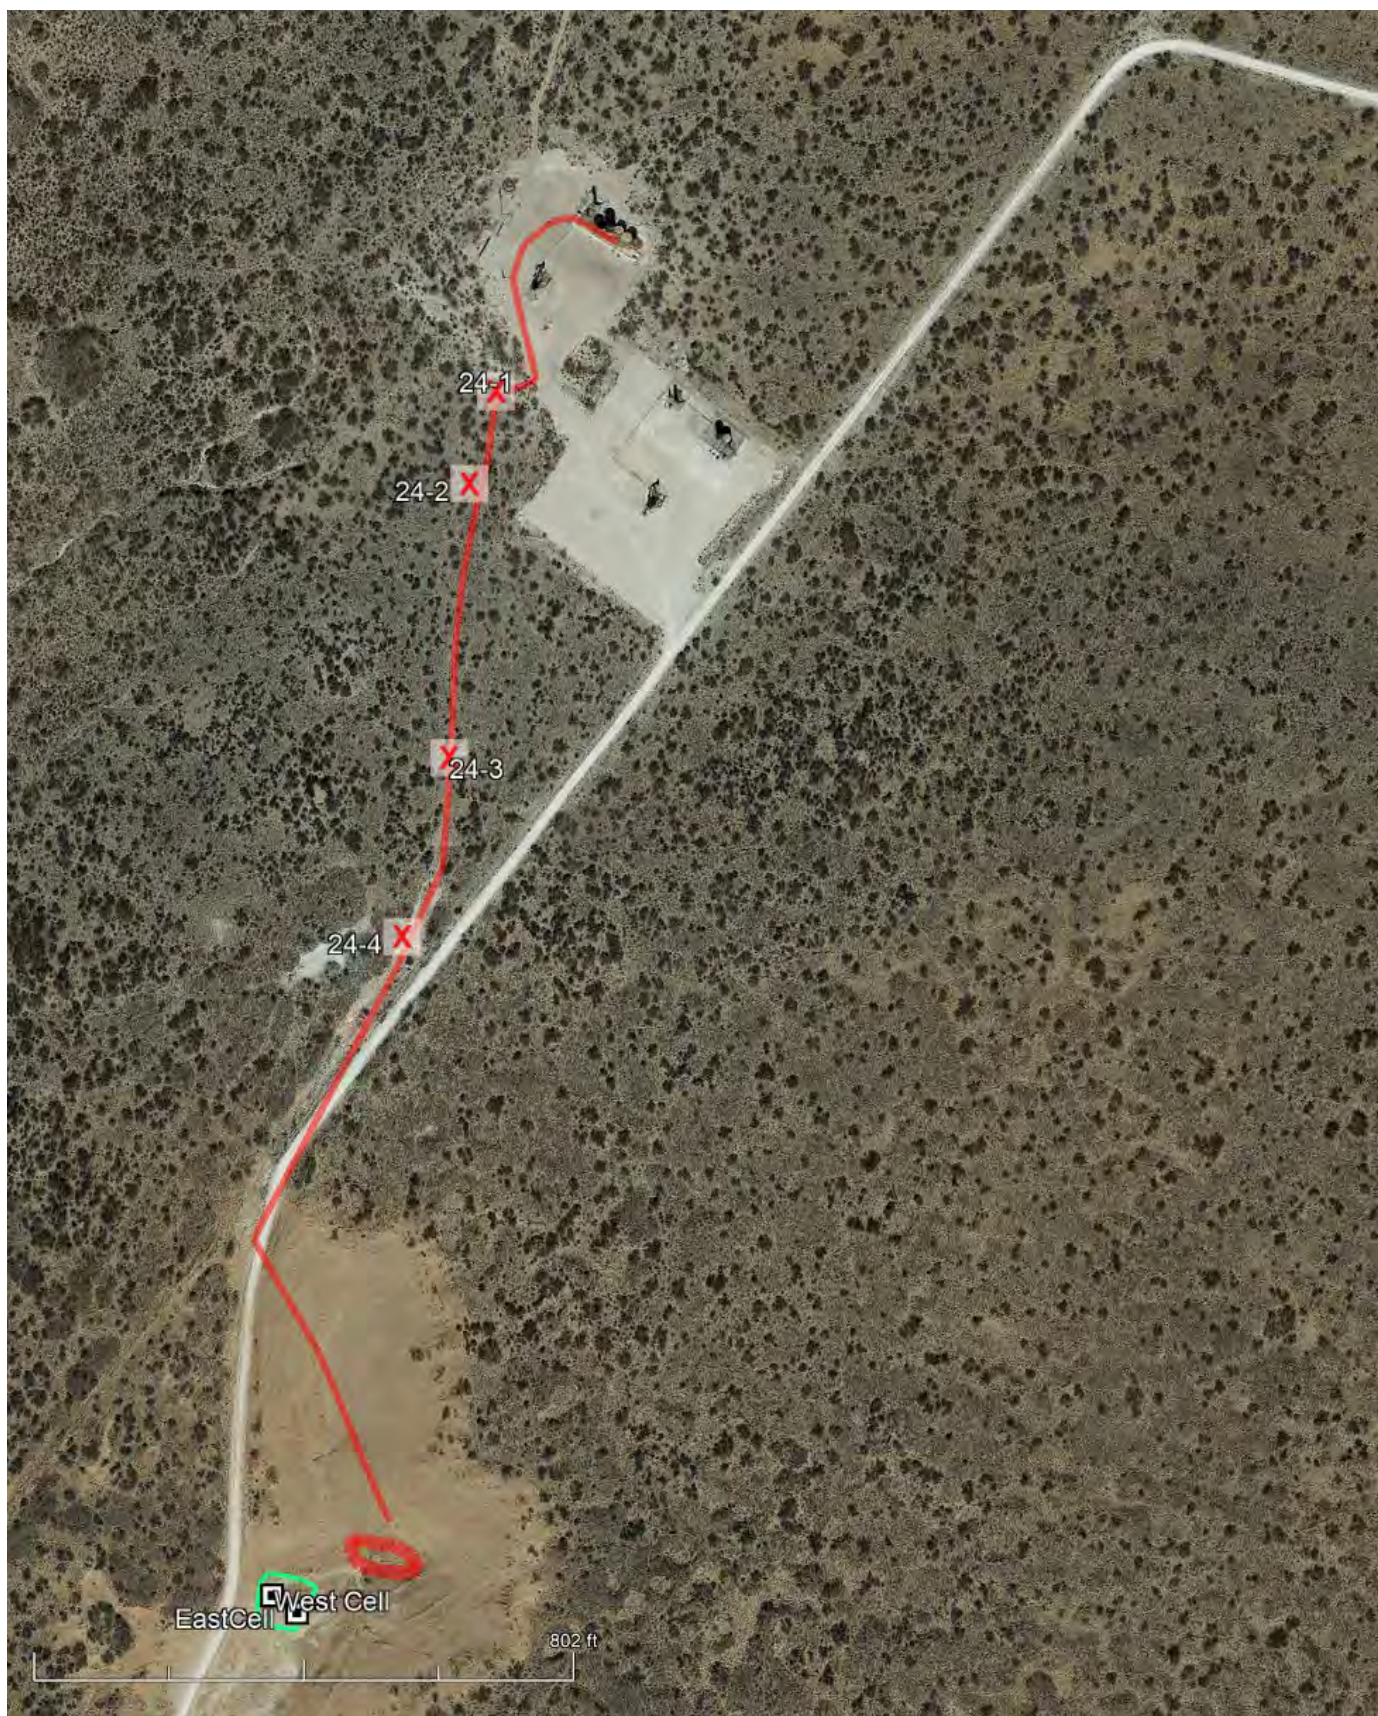
Figure 1

Scaled map showing McIlvain #2 Tanks, the origin of the release, and the flow path to the caliche pit pooling area. Sample locations presented in Table 1 are labeled on this map. Google Earth image 2/13/2014 prior to the release after reclamation of the caliche pit and two years prior to the release. The natural stormwater flow path is visible in this image.

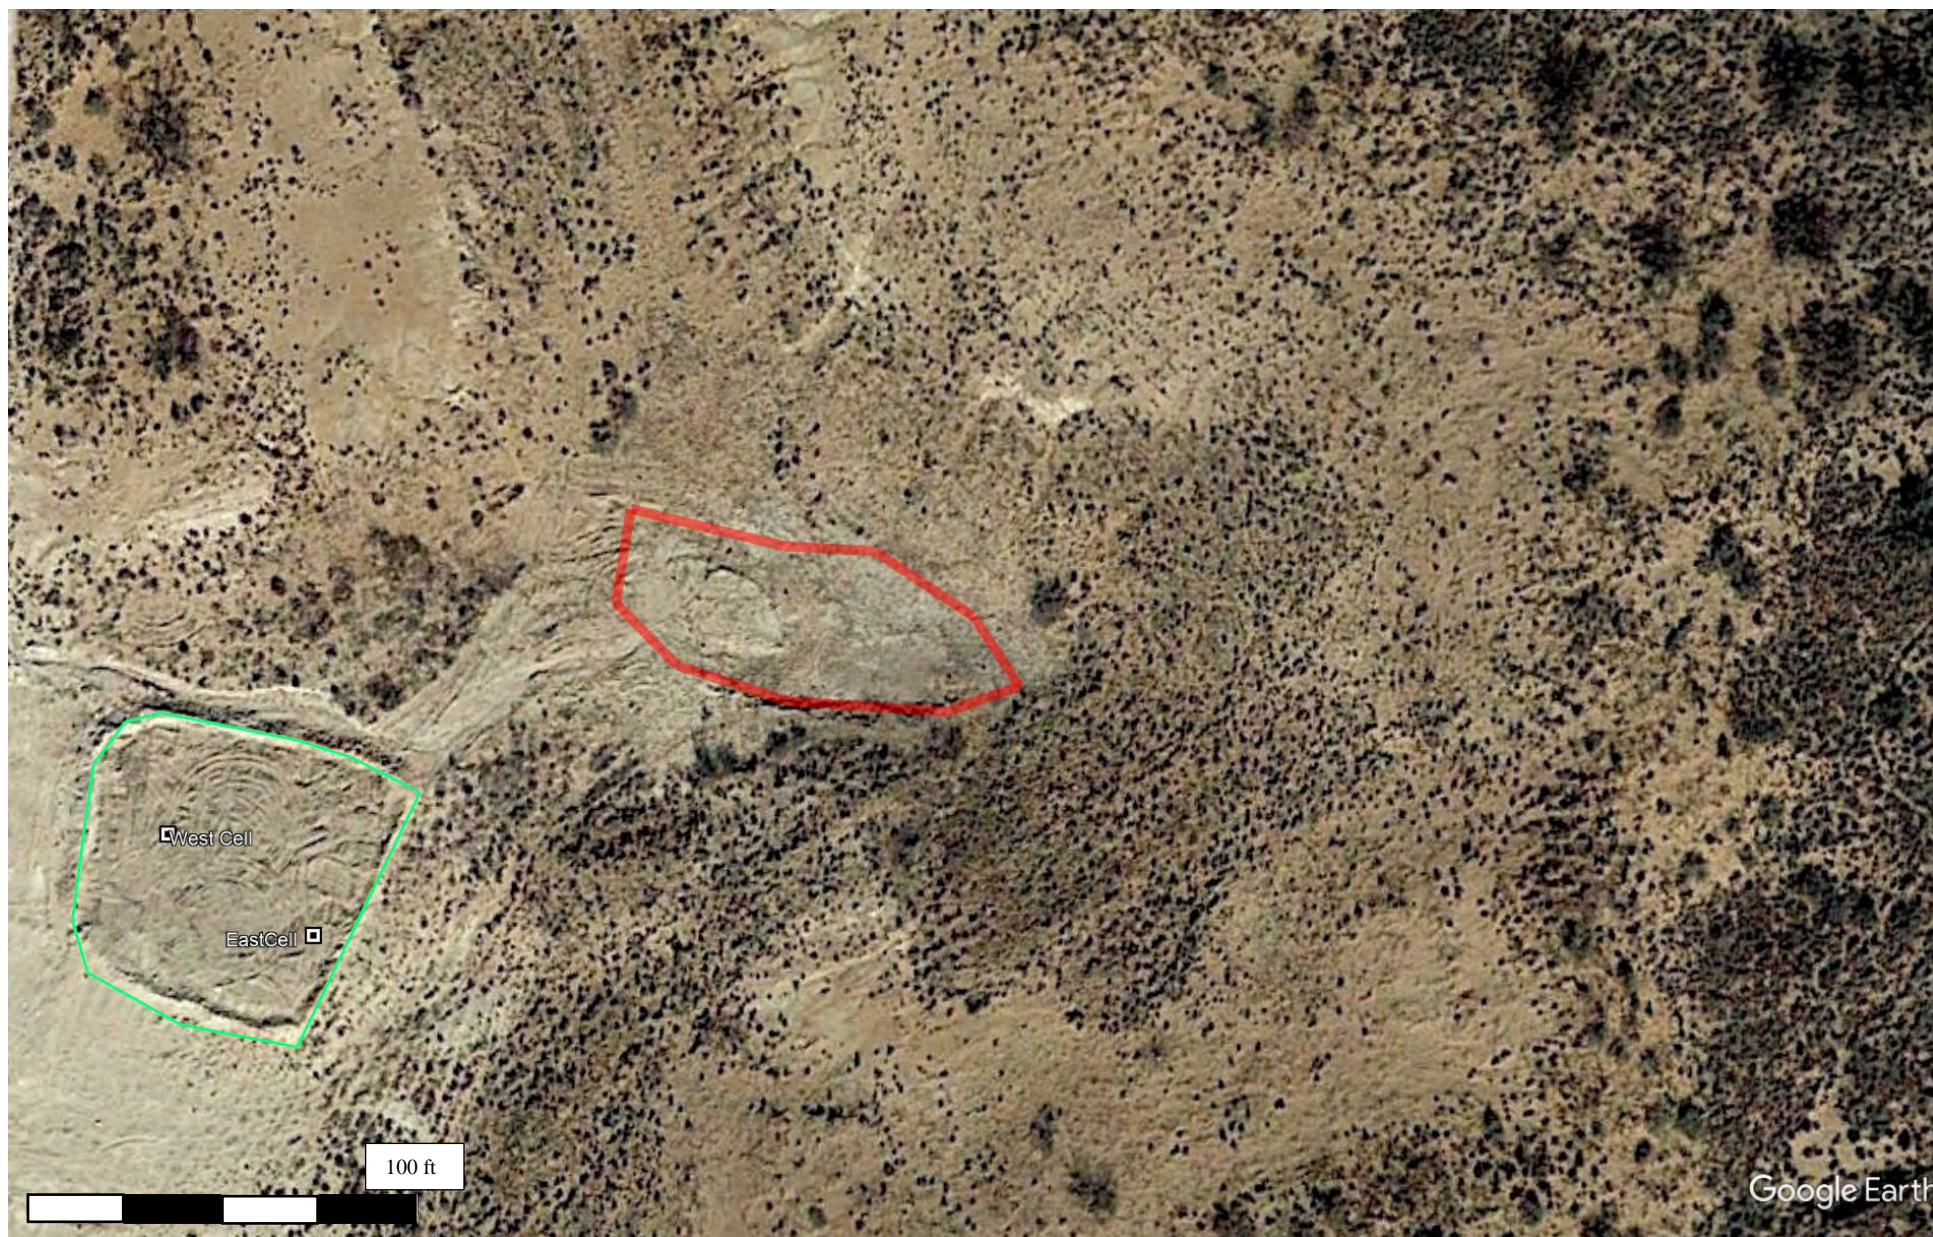
Figure 2  
Google Earth image from 2/1/2017, four months after the release. McElvain removed crude oil pooling in the caliche pit (red polygon) to the square phyto-remediation cell shown in green. The approximate location of the two sampling points within the cell are displayed.

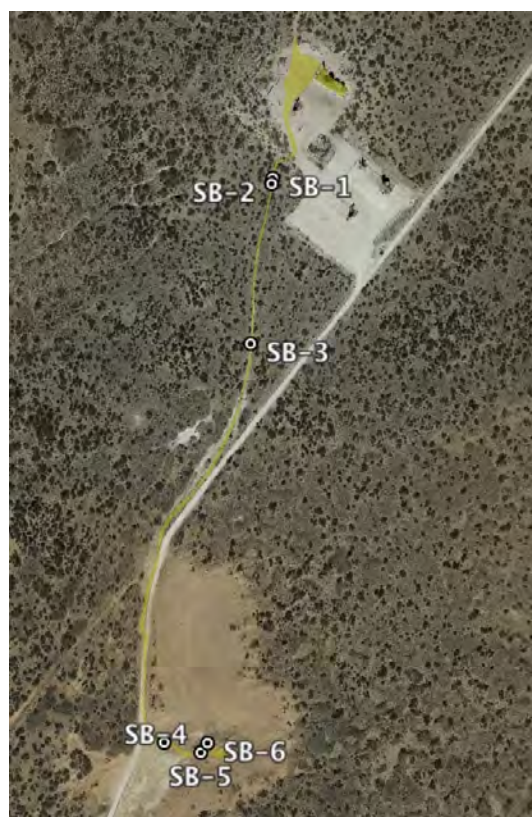
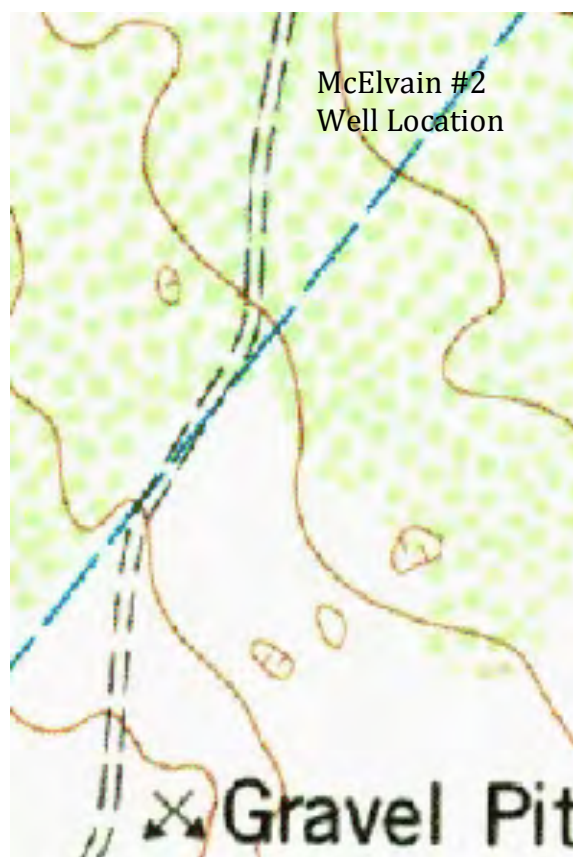
Overview of Spill Area: The stained soil extends from the McElvain No. 2 well tank battery containment berm, across the well pad and down slope along an old dirt road (2-track) to the intersection of the current lease road. Evidence of the flow follows along both sides of the lease road for a short distance, then primarily along the east side of the road to a short drainage feature that extends from the lease road to the former caliche pit (see detail photograph of the pit area).

Sample locations along the flow path (yellow shading) and at the pit, where the flow terminates, are shown on the adjacent February 2014 satellite image.

This portion of the USGS topographic map covers approximately the same area as the 2014 satellite image (above). It shows a slope of approximately 0.02 ft/ft along the former dirt road, which served as the primary flow path for the released fluids.

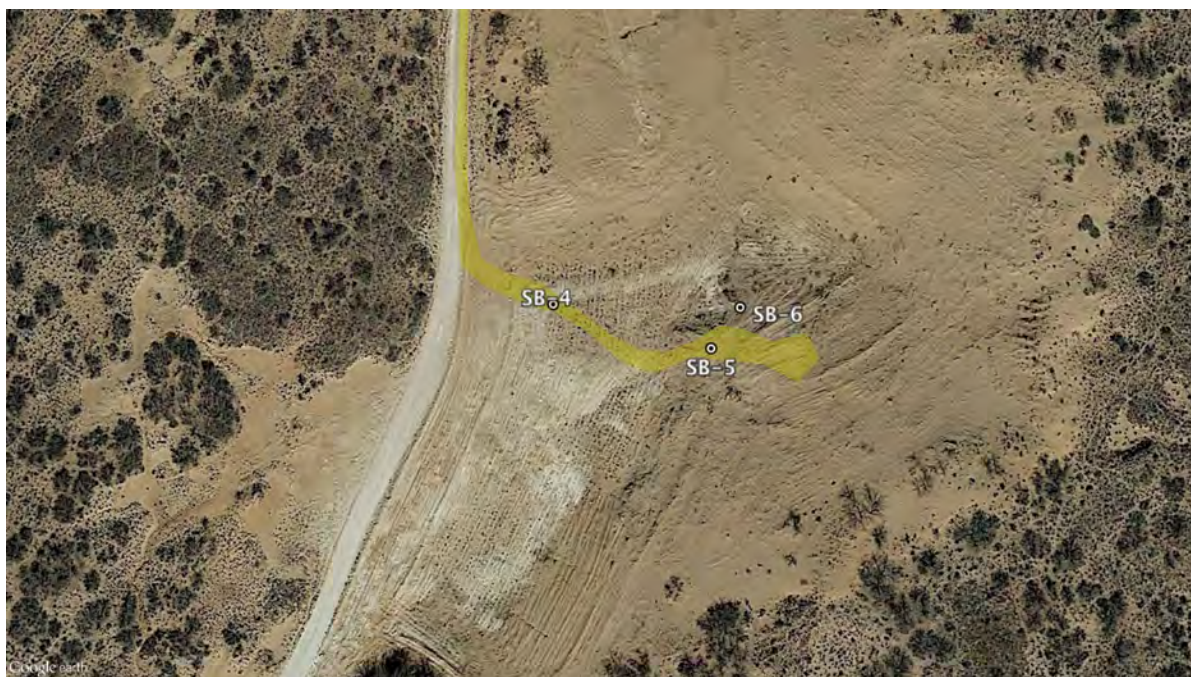
Termination point of the release flow path is a restored BLM depression, which was dry on the date of inspection. The 2014 satellite photograph does not show the current surface conditions but the flow area (yellow) and sample locations are correctly geo-referenced.

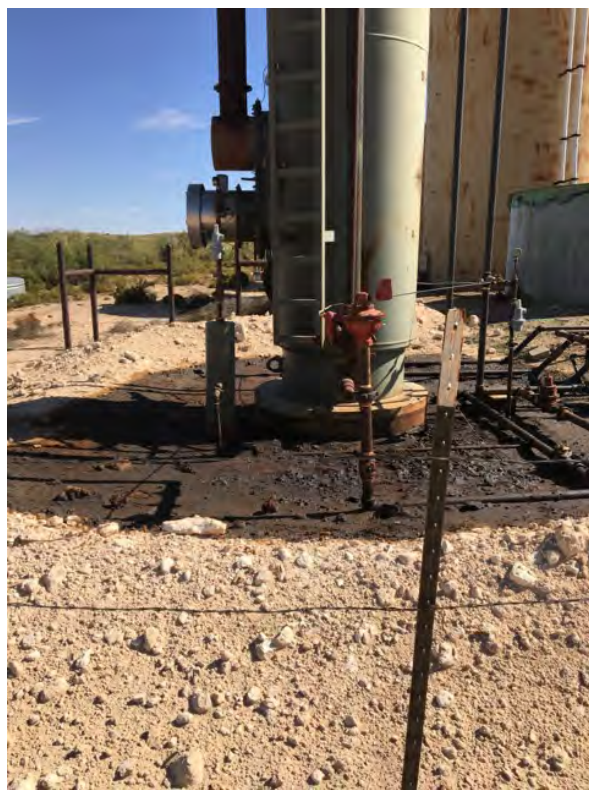
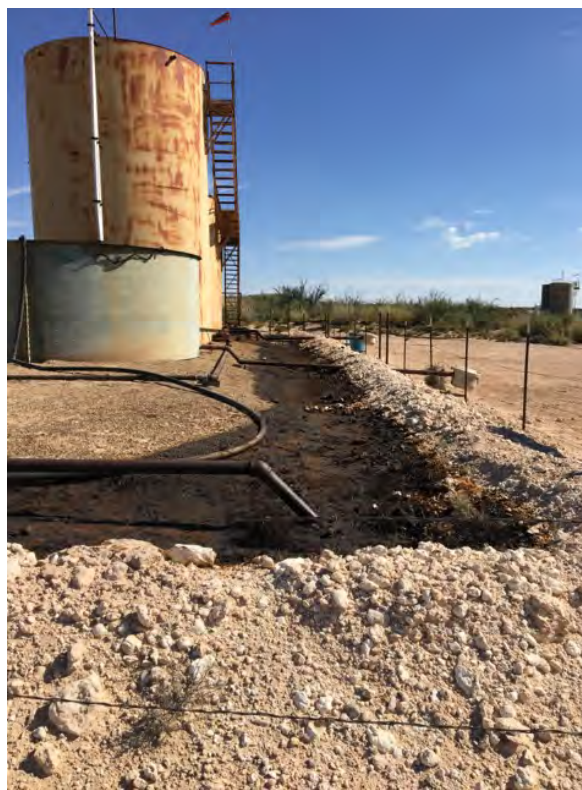
Fluid was forced through the stuffing box at the wellhead to the tank battery containment. The fluid escaped the containment at the low point in the berm near the separator.

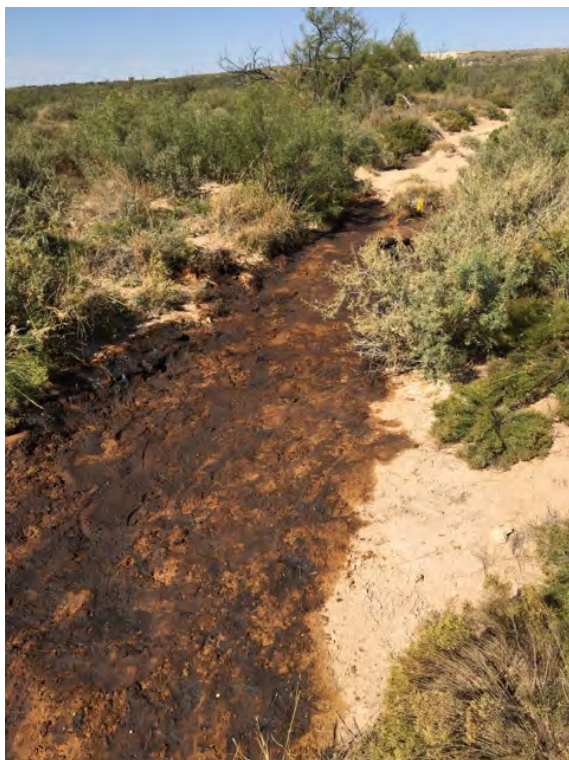
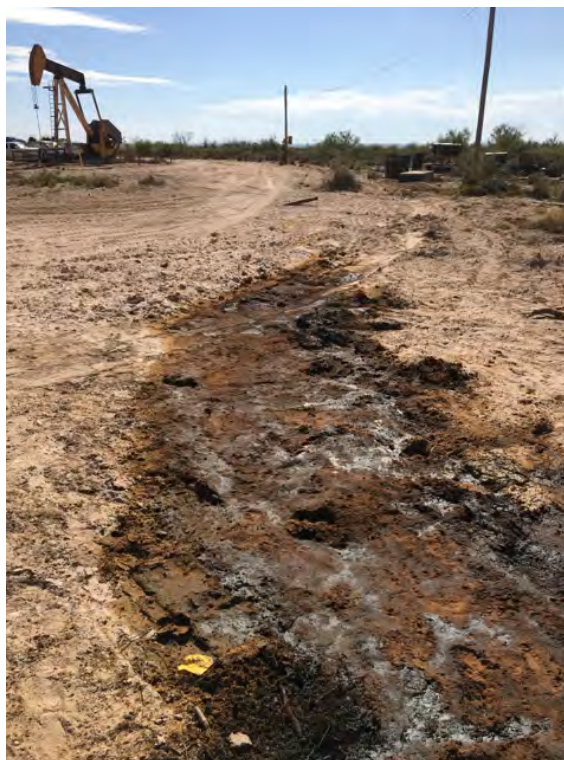
Fluid from the release extended approximately 40 feet to the north along the old dirt road (right photo) and to the south across the well location (left photo). Clean sand was placed on the well pad to allow continued access to the well.

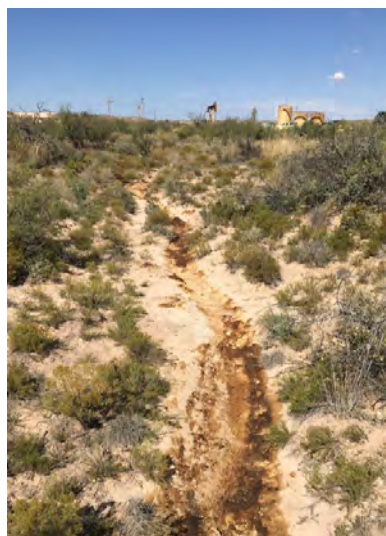
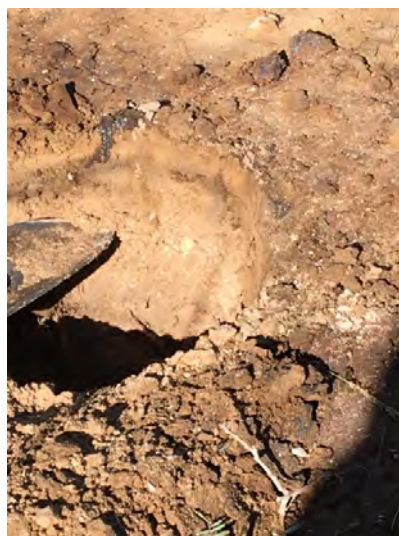
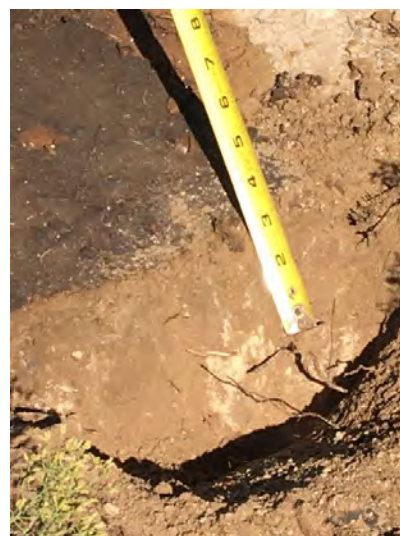
These photographs indicate the character of the stained soil along the old dirt road that served as the primary flow path from the McElvain No. 2 well location to the lease road. They indicate that the hydrocarbons penetrated only an inch or two into the sandy soil.

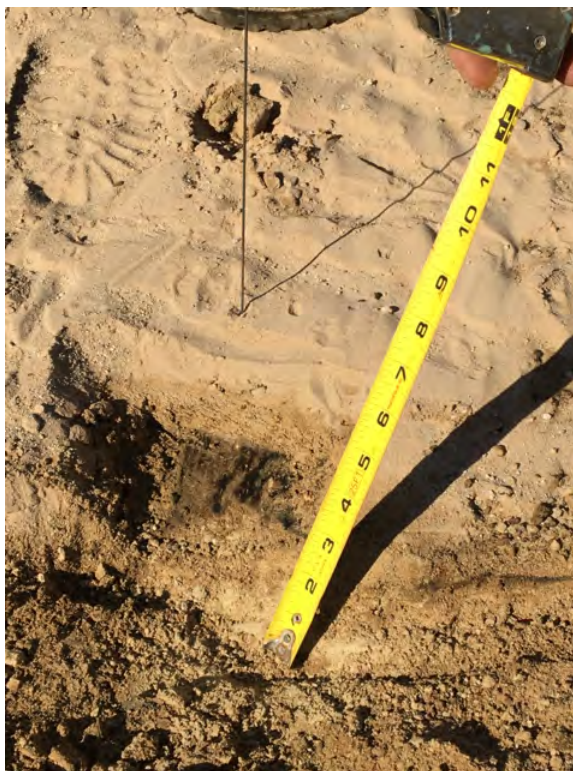
The adjacent photograph shows a cross-section in the primary flow path with unstained soil at the bottom, a thin layer of hydrocarbon staining in the middle, and a layer of sand at the surface. The sand was deposited by the final (and dominant) portion of the released fluid.

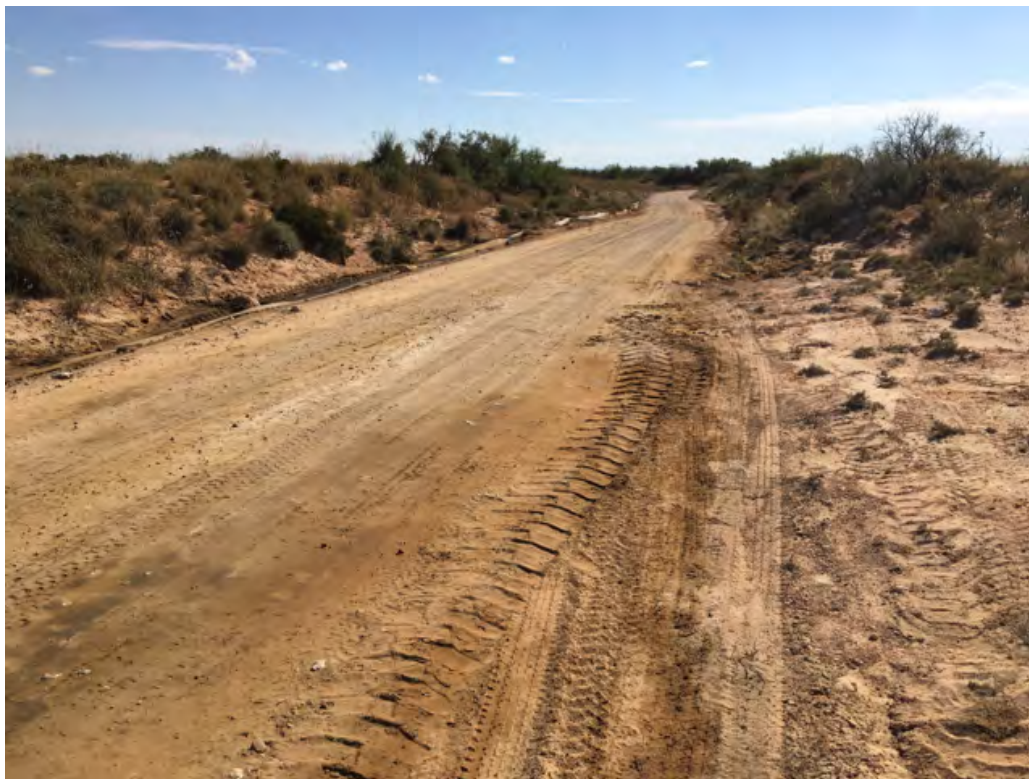
View to the south, just north of the pit, where the released fluid crossed the current lease road and continued down slope to the pit at the bottom of the hill to the left.

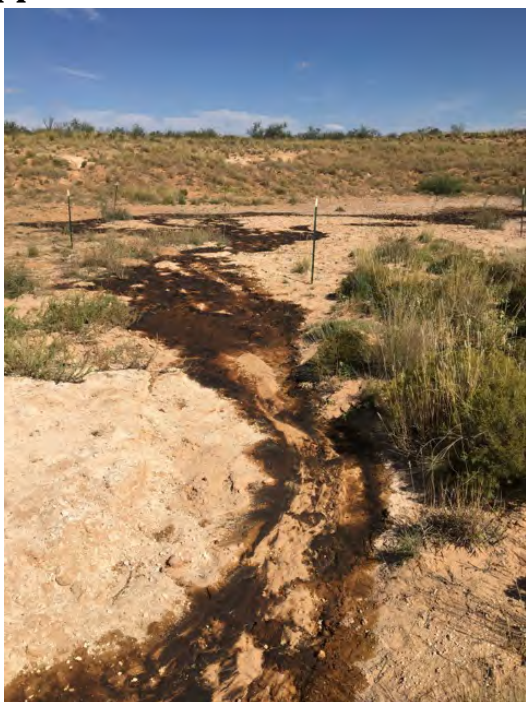
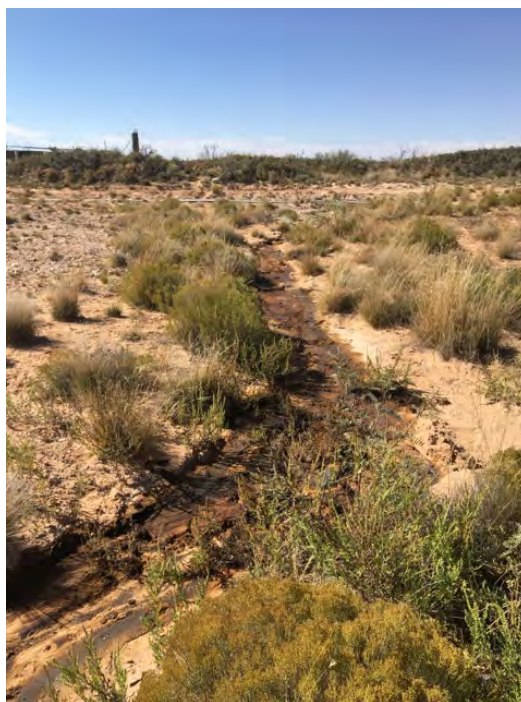
On the left is a photograph showing the flow path from the current lease road to the pit. The photograph on the right is a view back to the west from the pit toward the lease road.

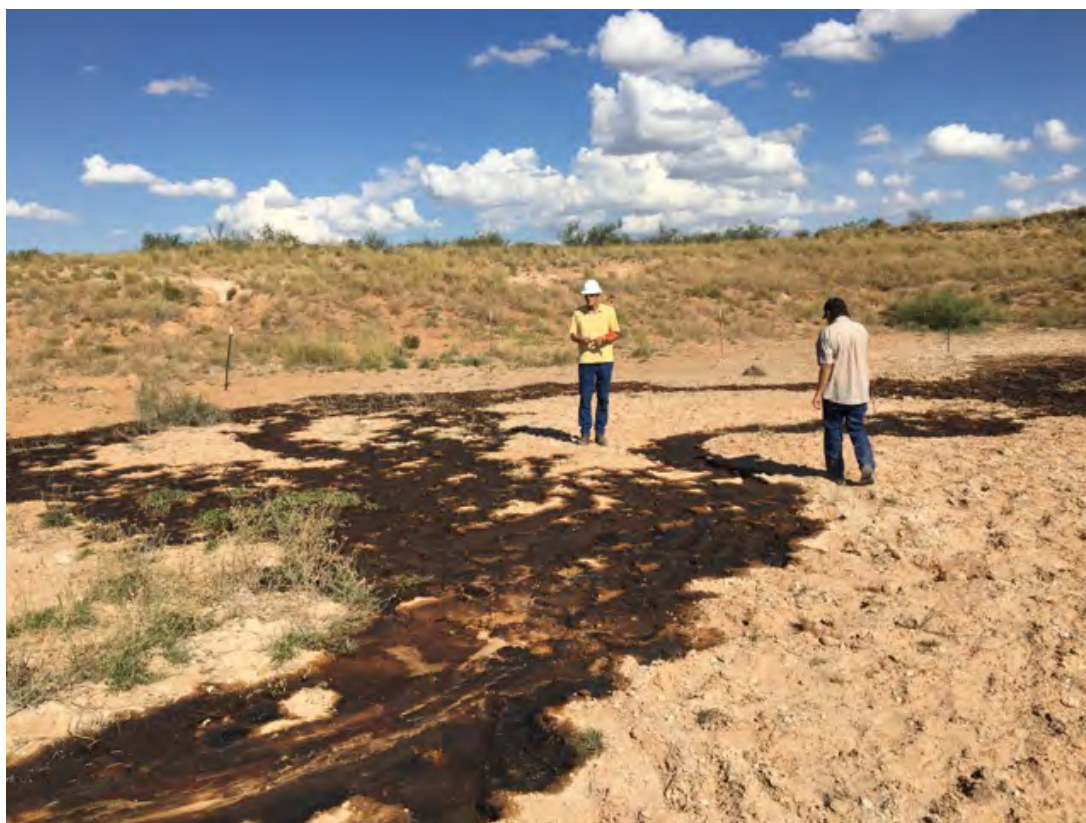
Photograph inside the pit (view to the east) demonstrating that the release was of an insufficient volume cover the entire pit, filling only the low spots in the pit floor.

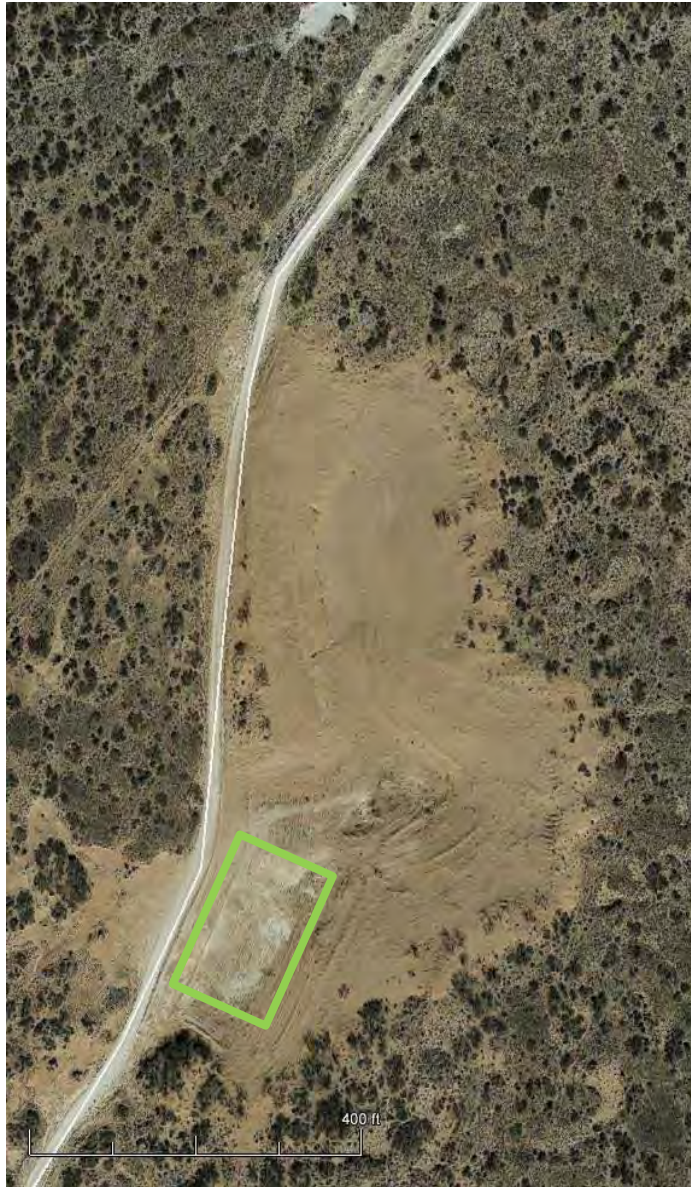
Figure C-1 – Location of phyto-remediation cell (green outline) in restored caliche pit. This area is exposed caliche and would benefit from the addition of sand/soil and seeding as proposed. Phytoremediation, not Micro-Blaze treatment is proposed for this cell.

1. At the restored caliche pit floor, remove all stained soil and soil exhibiting hydrocarbon odor to the “phytoremediation cell” near the lease road as shown in Figure C-1 below. Berms along the edges of the phytoremediation cell will prevent erosion and redistribution of the impacted material as well as run-on of storm water. .

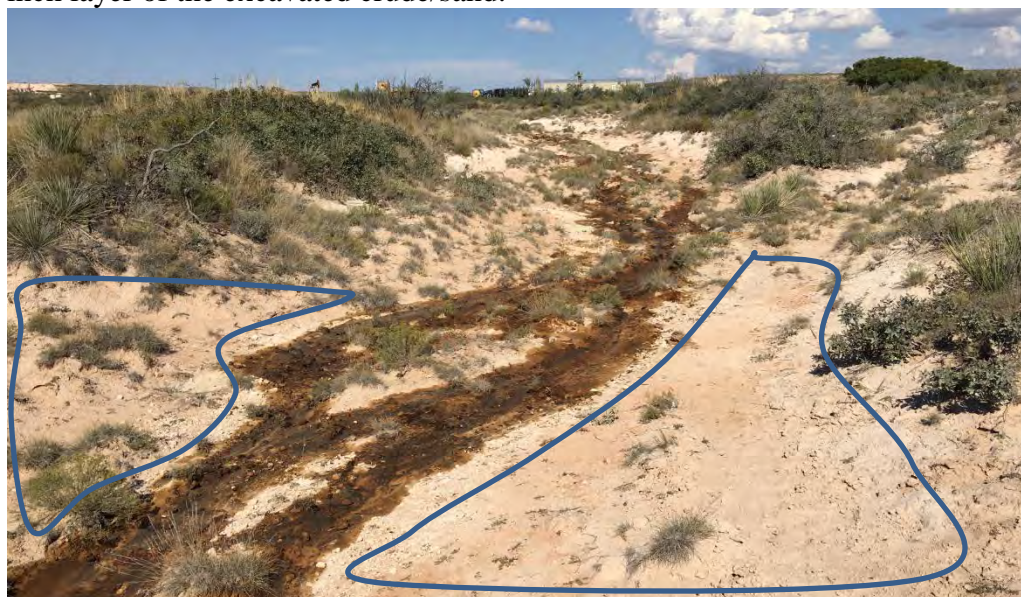
Figure C-2 – Crude footprint in abandoned road “drainage” is limited in extent. After disaggregation of the surface crude and mixing with underlying sand, the mixed material should be dispersed along the sides of the flow path. Areas outlined in blue can be covered with a 2-4 inch layer of the excavated crude/sand.

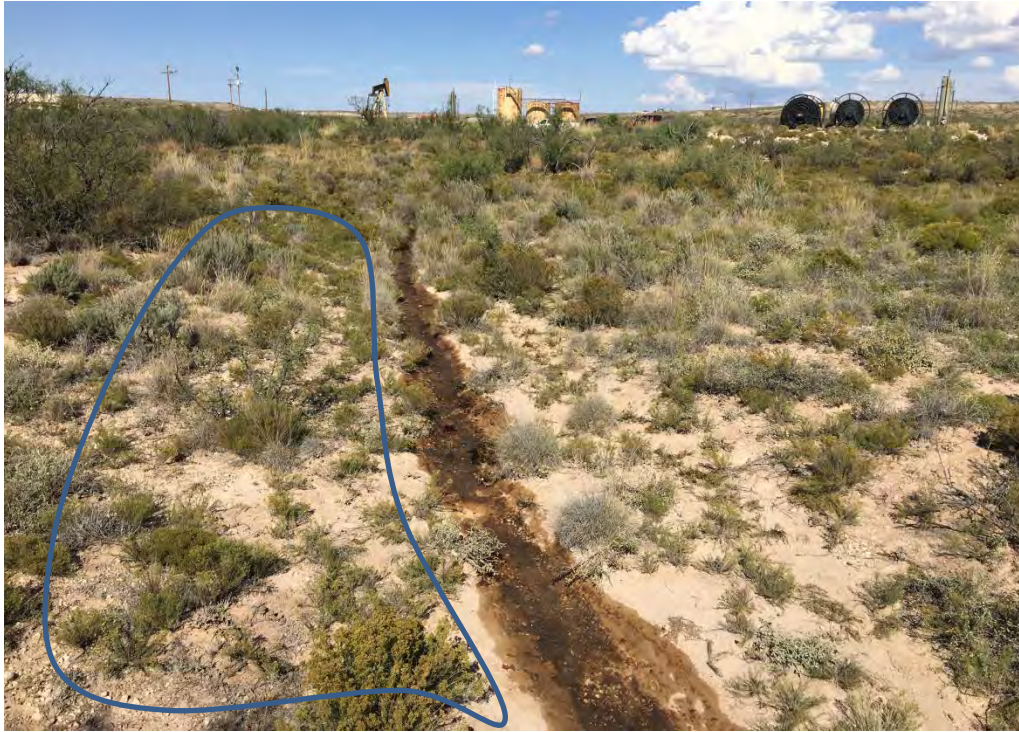
Figure C-3 Footprint of crude in highly vegetated area of abandoned road “drainage”. In these areas, mixing the crude with sand and disaggregation to less than  $\frac{1}{4}$  inch size particles, which is the closure criteria, is critical. Once distributed into the vegetation, the crude/sand particles cannot be easily re-worked to meet closure criteria.

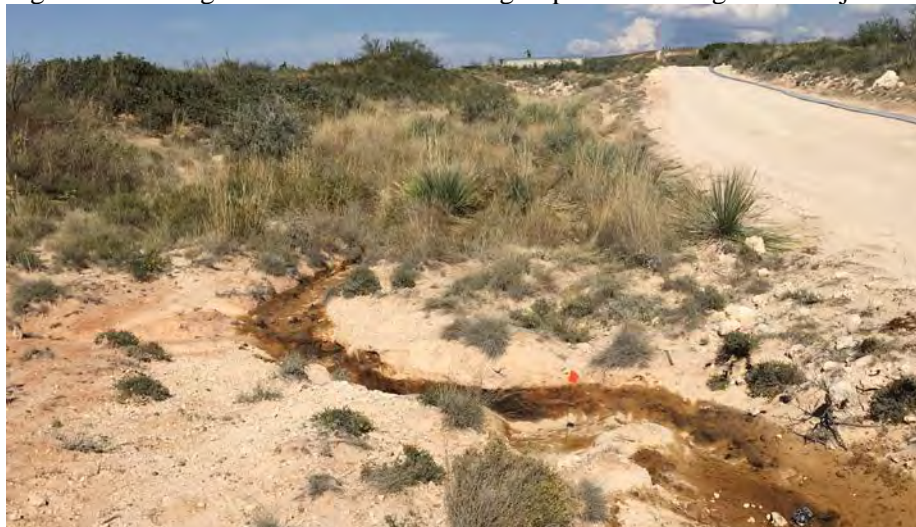
Figure 1A – Image from 10-25-17 showing impact to drainage ditch adjacent to lease road.

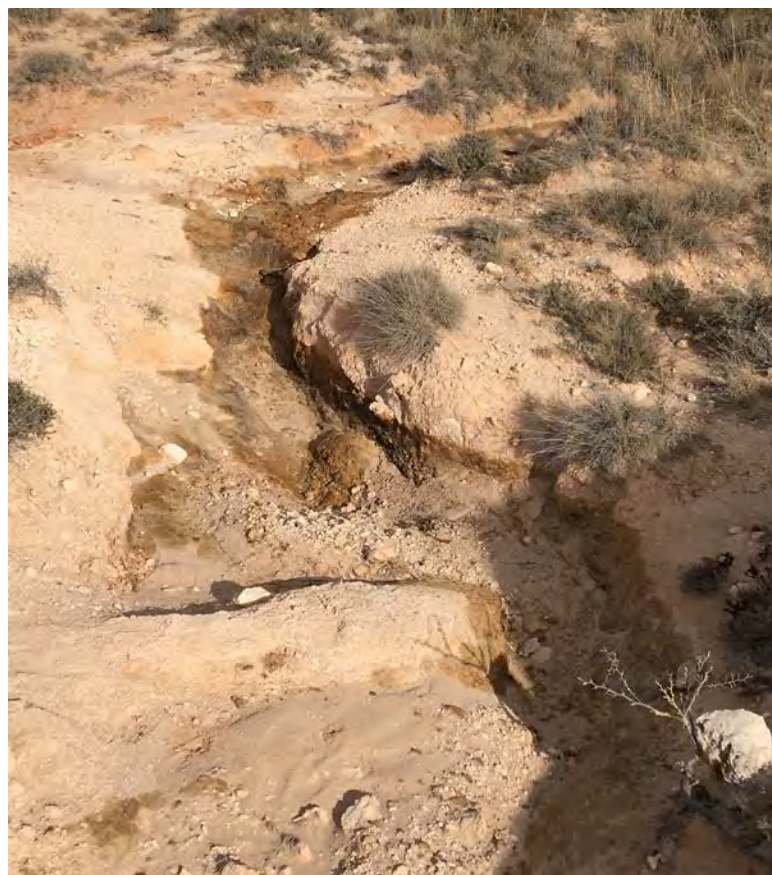
Figure 1B – Image taken 12-13-16 of the same area. Note that rock and small plant in the lower right corner of this image is the same rock/plant in the lower right part of image 1A. The staining and impact has been mitigated over the 6 weeks by natural processes.

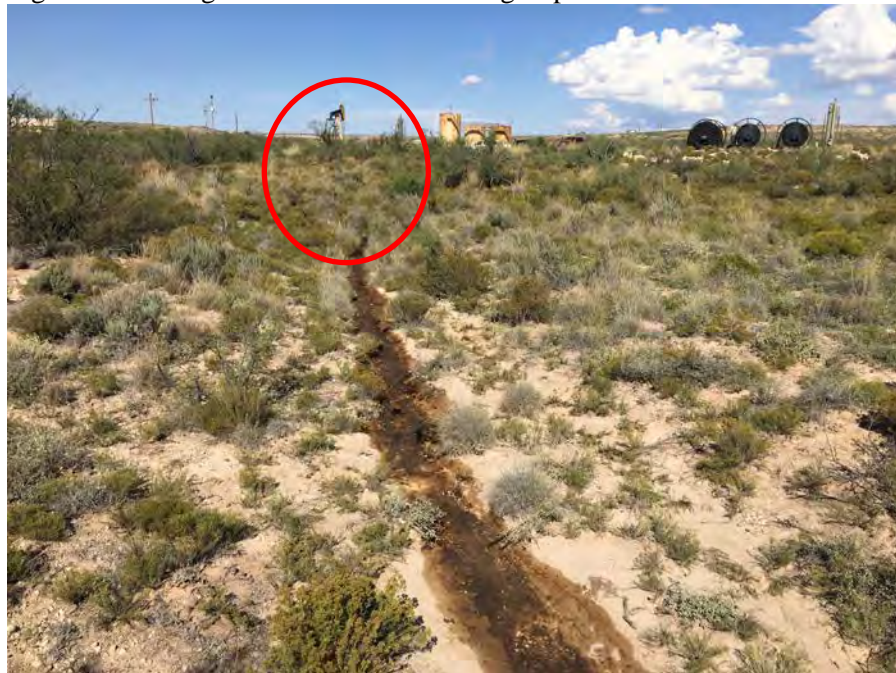
Figure 2A – Image from 10-25-17 showing impact downhill from the location.

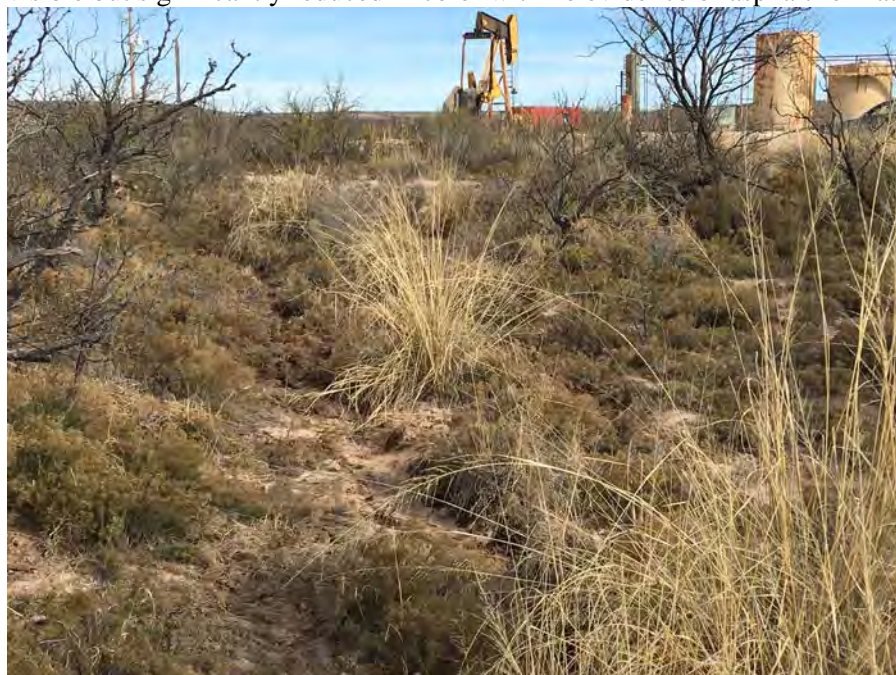
Figure 2B – Image from 10-25-17 showing area of the spill footprint within the red circle of image 2A. The stained soil footprint downhill of this image (in the foreground of image 2 A) remains visible but significantly reduced in color with no evidence of asphalt formation.

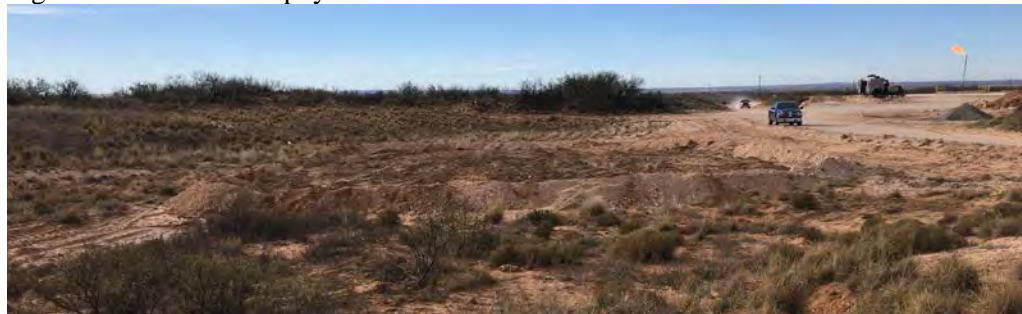
Figure 3 – Constructed phyto-remediation cell on 12-13-16.

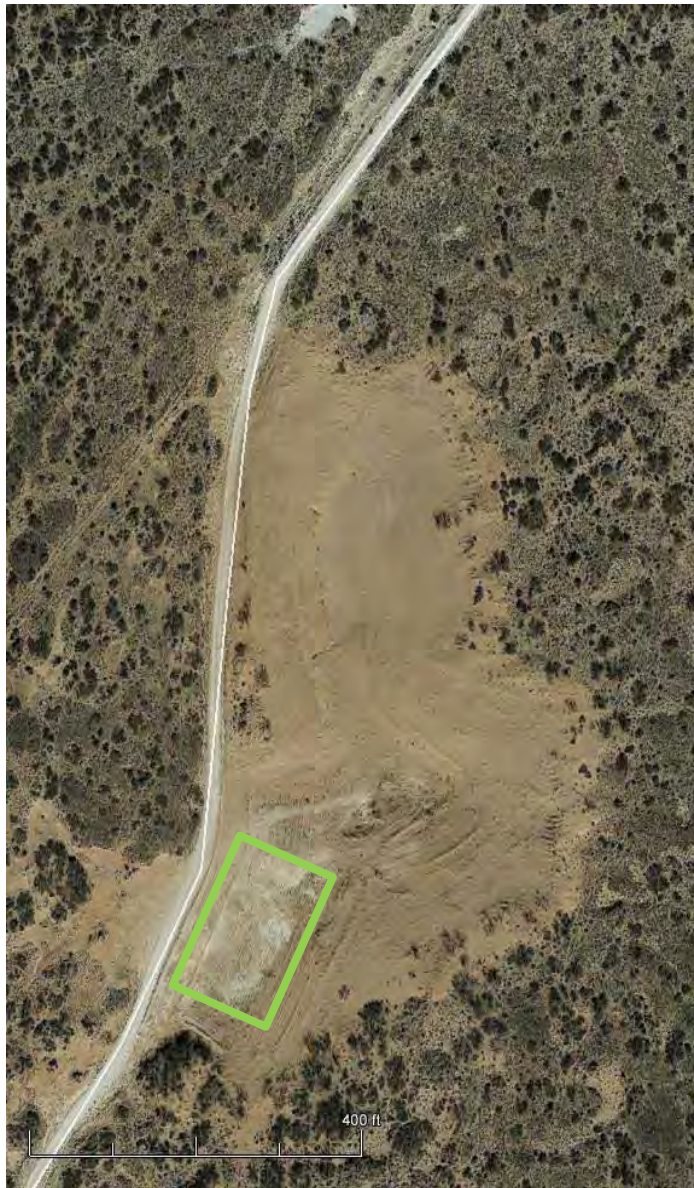
Figure C-1 – Location of phyto-remediation cell (green outline) in restored caliche pit. This area is exposed caliche and would benefit from the addition of sand/soil and seeding as proposed. Phytoremediation, not Micro-Blaze treatment is proposed for this cell.

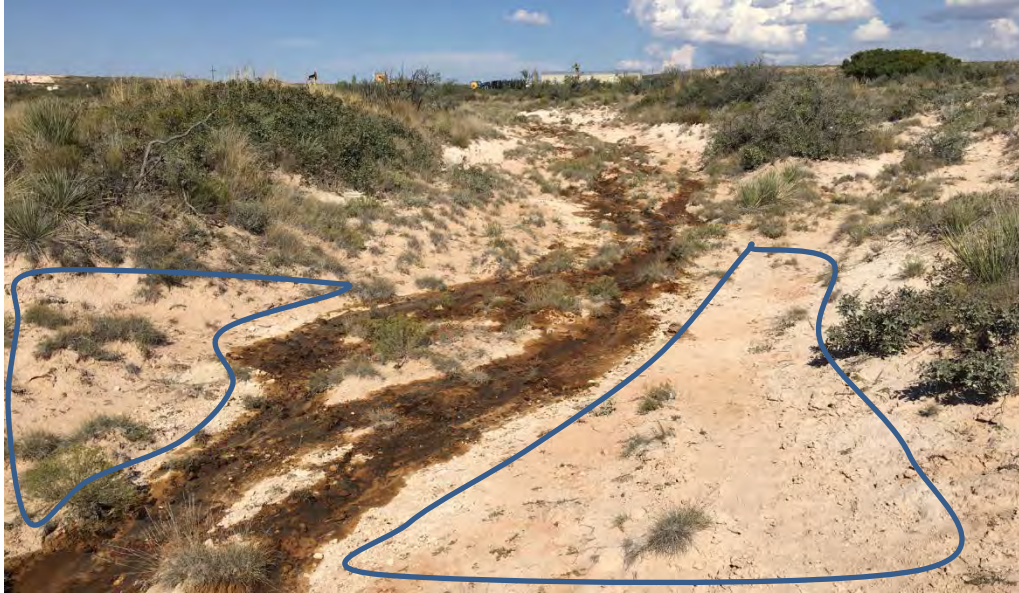
Figure C-2 – Crude footprint in abandoned road “drainage” is limited in extent. After disaggregation of the surface crude and mixing with underlying sand, the mixed material should be dispersed along the sides of the flow path. Areas outlined in blue can be covered with a 2-4 inch layer of the excavated crude/sand.

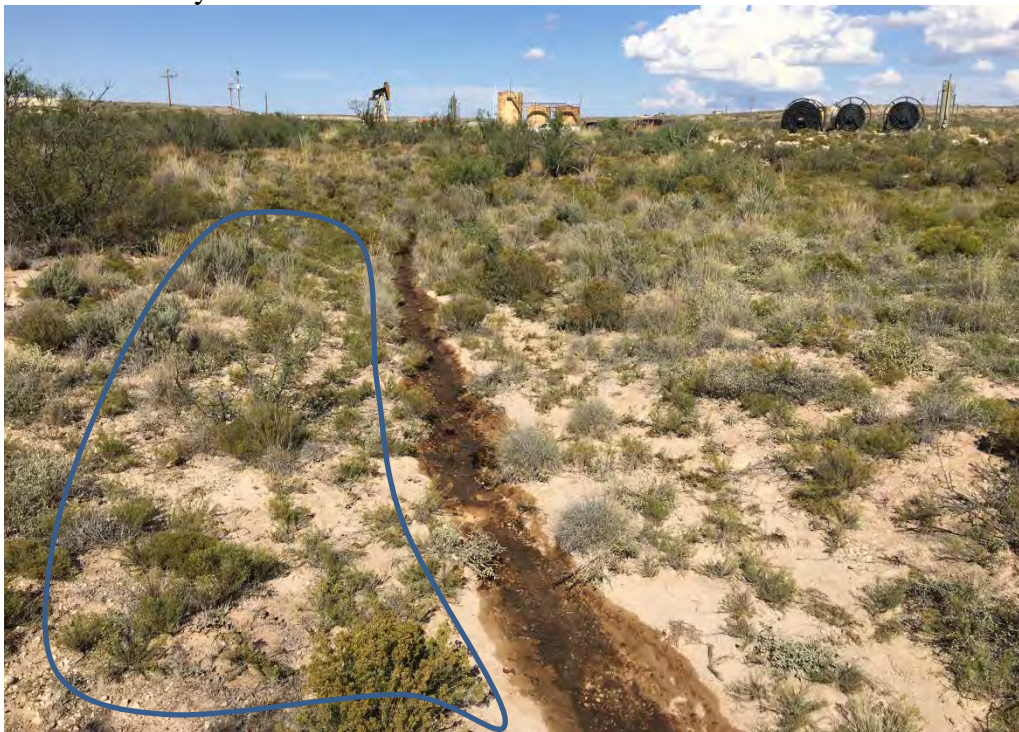
Figure C-3 Footprint of crude in highly vegetated area of abandoned road “drainage”. In these areas, mixing the crude with sand and disaggregation to less than ¼ inch size particles, which is the closure criteria, is critical. Once distributed into the vegetation, the crude/sand particles cannot be easily re-worked to meet closure criteria.

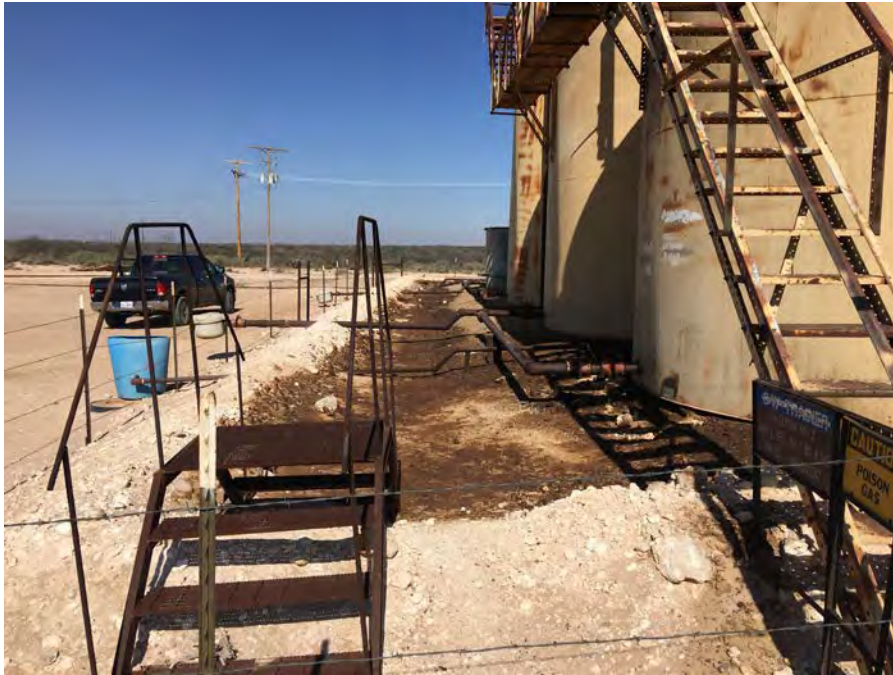
Figure 1: Southwest side of the tank battery showing the residual crude within the spill containment area. The fluids from the spill accumulated on this side of the containment and overflowed onto the location from the northwest side of the containment.

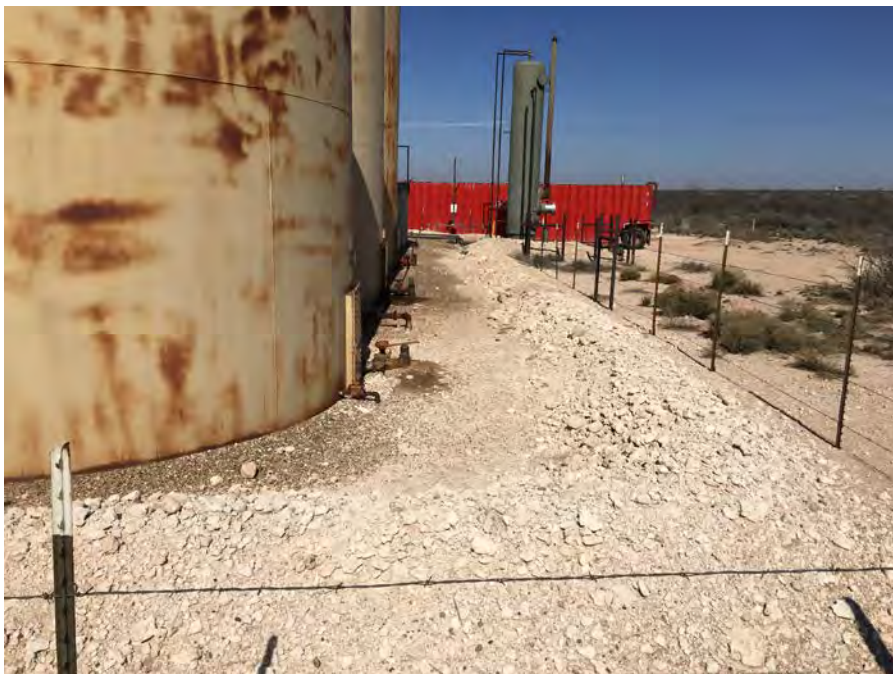
Figure 1b: Northeast side of spill containment area, which is slightly uphill from the southwest side where the fluids from the release accumulated then overflowed to the northwest.

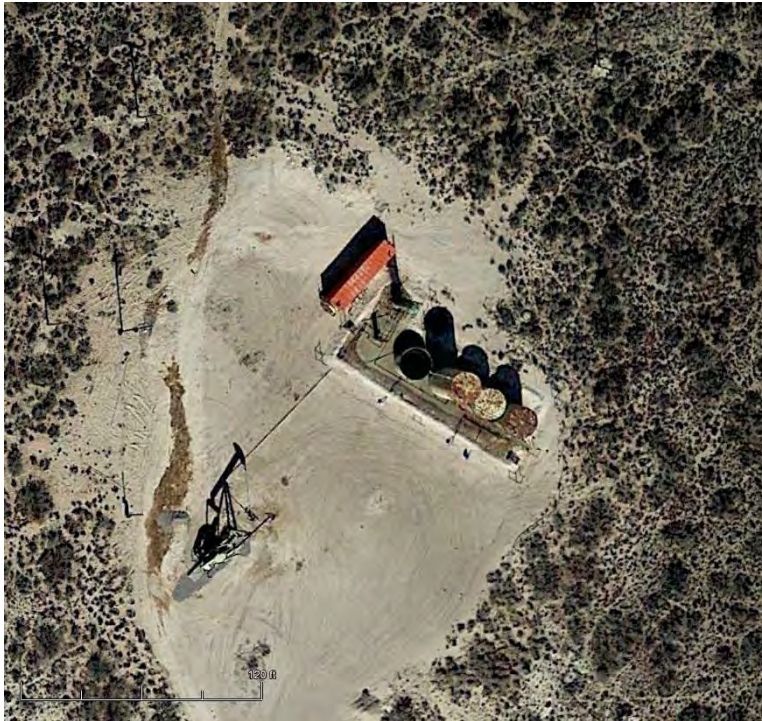
Figure 2 – This recent Google Earth image shows crude staining on the location as well as some staining off location on the abandoned dirt road on the northwest side of the image.

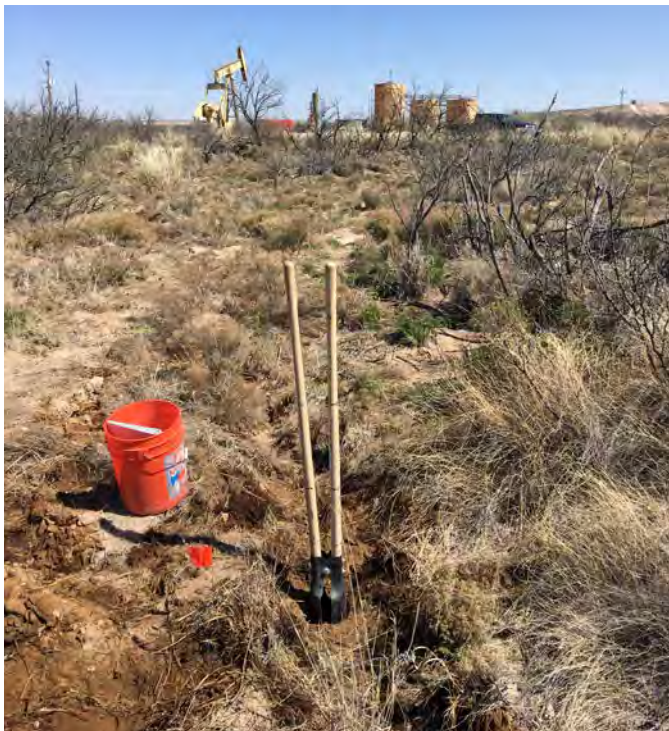
Figure 3 – This 3/23/17 image shows the location of sample SB-2. While the location of this sample relative to the of 10/25/2016 is not exact, the samples lie within feet of each other. Note that some residual staining remains.
